Inspection Photos
Location Name: Wray Mesa 36-34-47-20
API: 05-085-06049

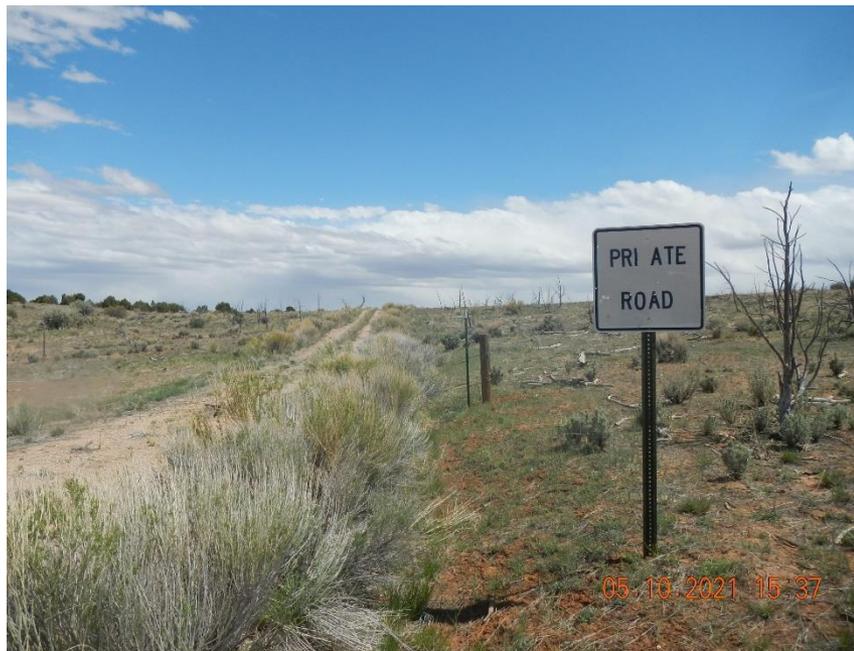
Private Road sign near intersection of access road and Road AA1.

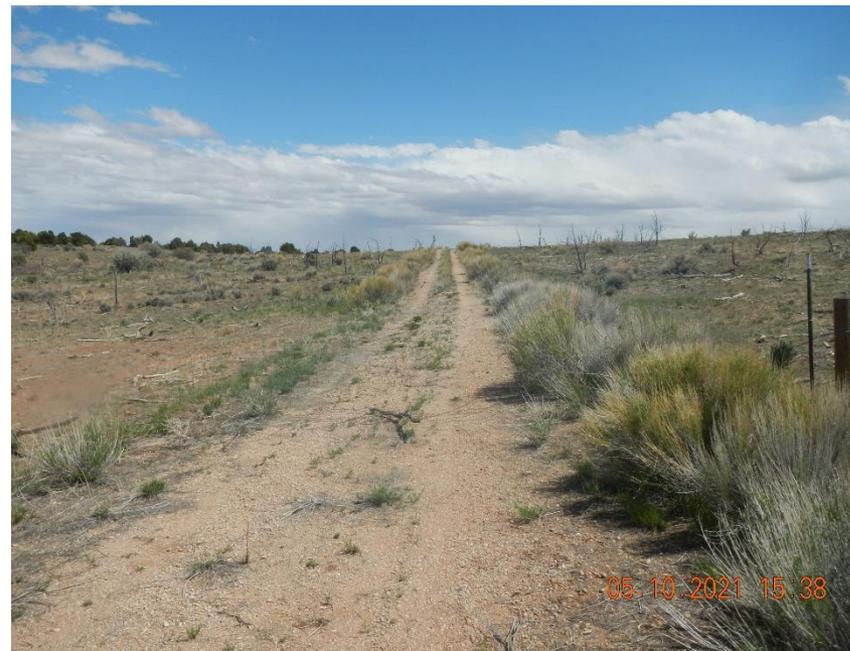
Entrance to access road from intersection of Road AA1.

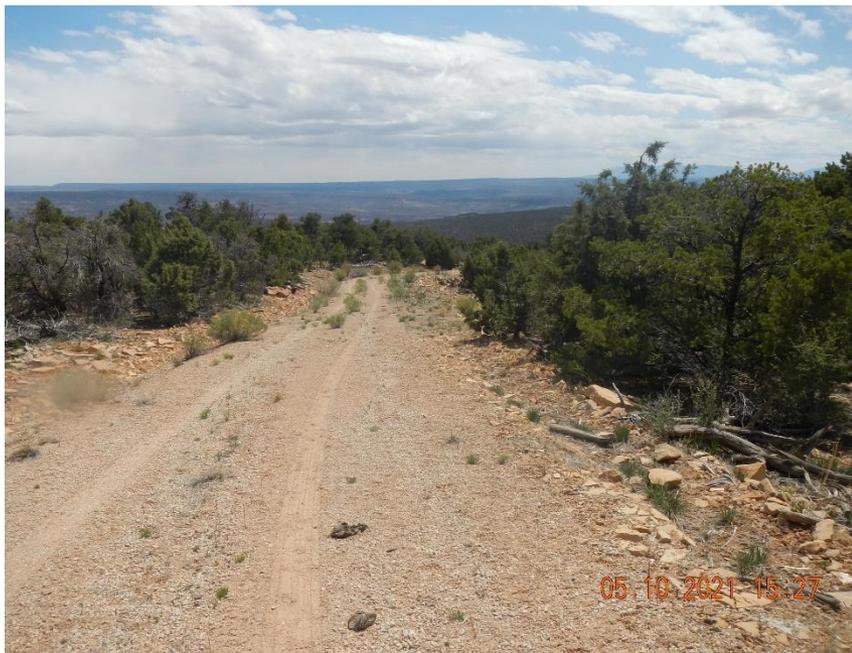
Access road to Wray Mesa 36-34-47-20 location.

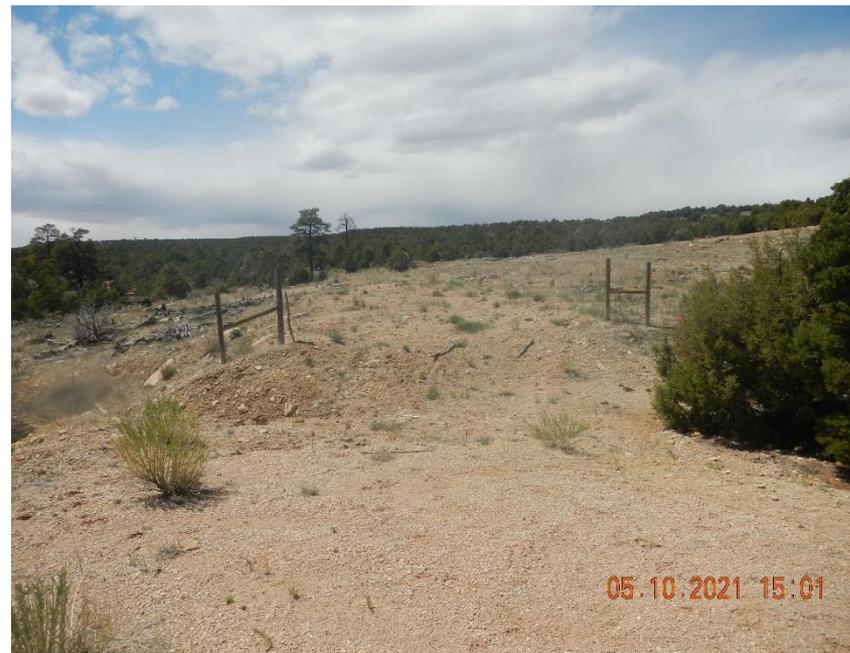
Entrance to location. Location drawings include a culvert at the location entrance. A storm water drainage channel was present at the time of this inspection.

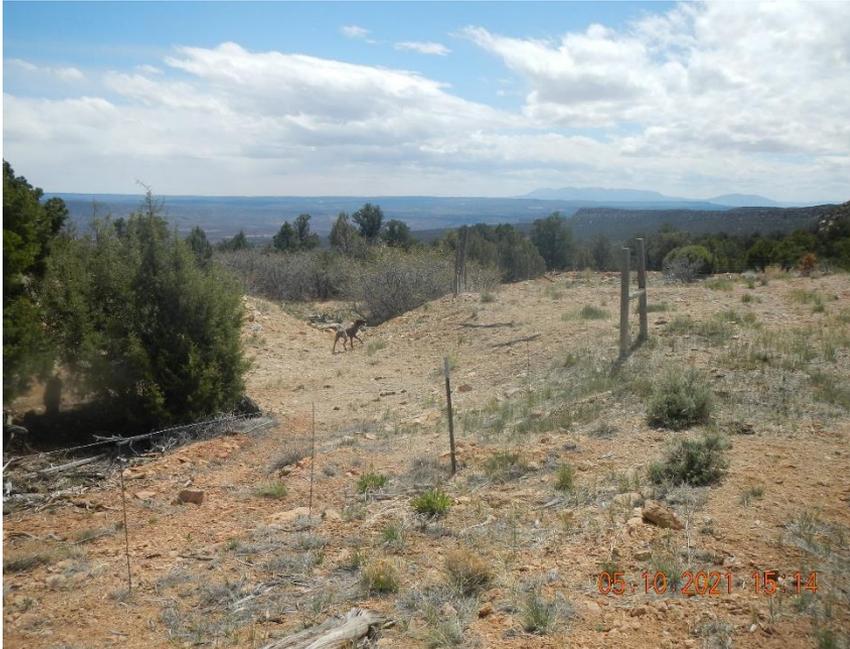
View of cut in access road at location entrance.

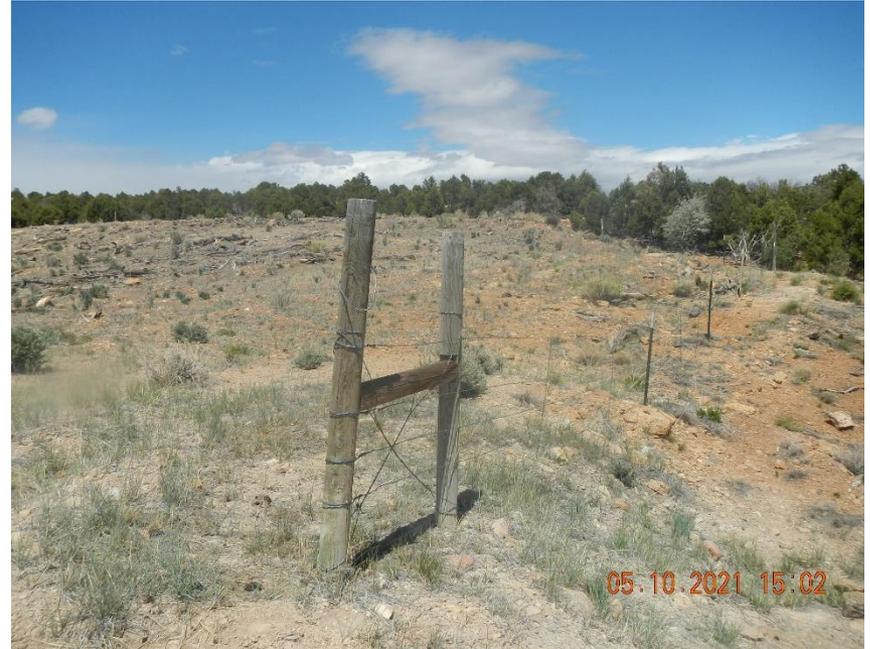
Location has perimeter fencing. Gate was down at the time of this inspection.

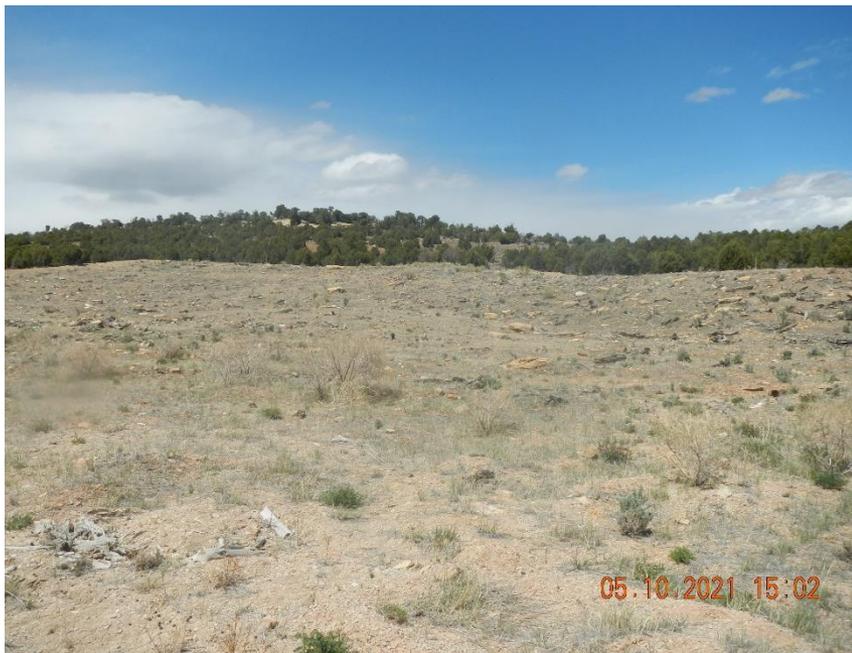
Location photo facing NW from location entrance.

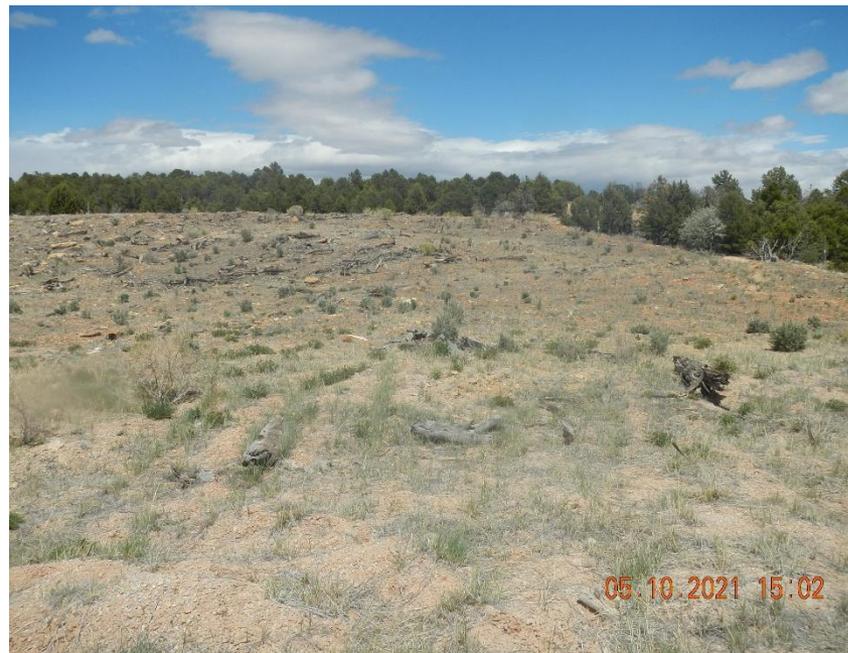
Southeast edge of location.

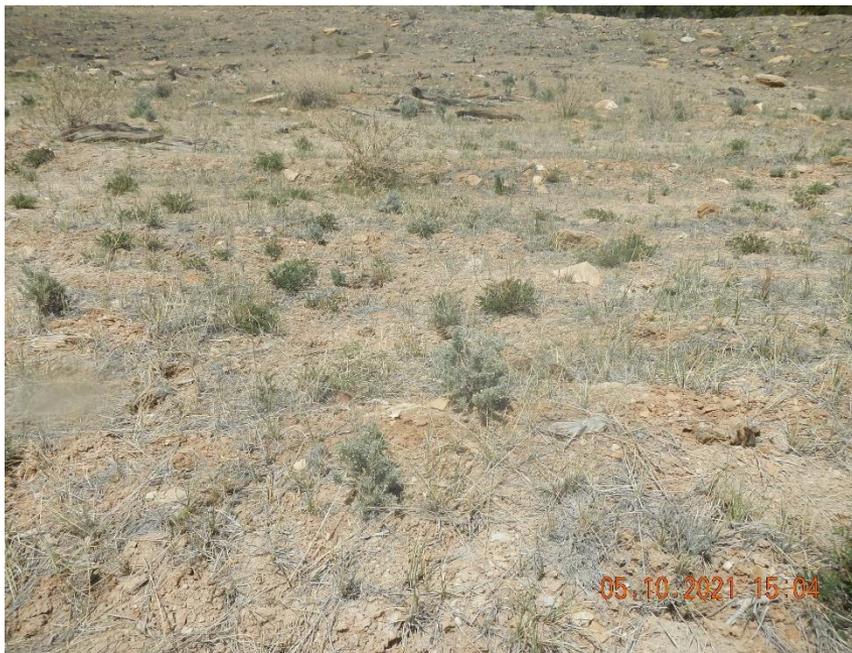
Typical vegetation within reclaimed area.

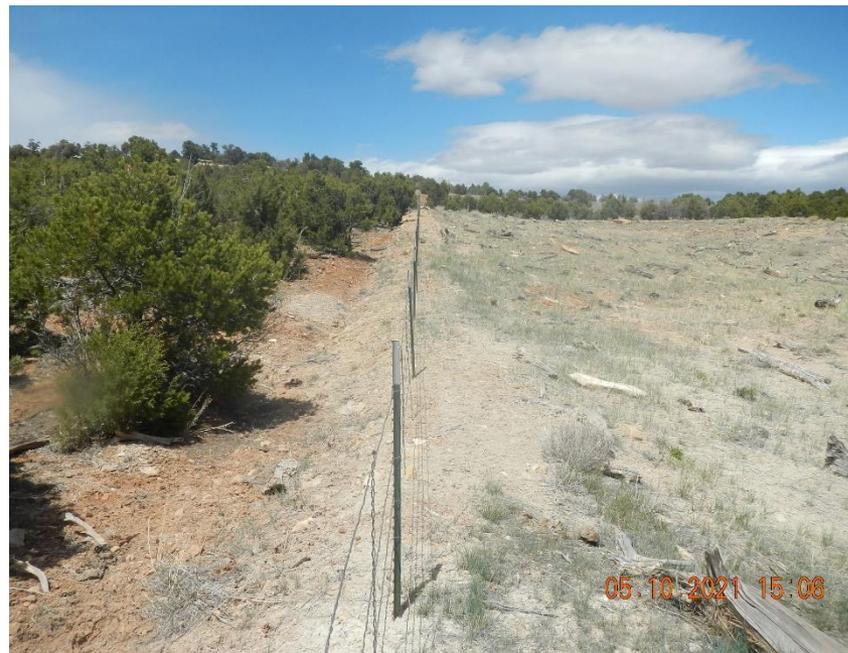
Northwest edge of location.

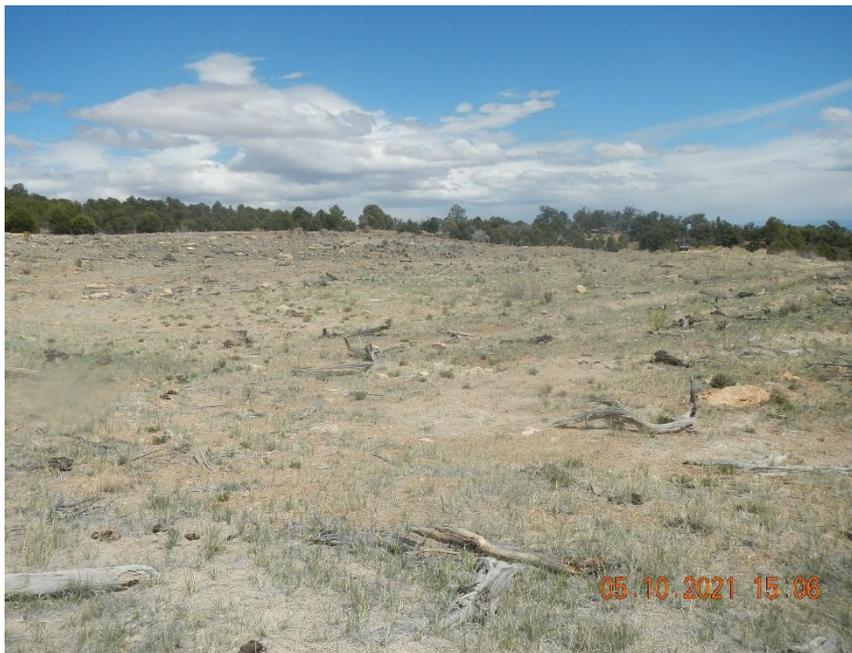
Location photo facing east.

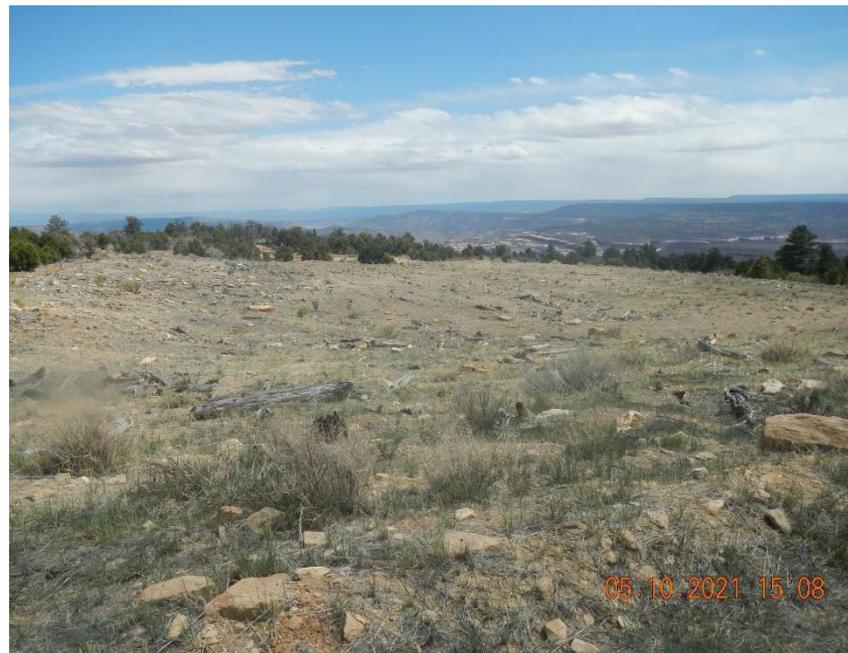
Location overview facing south.

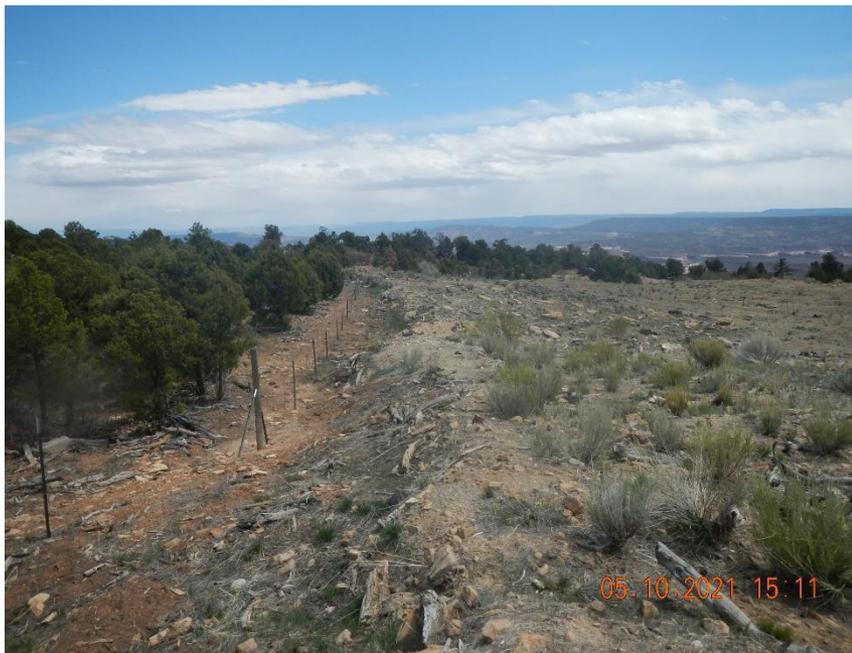
Northeast edge of location.

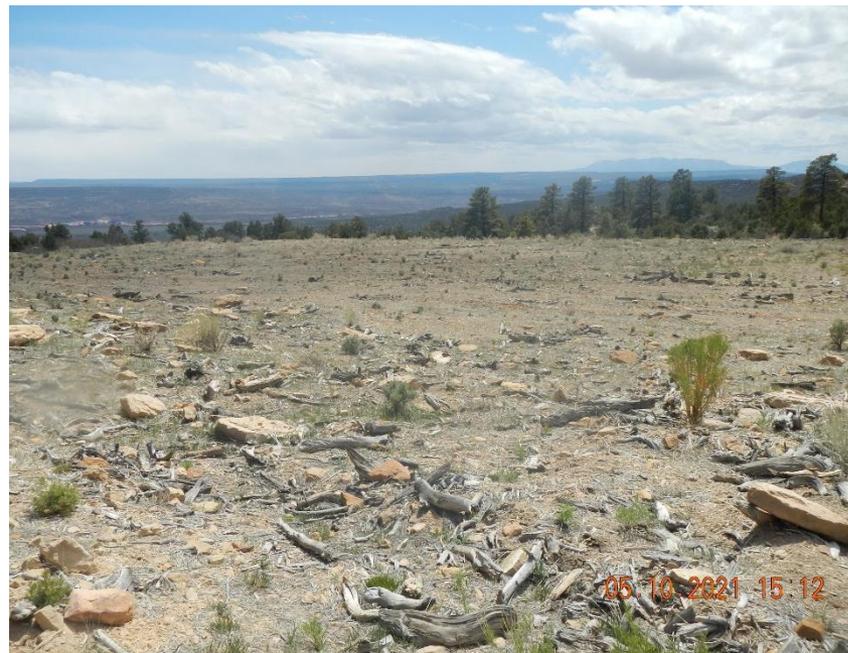
Location photo facing southwest.

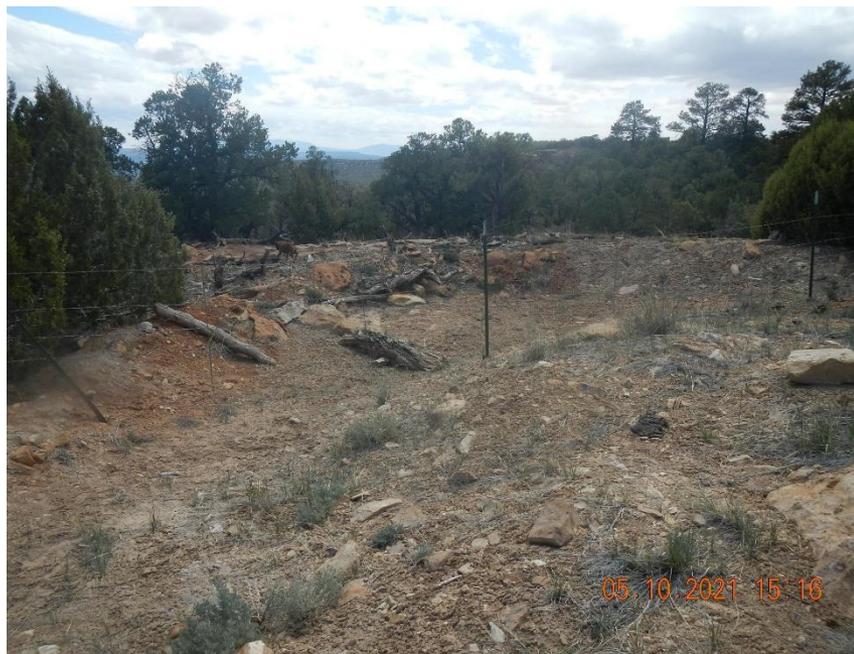
Sediment trap in south corner of location.

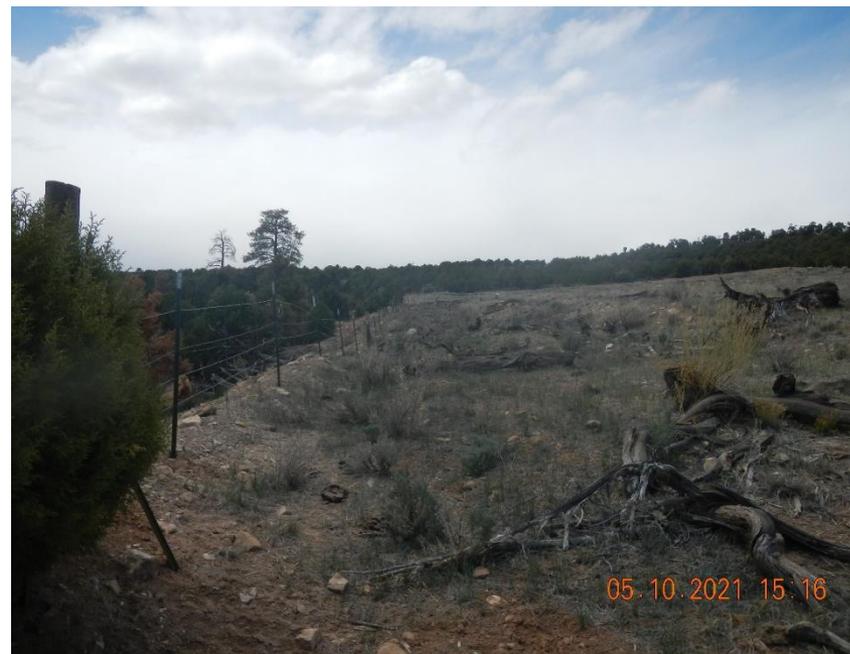
Location photo facing northwest.
