Inspection Photos
Location Name: Greeley Gas Plant
Location ID: 255957

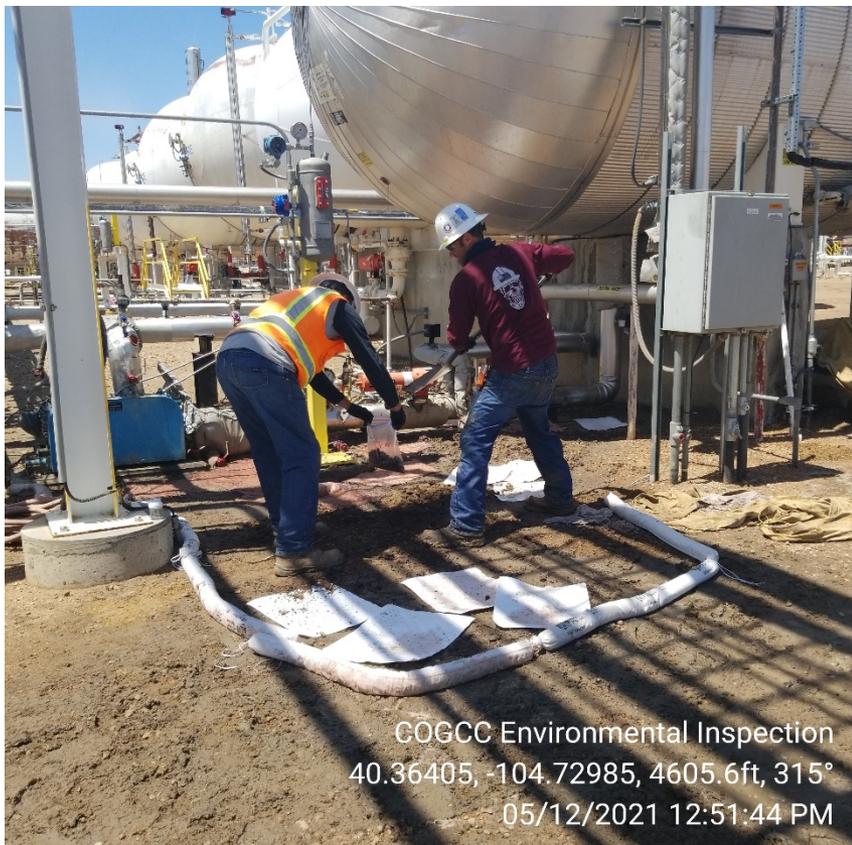
Photo 1 – Release source area: A ½” nipple valve broke, releasing condensate from a loading pump. Condensate mixed with rain water and spread across location.

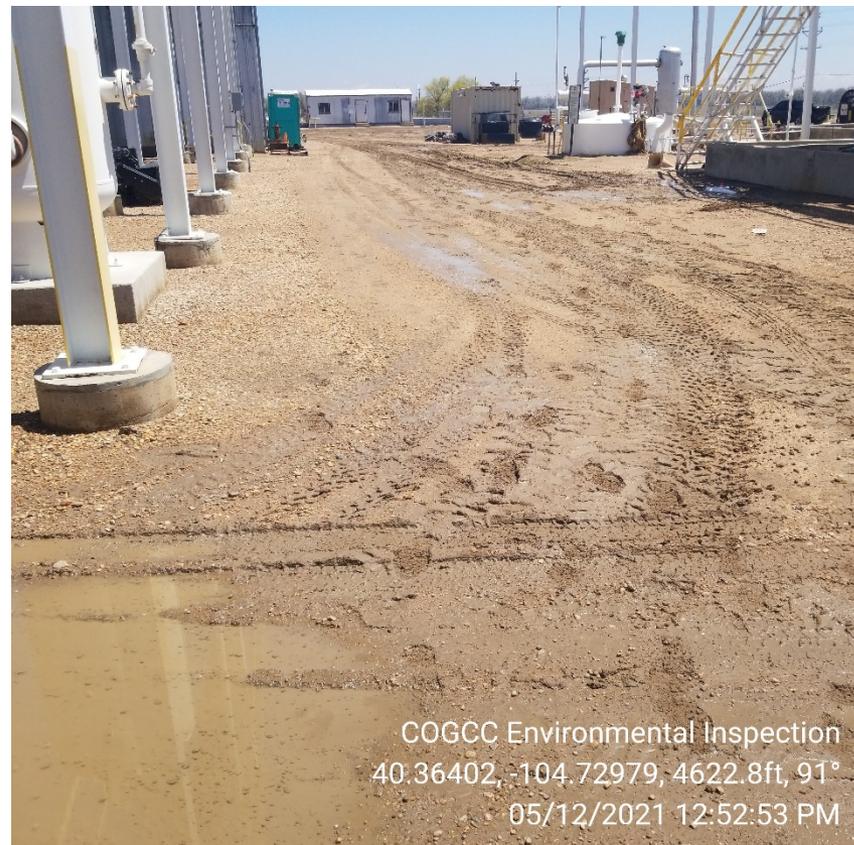
Photo 2 – Eastern pathway of the release.

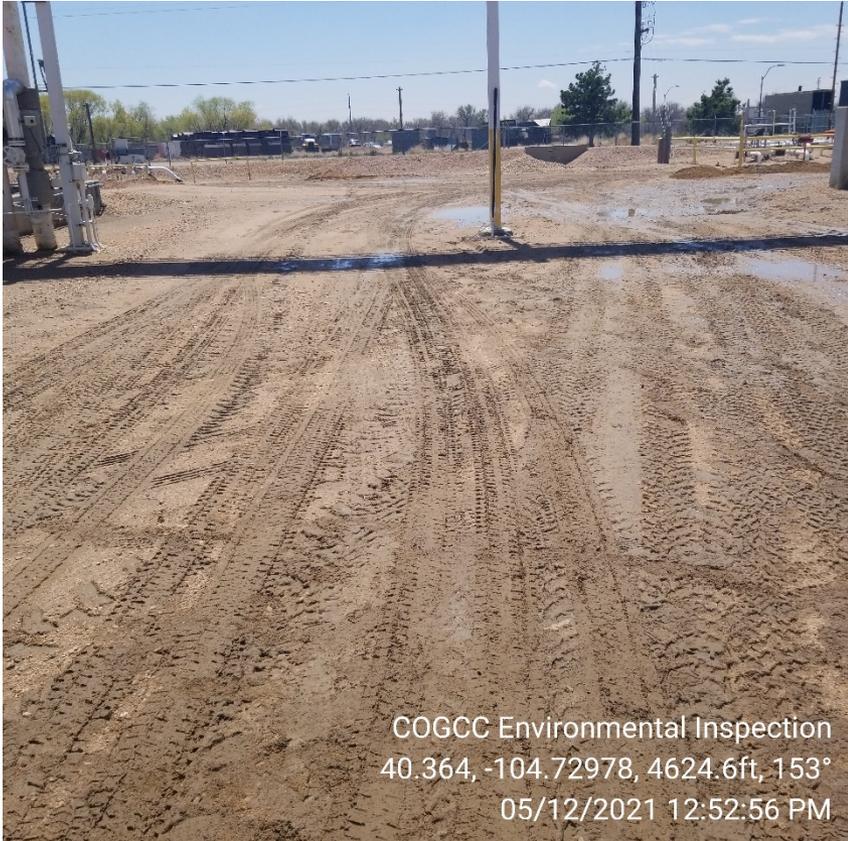
Photo 3 – Southern pathway of the release.

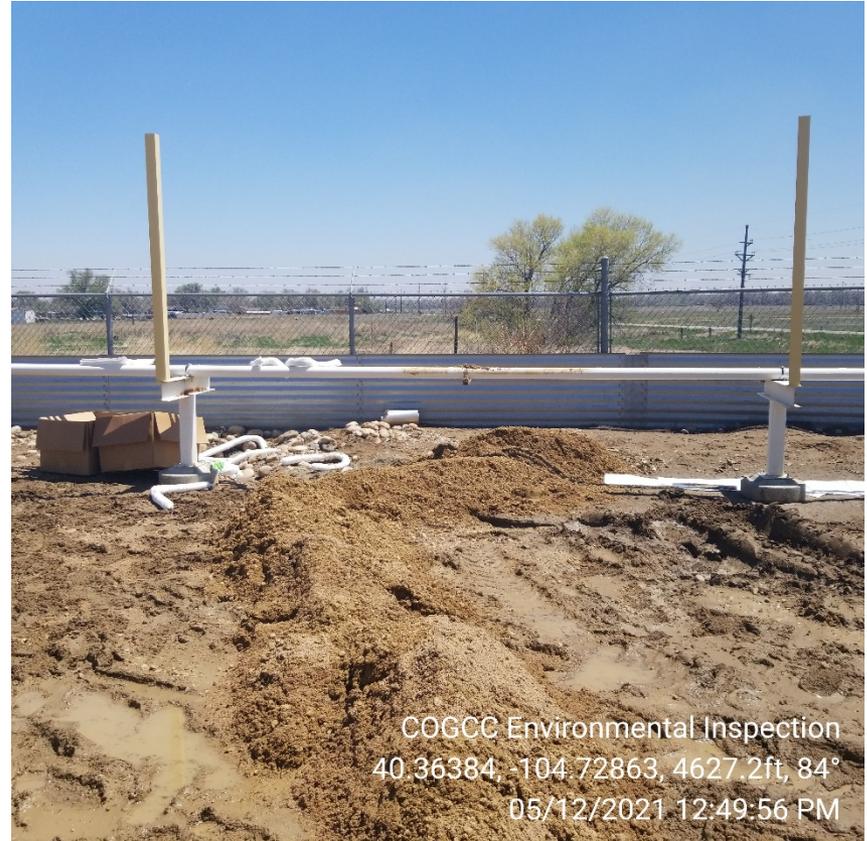
Photo 4 – Eastern terminus of the release. Impacts seeped under perimeter spill controls.

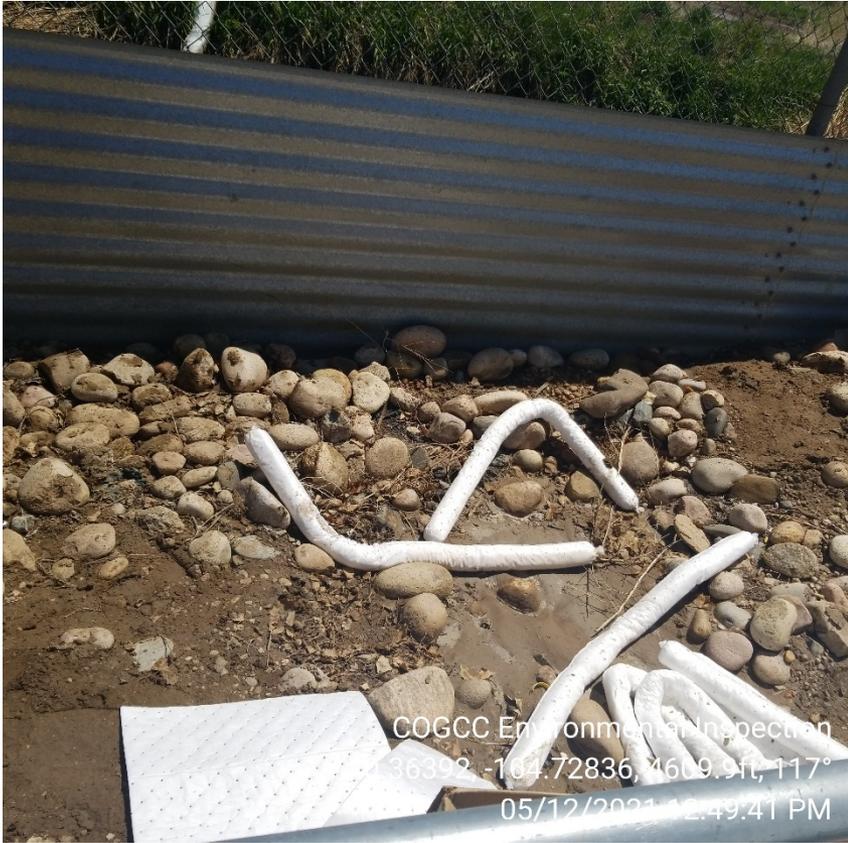
**Photo 5 – Eastern terminus of the release.
Impacts seeped under perimeter spill controls.**

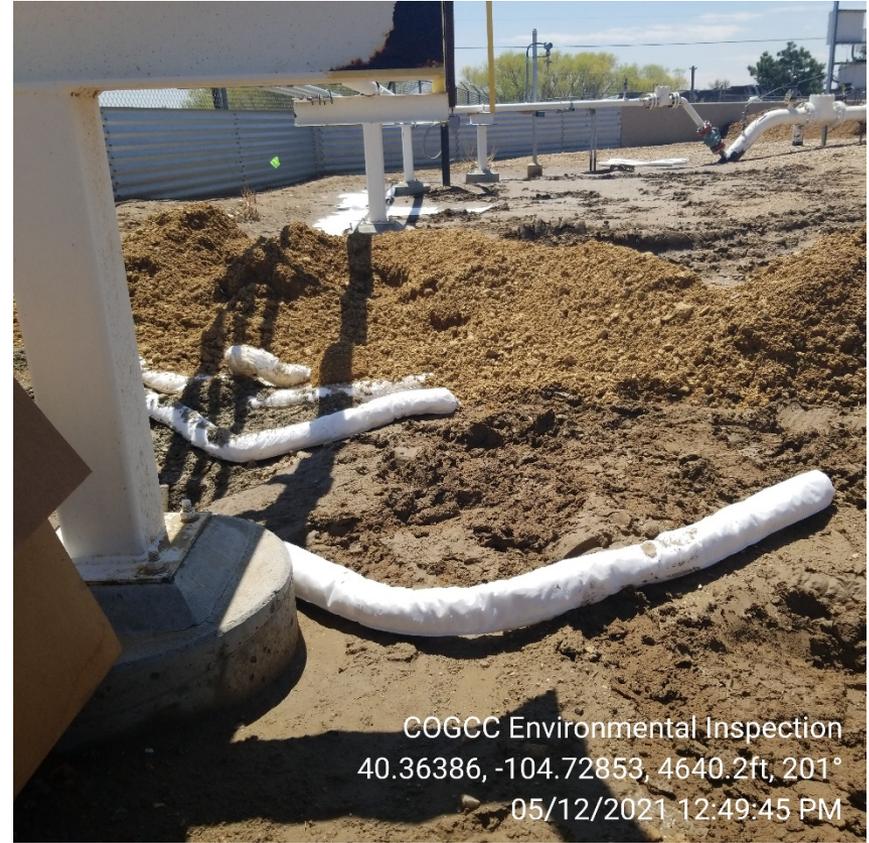
**Photo 6 – Southeastern terminus of the release.
Impacts seeped under perimeter spill controls.**

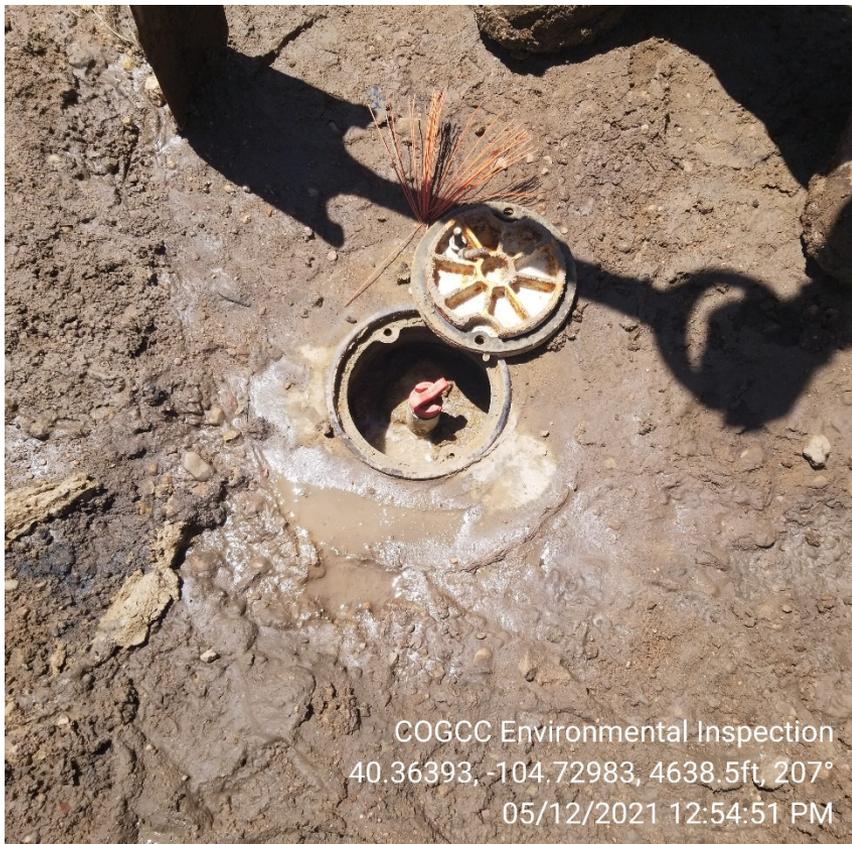
Photo 7 – The monitoring well network for Remediation Project #12644 was in the path of the flow. As of inspection all wells were visually inspected and were not impacted. Water will be sampled from these wells as part of spill cleanup.

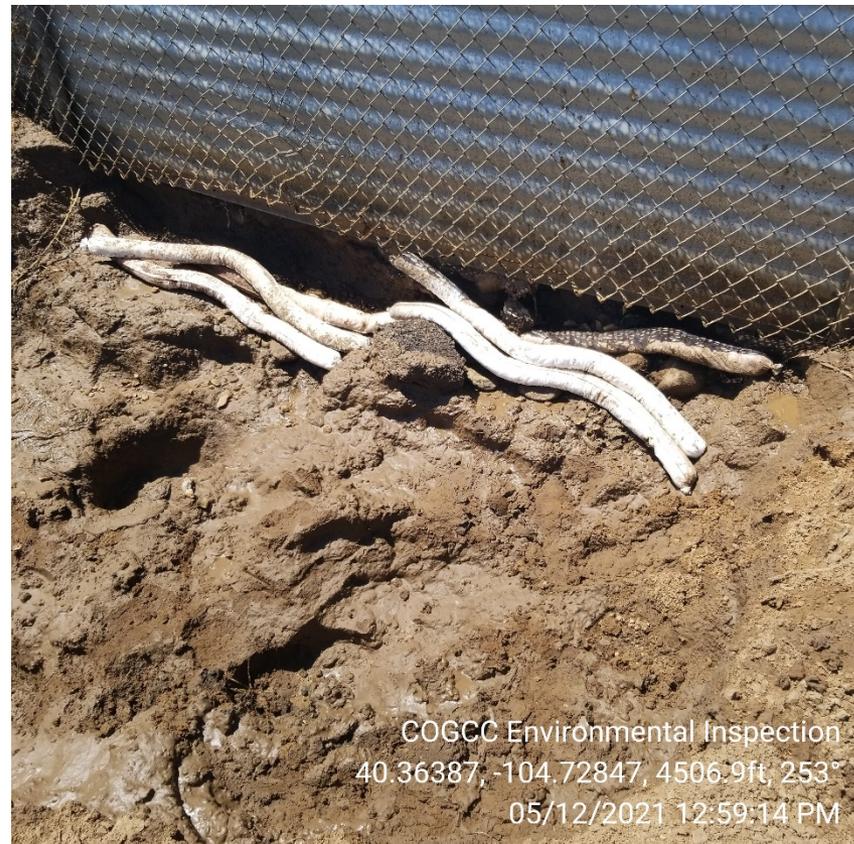
Photo 8 – Eastern terminus of spill outside of facility where impacts seeped under perimeter spill control.

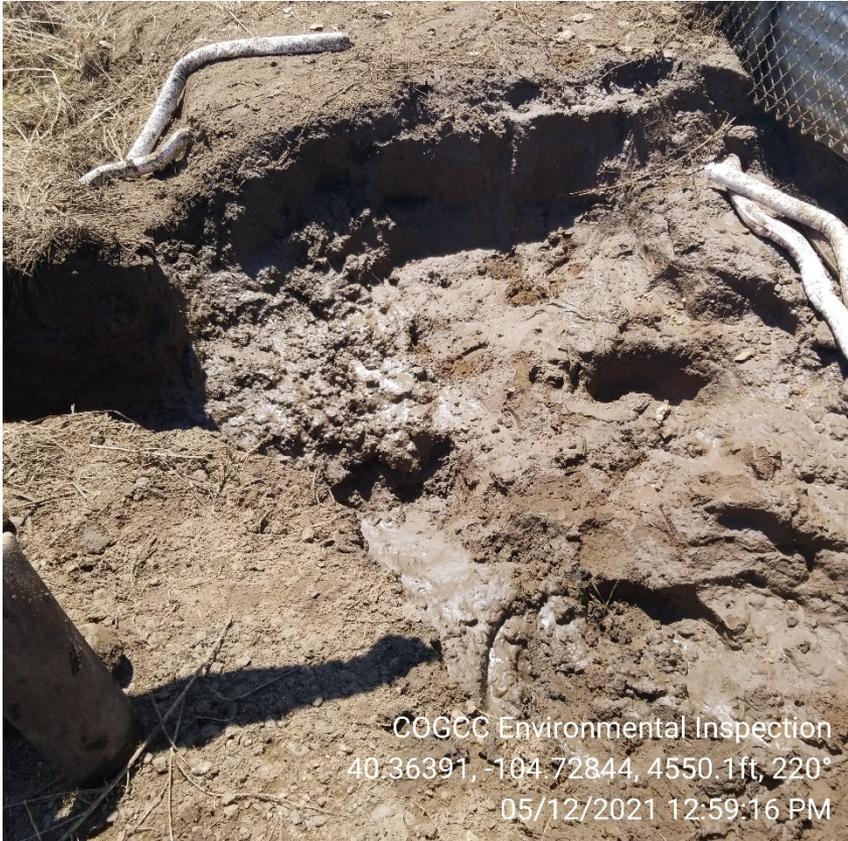
Photo 9 – Soil impact cleanup at eastern terminus of spill.

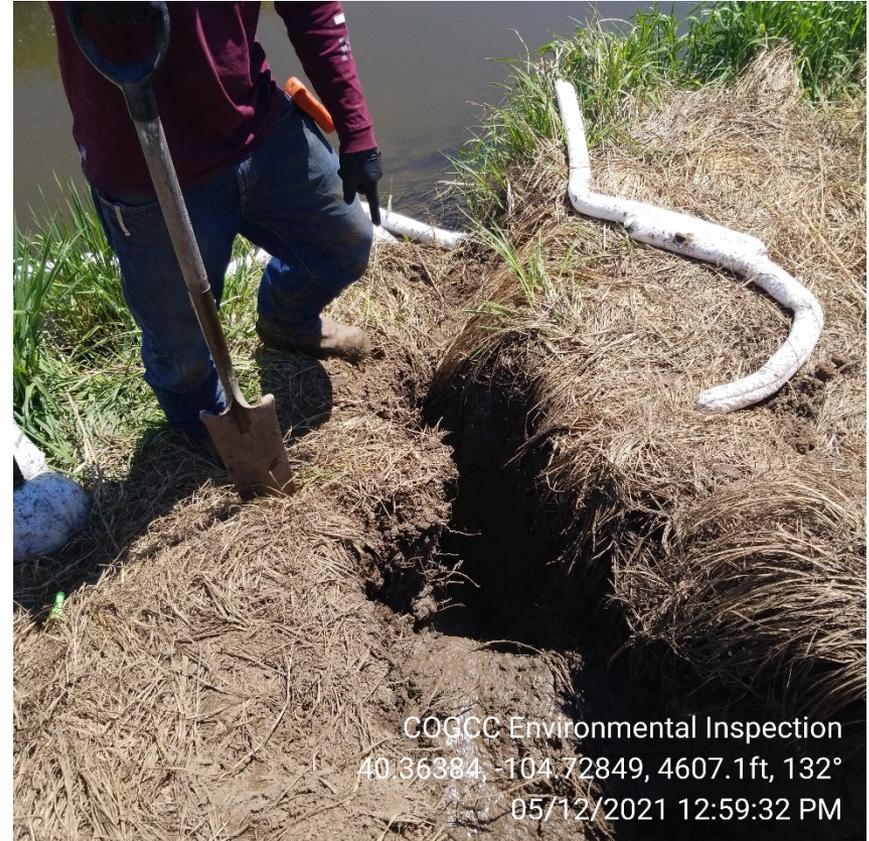
Photo 10 – Soil impact cleanup at eastern terminus of spill. Canal and booms in background.

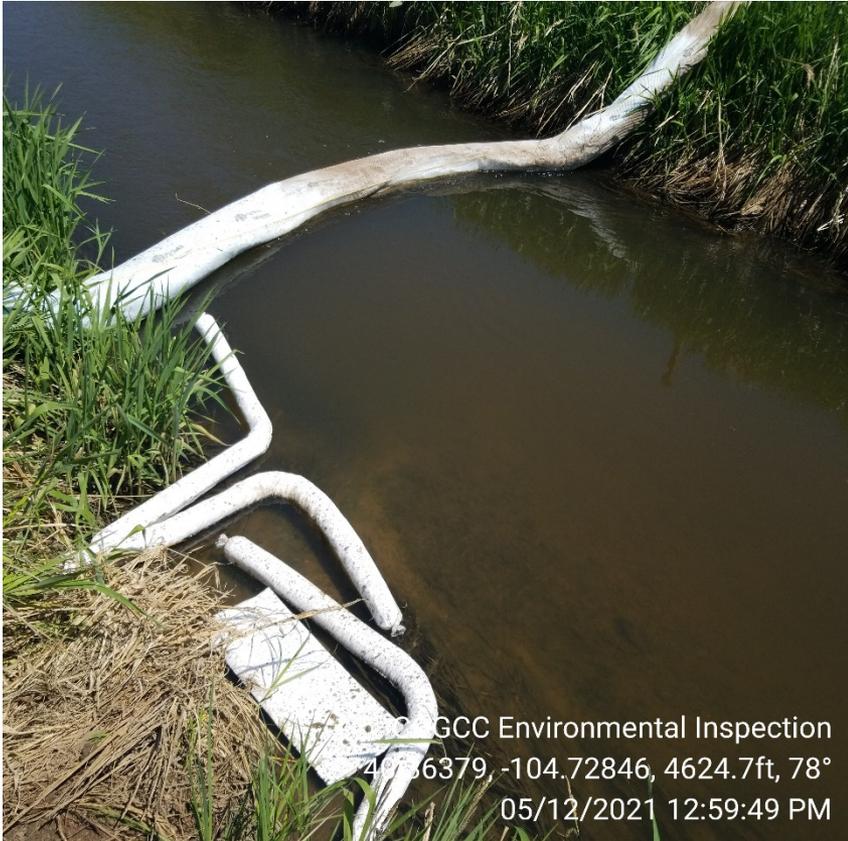
Photo 11 – Booms deployed in irrigation ditch to control hydrocarbons

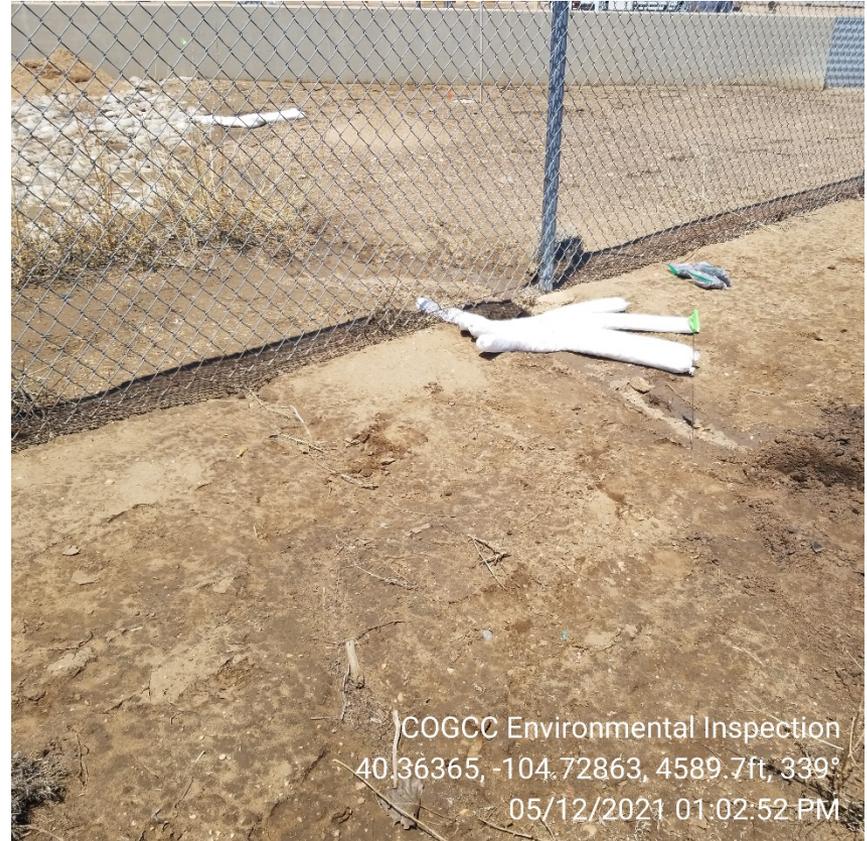
Photo 12 – Southern terminus of spill outside of facility.

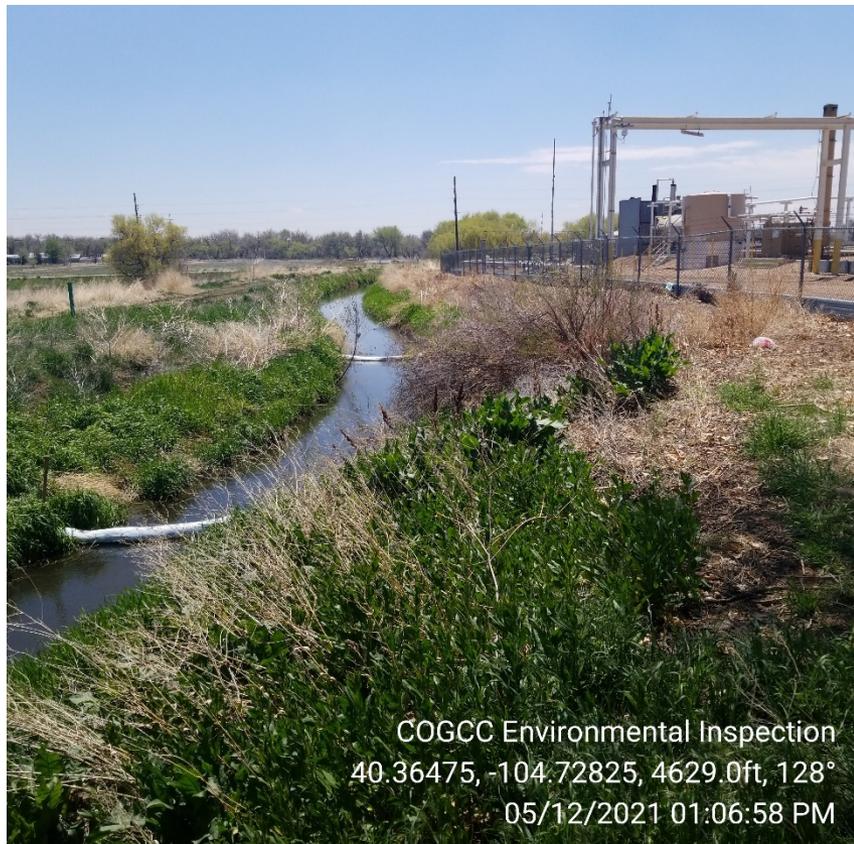
Photo 13 – Additional booms deployed down downstream of spill.

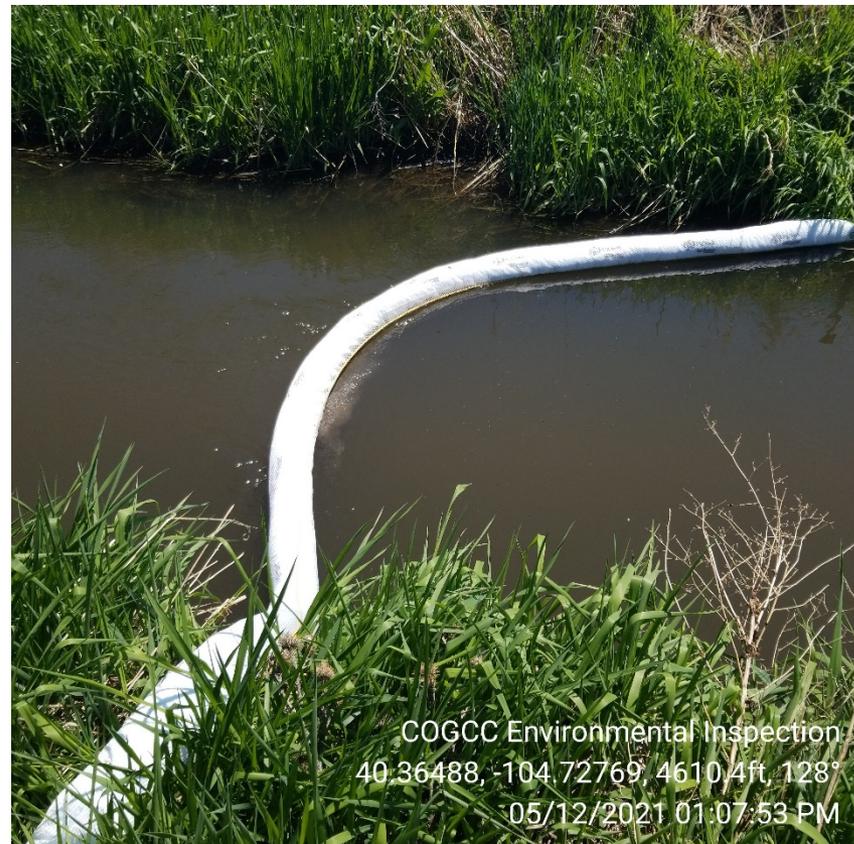
Photo 14 – Boom immediately down gradient of release area.

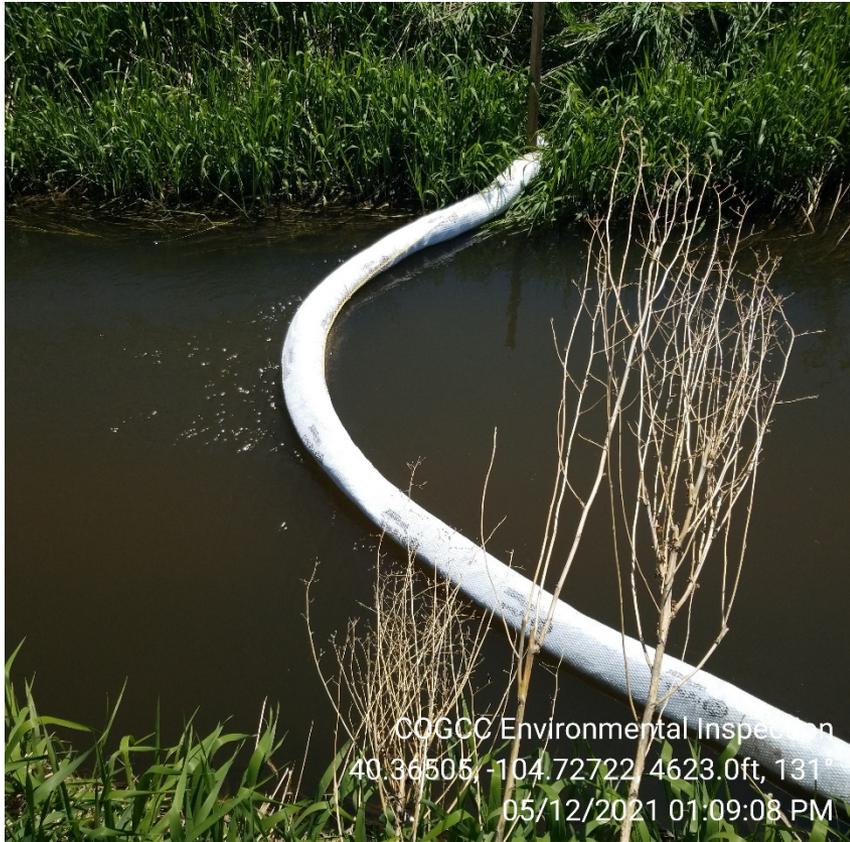
Photo 15 – Final downstream boom. All material caught in boom appears to be organic material from canal.

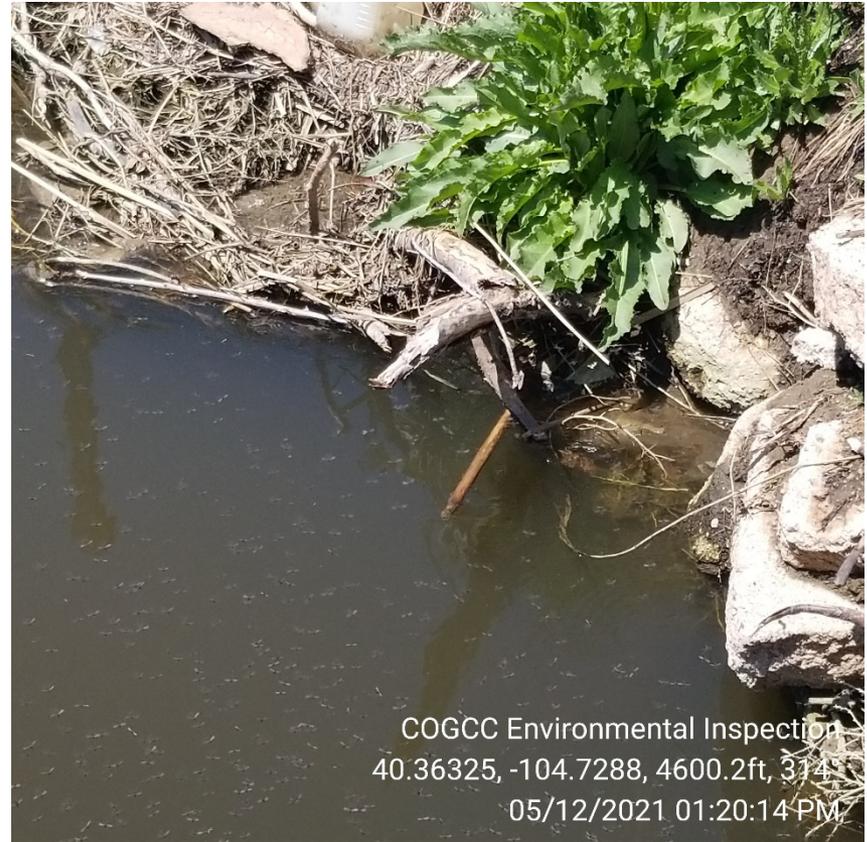
Photo 16 – Up gradient of spill; organic material present.
