Inspection Photos
UPRR 43 PAN AM G Consolidation #2
Remediation Project #16131/Spill ID 478086 (CL)

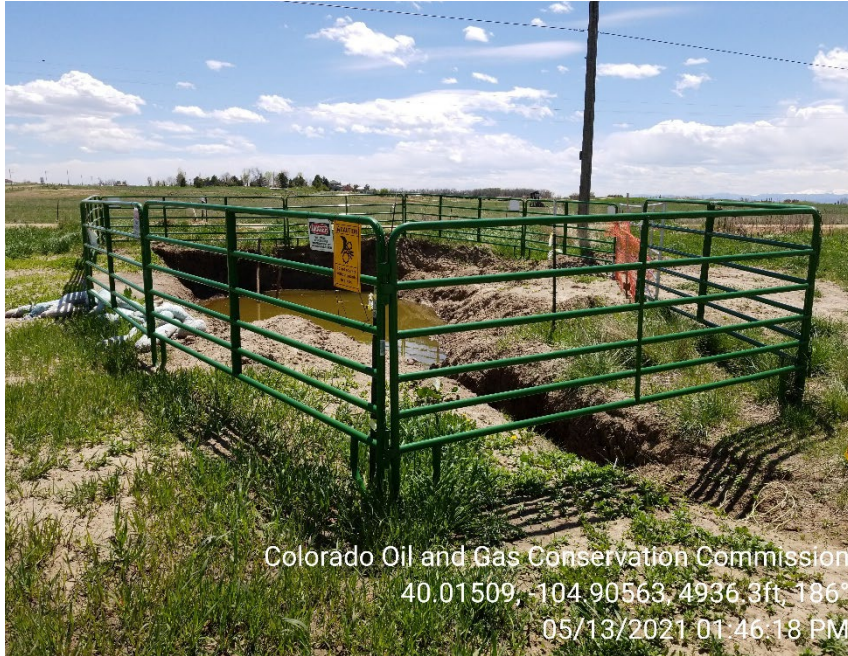
Photo 1 – Spill area with open excavation.

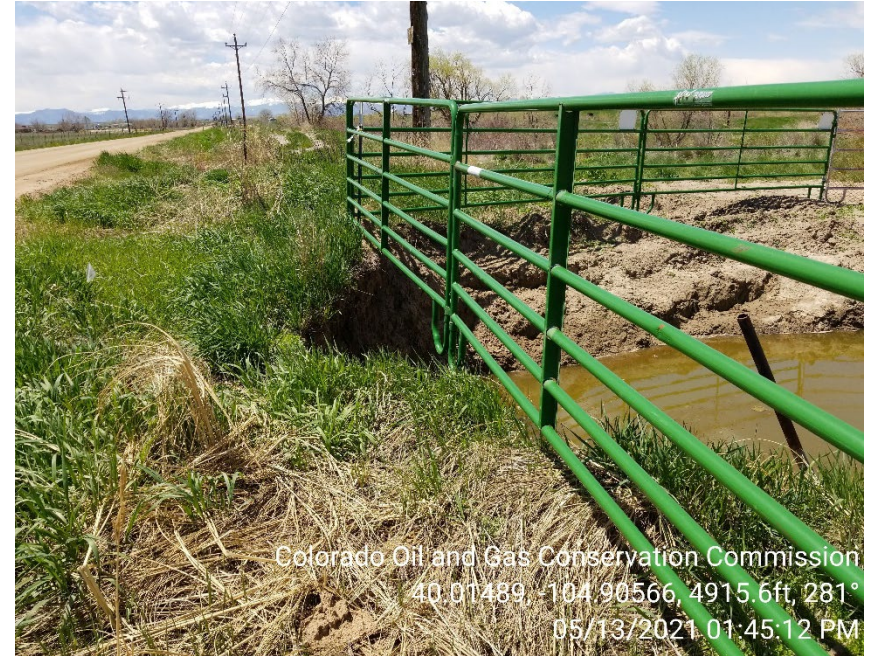
Photo 2 – Fencing around open excavation does not adequately protect access to the site.

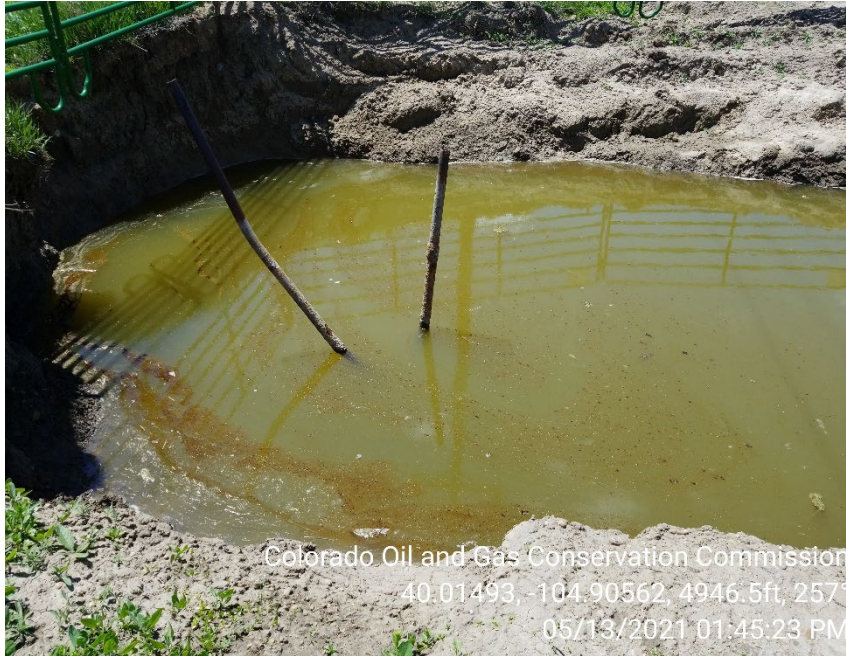
Photo 3 – Open excavation. Impacts appear to remain in situ. Hydrocarbons observed on groundwater.

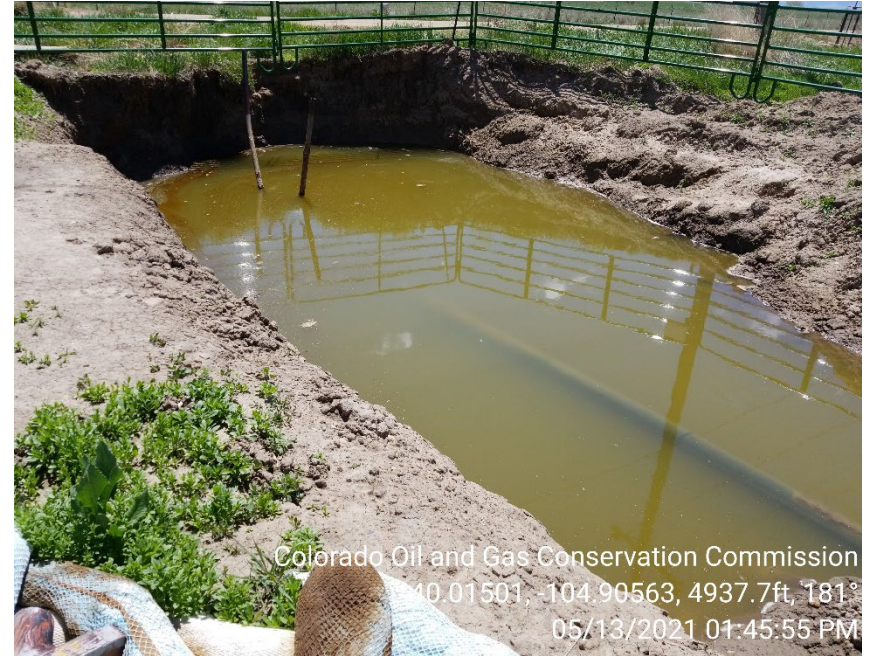
Photo 4 – Open excavation. Impacts appear to remain in situ. Hydrocarbons observed on groundwater.

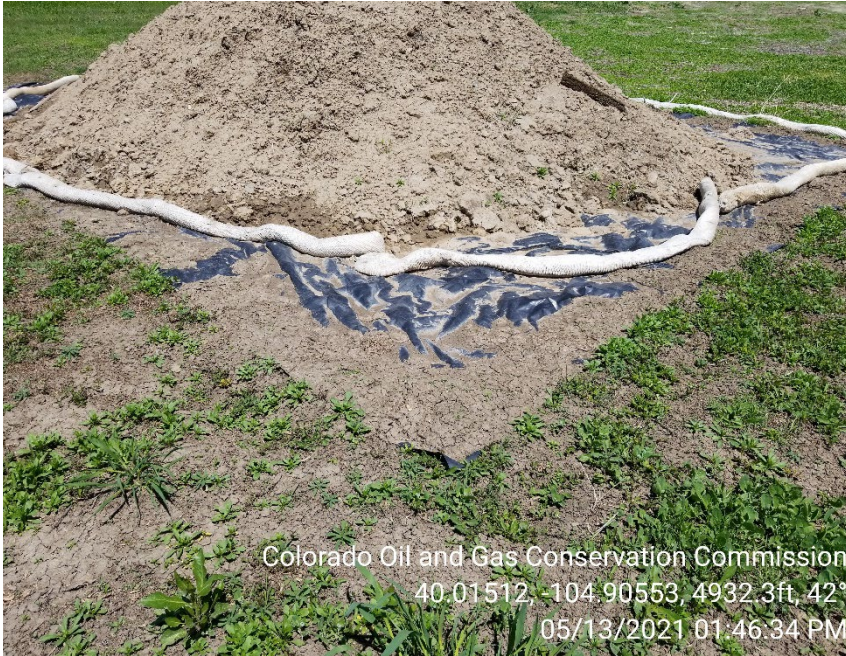
Photo 5 – Soil stored on location. Lining present under soil stockpile but BMPs are inadequate to prevent stormwater runoff.

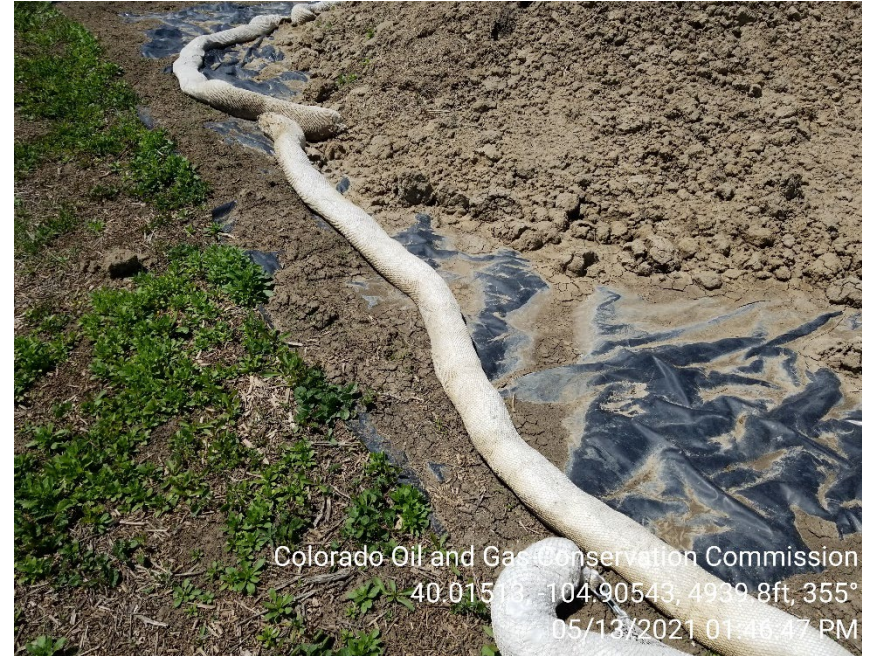
Photo 6 – Soil stored on location. Lining present under soil stockpile but BMPs are inadequate to prevent stormwater runoff.

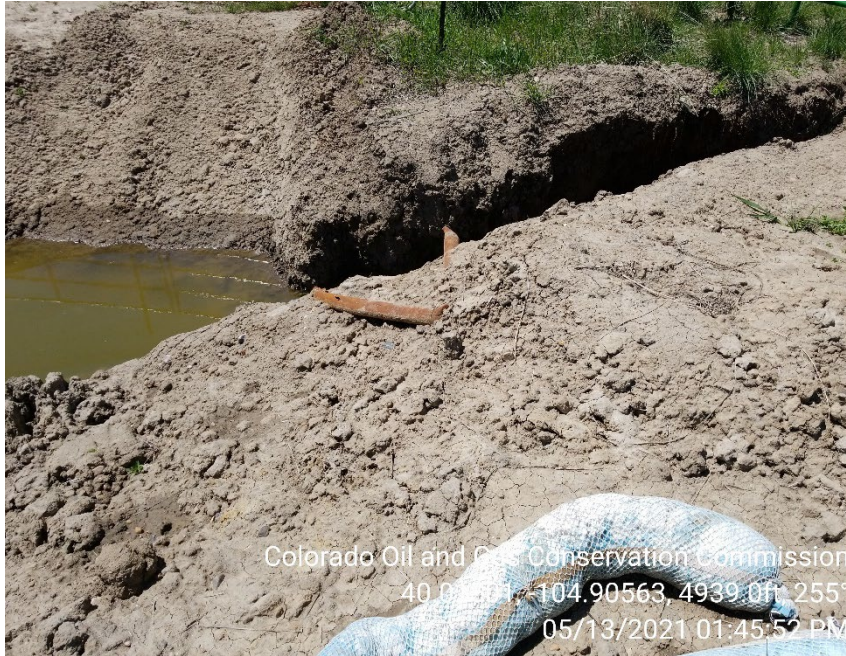
Photo 7 – Trash on location.

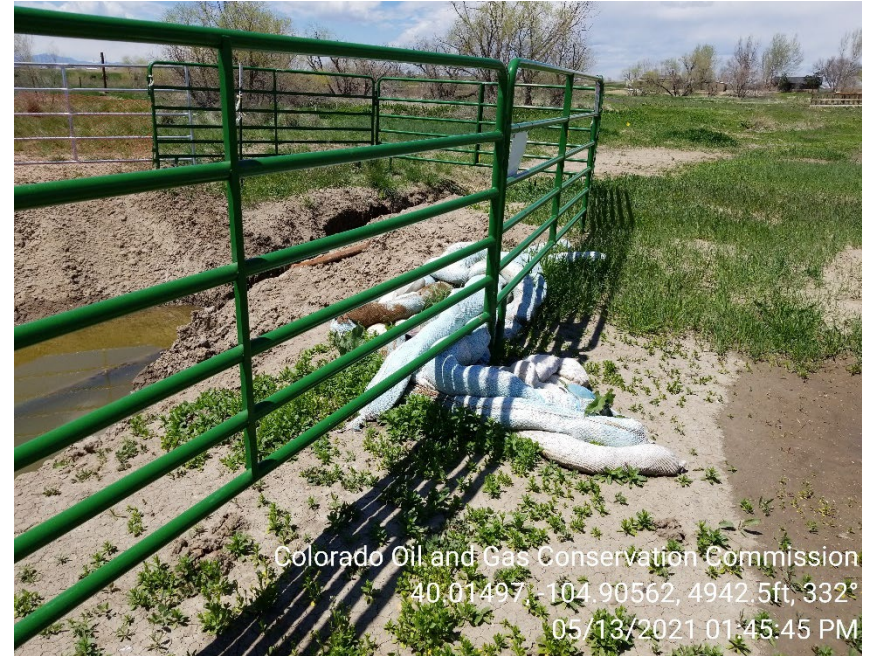
Photo 8 – Trash on location.
