Inspection Photos
Paul Heinze #1 Flowline
Spill ID 479232 (AC)

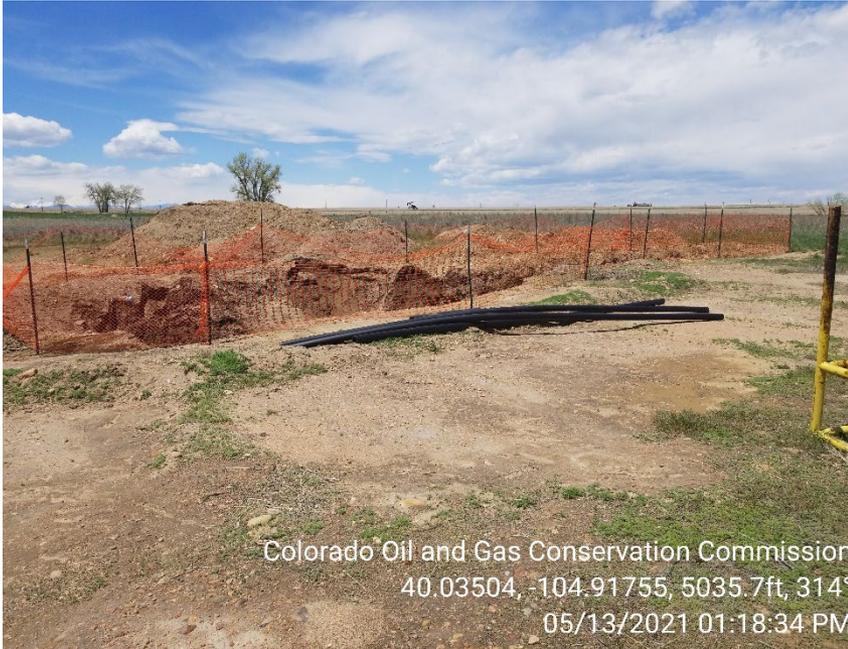
Photo 1 – Spill area. Trash on location.

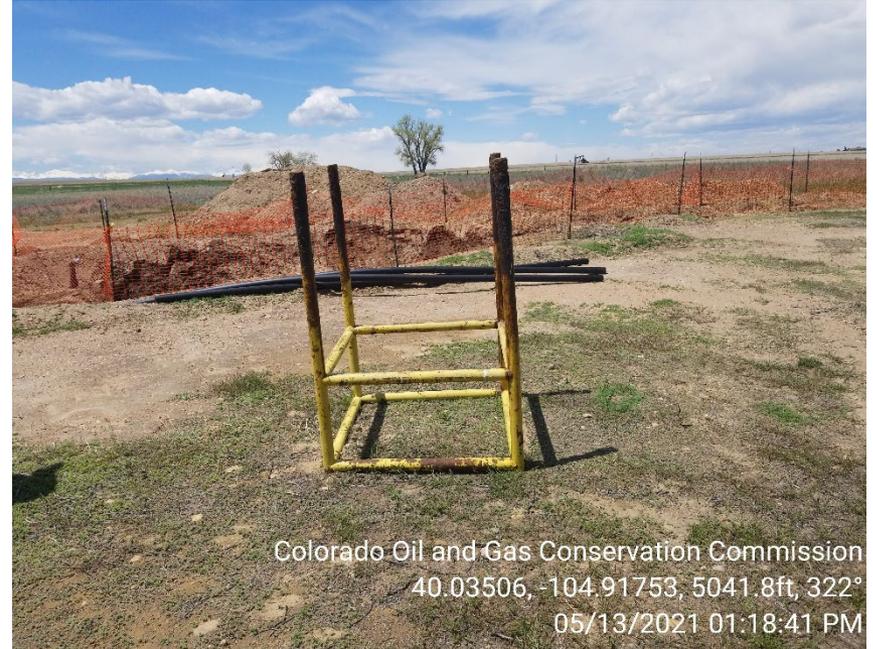
Photo 2 – Trash on location.

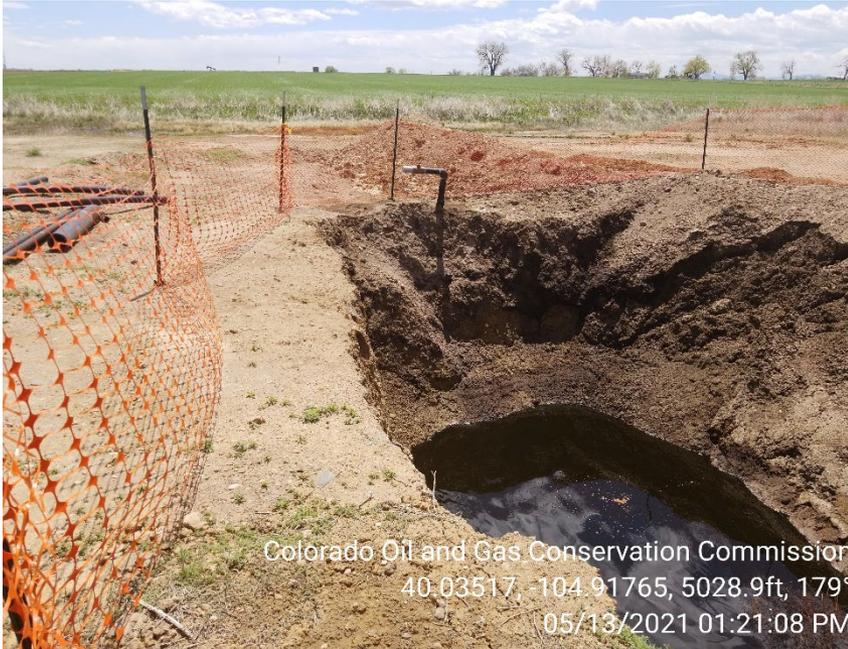
Photo 3 – Open excavation. Free product observed on groundwater. Impacts remain in situ.

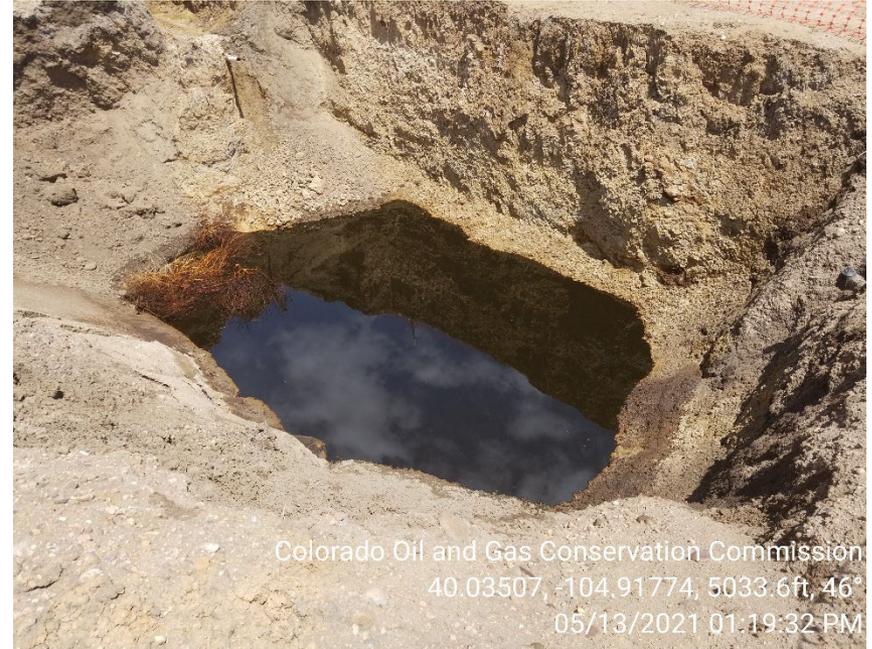
Photo 4 – Open excavation. Free product observed on groundwater. Impacts remain in situ.

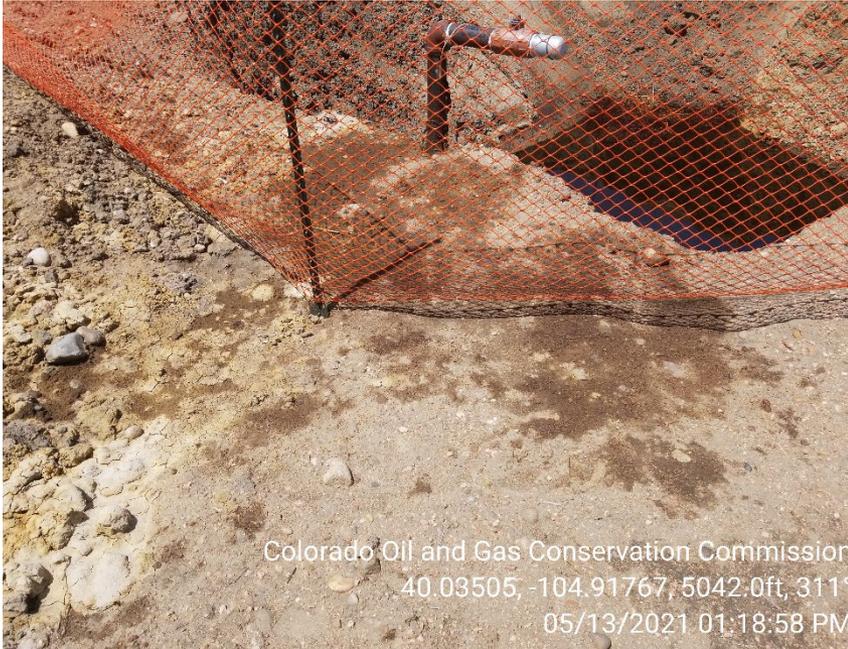
Photo 5 – Impacted soils remain on surface outside of excavation area.

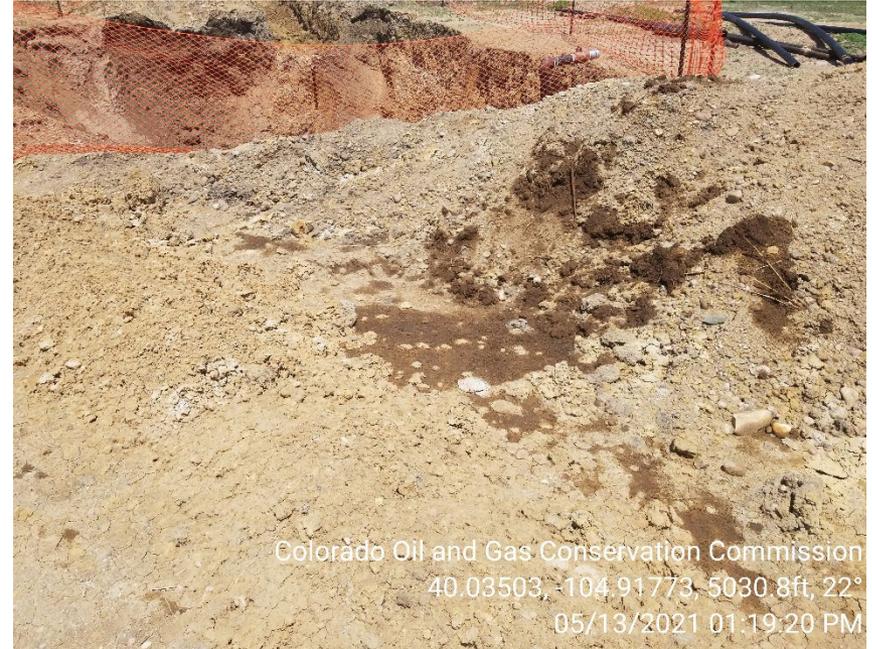
Photo 6 – Impacted soils remain on surface outside of excavation area. Soils stockpiled on location with inadequate BMPs.

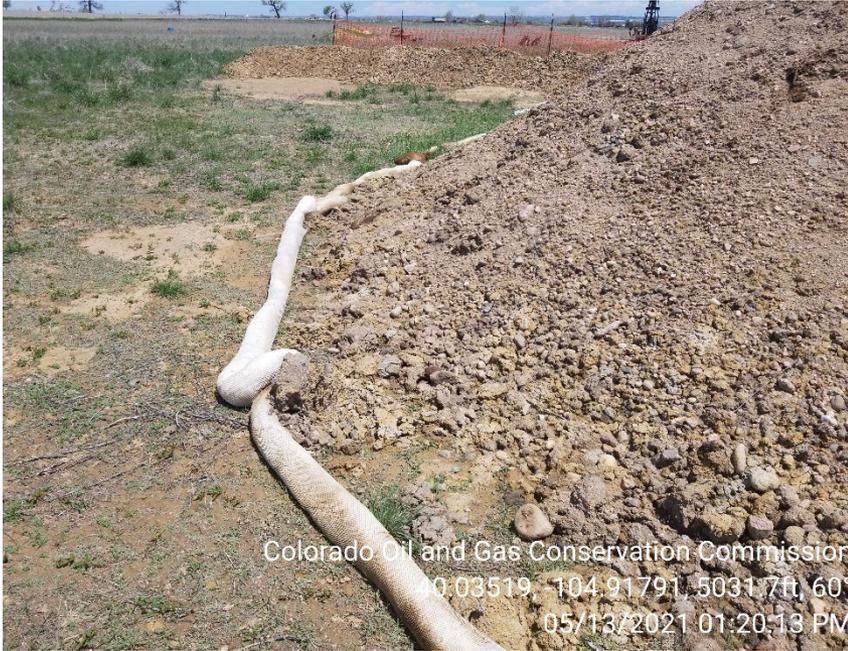
Photo 7 – Soils stored on location with inadequate BMPs

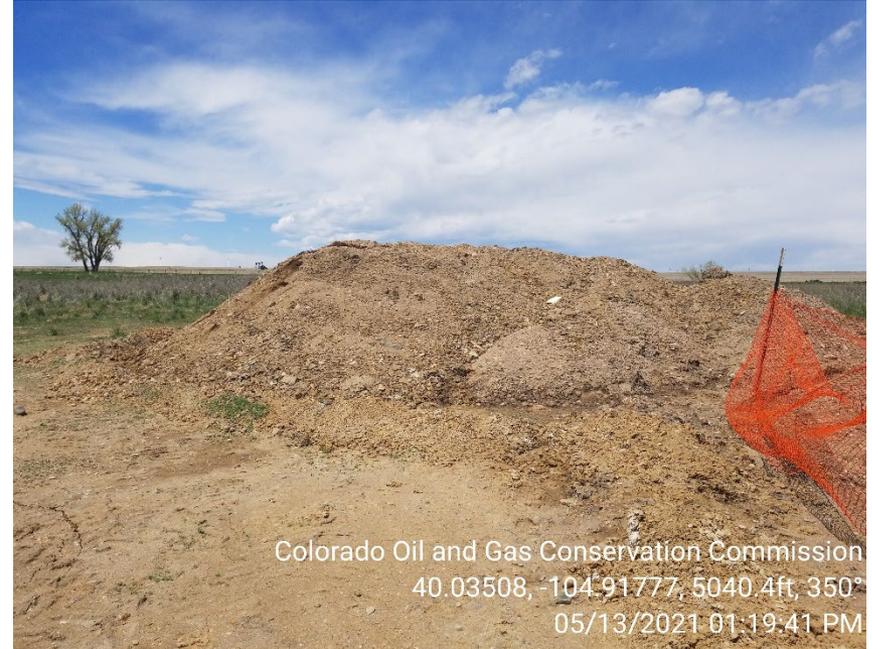
Photo 8 – Soils stored on location with inadequate BMPs

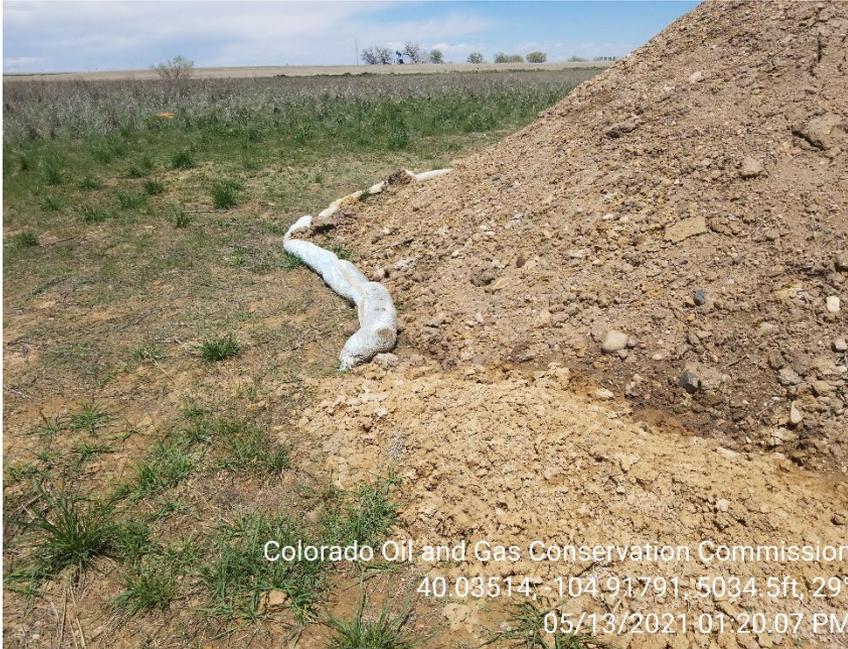
Photo 9 – Soils stored on location with inadequate BMPs

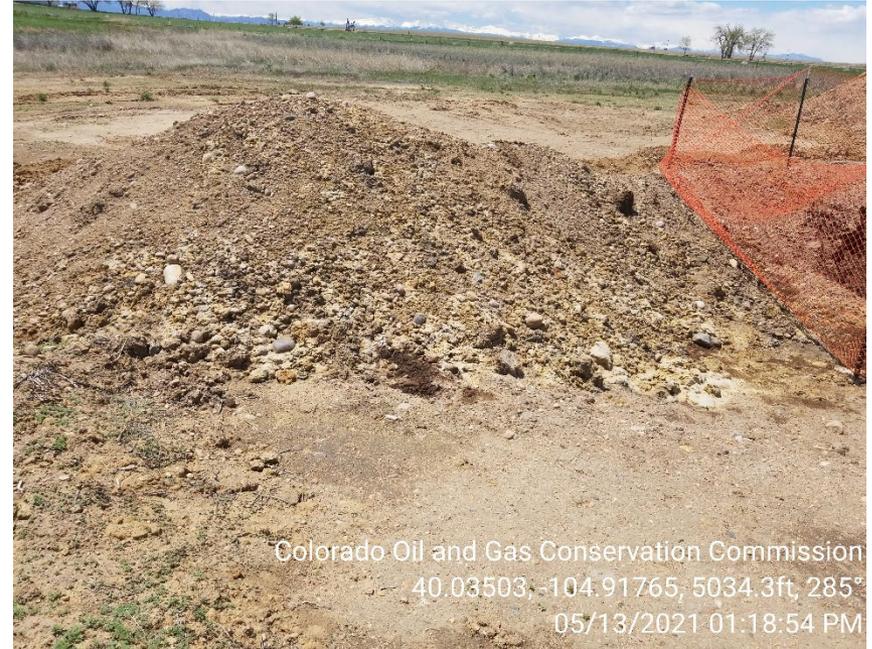
Photo 10 – Soils stored on location with inadequate BMPs

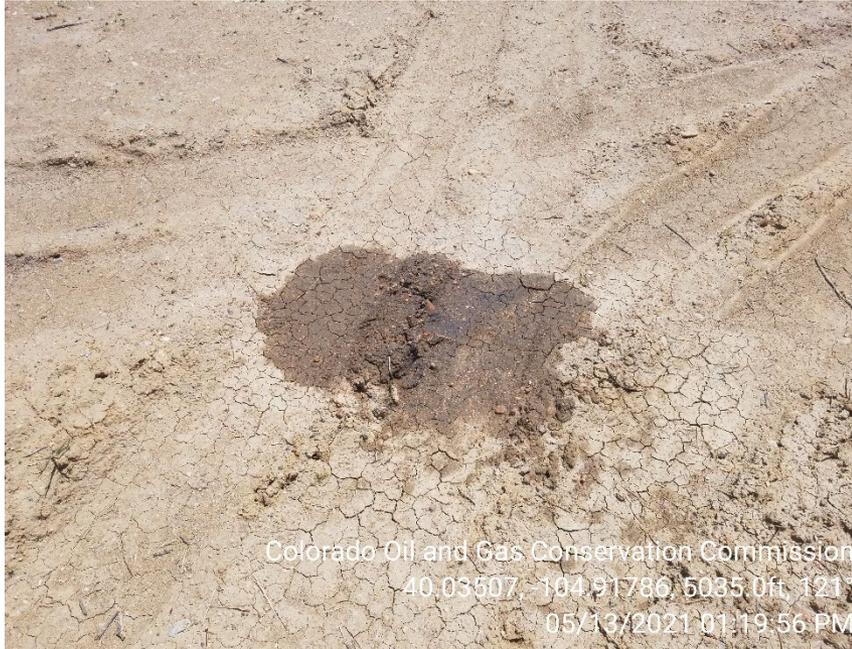
**Photo 11 – Stained soil from equipment
observed on location.**

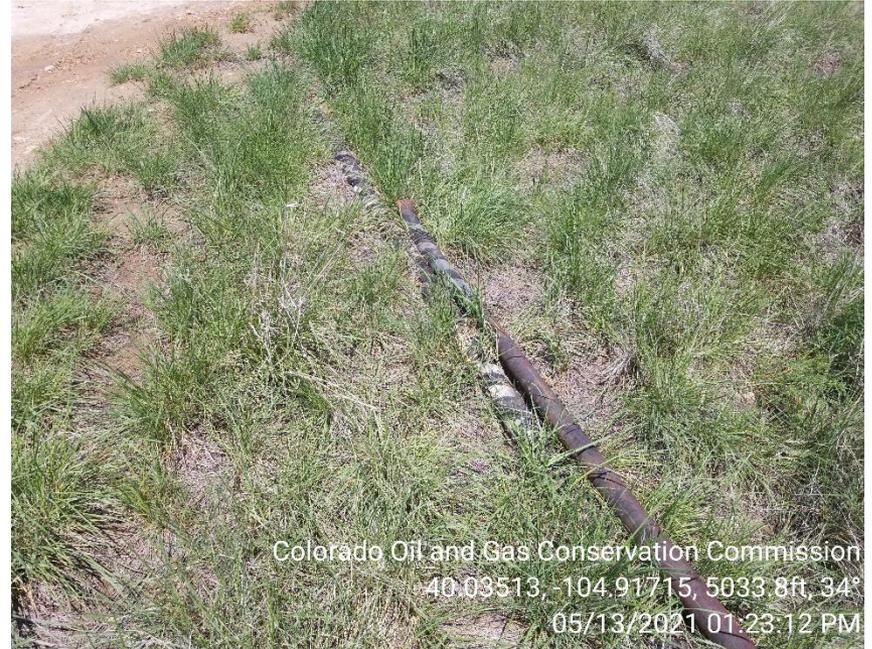
Photo 12 – Trash on location
