Inspection Photos
James S Haley Trustee B #2 Flowline
Spill ID 478014 (AC)

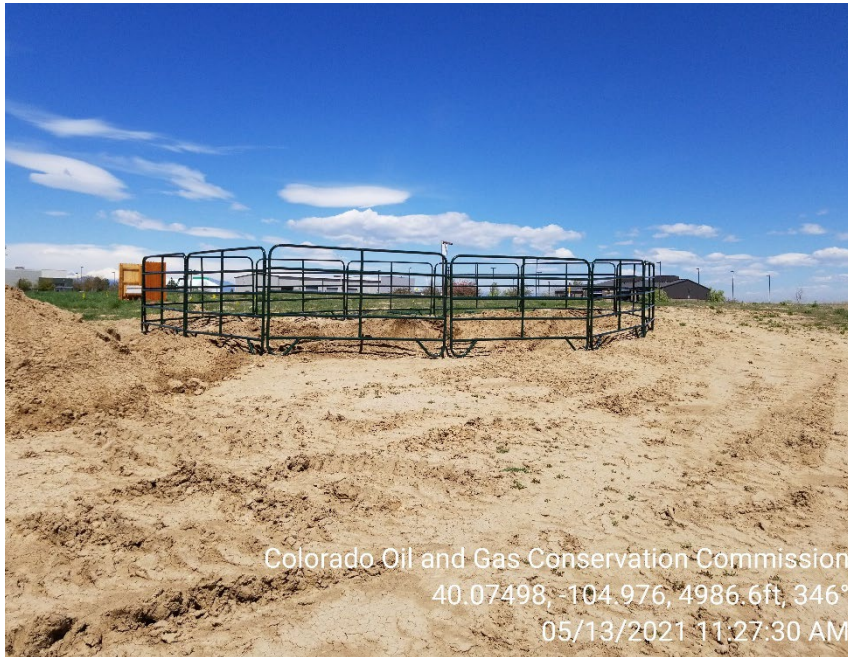
Photo 1 – Spill area. Fencing up around open excavation.

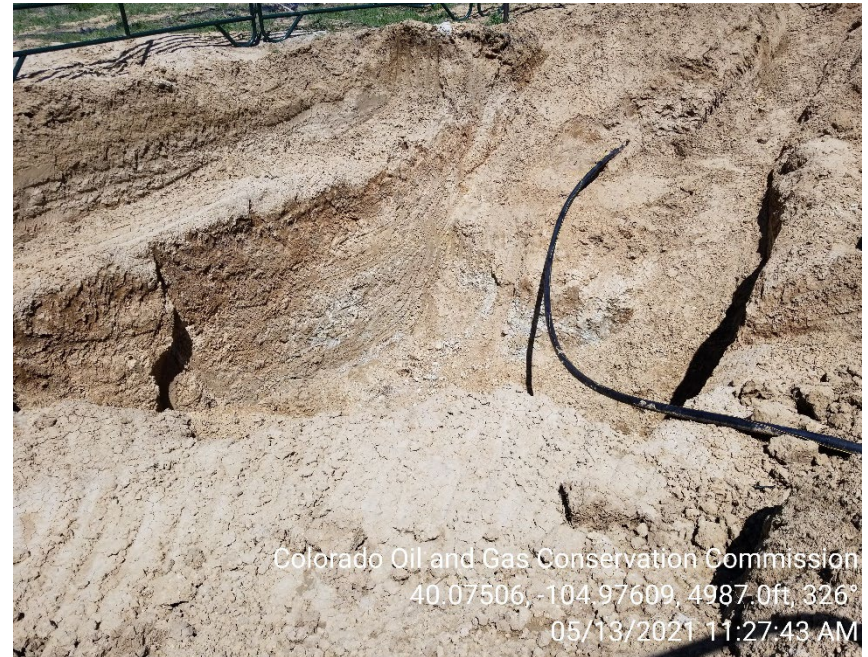
Photo 2 – Spill excavation.

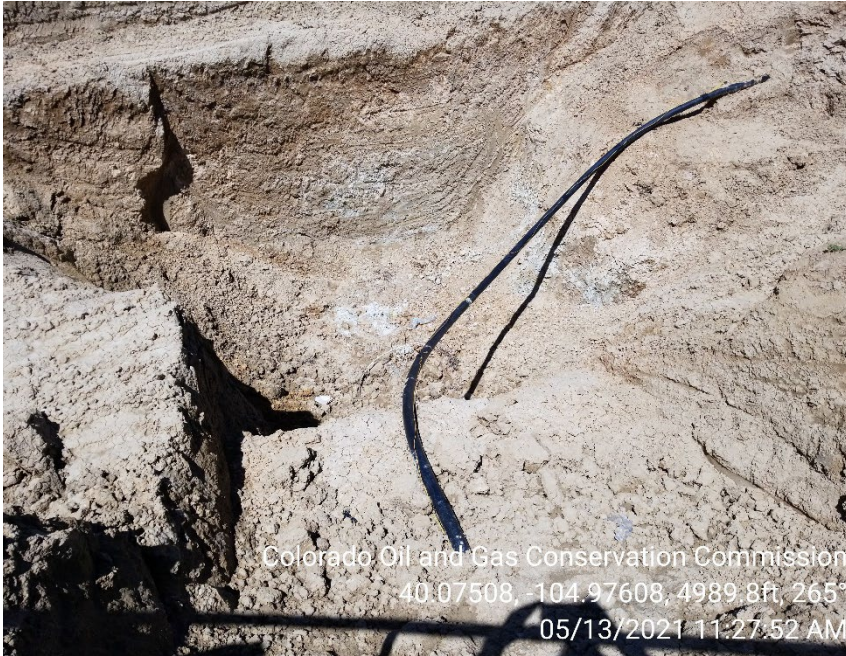
Photo 3 – Spill excavation. Trash observed in open excavation.

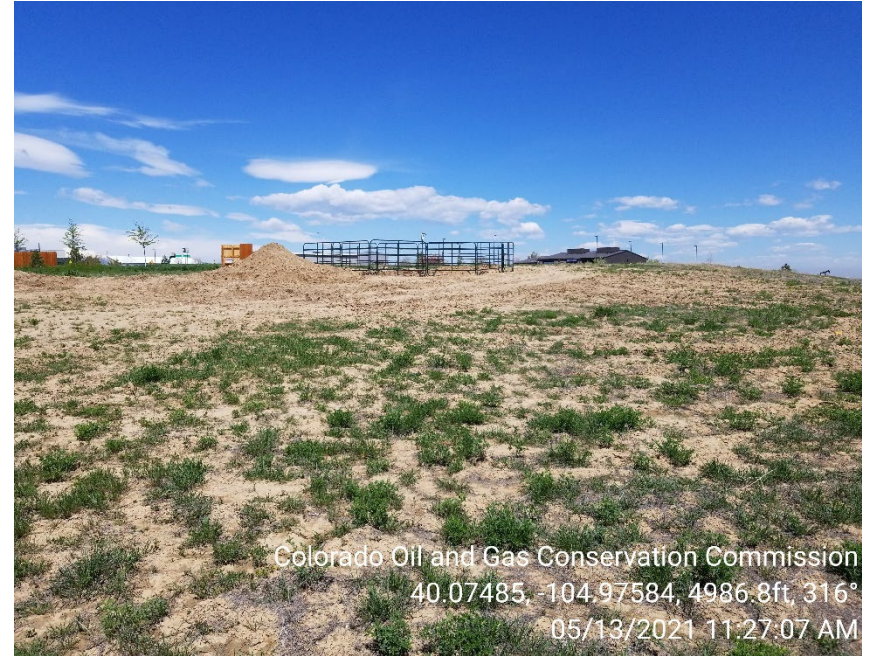
Photo 4 – Disturbed area from remediation.

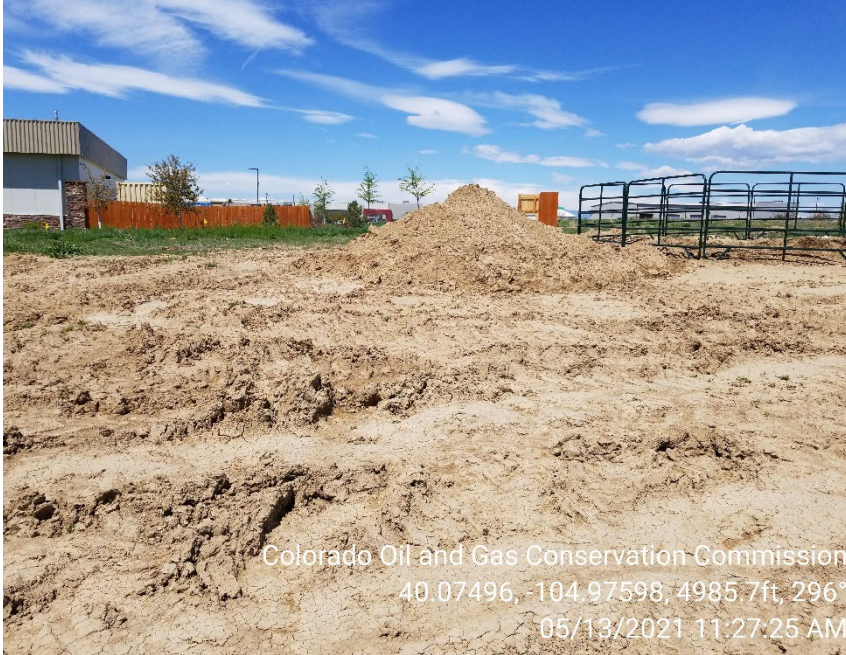
Photo 5 – Soils stockpiled on location with inadequate BMPs.

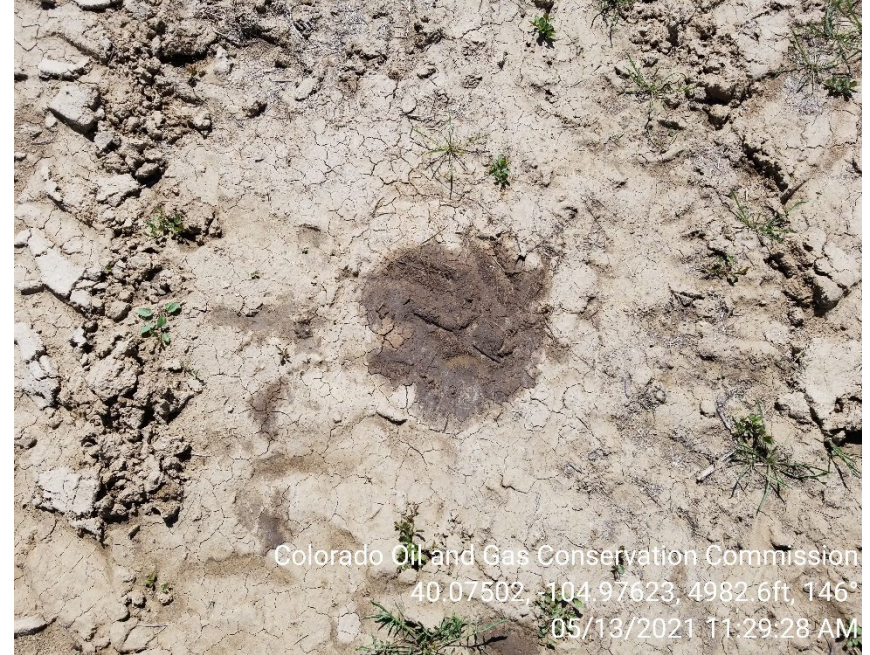
Photo 6 – Stained soil observed around open excavation.
