Inspection Photos
H. Huett Consolidation Release
Spill ID 478005 (AC)

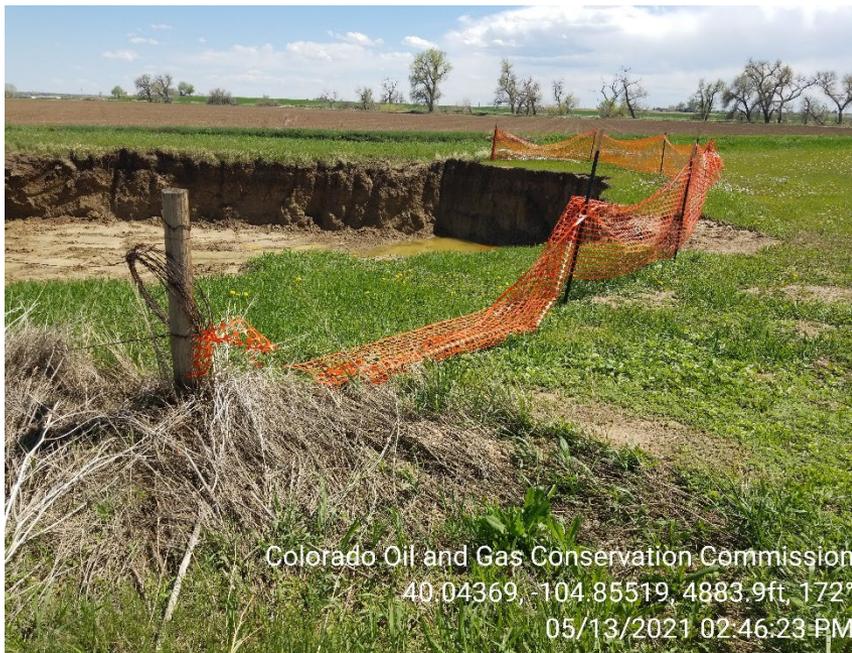
Photo 1 –Fencing down around open excavation.

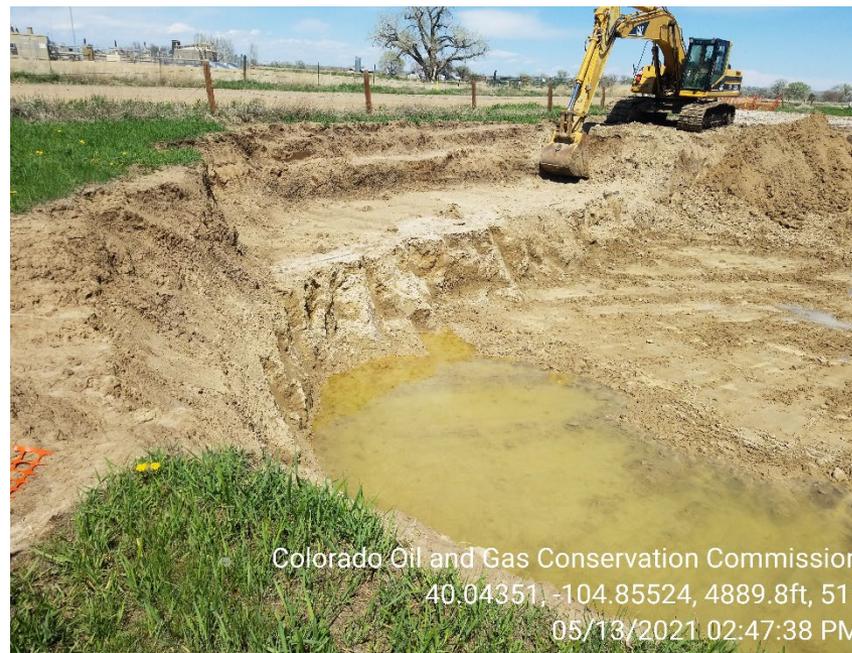
Photo 2 – Spill excavation. Impacts appear to remain in situ. Groundwater observed in open excavation.

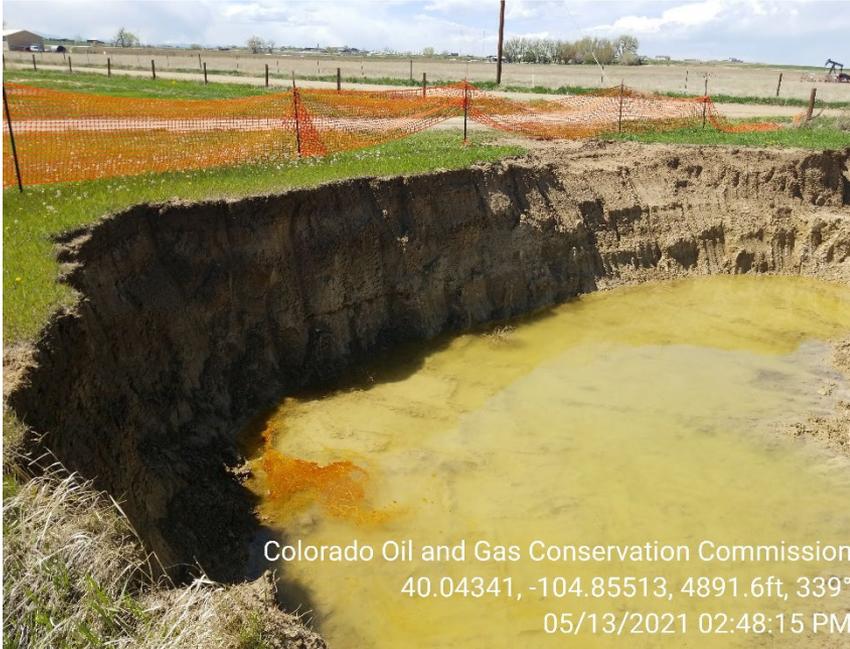
Photo 3 – Spill excavation. Impacts appear to remain in situ. Hydrocarbons observed on groundwater in open excavation.

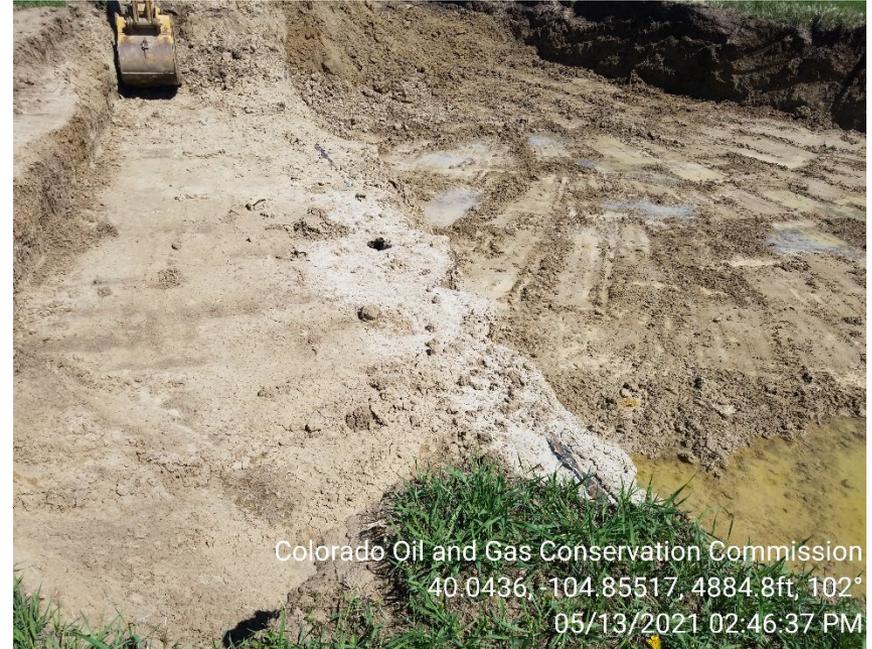
Photo 4 – Exposed flowline in open excavation.

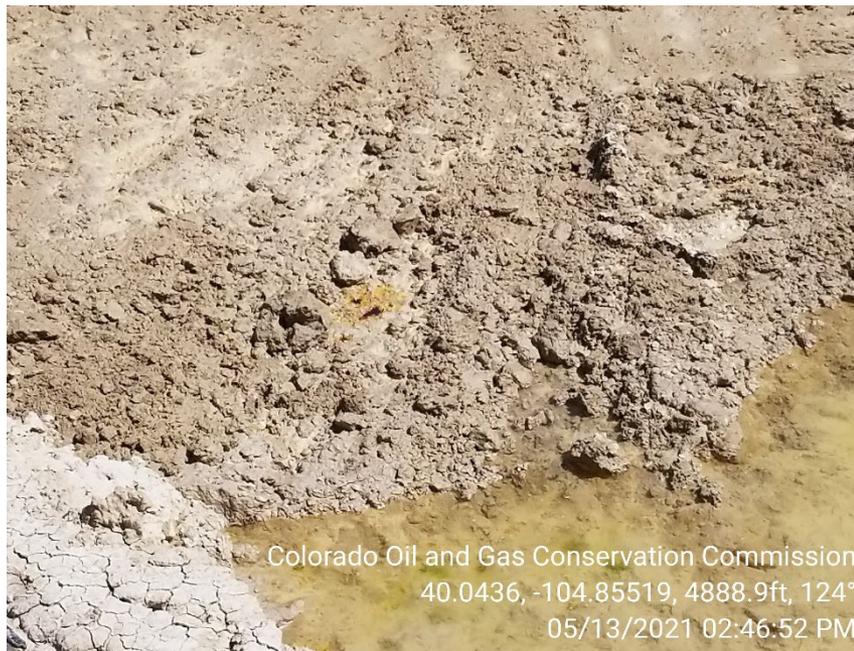
Photo 5 – Spill excavation. Impacts appear to remain in situ. Hydrocarbons observed on groundwater in open excavation.

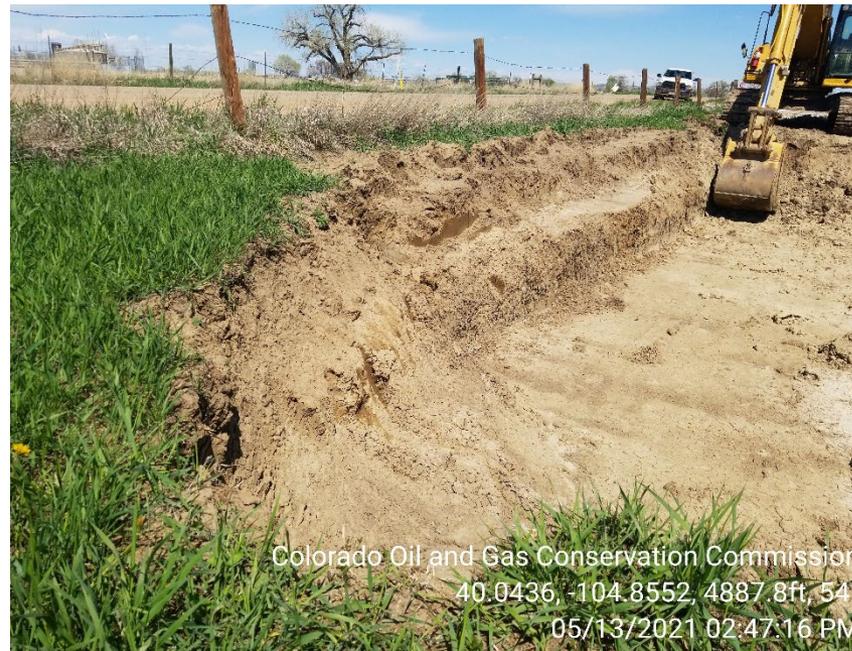
Photo 6 – Spill excavation. Impacts appear to remain in situ.
