Inspection Photos
Location Name: Carl A Miller A 4
Location ID: 318365

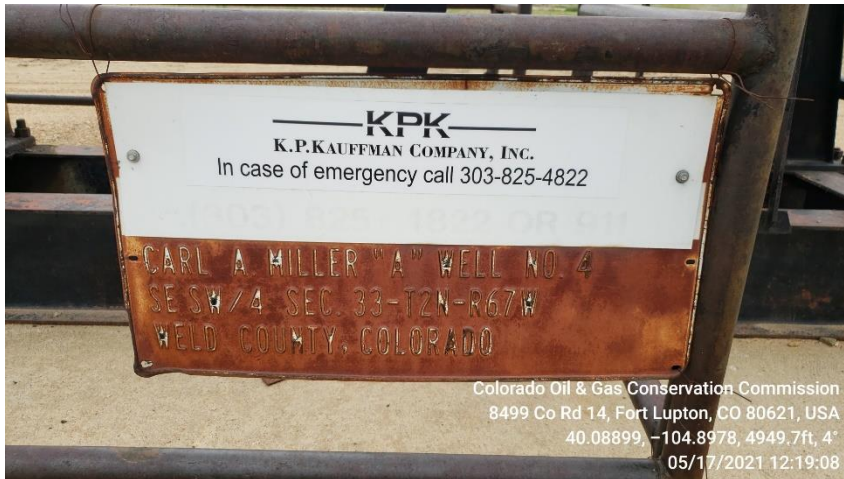
Photo 1 WH sign

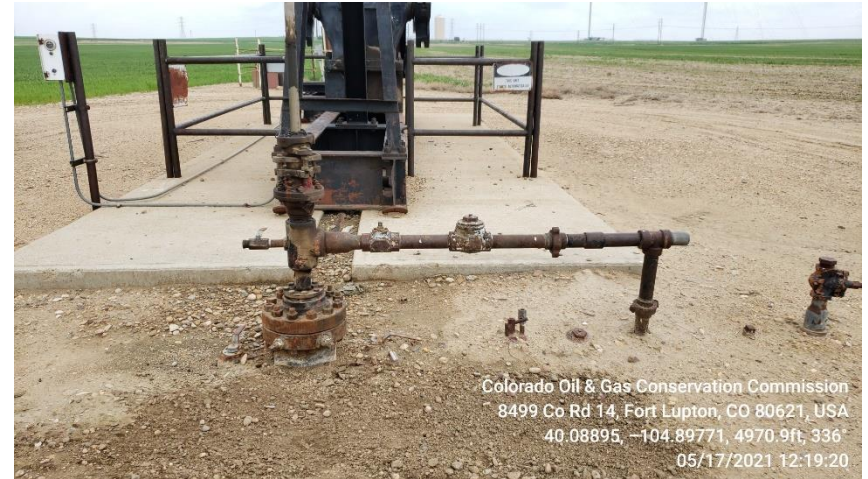
Photo 2 WH

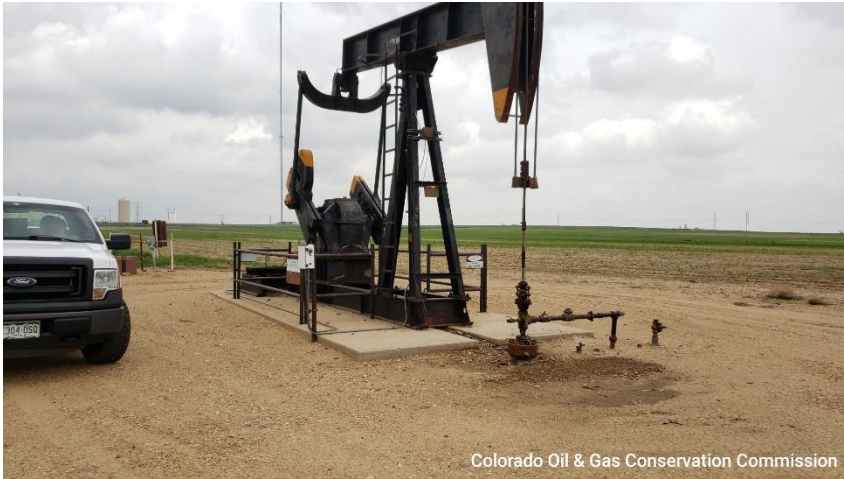
Photo 3 Pump jack

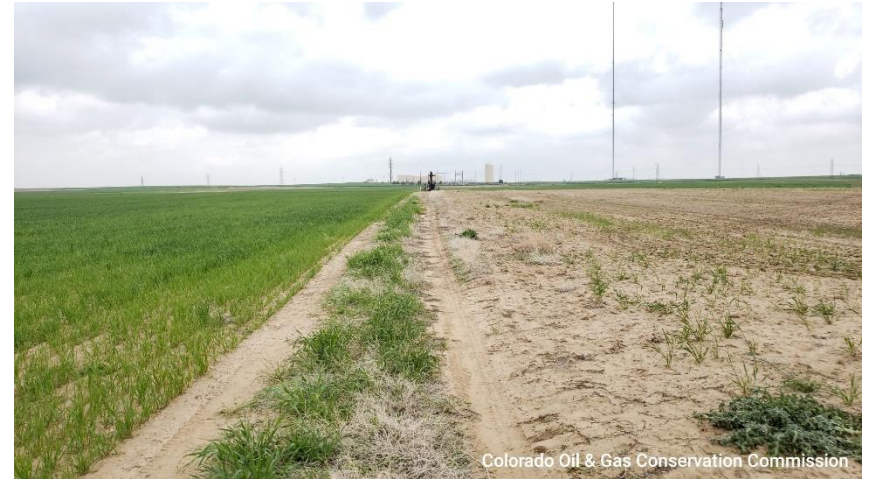
Photo 4 Weeds along access rd

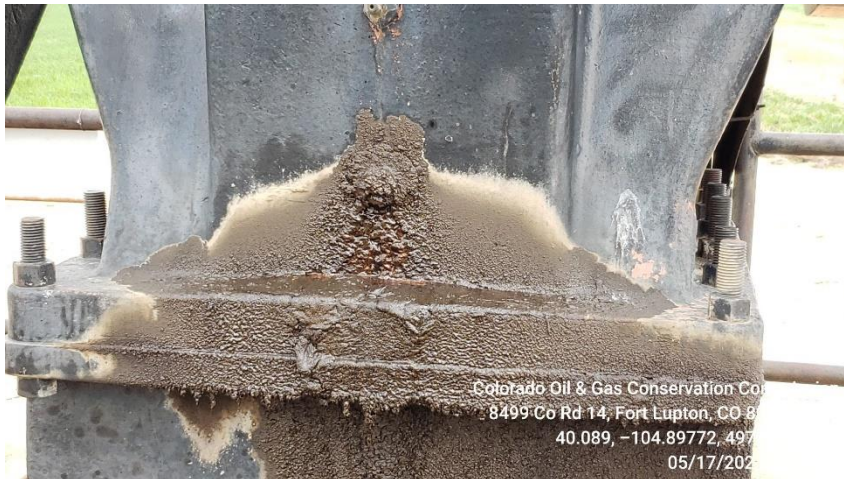
Photo 5 Leaking plug on pump jack gear box

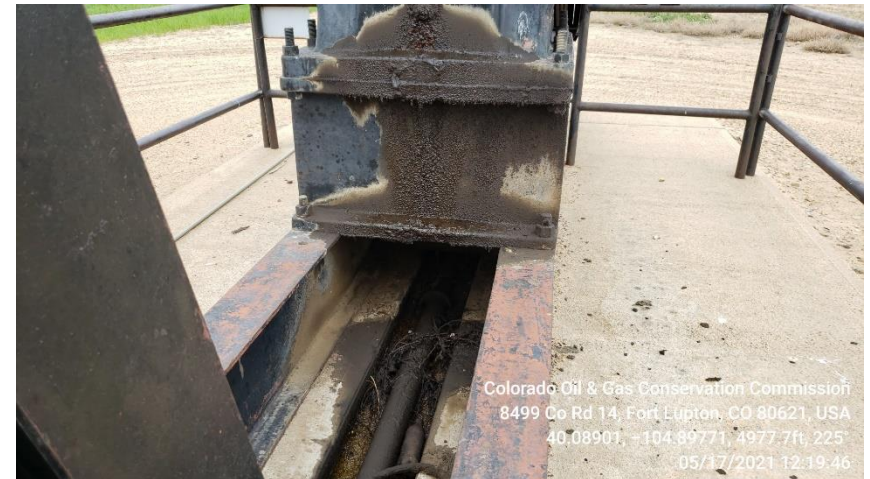
Photo 6 Stained soil in pump jack base
