Stormwater Inspection Report

Operator:	Laramie Energy, LLC
Project:	Cascade Creek
Location:	Cascade Creek 629-23-42 Pad
Date:	Monday, May 17, 2021
Weather:	Scattered Showers, Light Wind, 73°, Lo 50°

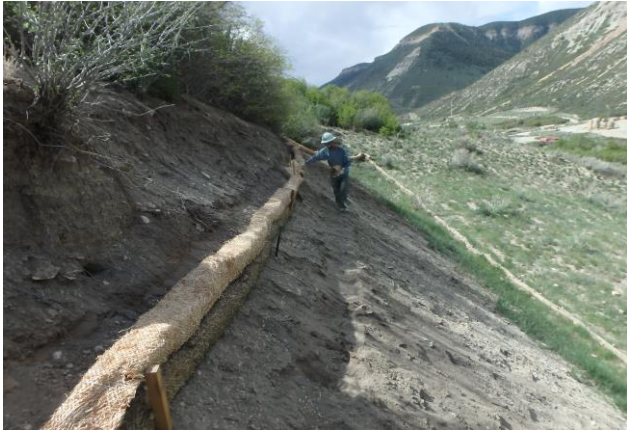
Photo 1

Double Stacking Wattle on CC 629-23-42 Pad

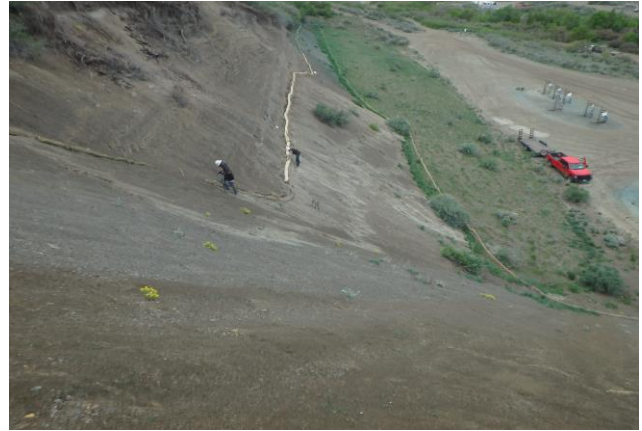
Photo 2

Overview of CC 629-23-42 Work

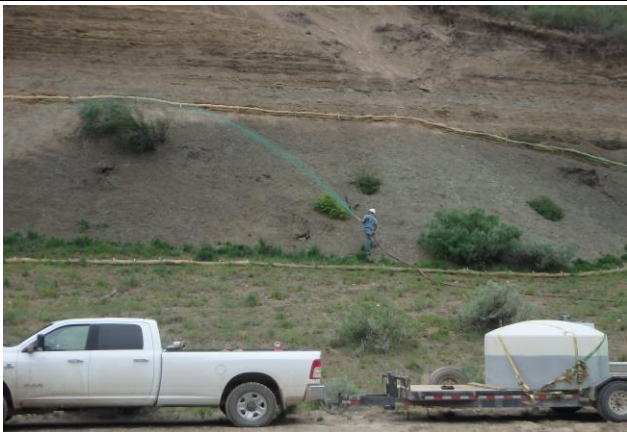
Photo 3

Applying Liquid Amenities and Nutrients

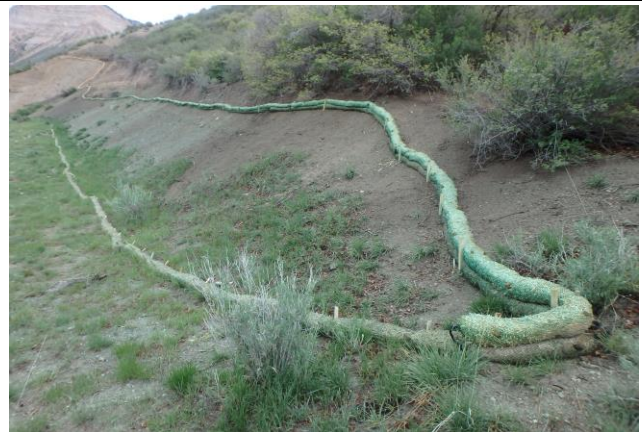
Photo 4

CC 629-23-42 Cut-Slope after Application
