Inspection Photos
Operator: Simcoe
API: 067-09080
Date: 5/17/2021

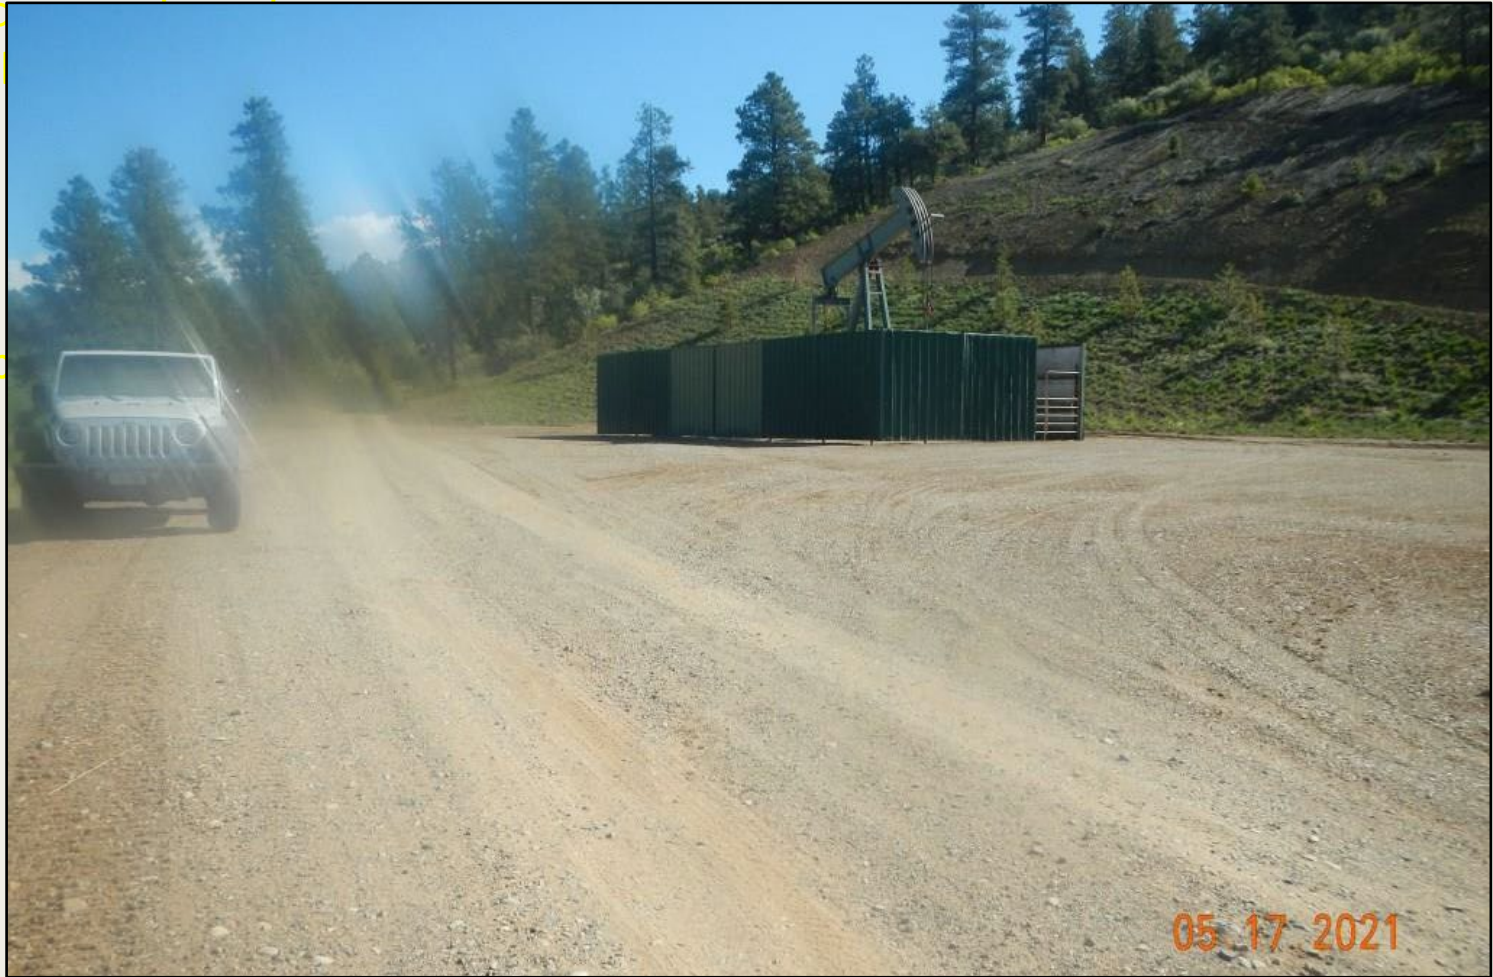
Photo 1. View of project area from the well pad entrance facing center.

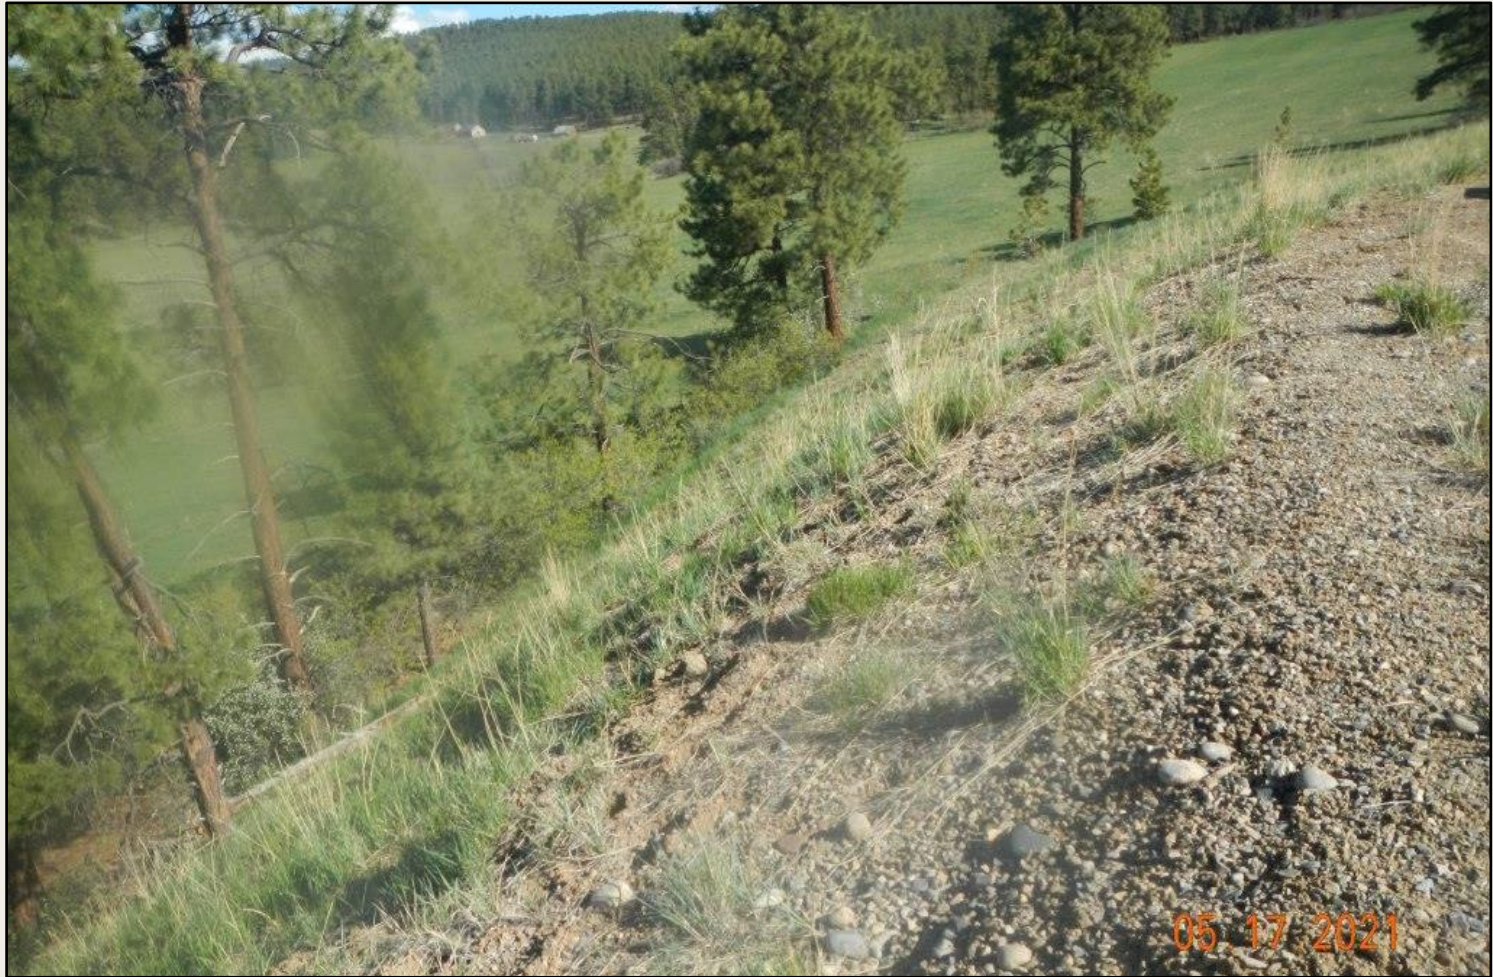
Photo 2. View of the western project area from the southwestern corner facing northward. Revegetation is progressing with a mixture of grasses such as western wheatgrass, smooth brome, and crested wheatgrass.

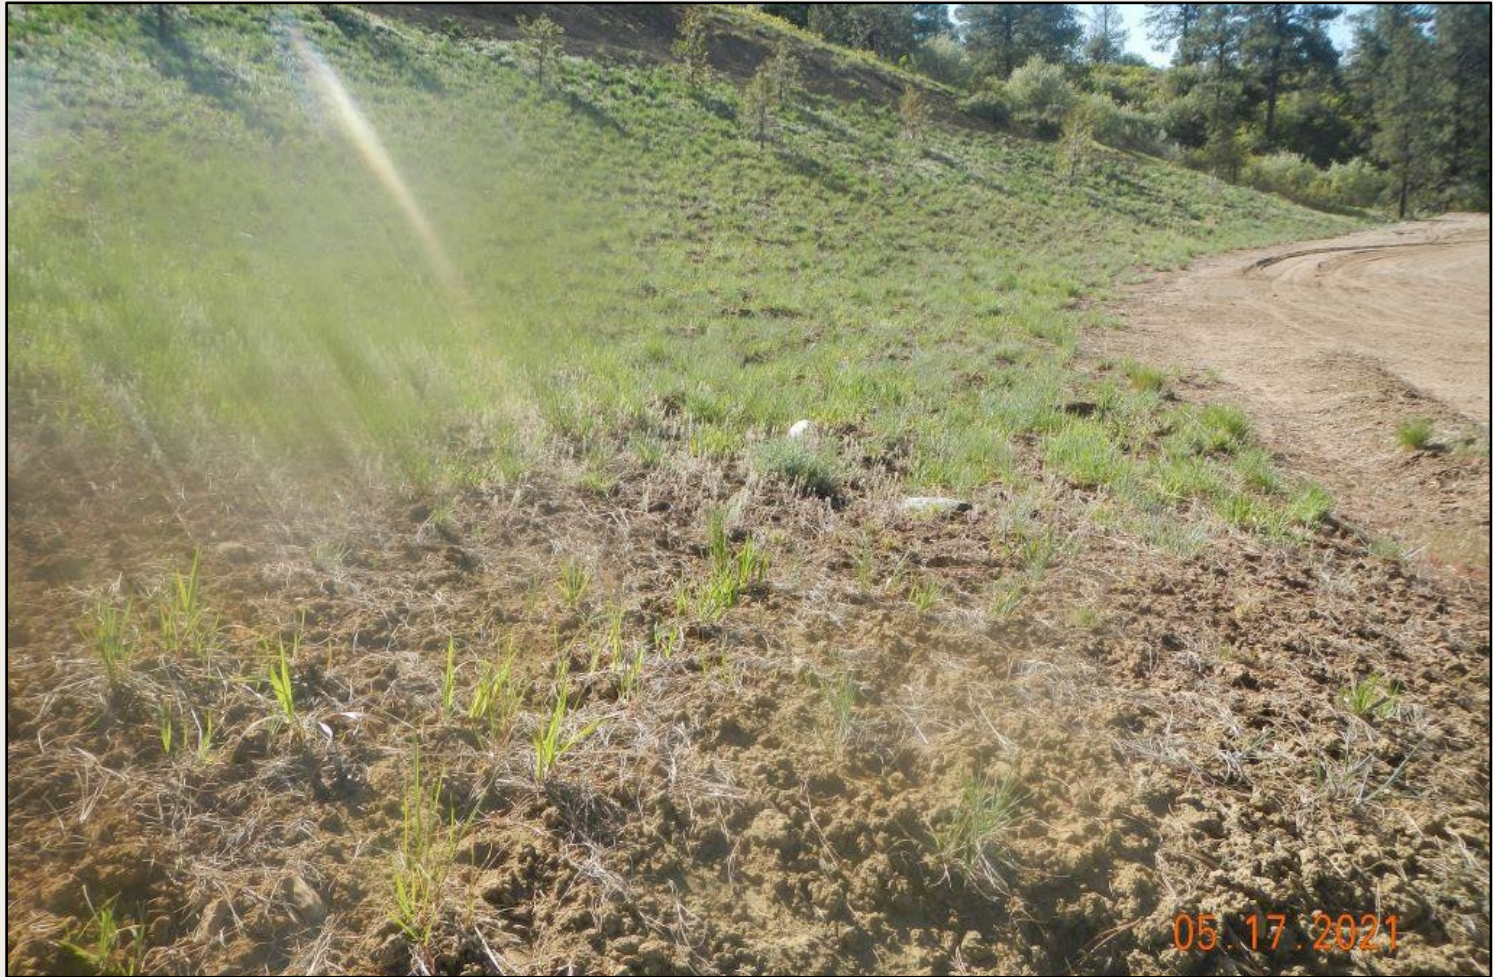
Photo 3. View of the lower, eastern cut-slope facing southward from the northeastern corner.

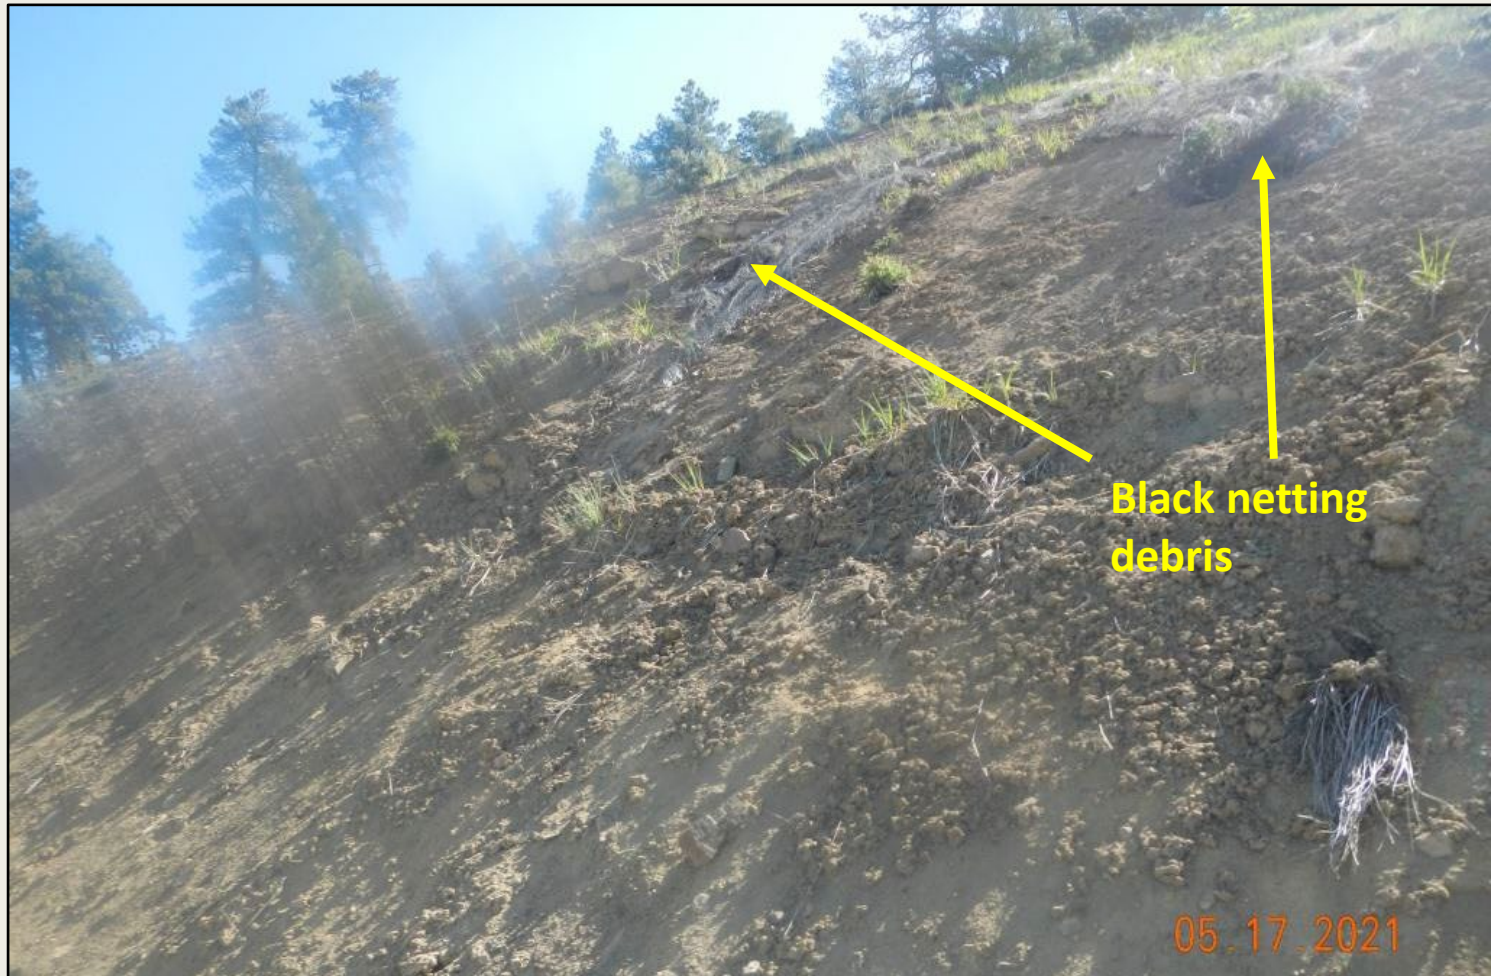
Photo 4. View of the upper portion of the eastern cut-slope. Revegetation remains sparse here. Black plastic netting debris needs to be removed.

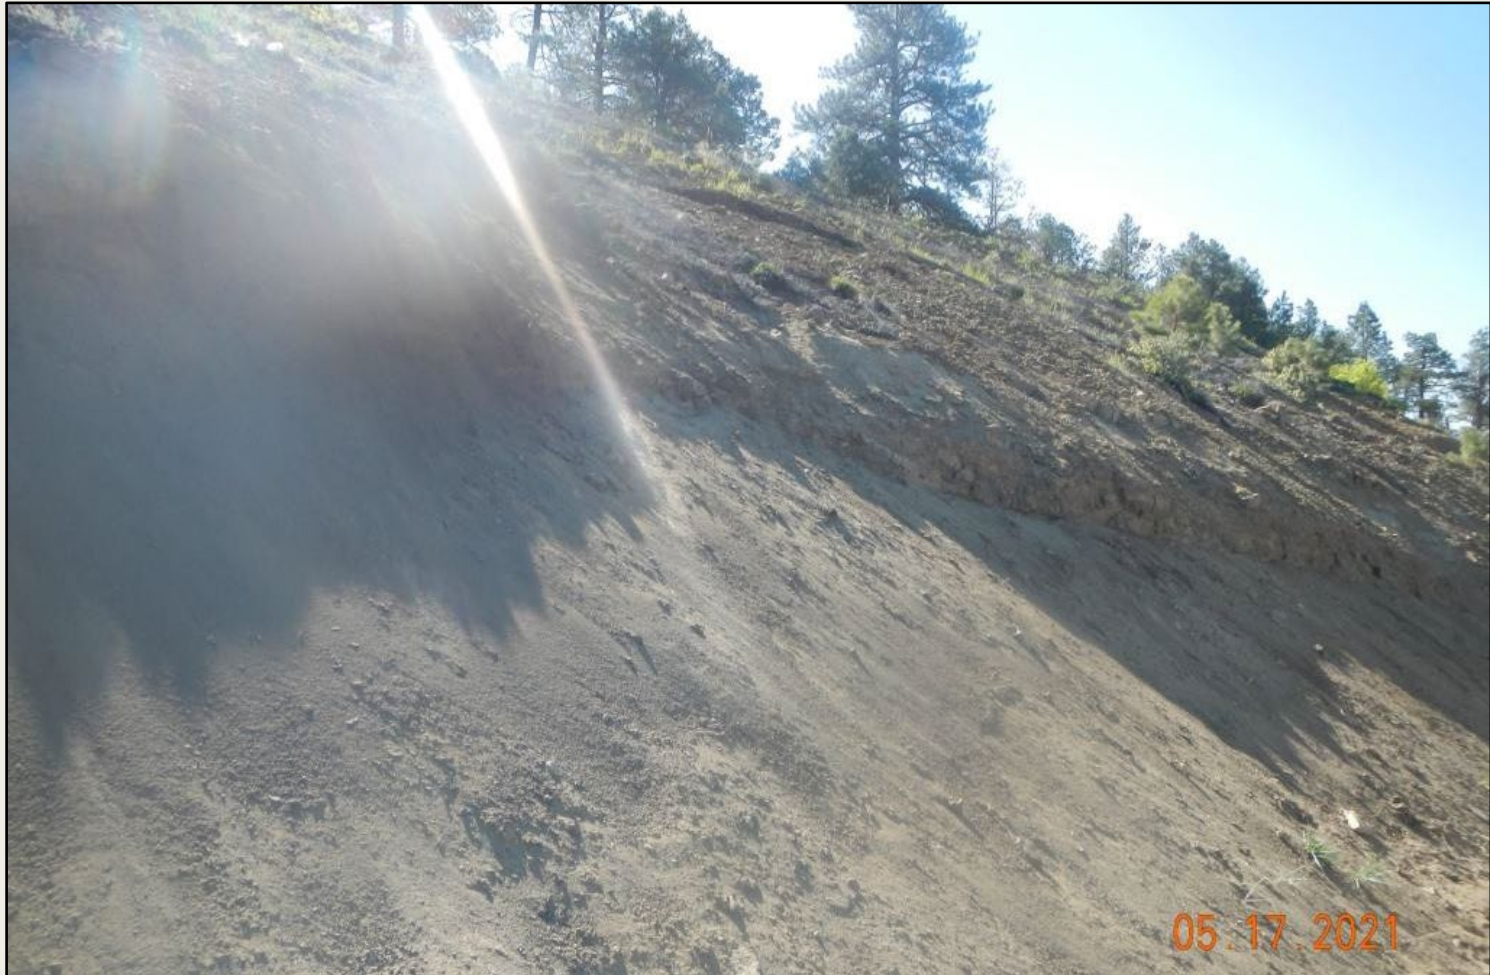
Photo 5. View of bare soils on the upper cut-slope and diversion. Long term soil stabilization measures need to be installed to stabilize soils here.

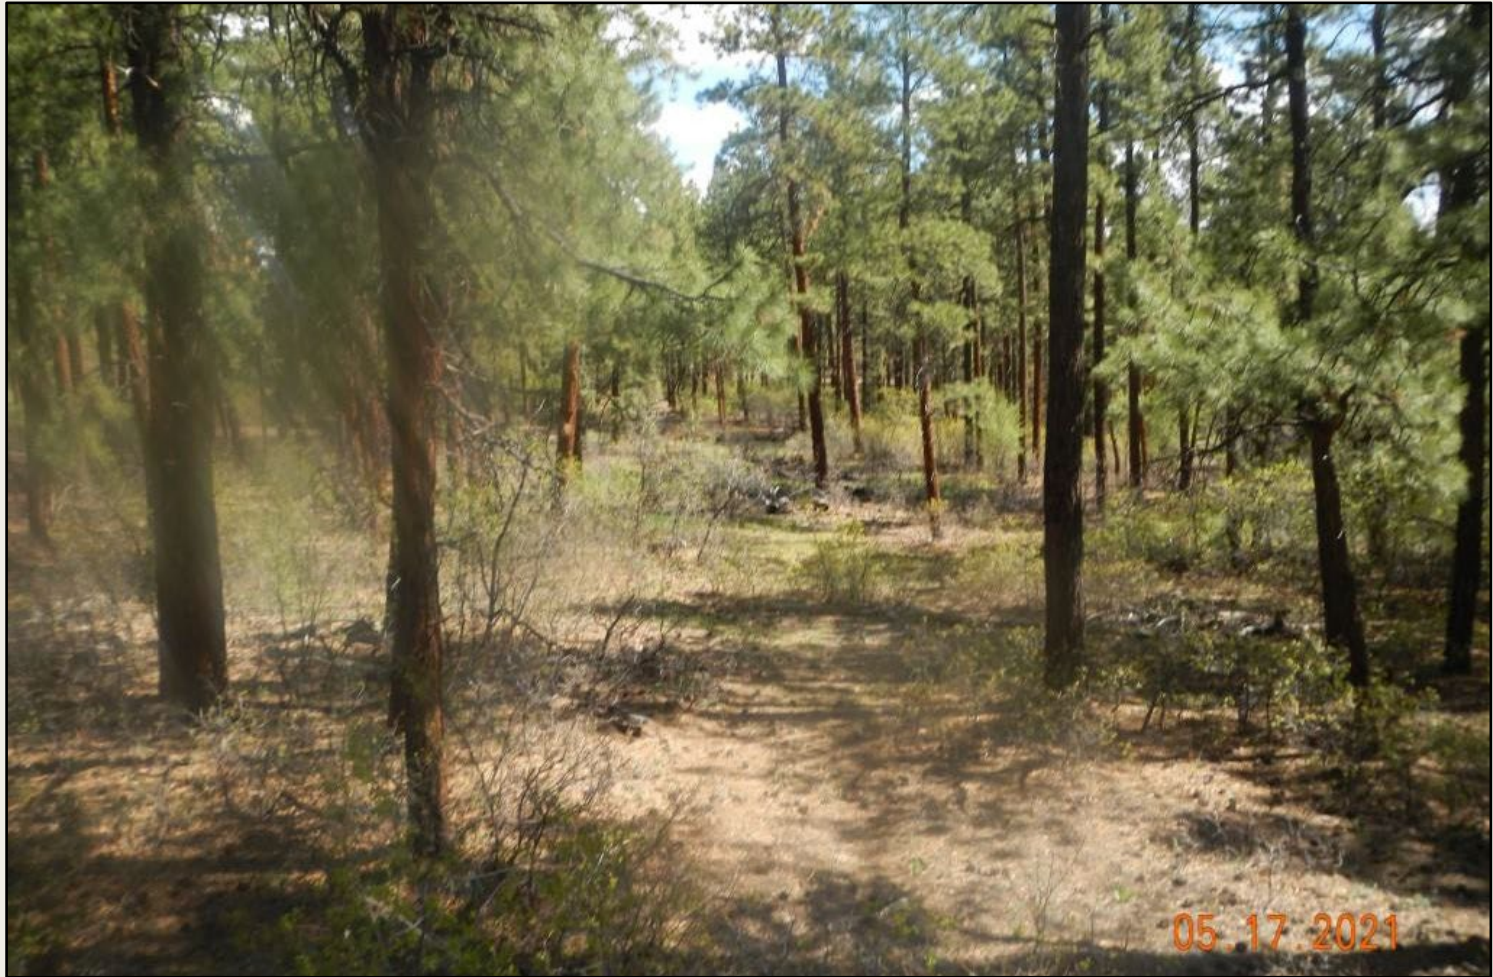
Photo 6. View of the reference area comprised of ponderosa pine forest with understory of gambel oak, Oregon grape, *Poa secunda*, and serviceberry.
