Stormwater Inspection Report

Operator:	Laramie Energy, LLC
Project:	Cascade Creek
Location:	Cascade Creek 629-02 Pad
Date:	Tuesday, May 18, 2021
Weather:	Partly Cloudy, Light Wind, 78°, Lo 44°

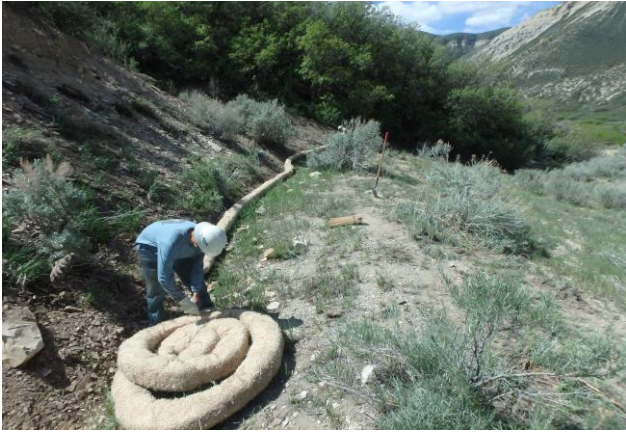
Photo 1

Installing Wattle on CC 629-02 Pad

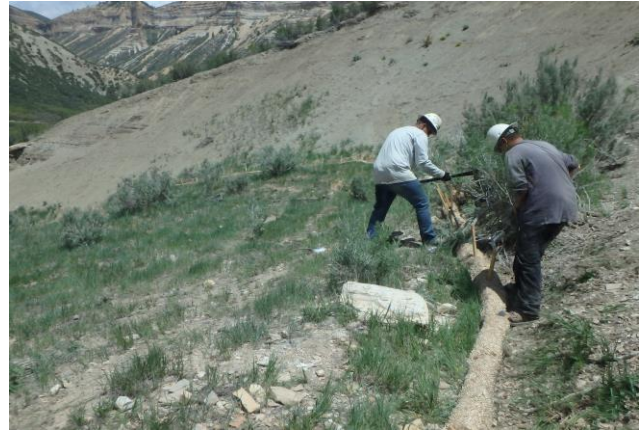
Photo 2

Installing Wattle on CC 629-02 Pad

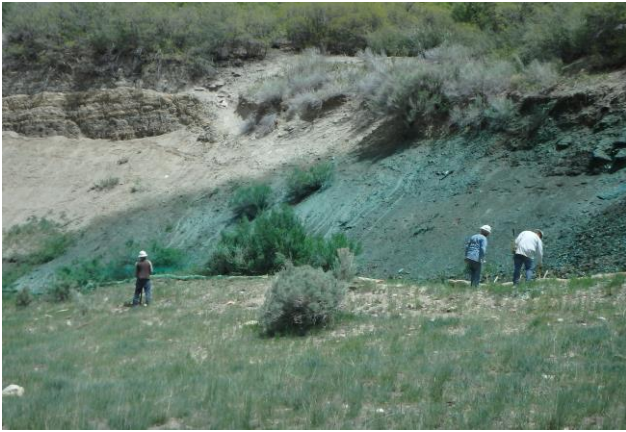
Photo 3

Applying Liquid Amenities and Nutrients

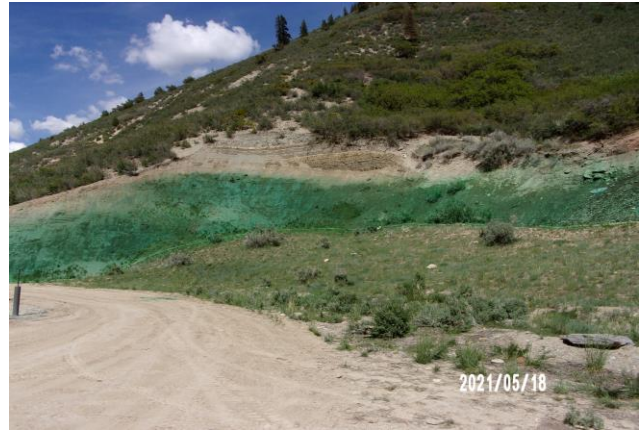
Photo 4

CC 629-02 after Repairs Complete
