## Stormwater Inspection Report

<b>Operator:</b>	Laramie Energy, LLC
<b>Project:</b>	Cascade Creek
<b>Location:</b>	CC 629-31-11 Pad
<b>Date:</b>	Wednesday, May 19, 2021
<b>Weather:</b>	Partly Cloudy, Light Wind, 82°, Lo 47°

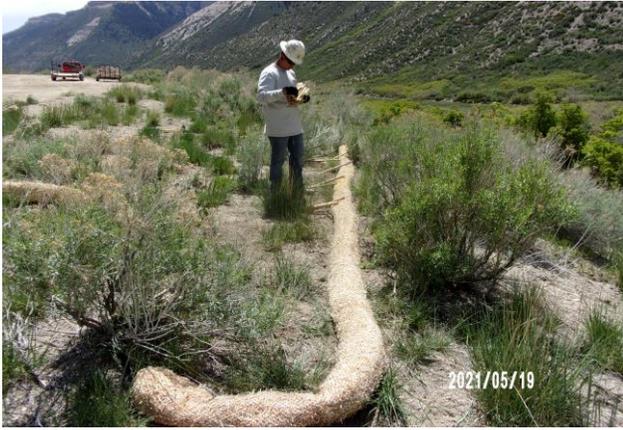
**Photo 1**

*Installing Excelsior Wattle on CC 629-31-11 Pad*

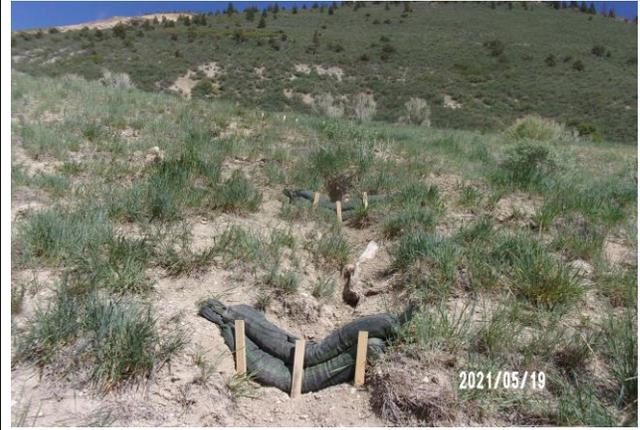
**Photo 2**

*Erosion Channel Checked Up on CC 629-31-11*

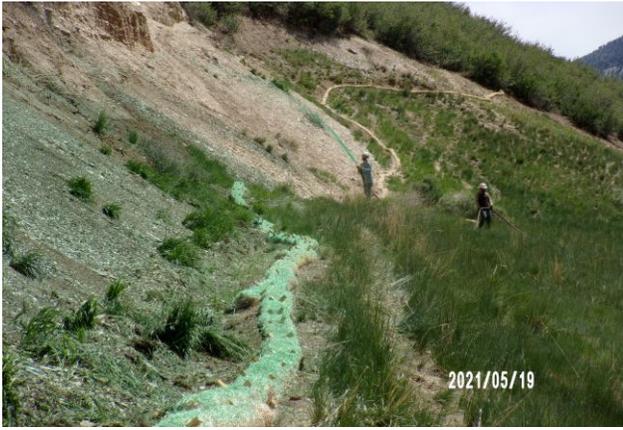
**Photo 3**

*Applying Water to Seeded Area on CC 629-31-11*

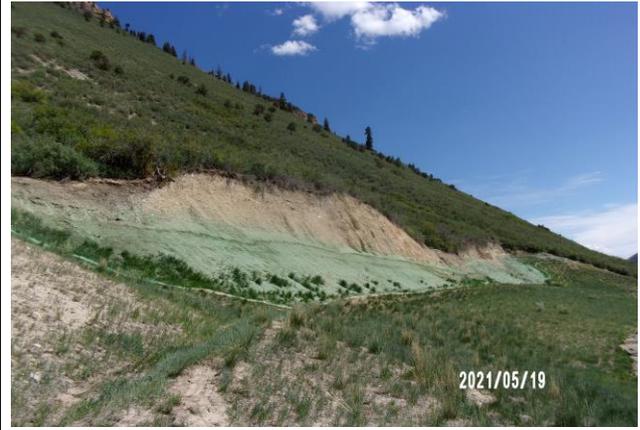
**Photo 4**

*CC 629-31-11 after Repairs Completed*
