## Stormwater Inspection Report

<b>Operator:</b>	Laramie Energy, LLC
<b>Project:</b>	Cascade Creek
<b>Location:</b>	CC 697-03-07 Pad
<b>Date:</b>	Monday, May 24, 2021
<b>Weather:</b>	Mostly Sunny, Light Wind, 72°, Lo 40°

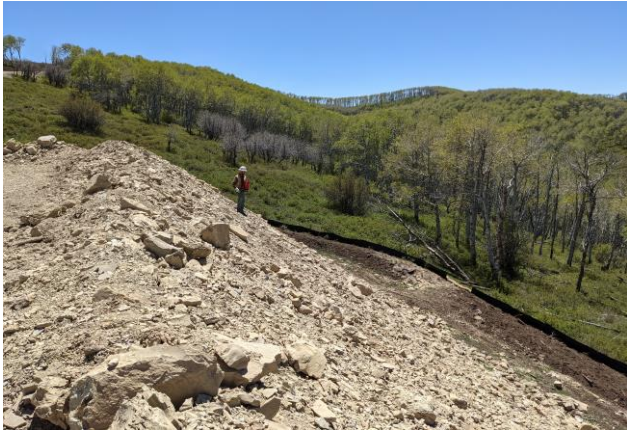
**Photo 1**

*Broadcasting Temporary Seed over Rocky Fill Slopes*

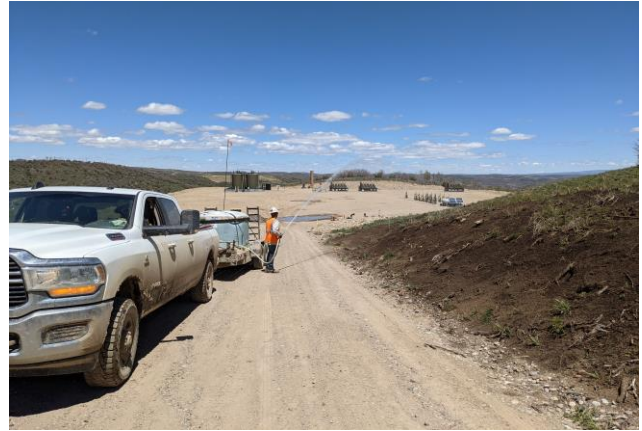
**Photo 2**

*Irrigating Seedlings along CC 697-03-07 Access Roads*

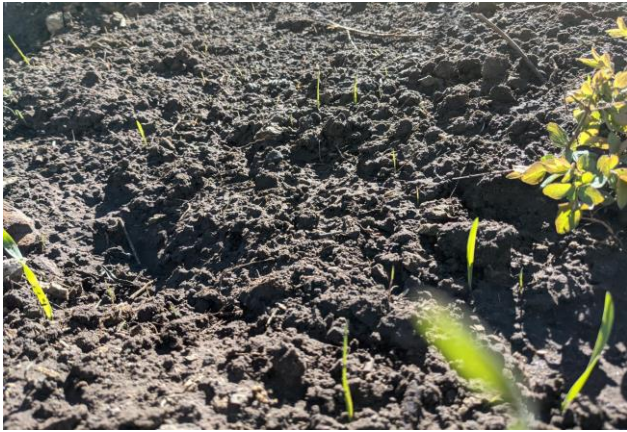
**Photo 3**

*Seed Germinating on the CC 697-03-07 Access Road  
Cut Slope*

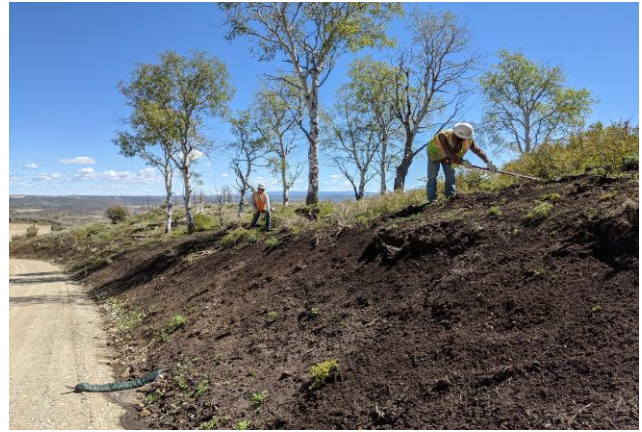
**Photo 4**

*Hand Raking New Seeding along CC 697-03-07  
Access Road*
