Inspection Photos

5/26/2021

Operator: CAERUS ENERGY SERVICES LLC #
10668

Location ID: 335669
Garfield County, CO

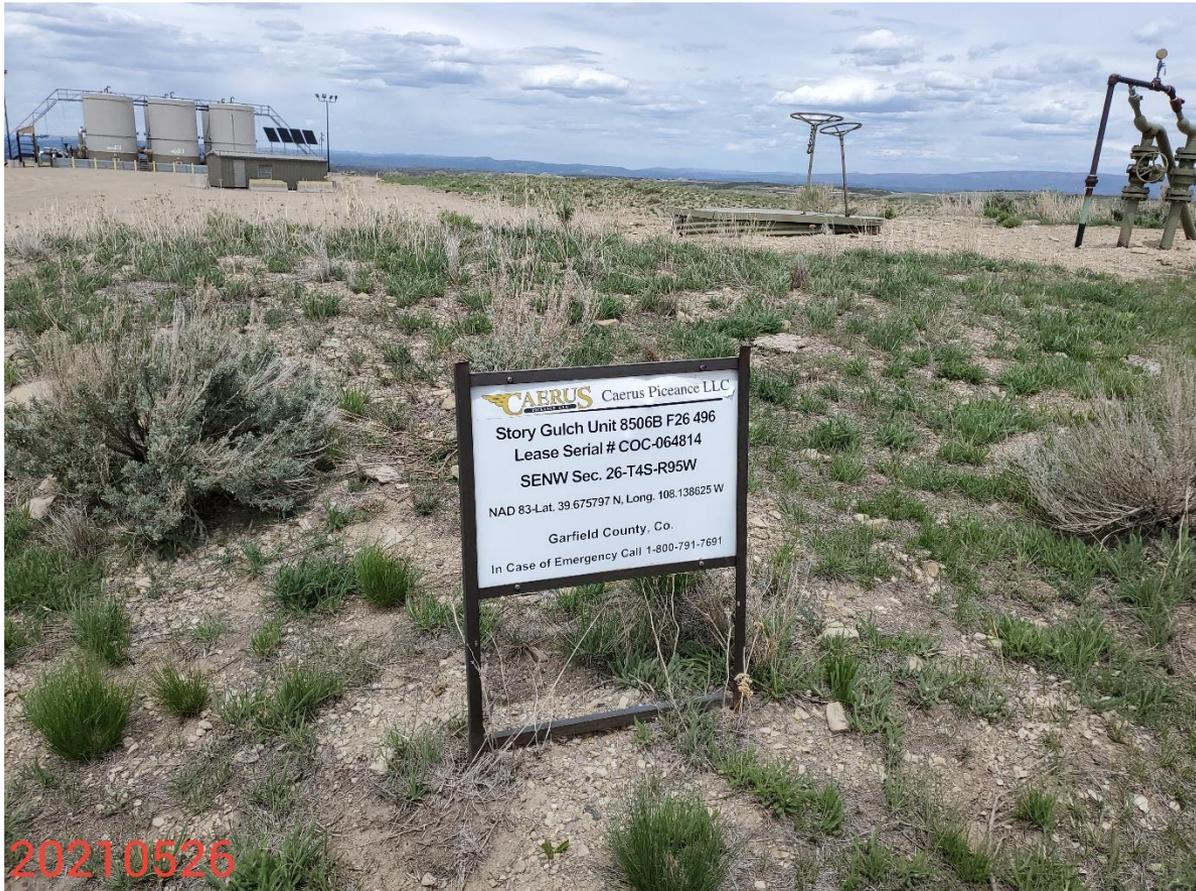
Photo 1: Photo of signage at location entrance.

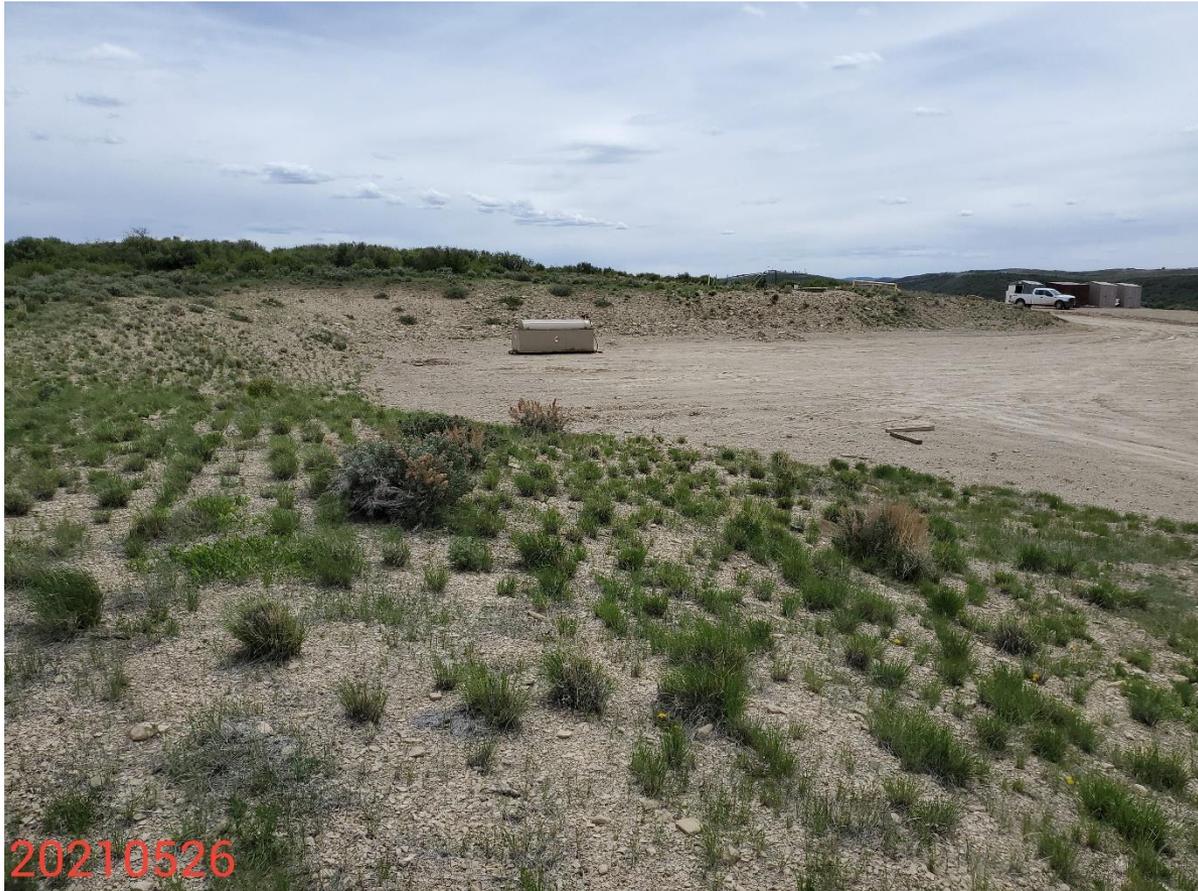
Photo 2: Photo taken from the east end of the Location, facing south. Photos 2-5 provide an overview of the Location from south, southwest, northwest to north. Photo also shows diesel tank stored on the southeast end of the Location; tank requires removal.

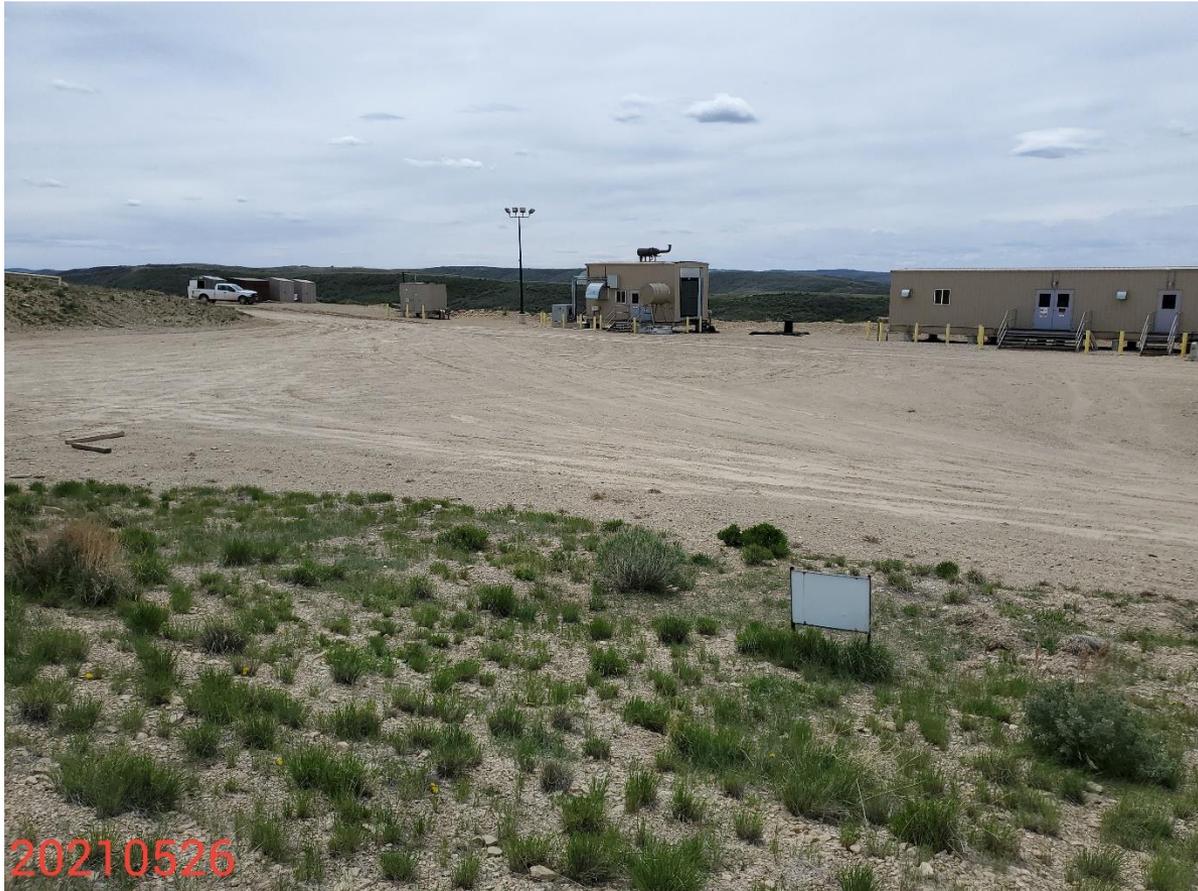
Photo 3: See comments under photo 2.

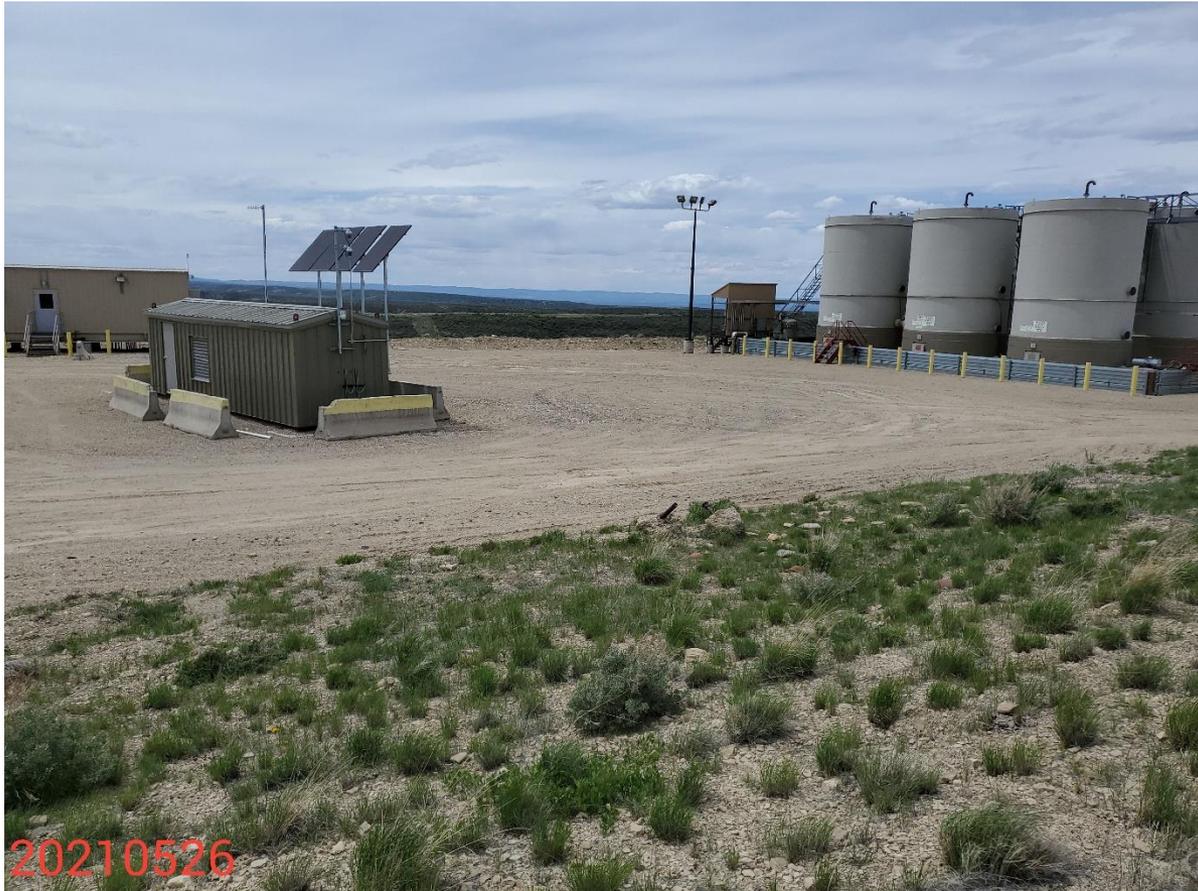
Photo 4: See comments under photo 2.

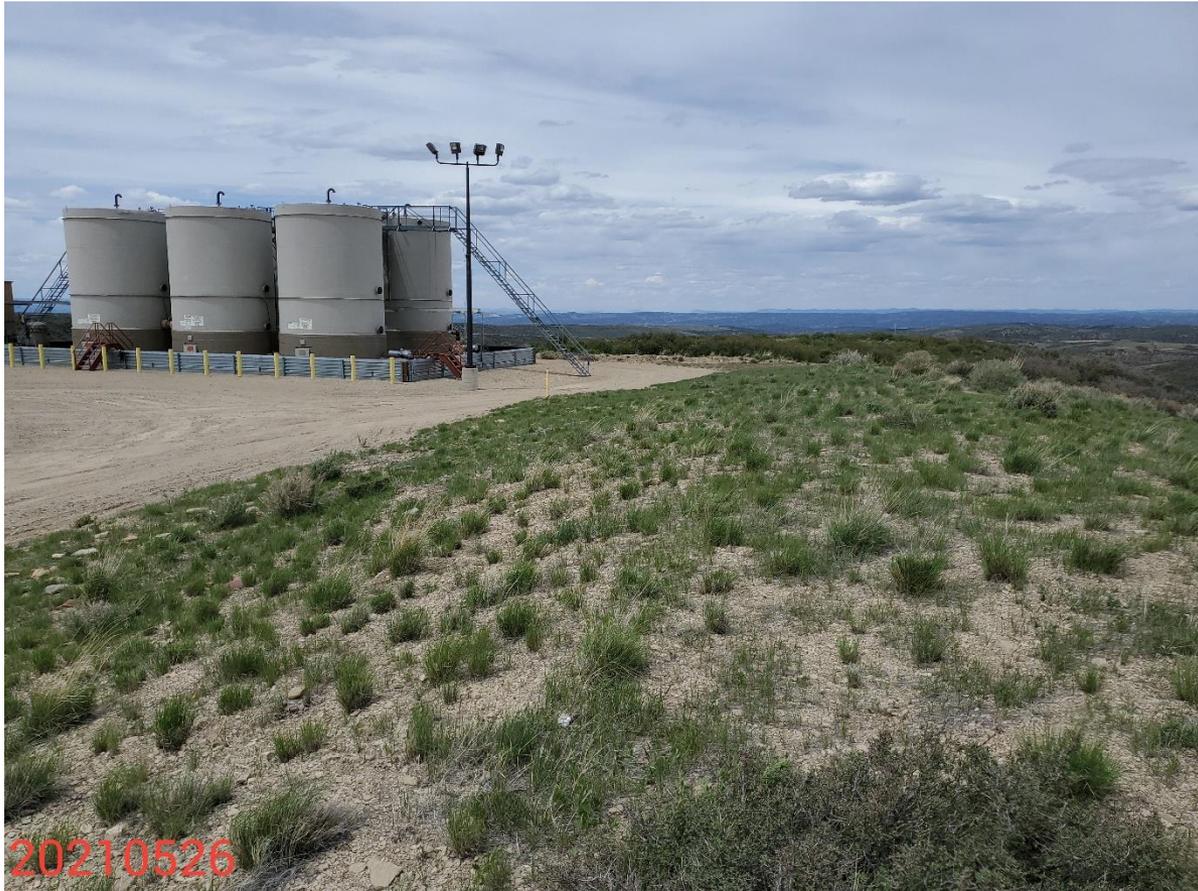
Photo 5: See comments under photo 2.

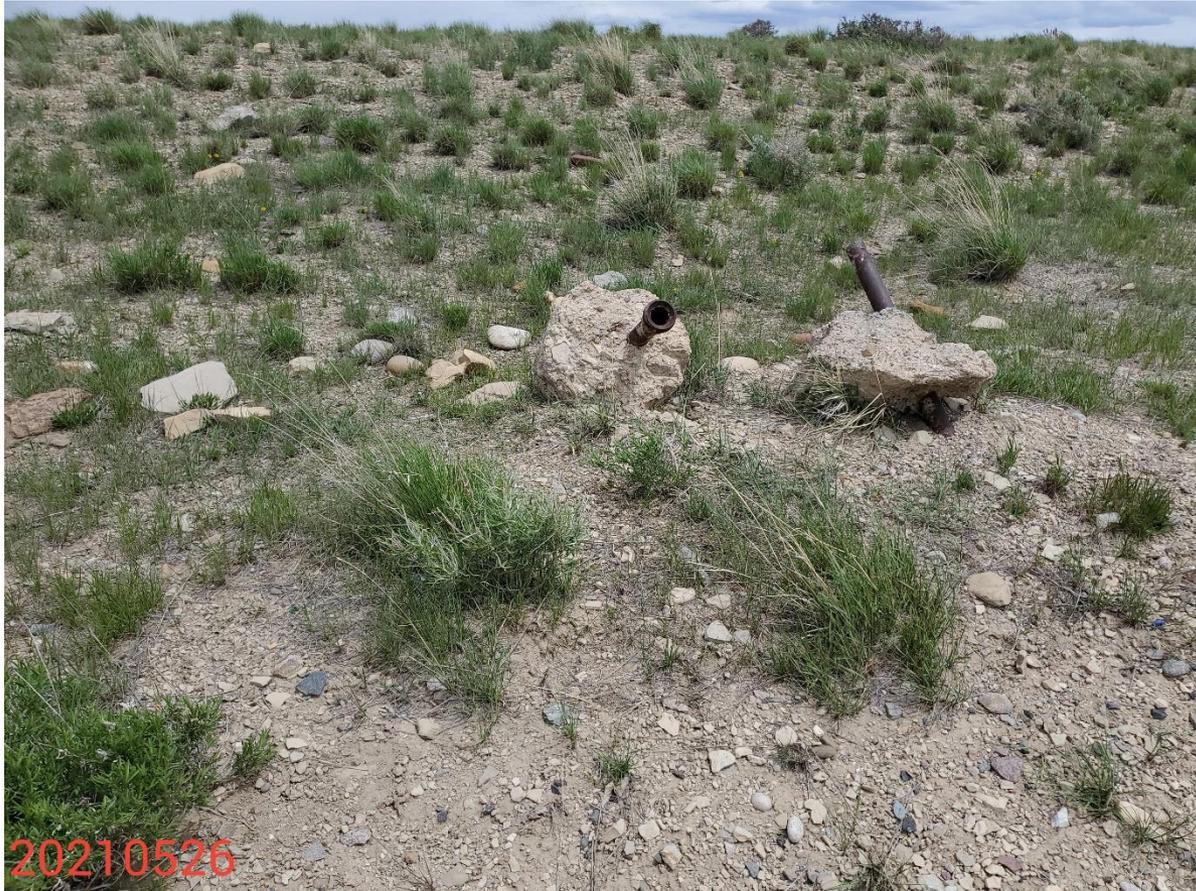
Photo 7: Photo taken from the east end of the Location. Photo shows concrete and pipe debris stored on edge of the pad. Debris was documented in inspection #680102840 and was required to be removed by 5/7/2018; debris has not been removed per the corrective action.

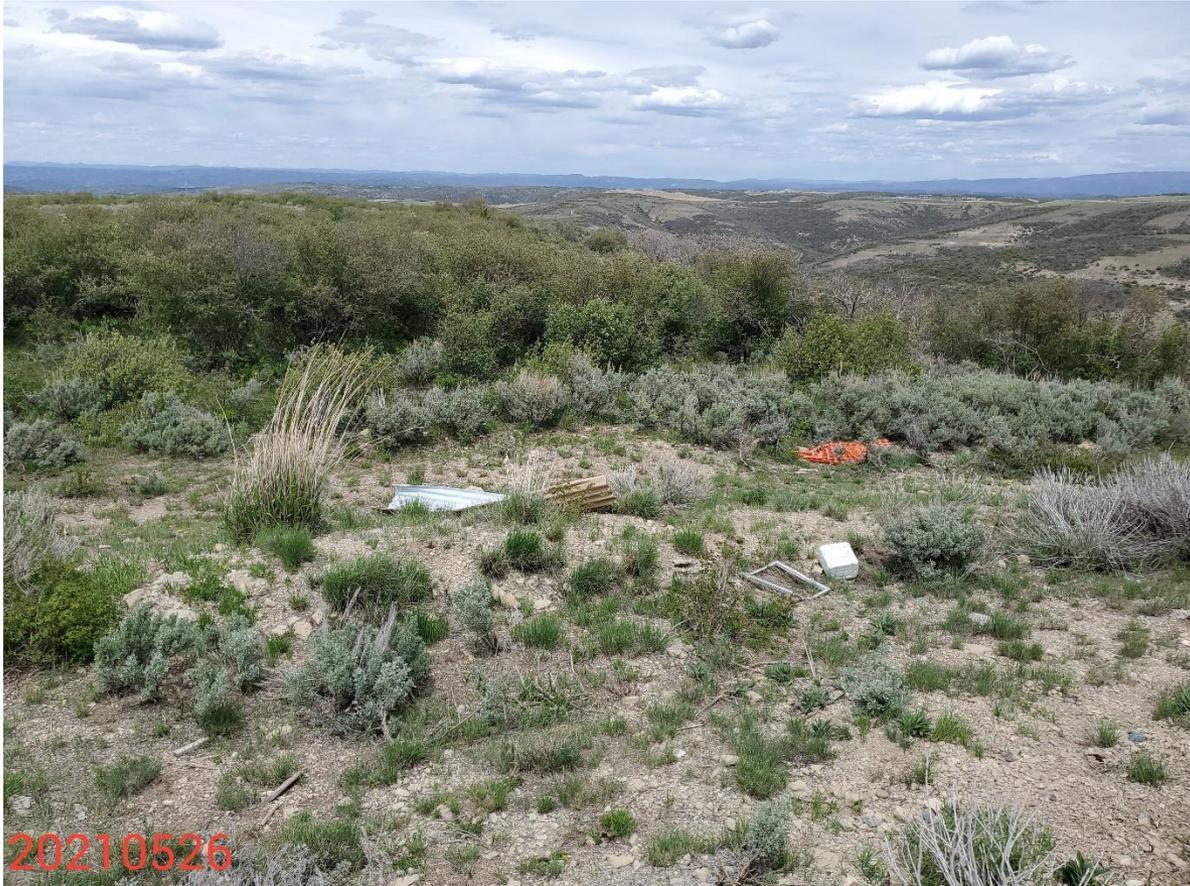
Photo 8: Photo shows various trash debris on the northern interim areas of the Location.

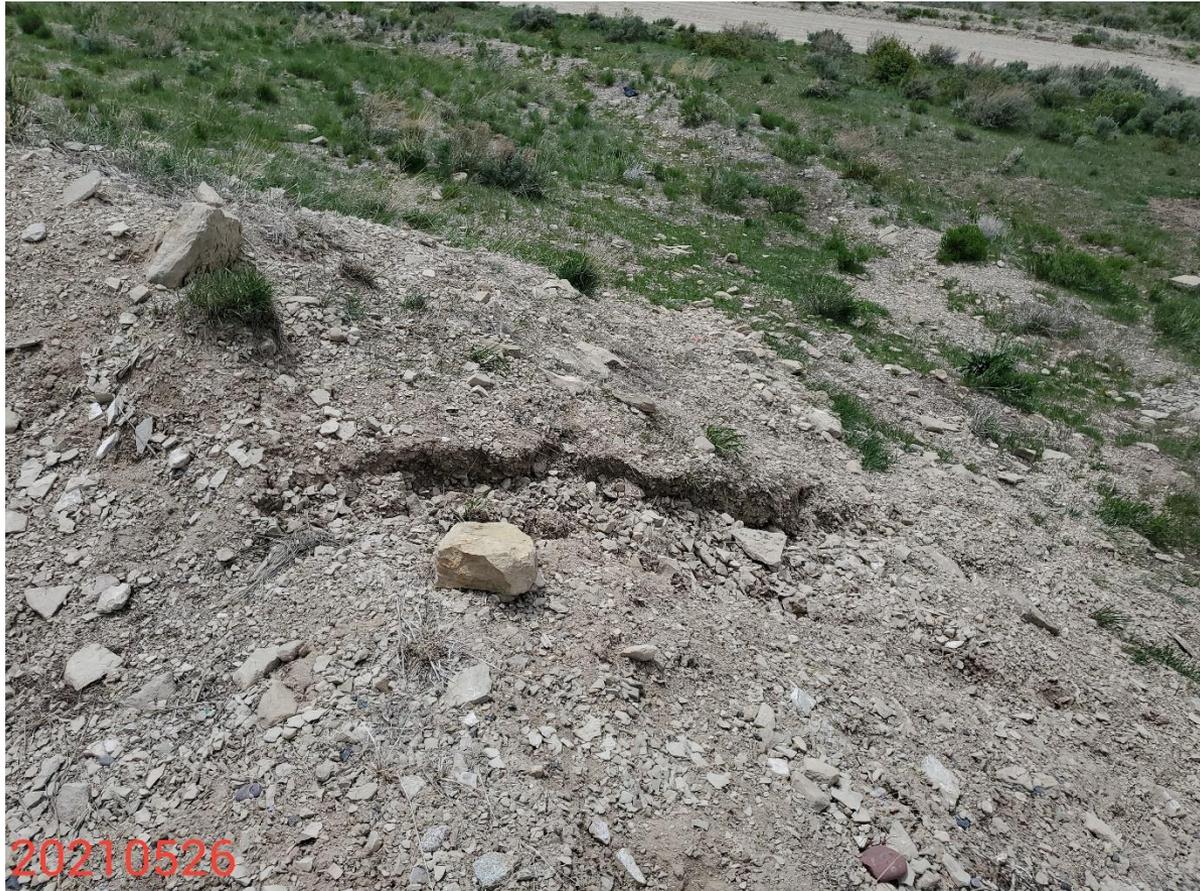
Photo 9: Photo taken from the northwest corner of the Location. Photo shows stormwater erosion degradation; control measures to protect and stabilize the slopes of the Location, and properly manage runoff from the location are missing or insufficient

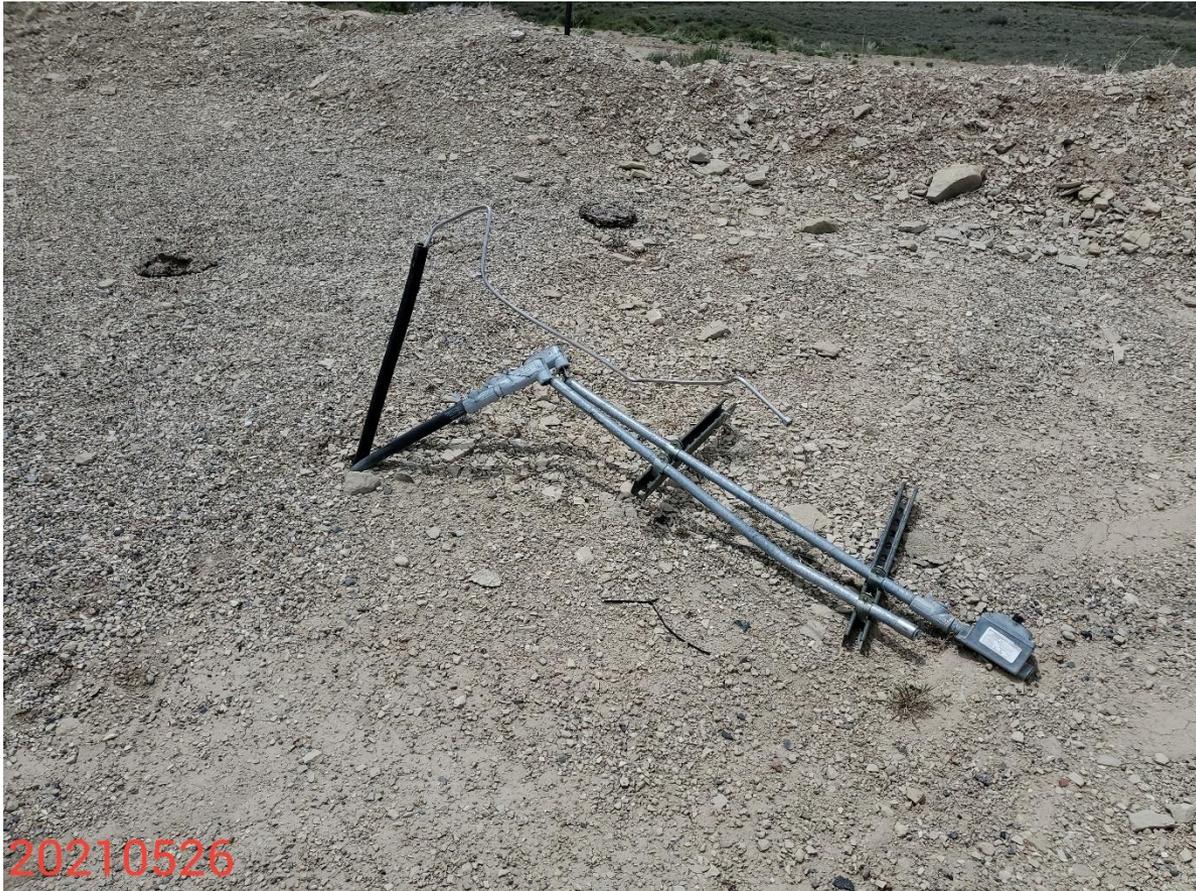
Photo 10: Photo shows unused equipment observed on the west end of the Location. Equipment requires removal pursuant with Rule 606.a

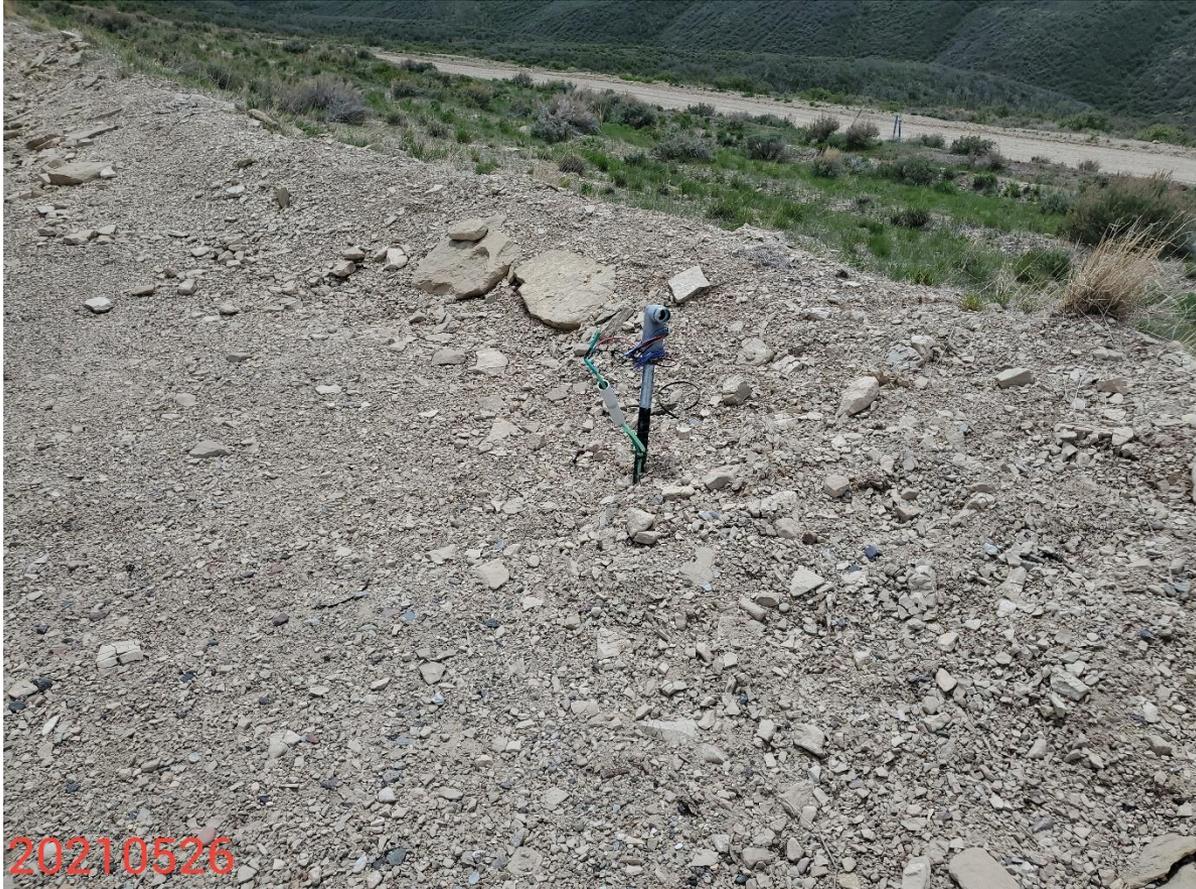
Photo 11: Photo shows unused equipment observed on the west end of the Location. Equipment requires removal pursuant with Rule 606.a

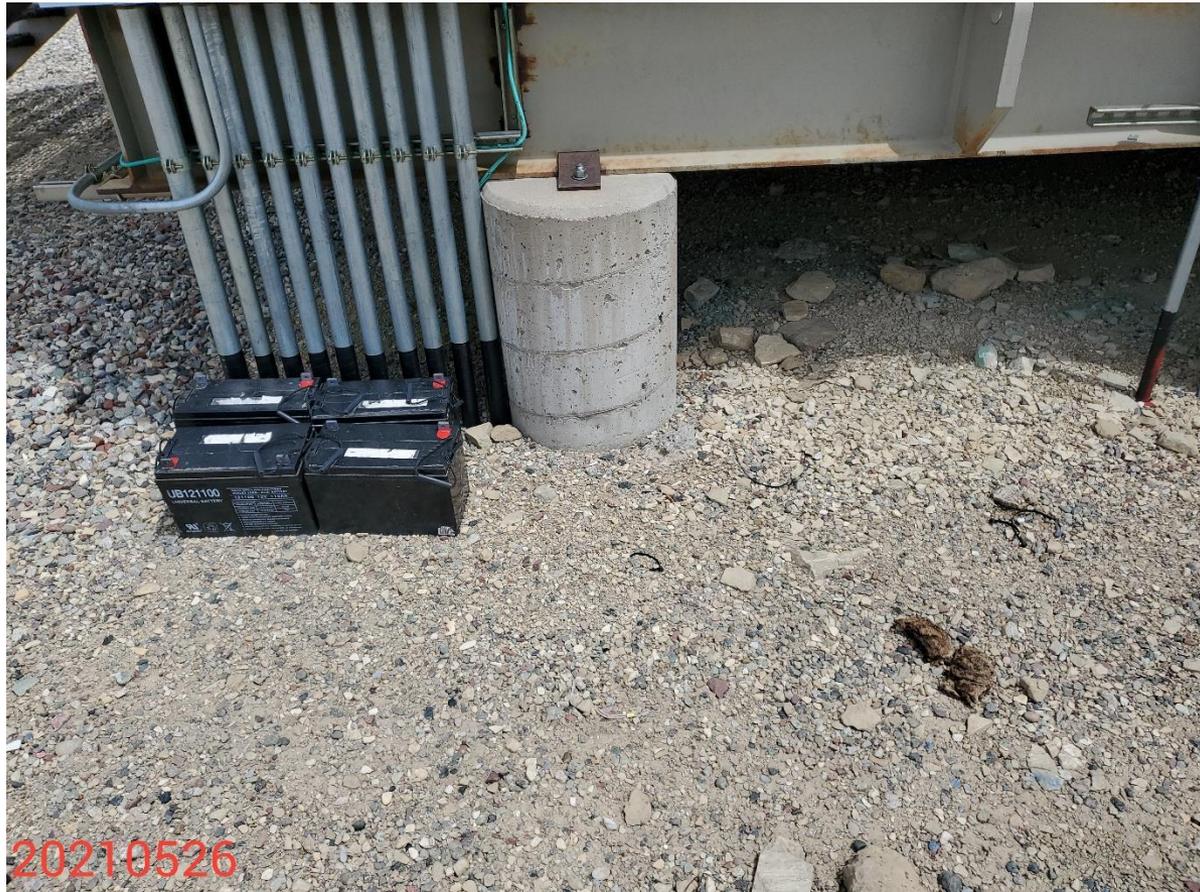
Photo 12: Photo taken from the northwest corner of the housing unit on the west end of the Location. Photos show batteries improperly stored on the Location.

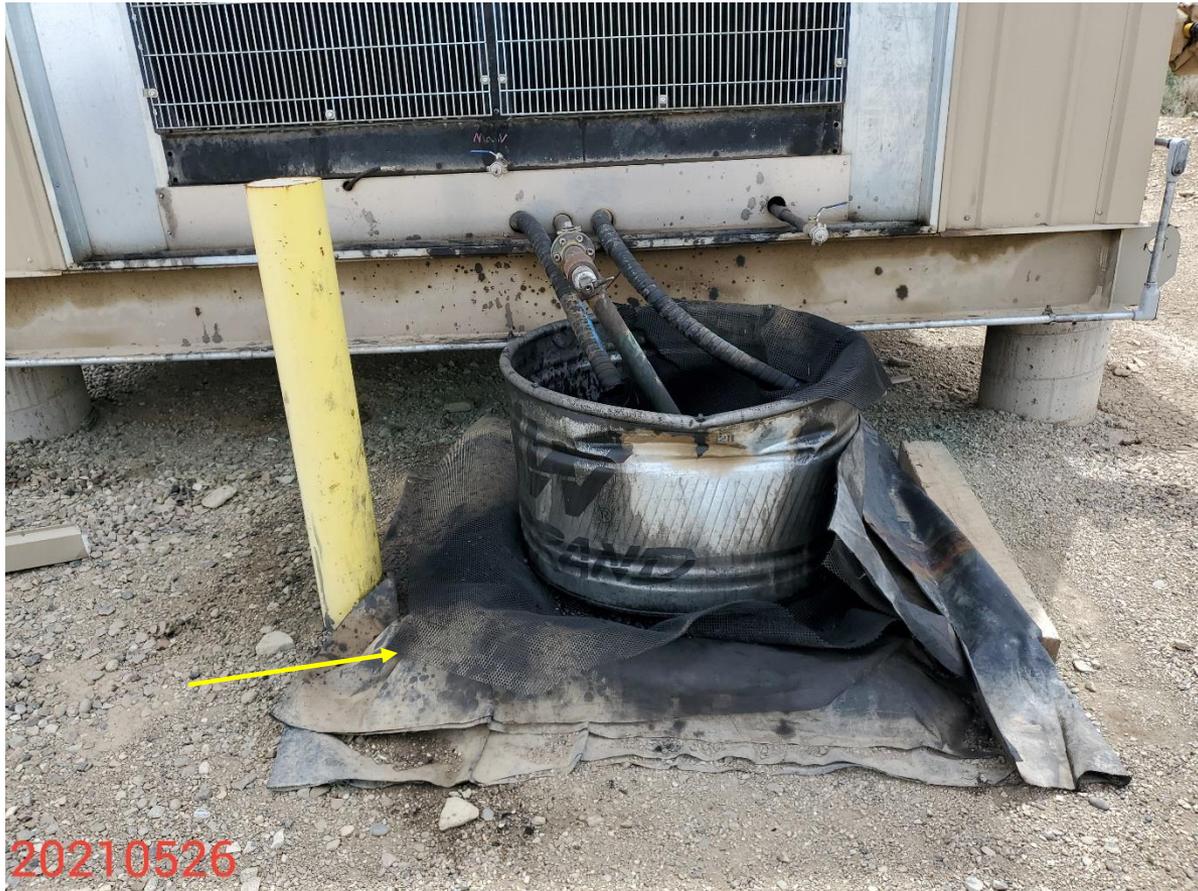
Photo 13: Photo taken from the north side of the generator housing. Photo shows tank installed to collect various chemicals from the housing unit. Photo also shows the containment BMP at base of tank; containment BMP is insufficient to prevent and/or contain a spill from the tank.

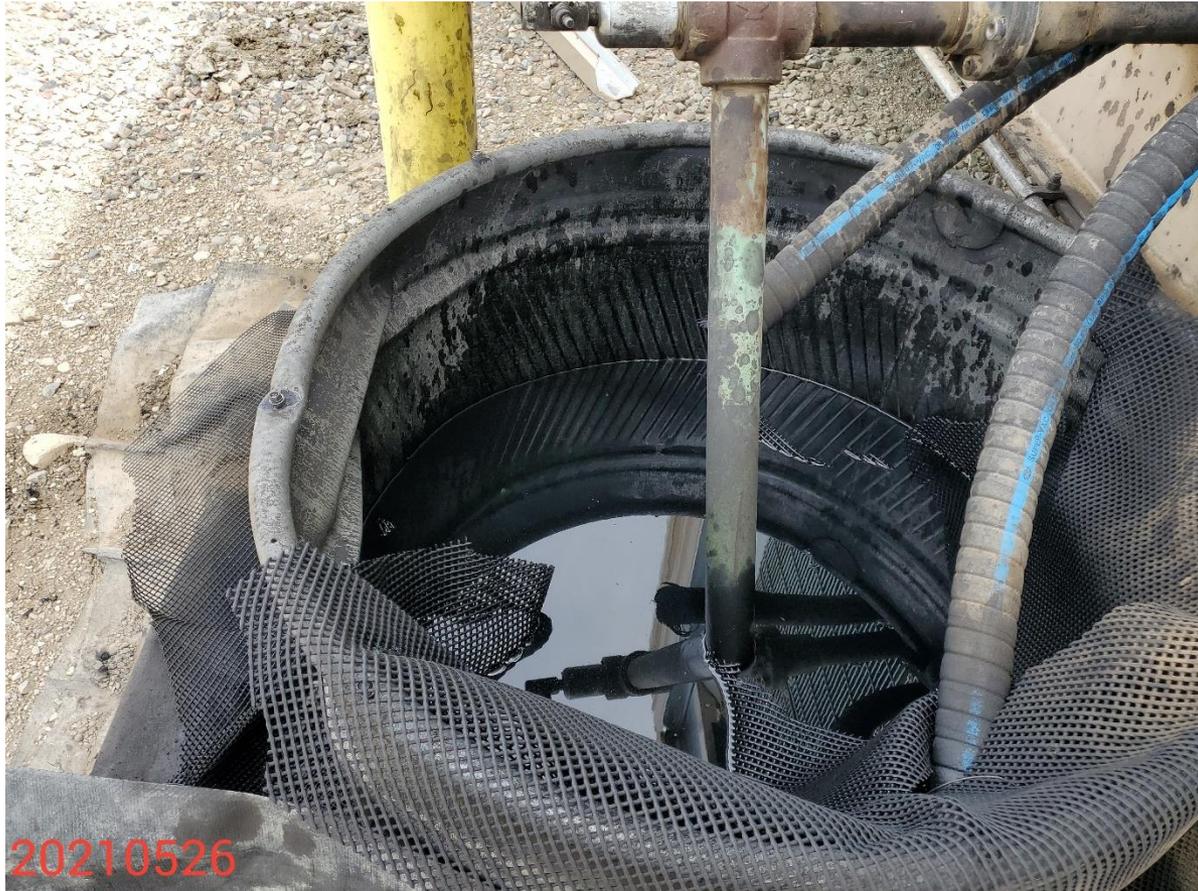
Photo 14: See comments under photo 13. Photo shows chemicals within tank. Equipment to prevent entry by wildlife missing.

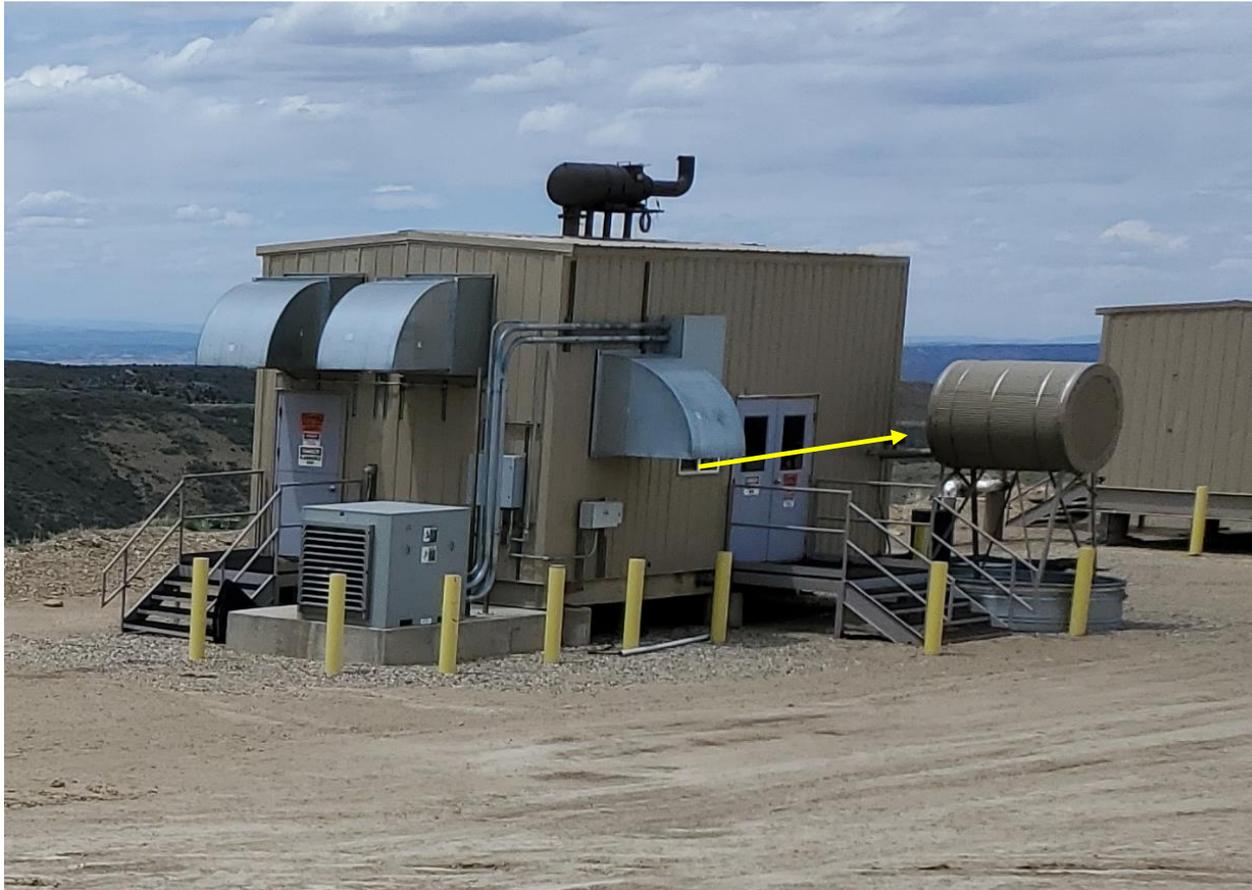
Photo 15: Photo shows tank in front of generator housing; sign or label not posted, or installed in a place where not visible.

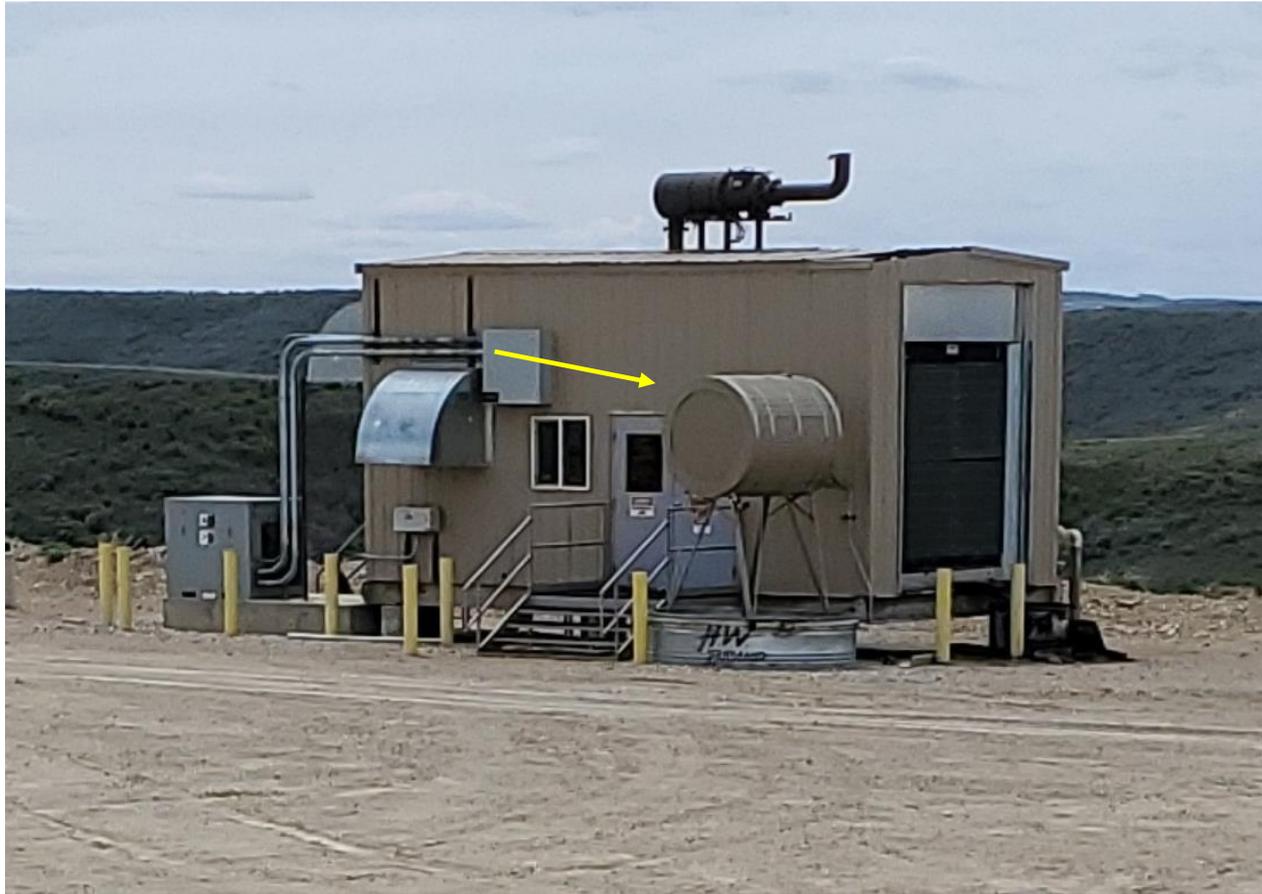
Photo 16: Photo shows tank in front of generator housing; sign or label not posted, or installed in a place where not visible.

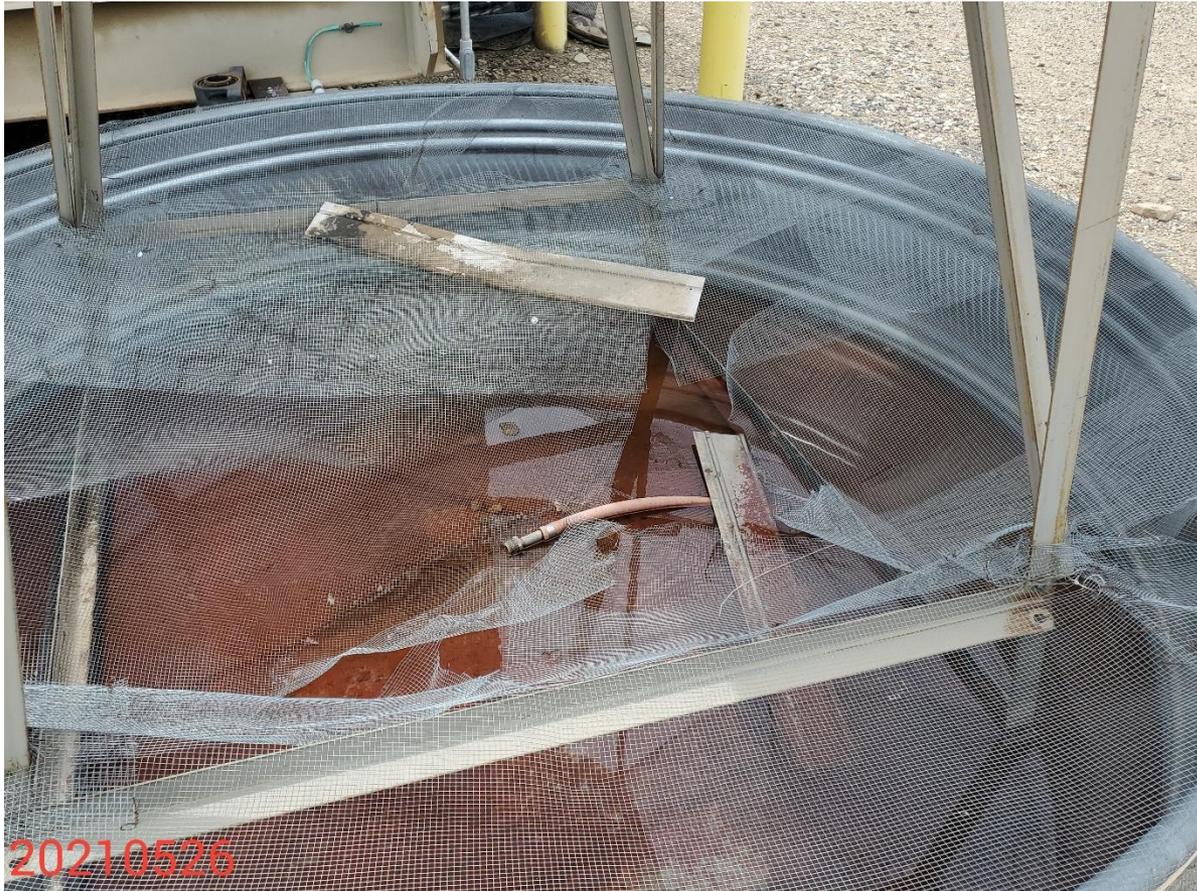
Photo 17: Continued from photo 16. Photo shows wildlife protection screen is not in proper functioning condition. Photo also shows various trash debris within tank.

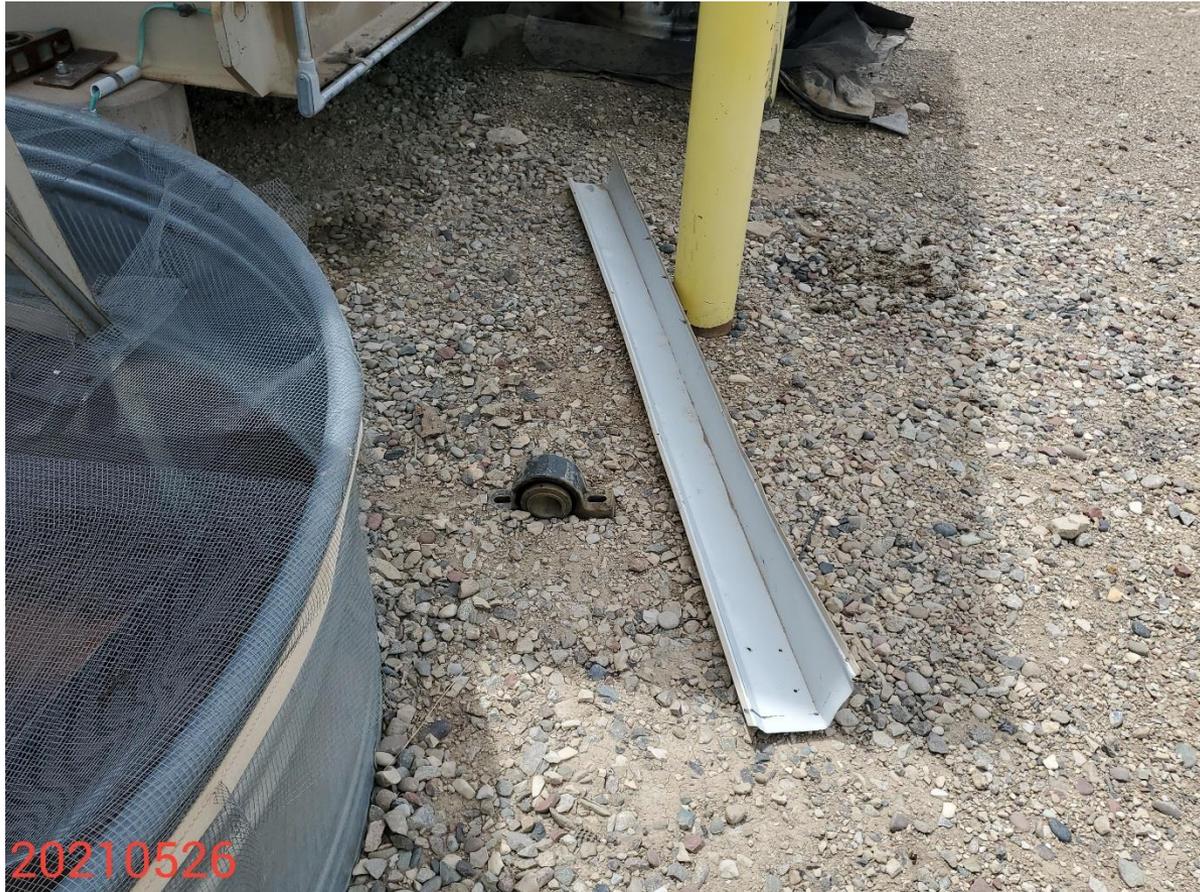
Photo 18: Continued from photo 18. Photo shows various trash debris on Location.

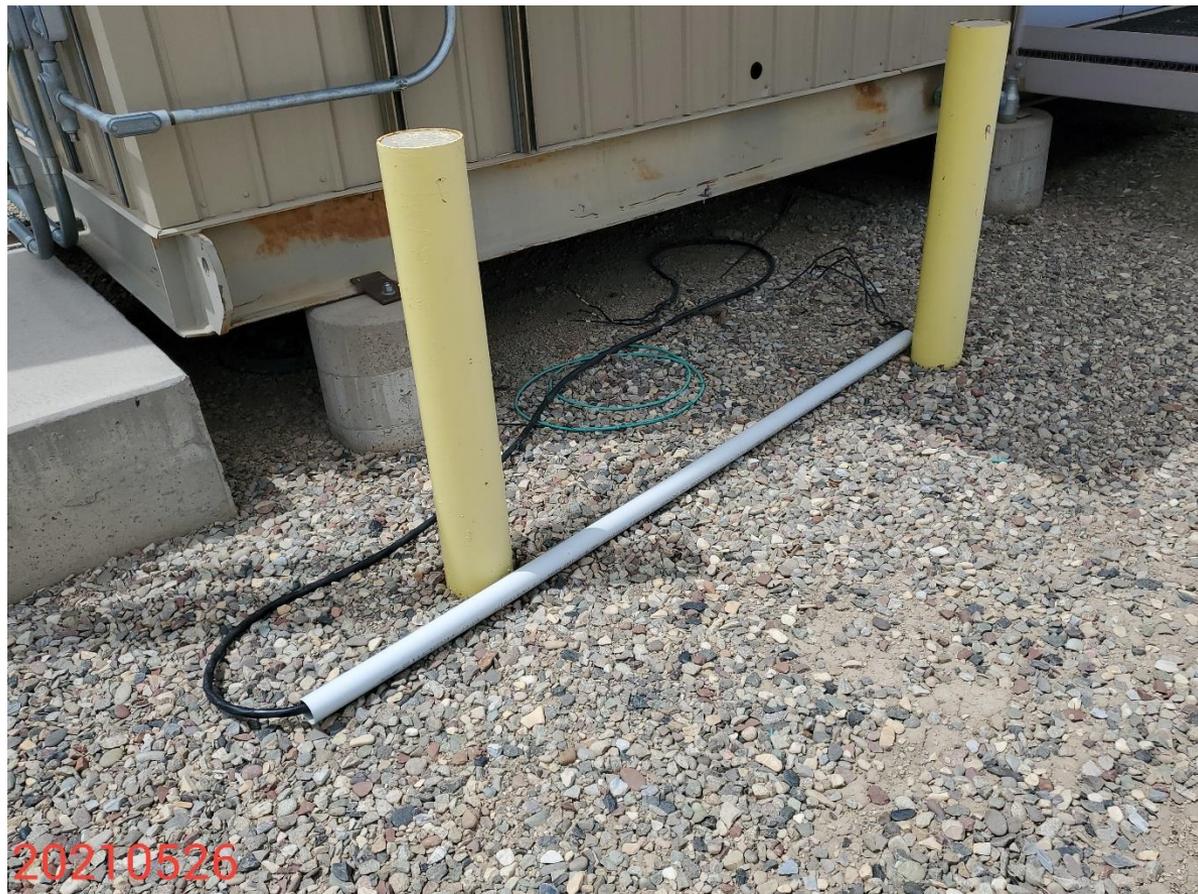
Photo 19: Photo shows various trash debris or unused equipment stored around the generator housing unit.

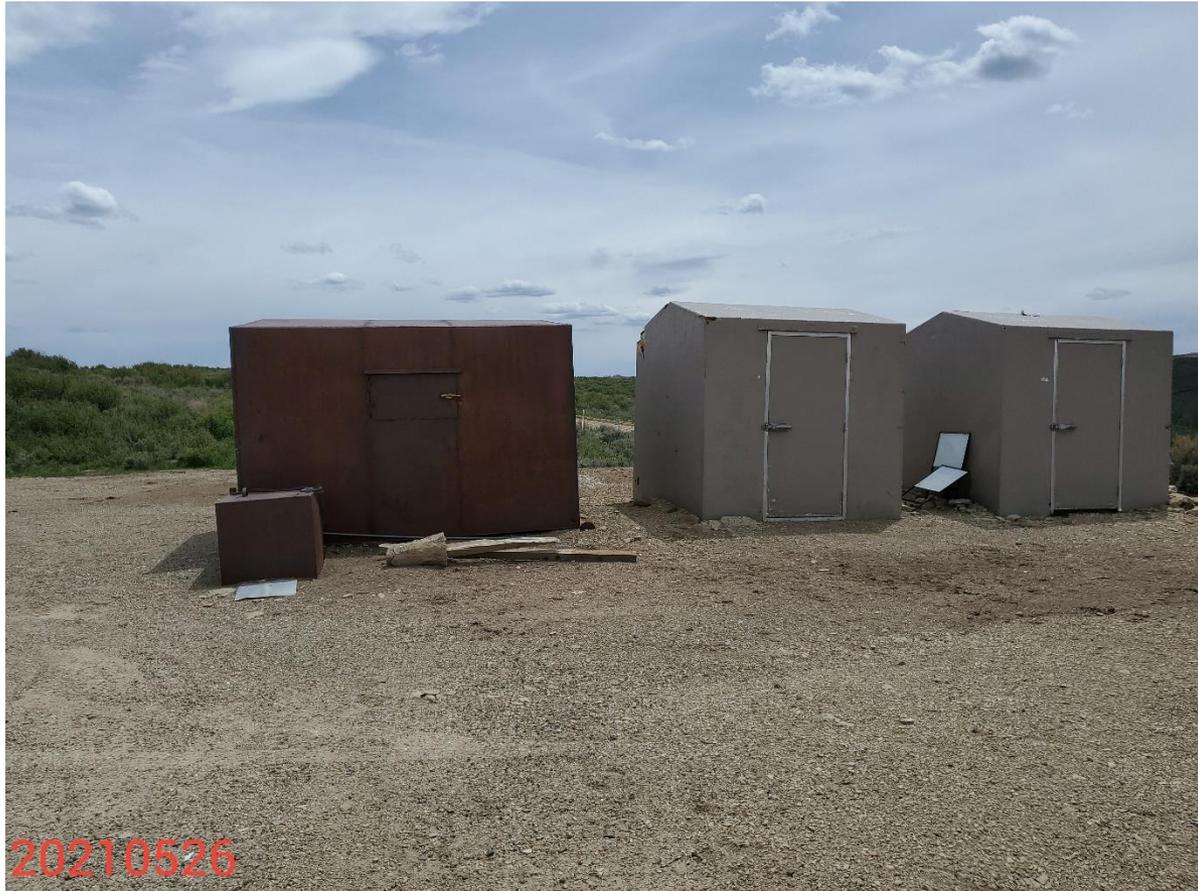
Photo 20: Photo shows 3 of the 4 sheds stored on the southwest corner of the Location, as well as various trash debris and unused equipment stored next to the sheds. After review of the Compliance Unit manager, the two white sheds on the right require removal.

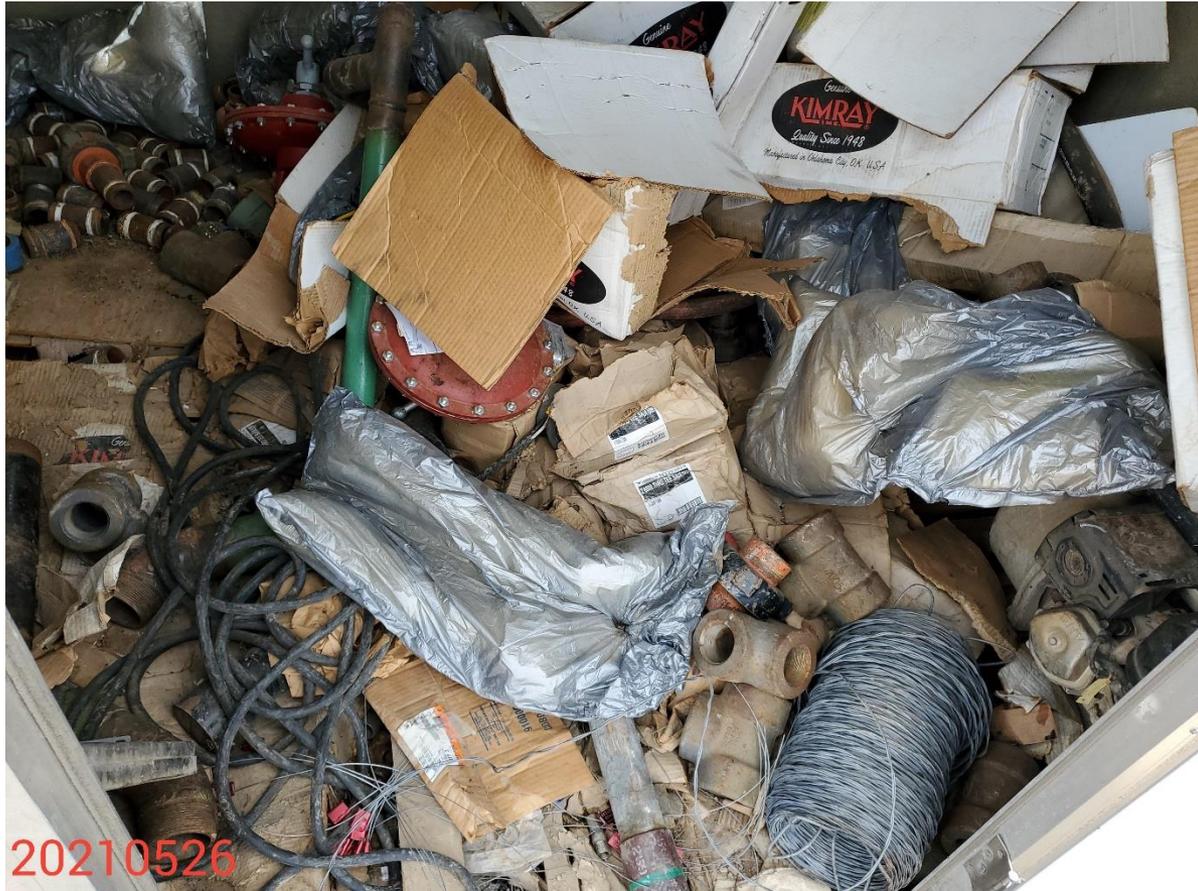
Photo 21: Photo shows various trash debris observed stored within shed.

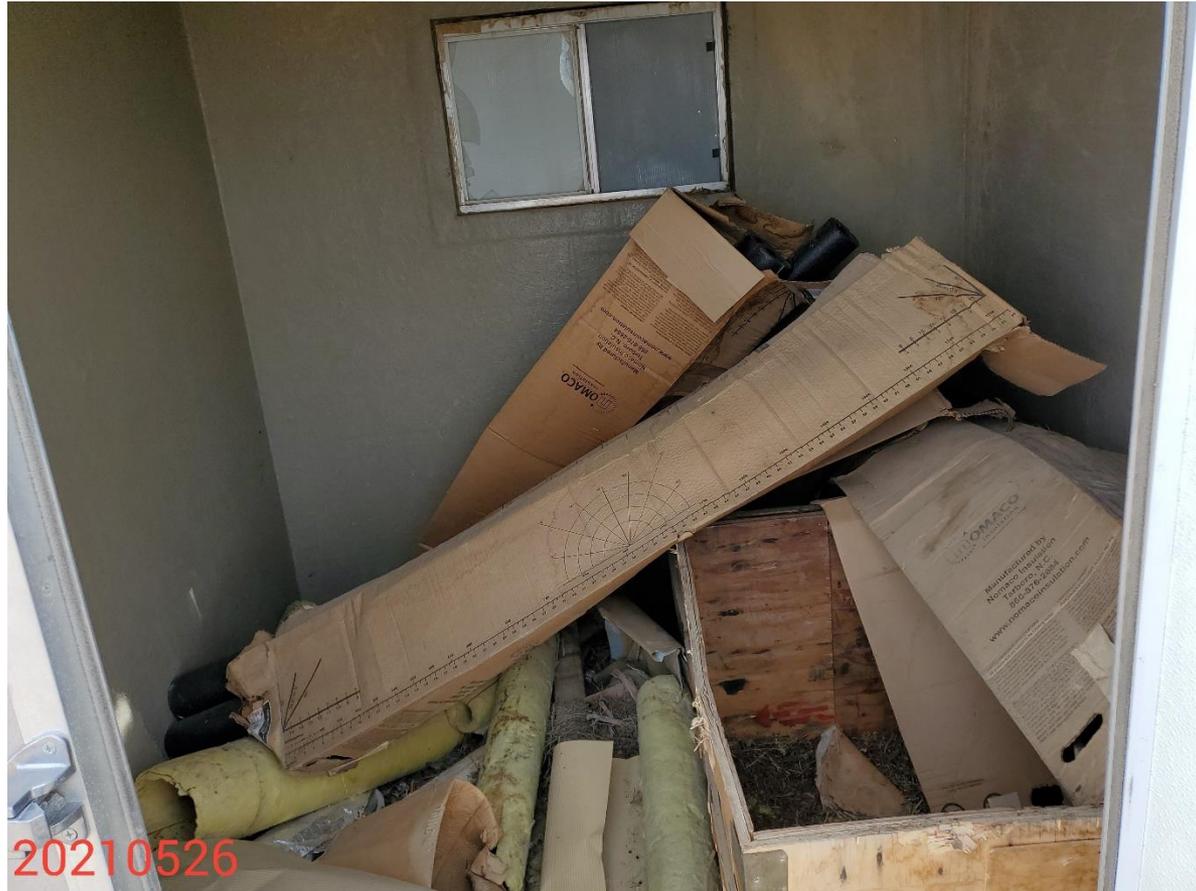
Photo 22: Photo shows various trash debris observed stored within shed.
