Inspection Photos

5/26/2021

Operator: CAERUS ENERGY SERVICES LLC #
10668

Location ID: 335669
Garfield County, CO

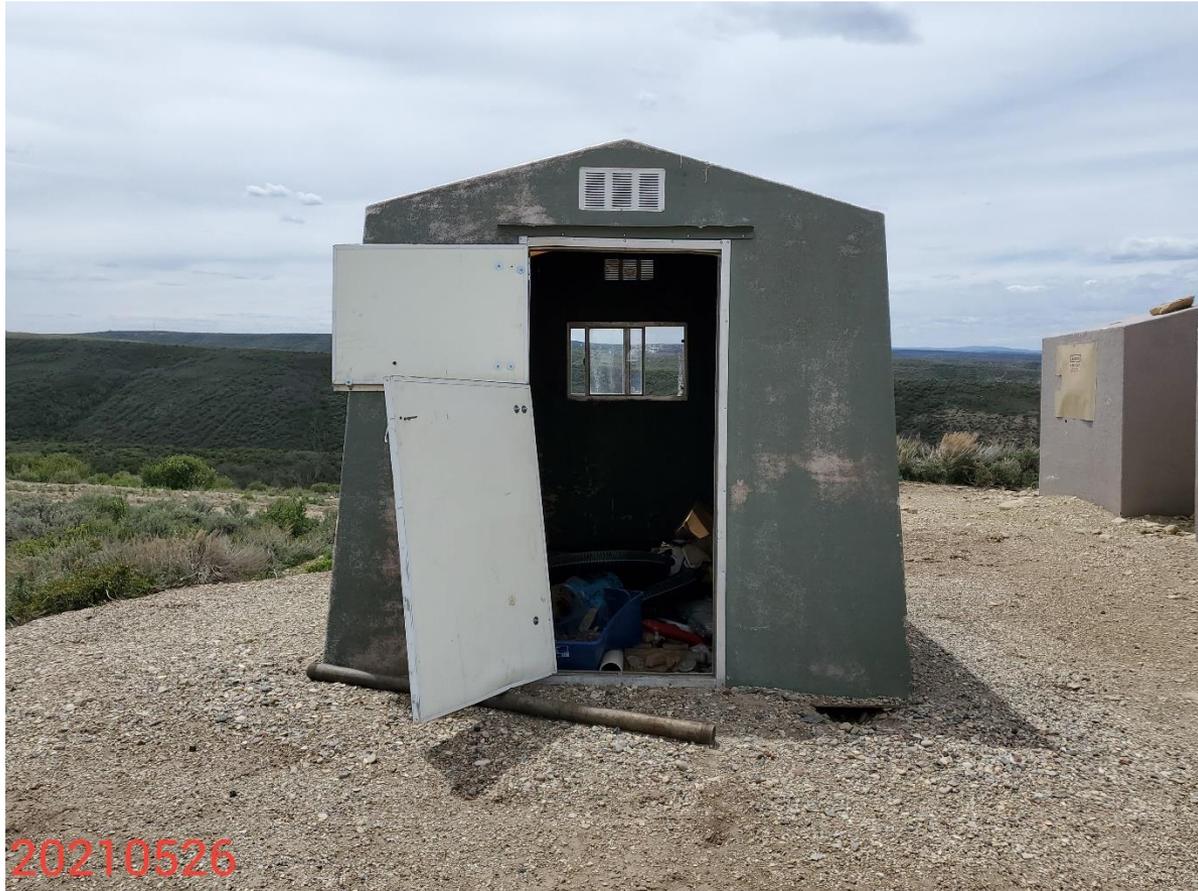
Photo 23: Photo shows 4th shed stored on the southwest end of the Location. After review of the Compliance Unit Manager, shed requires removal.

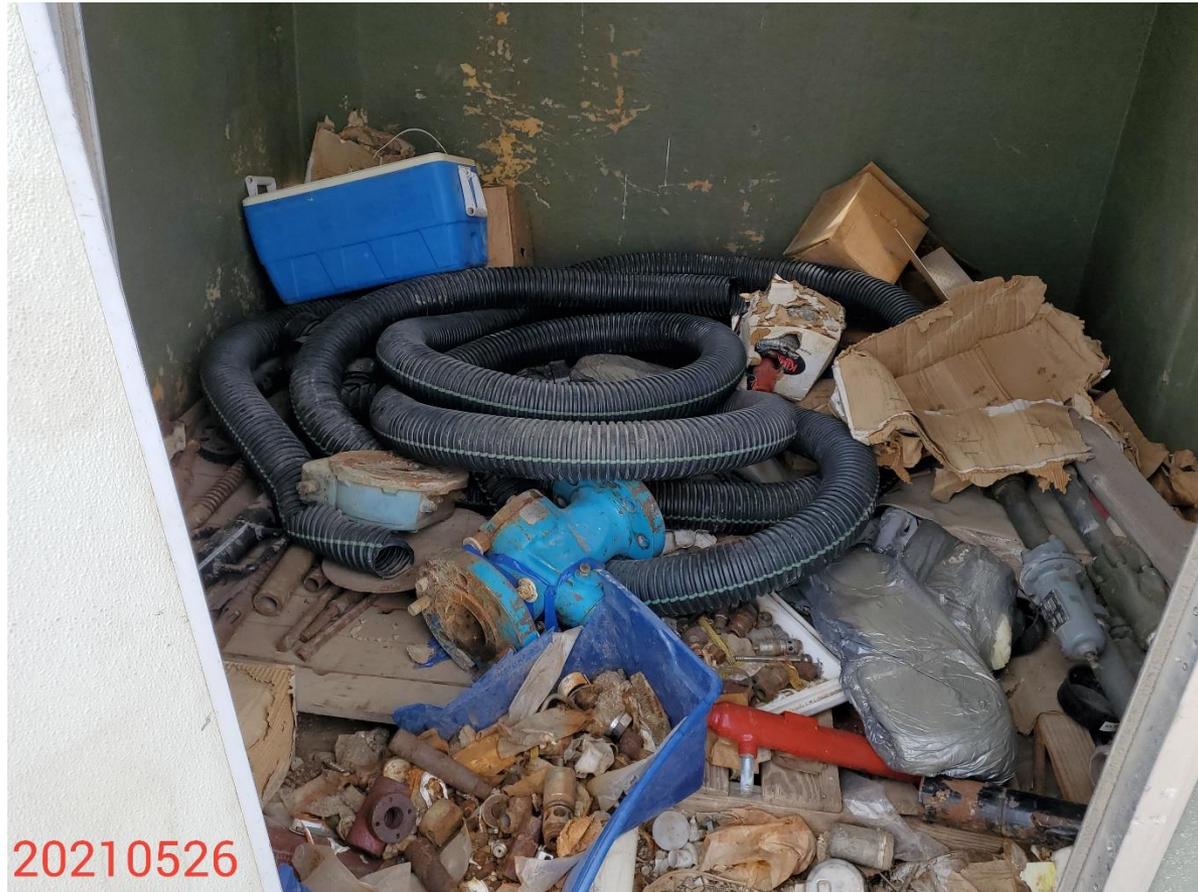
Photo 24: Photo shows various trash debris observed stored within shed.
