Inspection Photos

API: 055-06105

Operator: OXY USA INC

Inspection Date: 5/26/2021

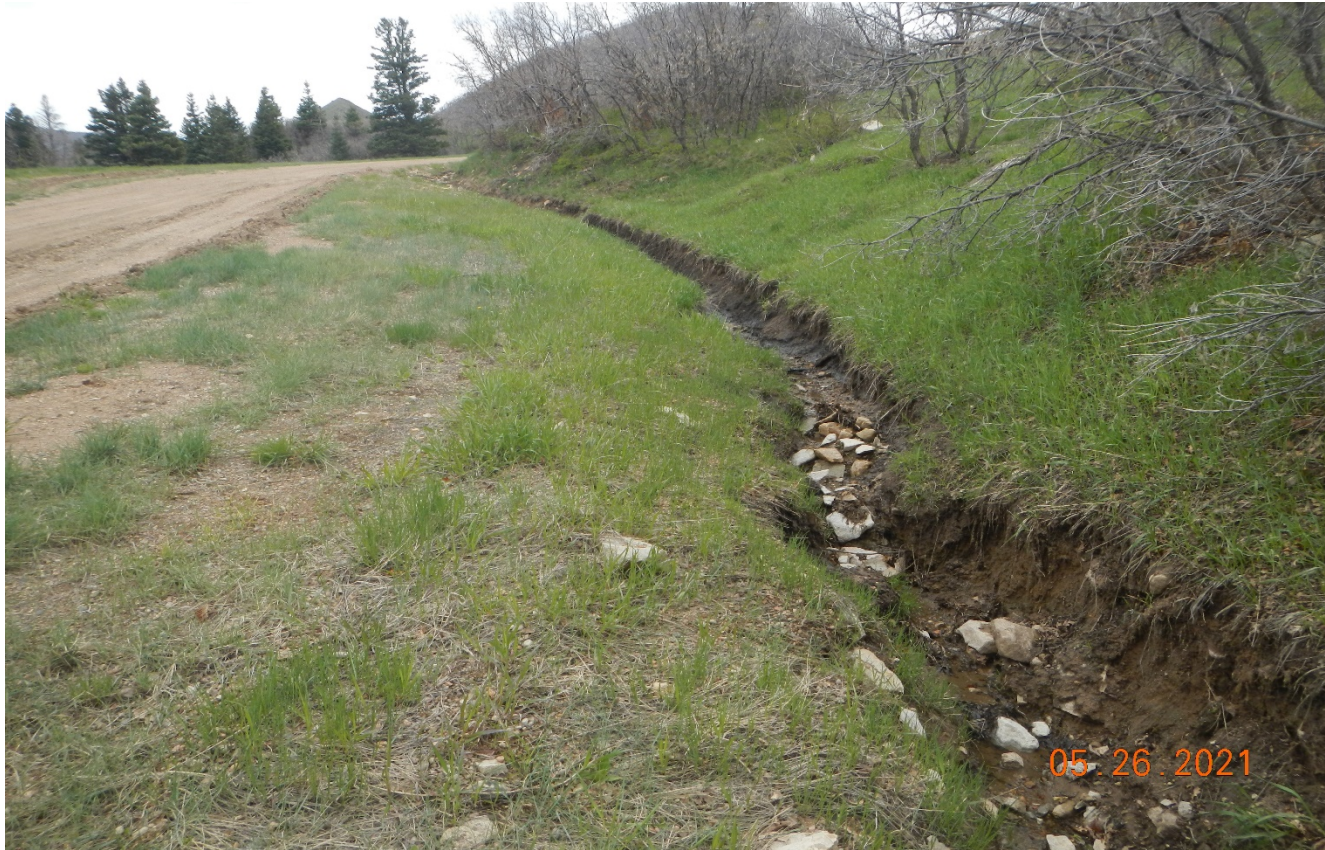
Photo 1. Facing southeast ascending the hill toward the location. There is erosion occurring along the road. BMP's are needed in this area along the road to prevent further erosion.

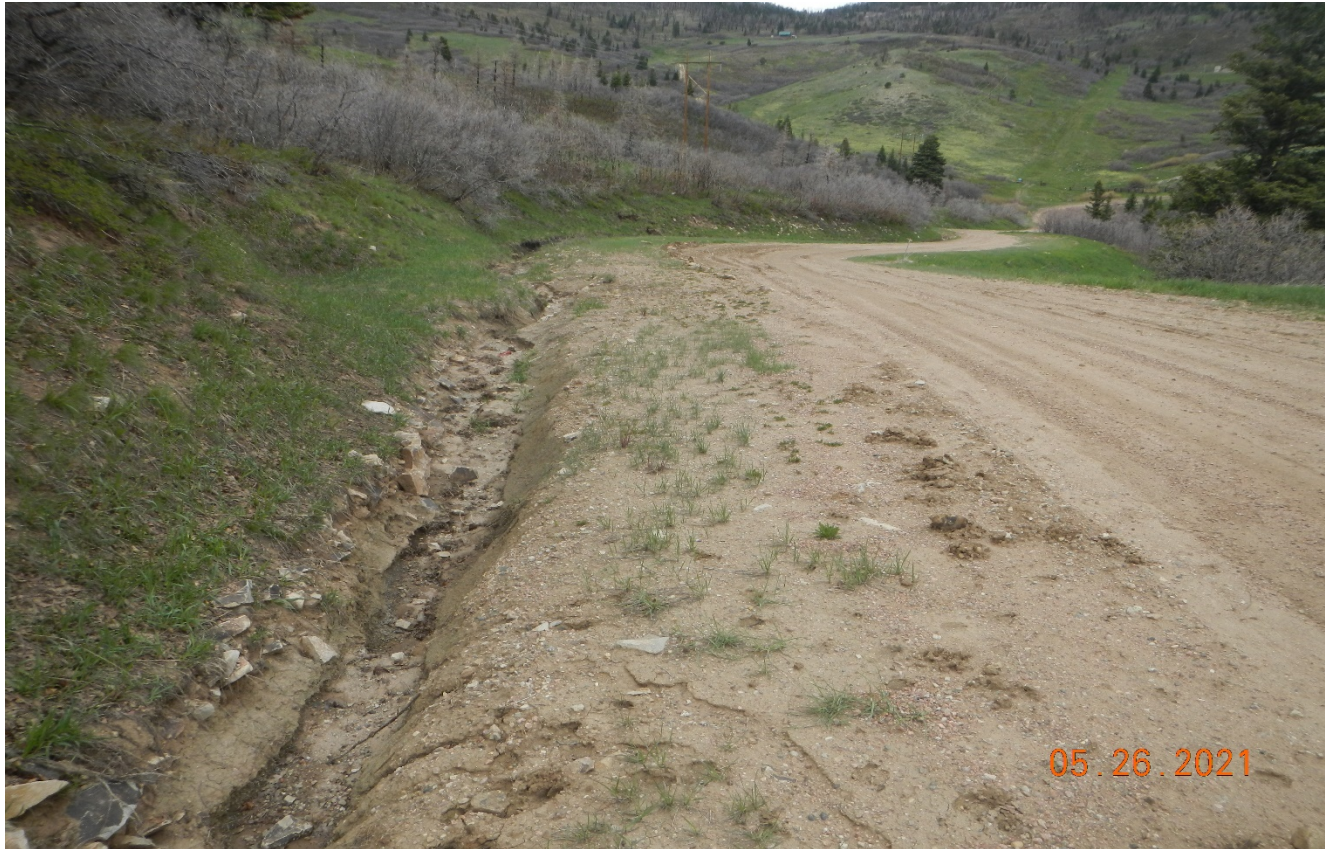
Photo 2. Facing northwest looking back down the road. There is erosion occurring along the road. BMP's are needed in this area along the road to prevent further erosion.

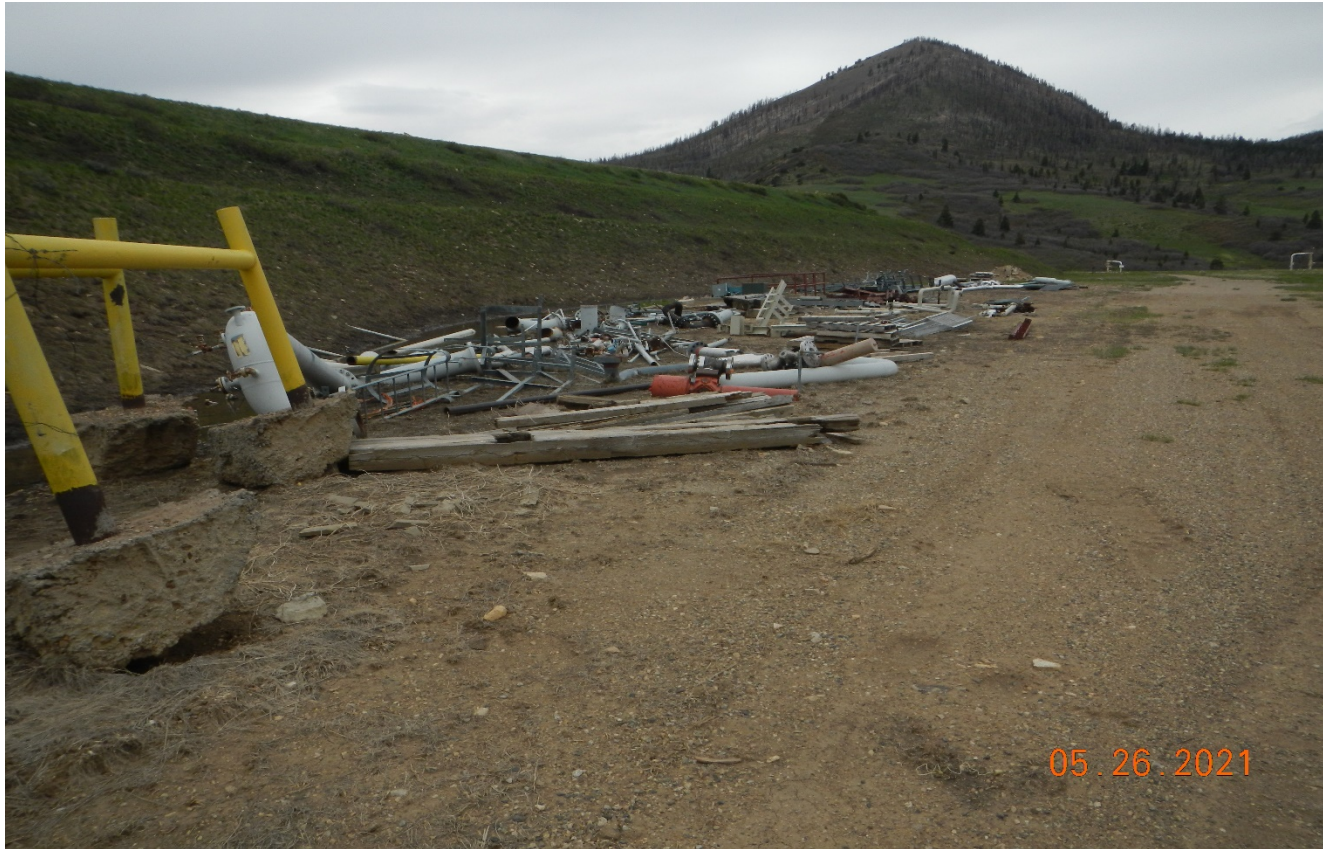
Photo 3. Facing northwest at the location. There is various unused equipment stored in this area. Since last year during inspection, the amount of unused equipment has increased in this area and remains in the same position indicating the equipment has not been used.
