Stormwater Inspection Report

Operator:	Laramie Energy, LLC
Project:	Cascade Creek
Location:	CC 697-09-61 Pad
Date:	Monday, May 31, 2021
Weather:	Mostly Sunny, Light Wind, 81°, Lo 47°

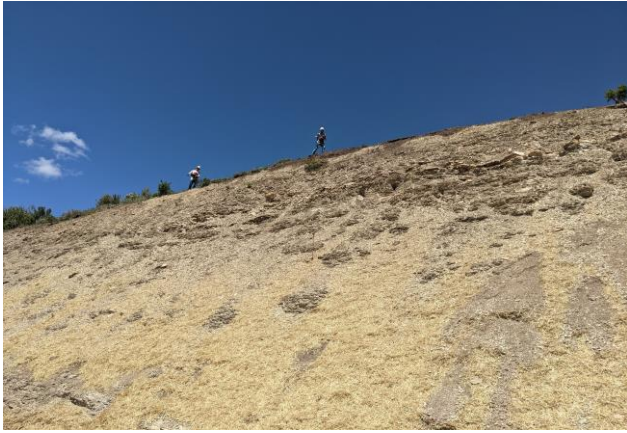
Photo 1

Broadcasting QuickGuard over CC 697-09-61 Cut-Slopes

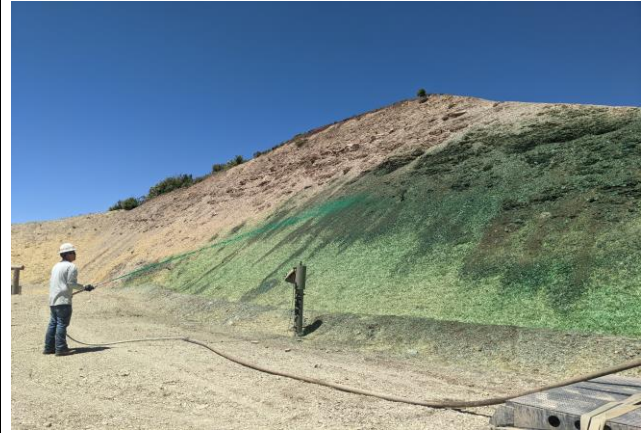
Photo 2

Applying Liquid Soil Amenities and Plant Nutrients

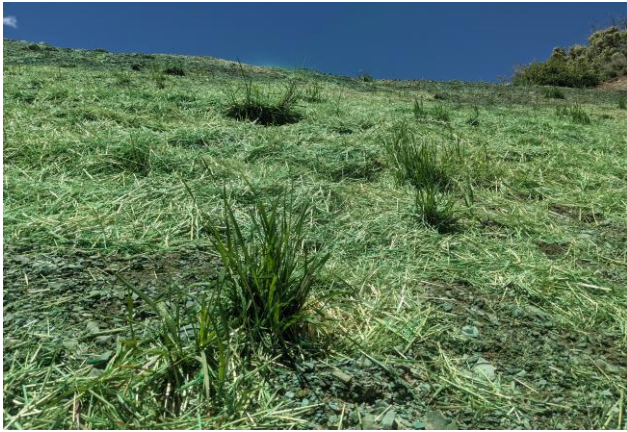
Photo 3

Desirable Permanent Vegetation Established from Previous Seedings

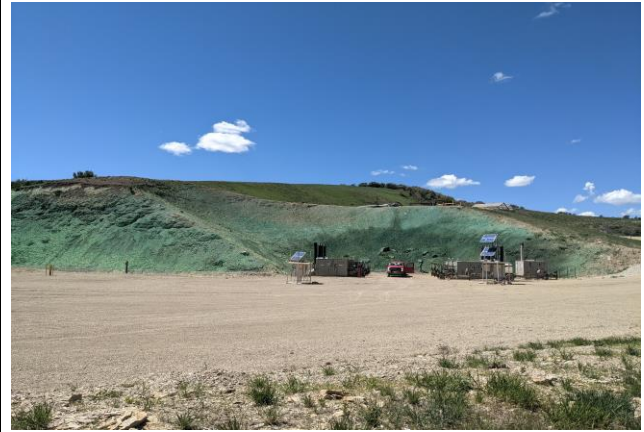
Photo 4

Location after Making Liquid Application
