## Stormwater Inspection Report

<b>Operator:</b>	Laramie Energy, LLC
<b>Project:</b>	Cascade Creek
<b>Location:</b>	Cascade Creek 697-08-53 Pad
<b>Date:</b>	Wednesday, May 12, 2021
<b>Weather:</b>	Mostly Sunny, Light Wind, 61°, Lo 34°

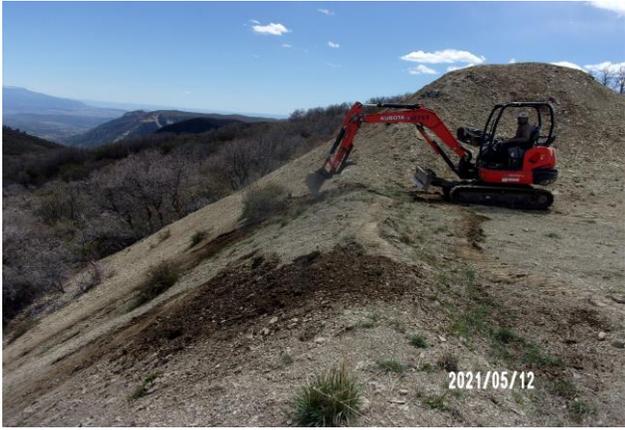
**Photo 1**

*Pulling Concrete out of the Fill Slope*

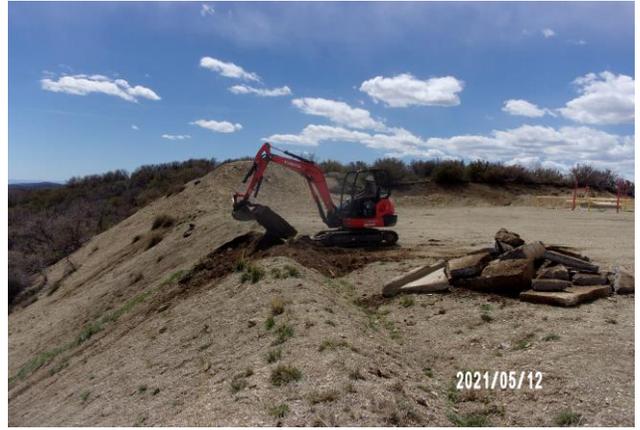
**Photo 2**

*Pulling Concrete out of the Containment Berm*

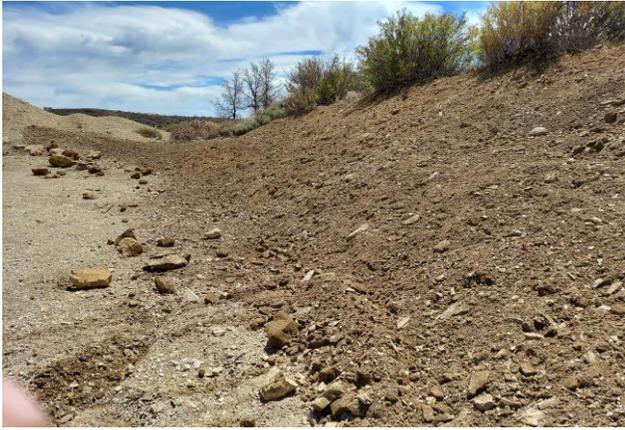
**Photo 1**

*Material Pulled into the Cut Slope*

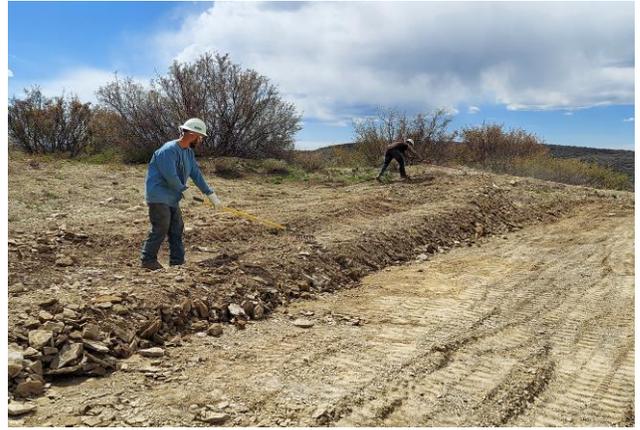
**Photo 2**

*Hand Raking Seed to Incorporate into Soils*

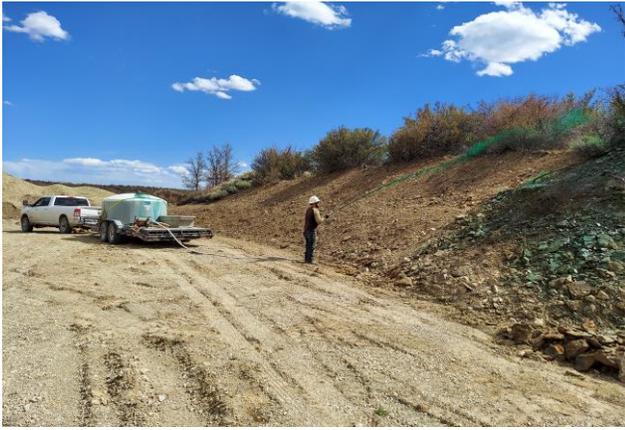
**Photo 3**

*Applying Soil Amenities and Nutrients*

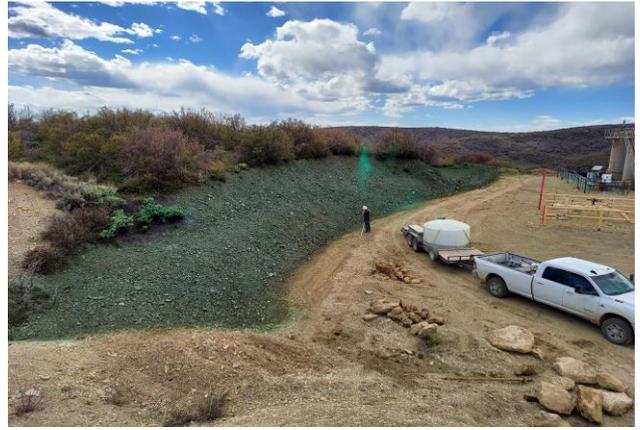
**Photo 4**

*Applying Soil Amenities and Nutrients*

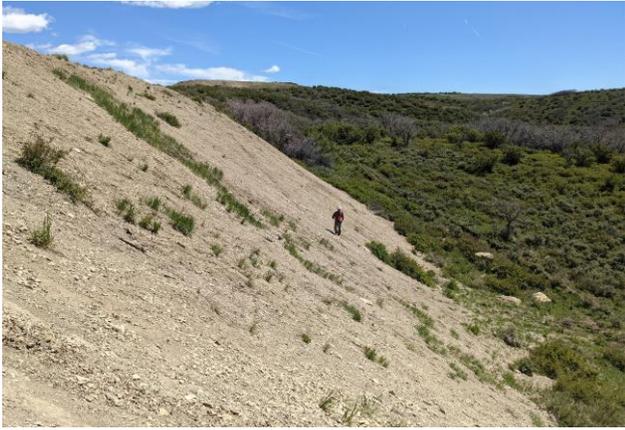
**Photo 1**

*Broadcast Seeding Eastern Fill Slope*

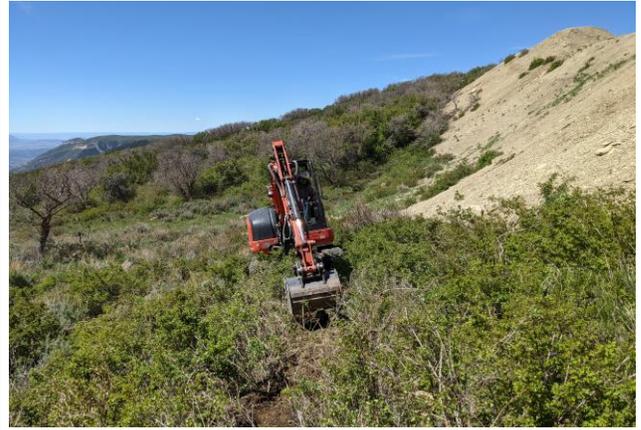
**Photo 2**

*Removing Existing Vegetation to Install Excelsior Wattle*

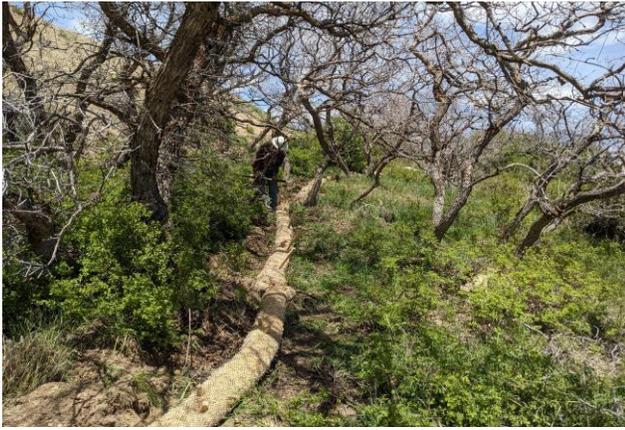
**Photo 3**

*Excelsior Wattle Installed on East Side of Location*

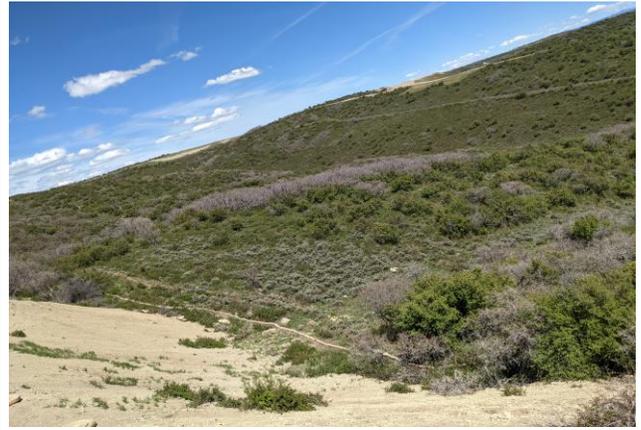
**Photo 4**

*Excelsior Wattle Installed on East Side of Location*

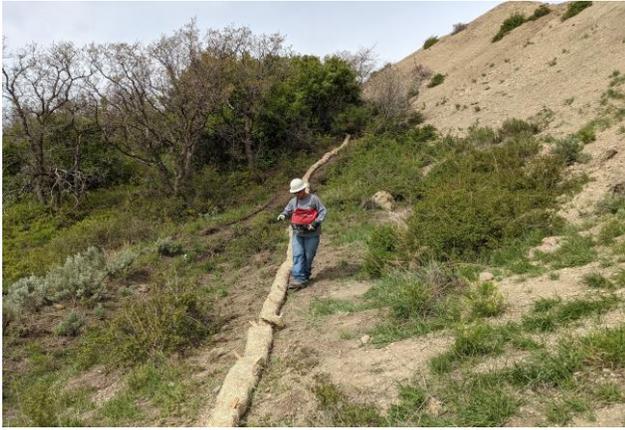
**Photo 1**

*Broadcasting Seed over Disturbed Ground*

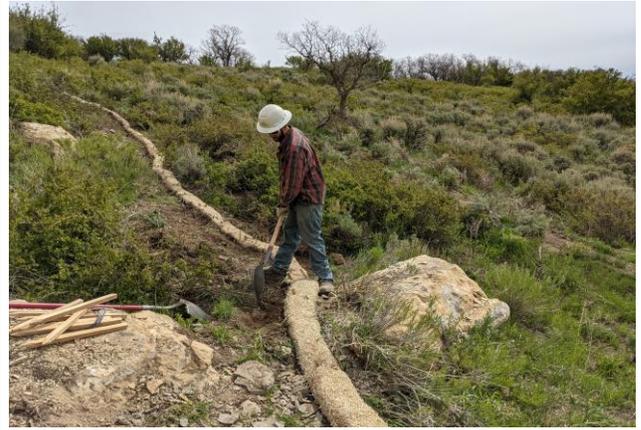
**Photo 2**

*Installing Excelsior Wattle on the CC 697-08-53 Pad*

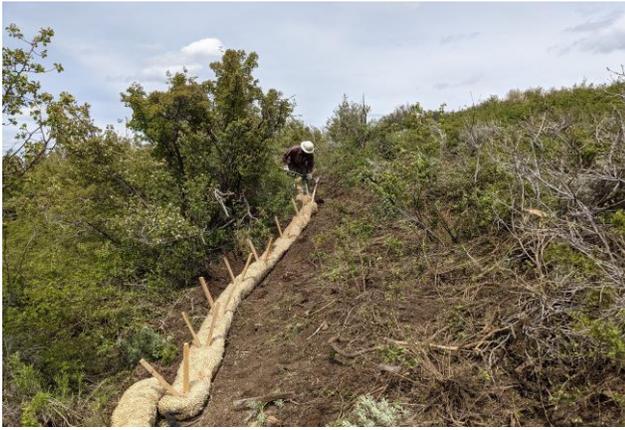
**Photo 3**

*Installing Excelsior Wattle on the CC 697-08-53 Pad*

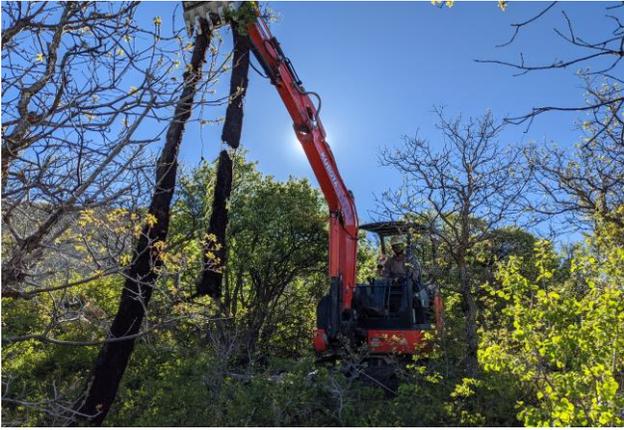
**Photo 1**

*Removing Old Deteriorated Wattle on CC 697-08-53 Pad*

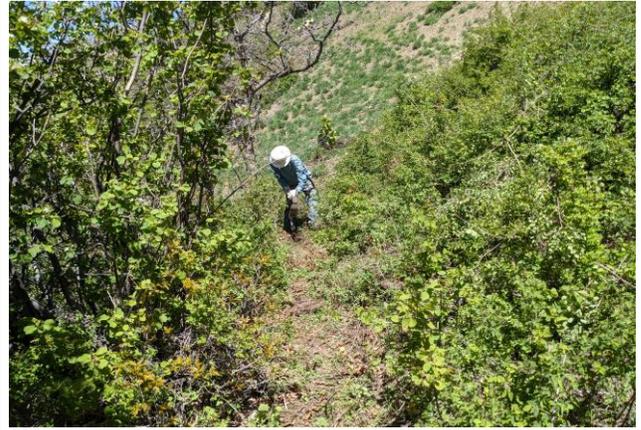
**Photo 2**

*Installing Trench for Wattle Installation*

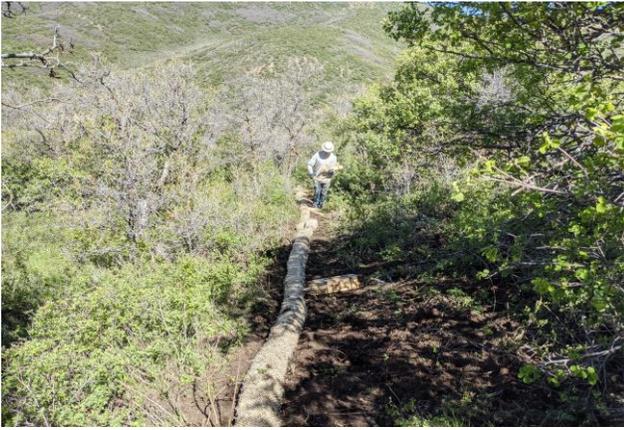
**Photo 3**

*Installing Wattle on the CC 697-08-53 Pad*

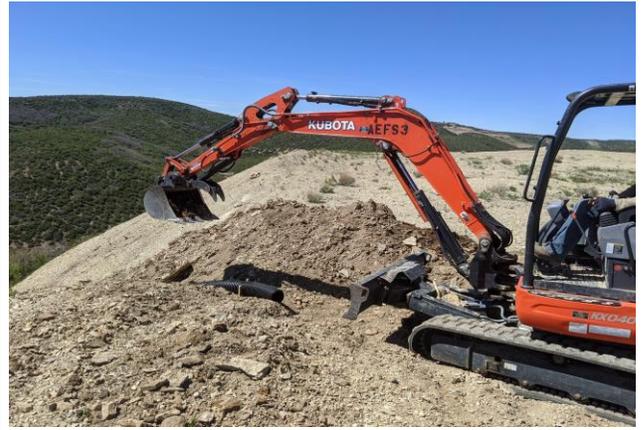
**Photo 4**

*Installing Flex Hose Outlet on CC 697-08-53 Pad*
