Inspection Photos
Operator: Simcoe
API: 067-07854
Date: 5/28/2021

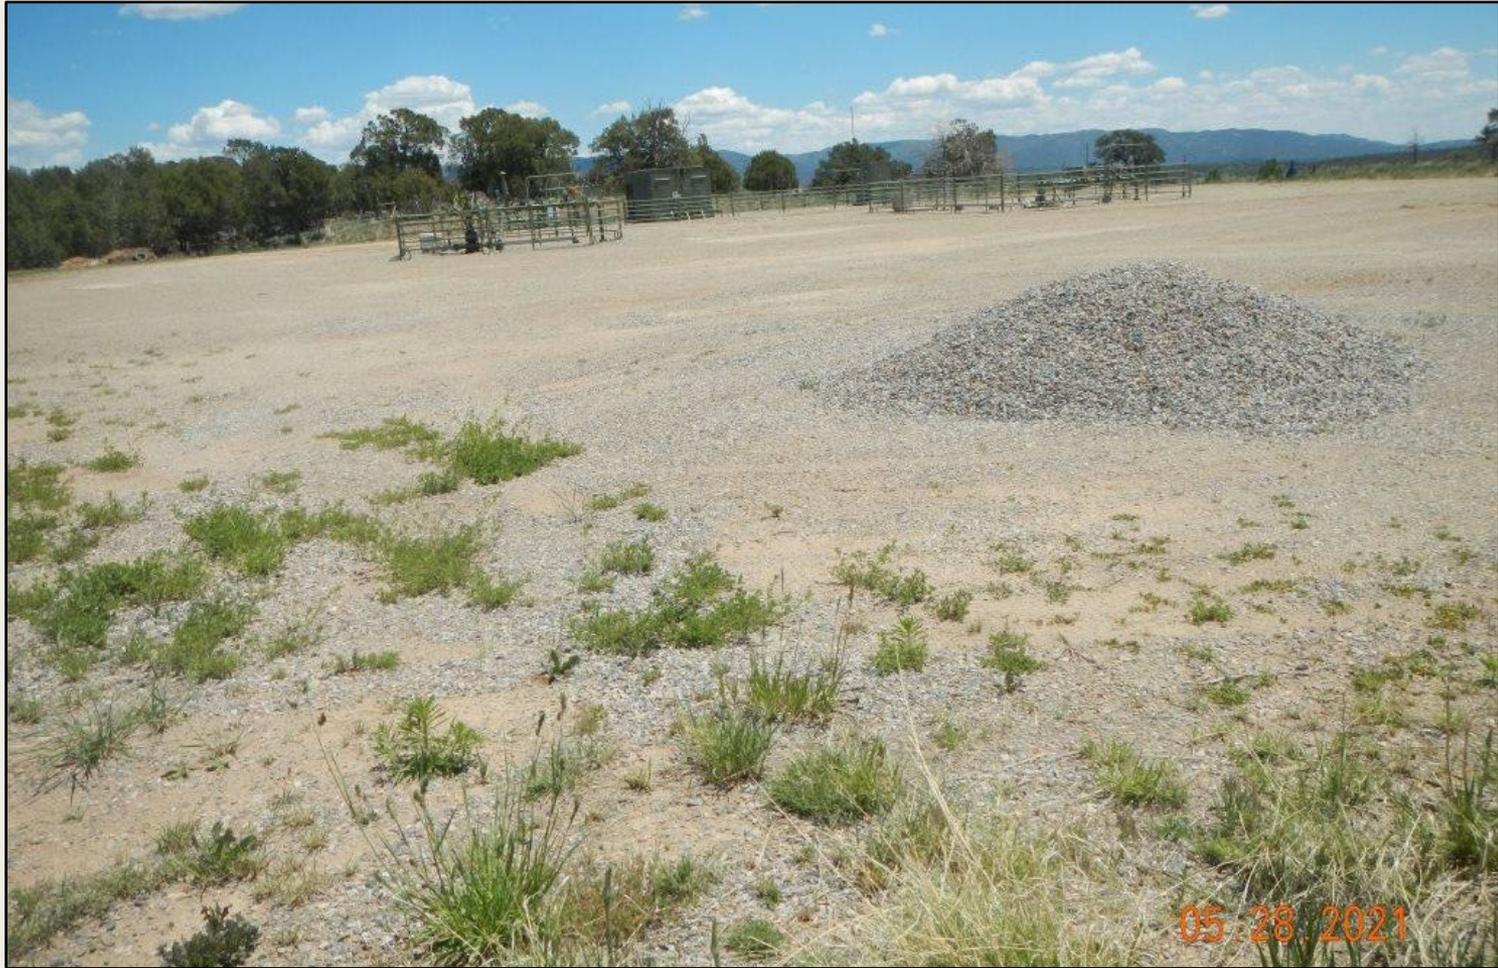
Photo 1. View of project area from the northwestern corner facing center.

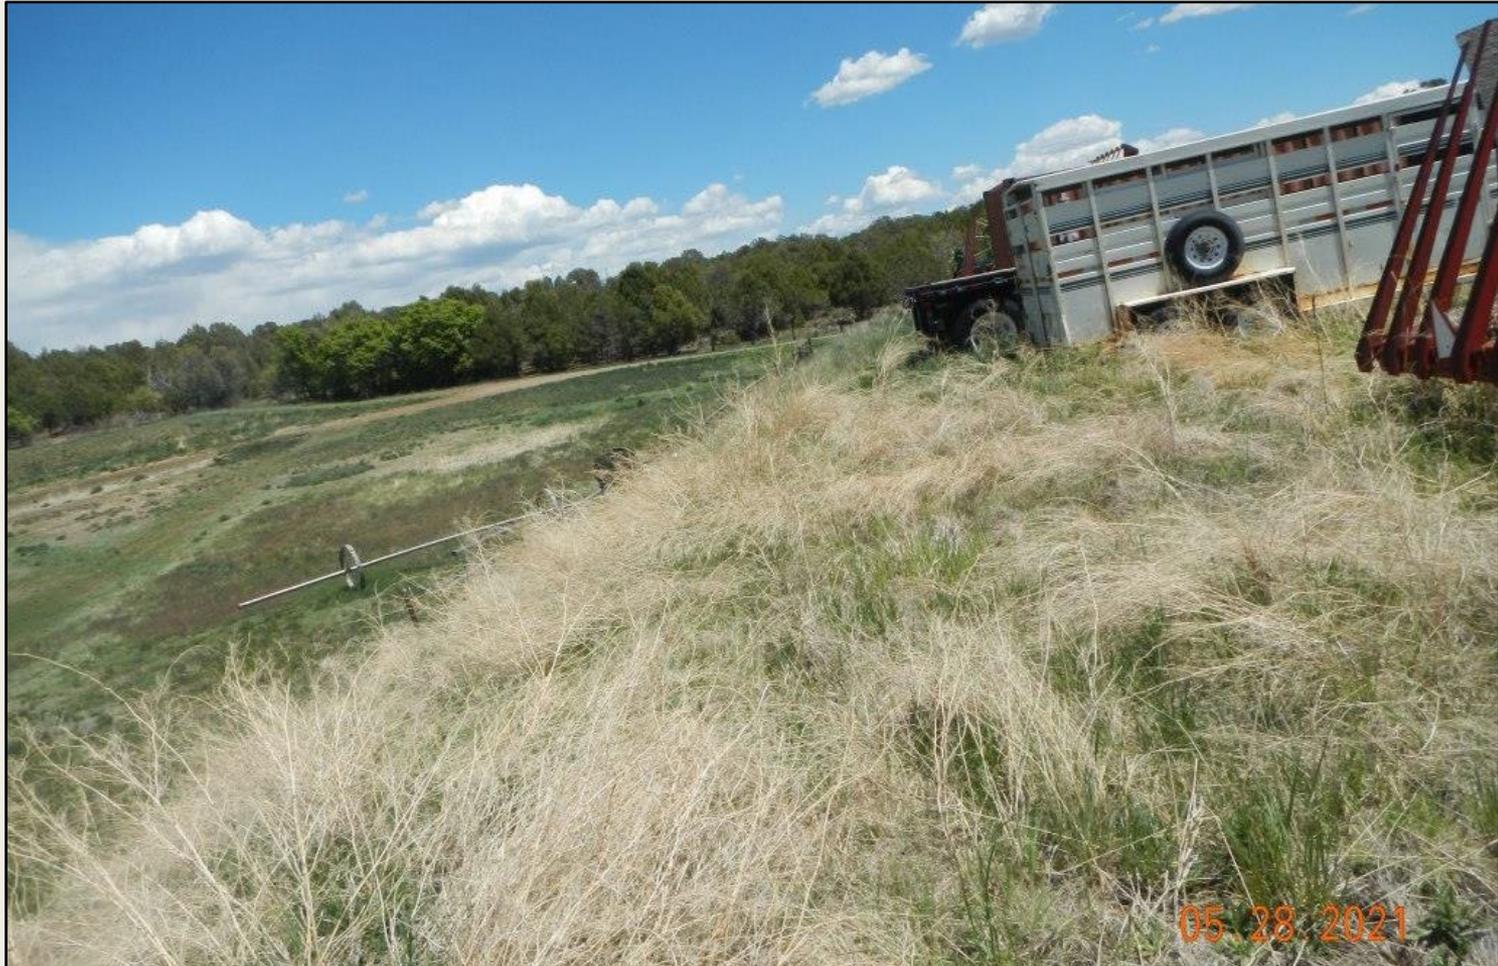
Photo 2. View of the northern project area from the northwestern corner facing eastward. Revegetation is mixed with desirable vegetation such as smooth brome, and weeds such as yellow tumbled mustard, Canada thistle, and Scotch thistle.

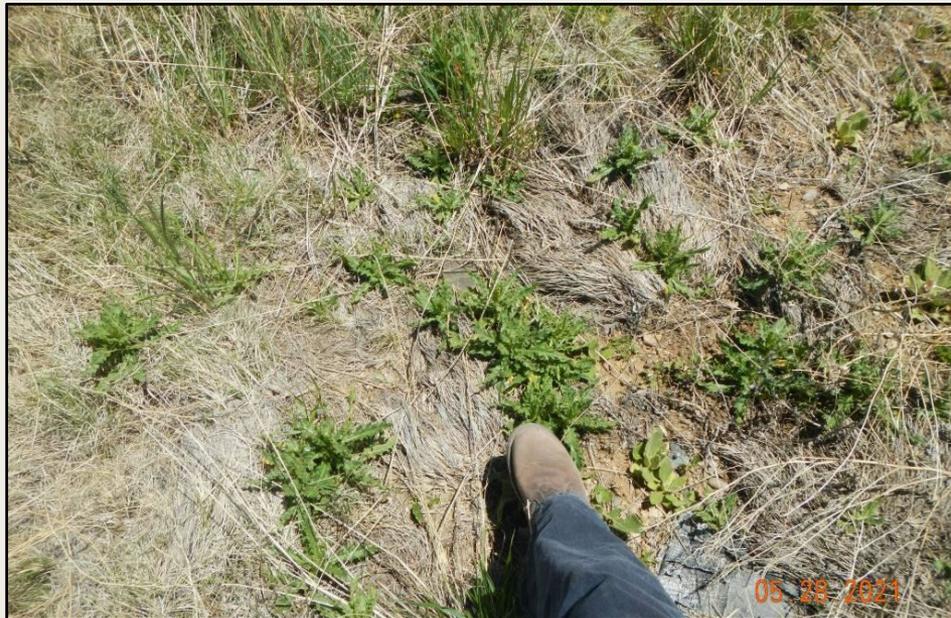
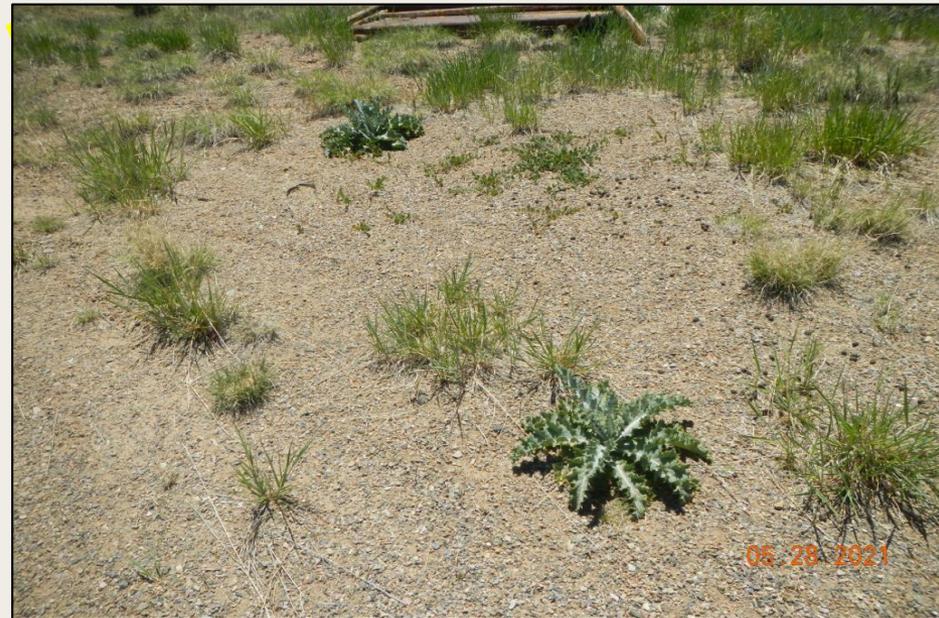
Photos 3/4. View of Canada thistles (left) and Scotch thistles (right) observed within the project area.

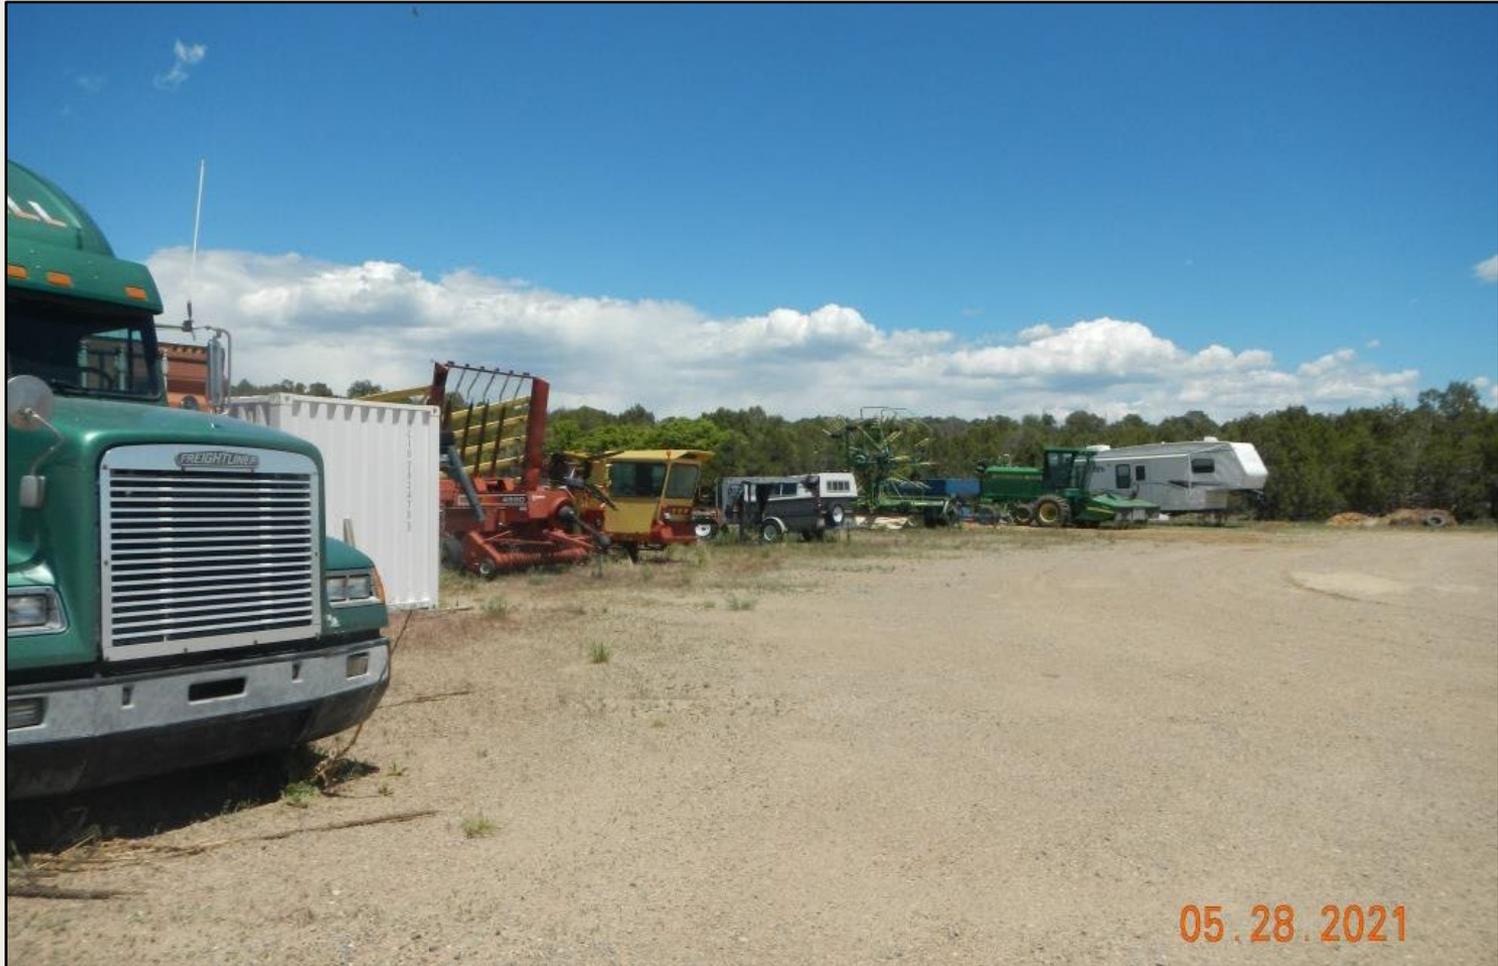
Photos 5. View trucks, trailers, farm equipment, and storage containers parked within the northern project area.

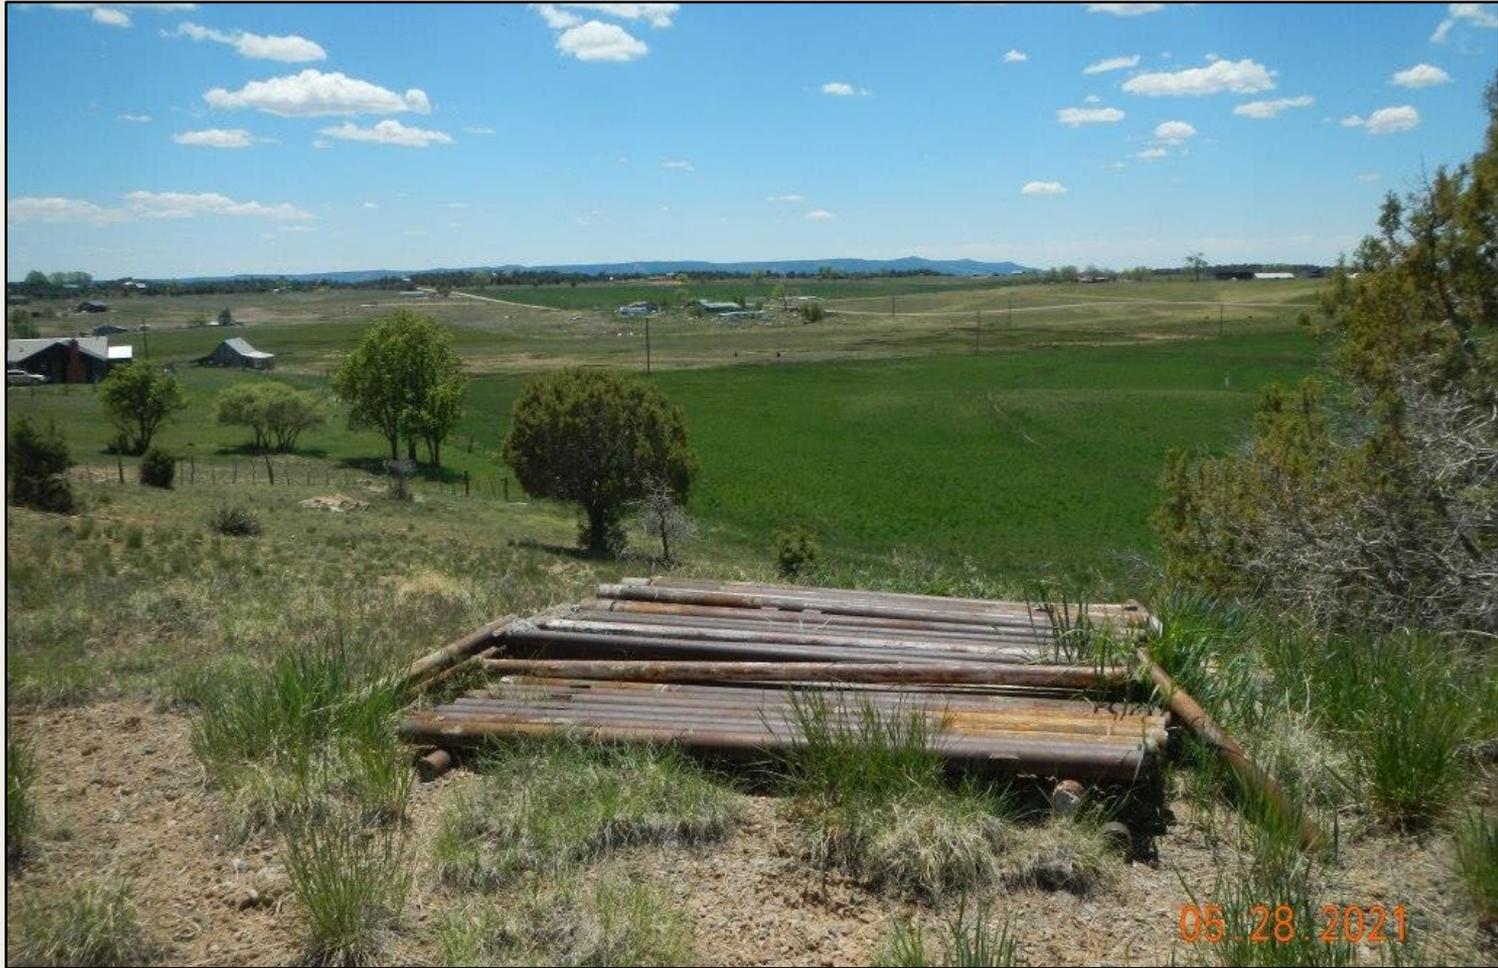
Photos 6. View of metal debris observed within the western interim reclamation area.

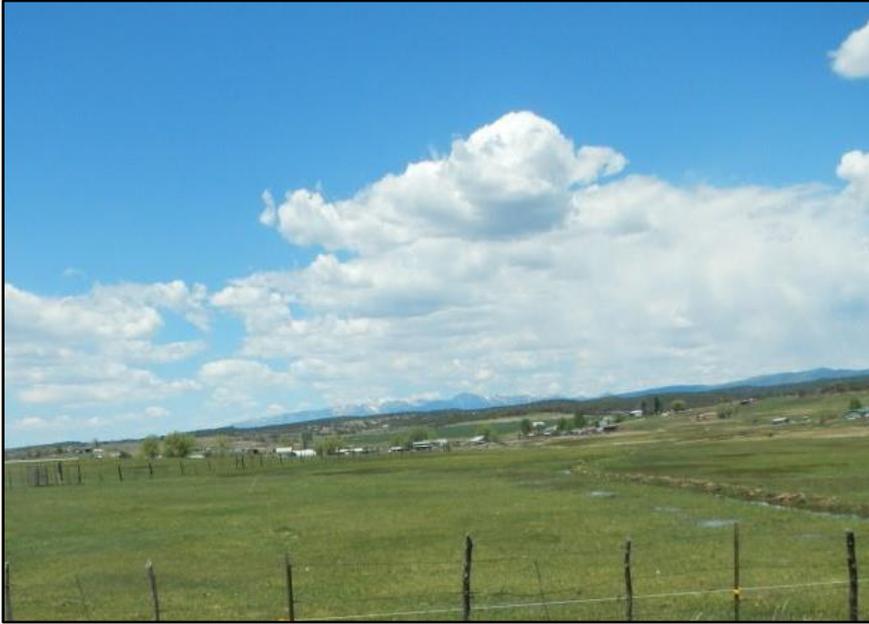
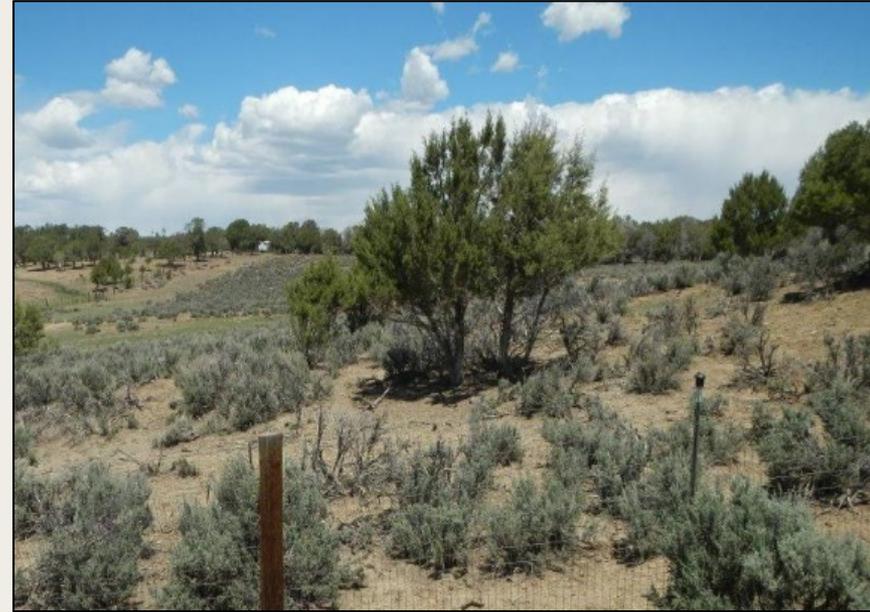
Photos 7/8. View of reference area(s), comprised of irrigated grass field (left) and pinyon and juniper woodland (right). As project area is located at the edge of these two reference areas, surface owner will determine whether final reclamation will return the area to native woodland habitat or irrigated crop field.
