Inspection Photos
Location Name: MV 9-32 PAD
Location ID: 335087 & Spill/Release ID: 479989
Inspection Date: May 25, 2021

COLORADO
Oil & Gas Conservation
Commission
Department of Natural Resources

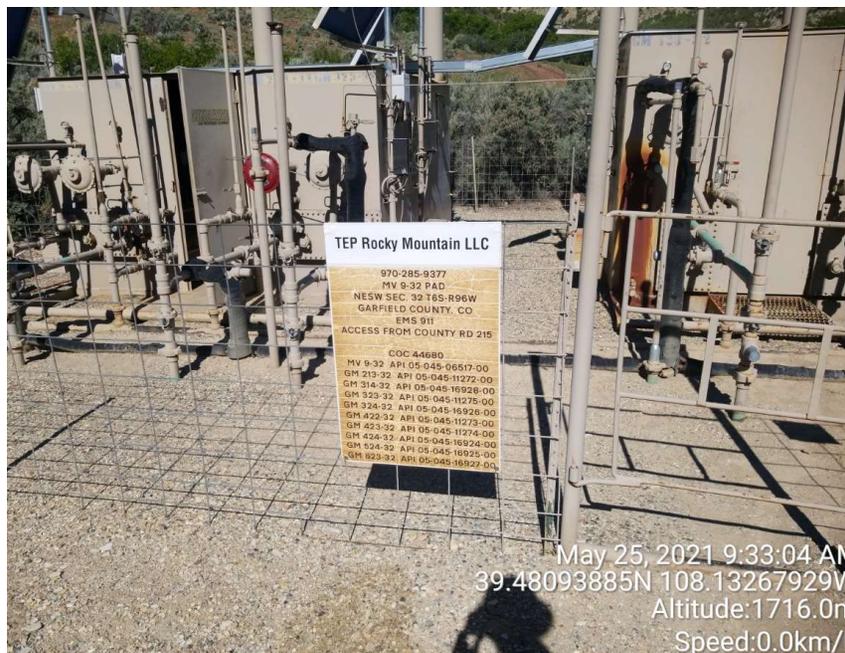
Location sign.

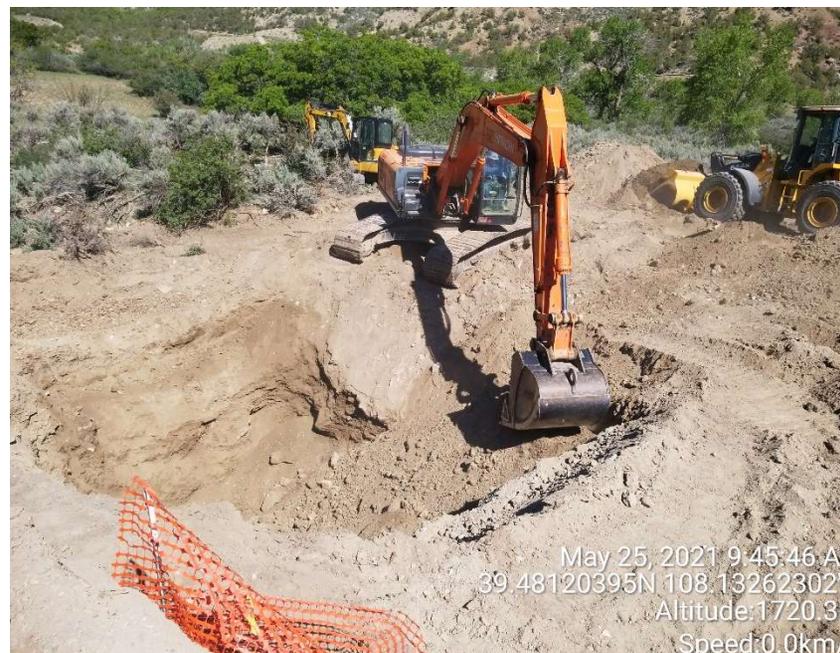
Excavation located northwest of the tank battery.

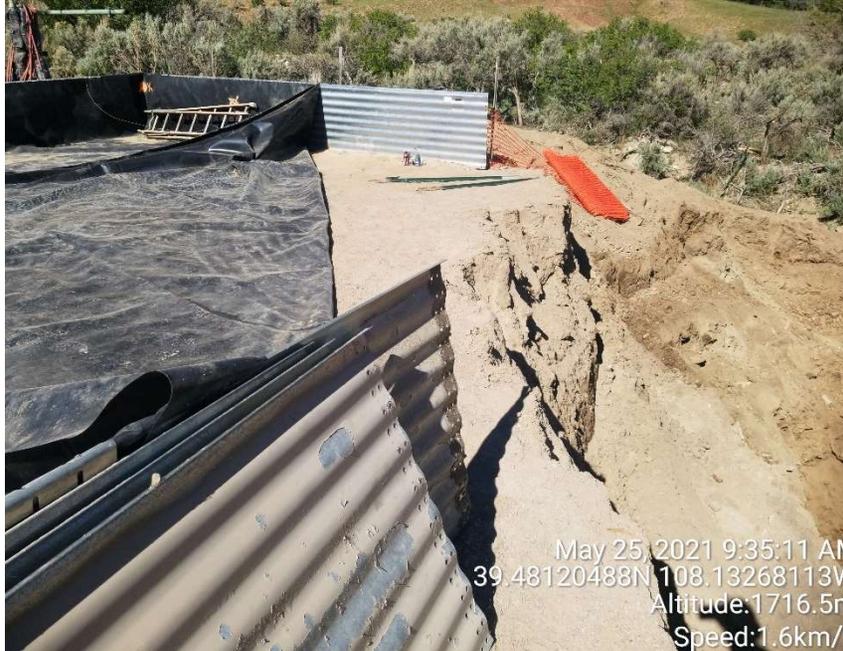
Excavation northwest of the tank battery. Note the tank battery is in disrepair but still in use.

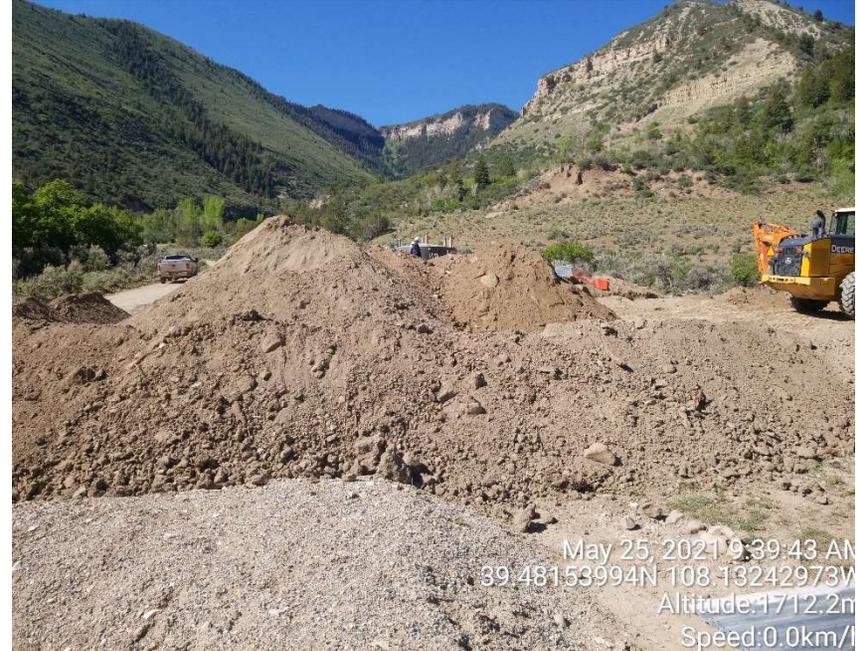
Stockpiles of potentially impacted material located adjacent to the excavation sidewalls.

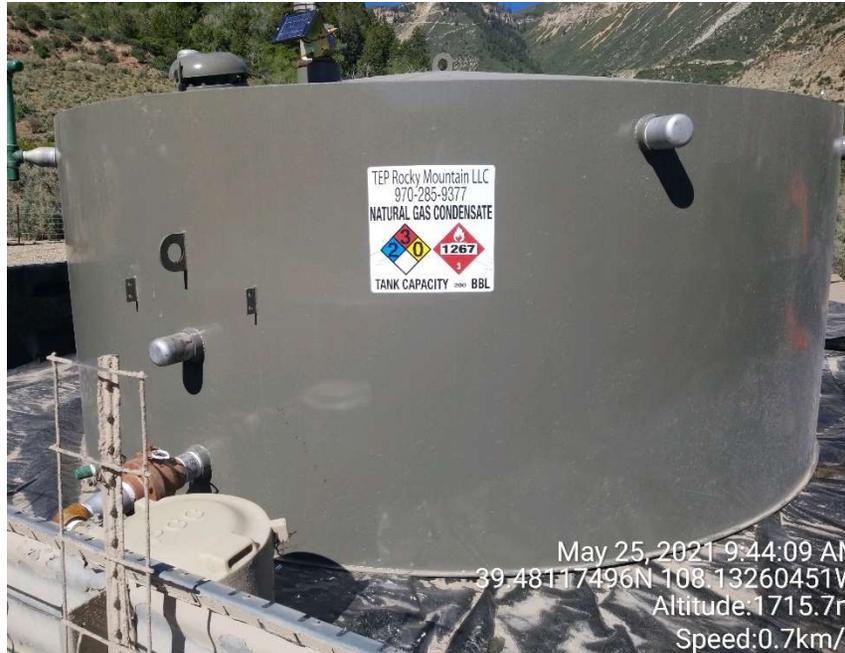
Newly installed 200 bbl Steel AST condensate tank.

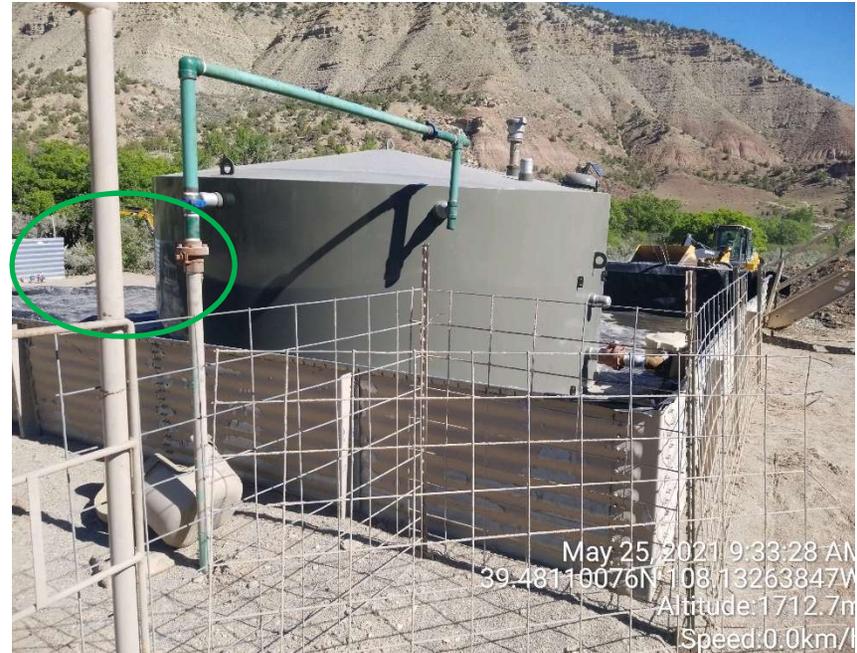
Newly installed 200 bbl Steel AST condensate tank, note the newly installed flowline that is attached to the Steel AST and the secondary containment structure in disrepair (green oval).

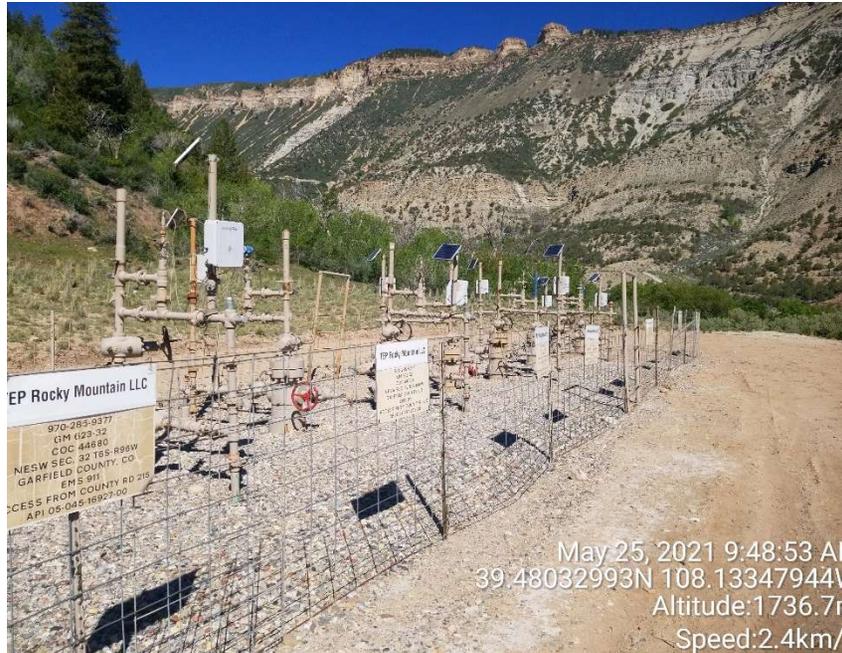
Wells associated with the MV 9-32 PAD Location. Note all wells appeared to be producing at time of inspection and have a PR status in the COGIS database.

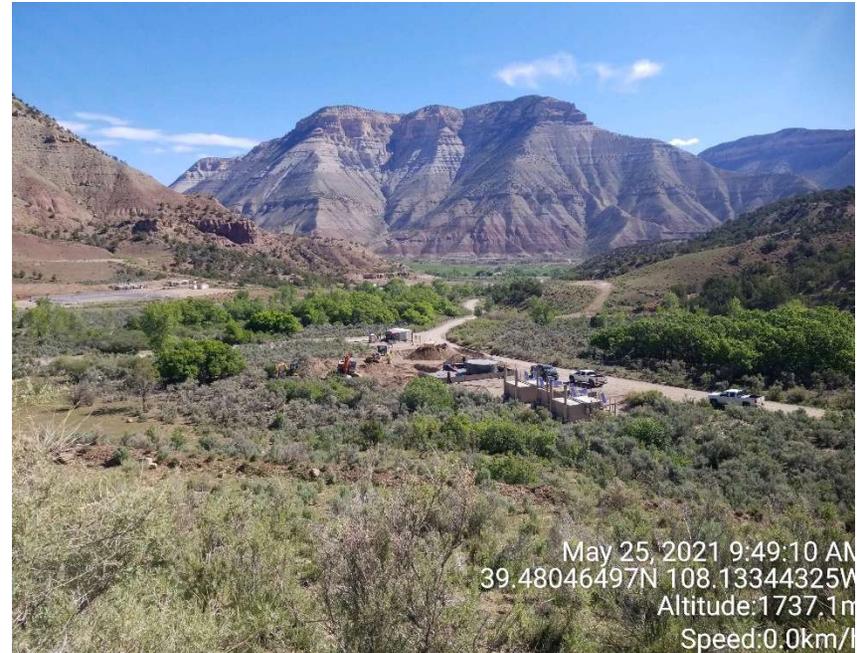
View of the MV 9-32 PAD PAD from the pad where the associated wells are located.

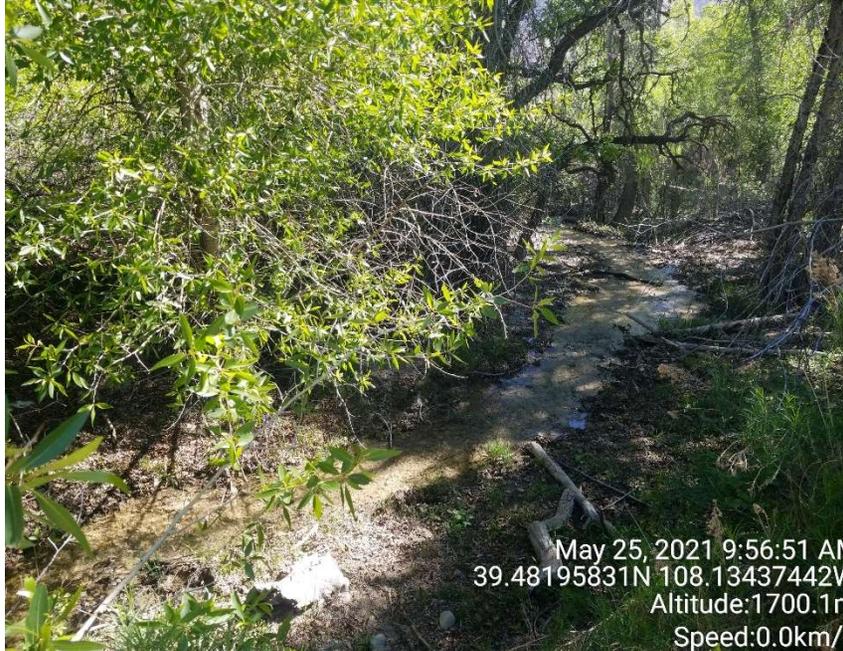
Starkey Gulch up-gradient of Spill/Release ID 479989.

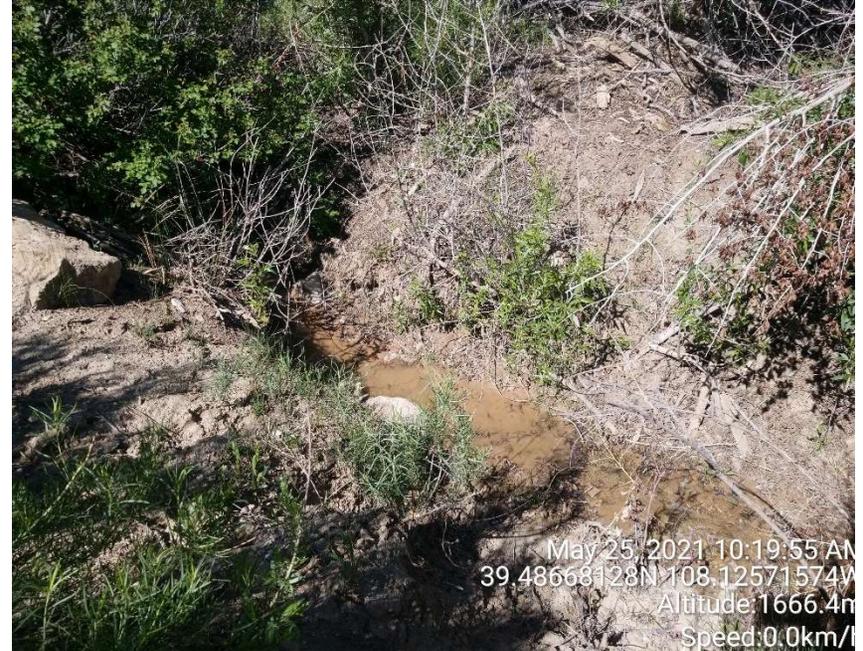
Starkey Gulch down-gradient of Spill/Release ID 479989.
