Inspection Photos
UPRR 43 PAN AM G Consolidation #2
Remediation Project #16131/Spill ID 478086 (CL)

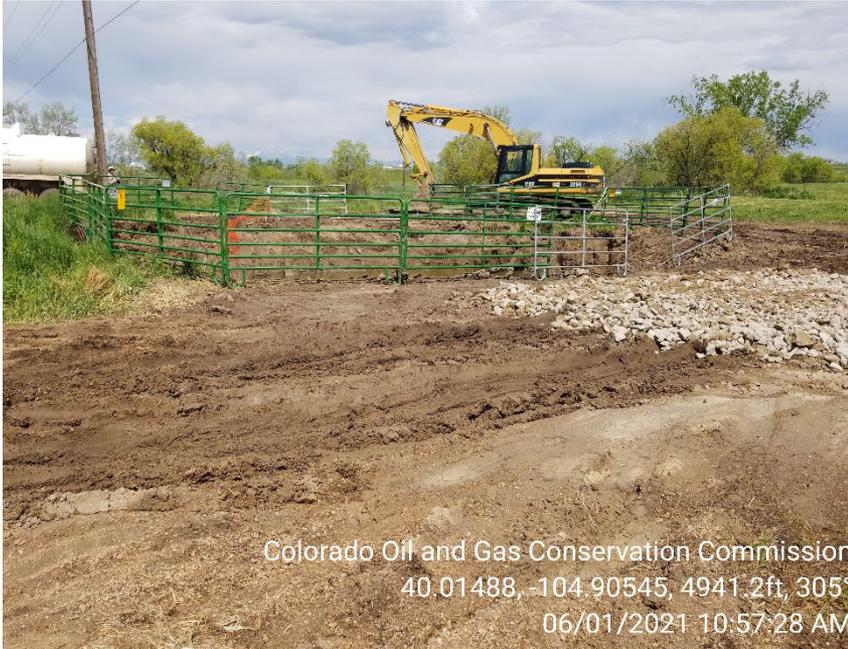
Photo 1 – Spill area with open excavation.

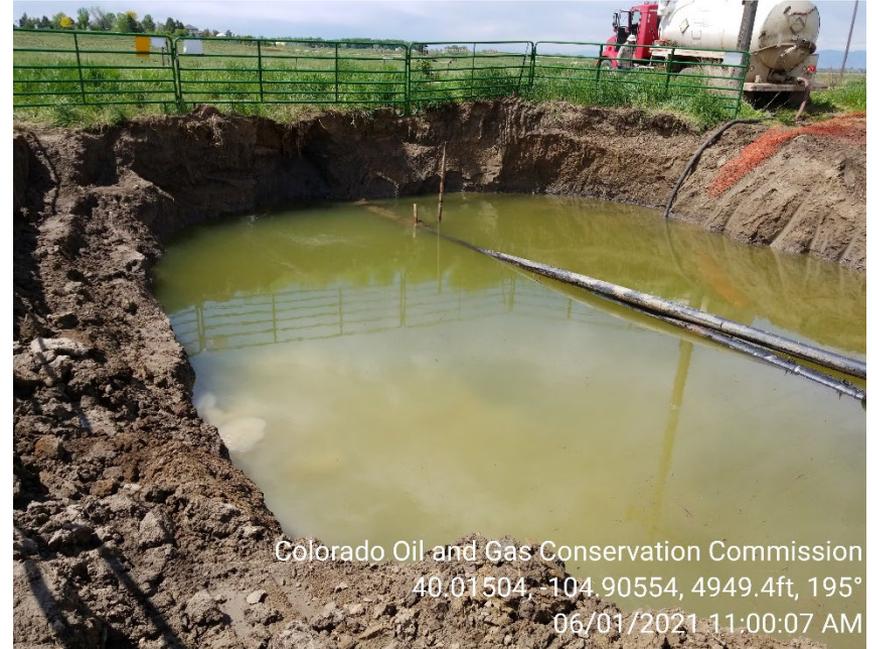
**Photo 2 – Open excavation with groundwater.
Impacts appear to remain in situ.**

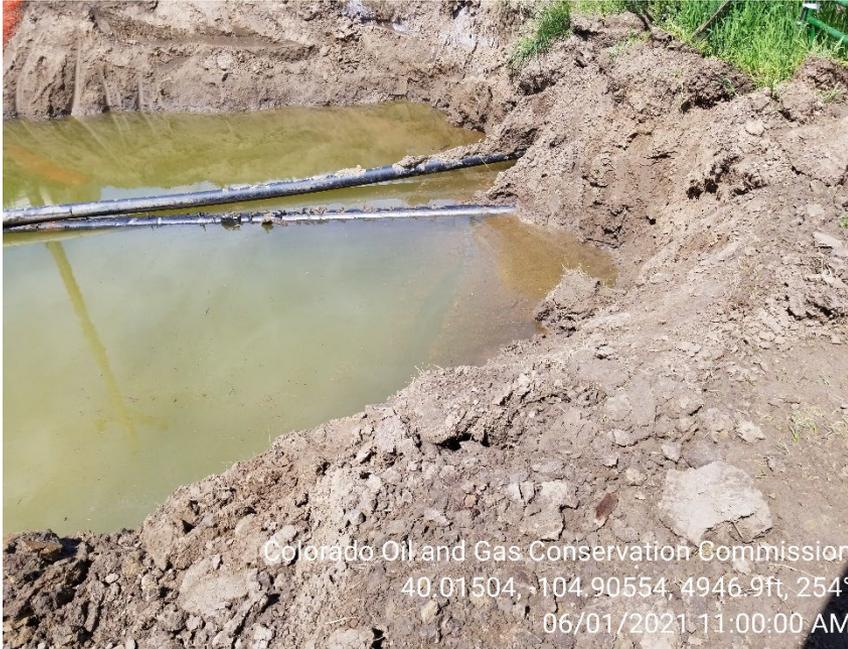
Photo 3 – Open excavation. Hydrocarbon sheen observed on groundwater.

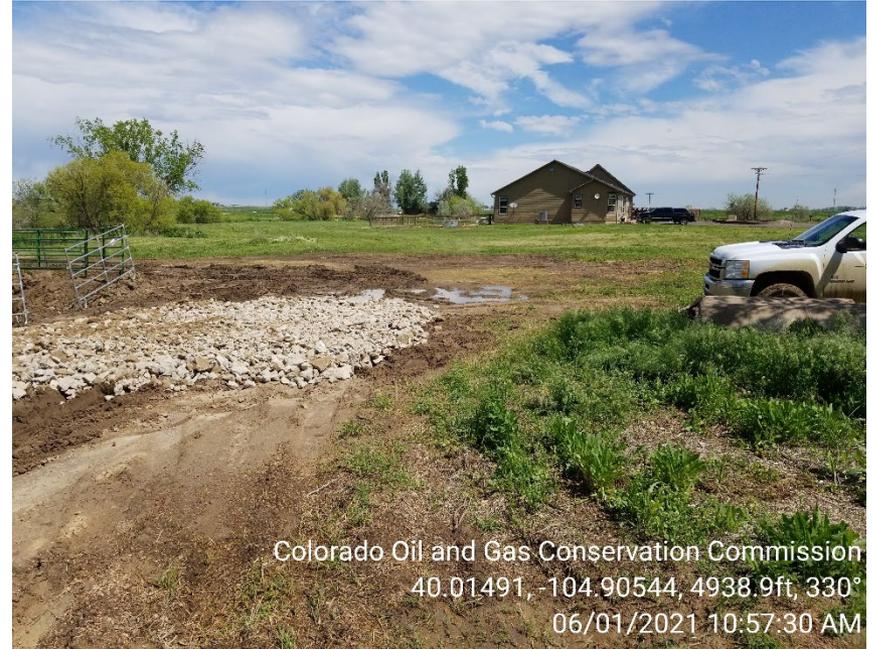
Photo 4 – Soils previously stored on location have been removed. Trash removed from location.
