Inspection Photos

API: 055-06309

Operator: ALTA MESA SERVICES LP

Inspection Date: 5/26/2021

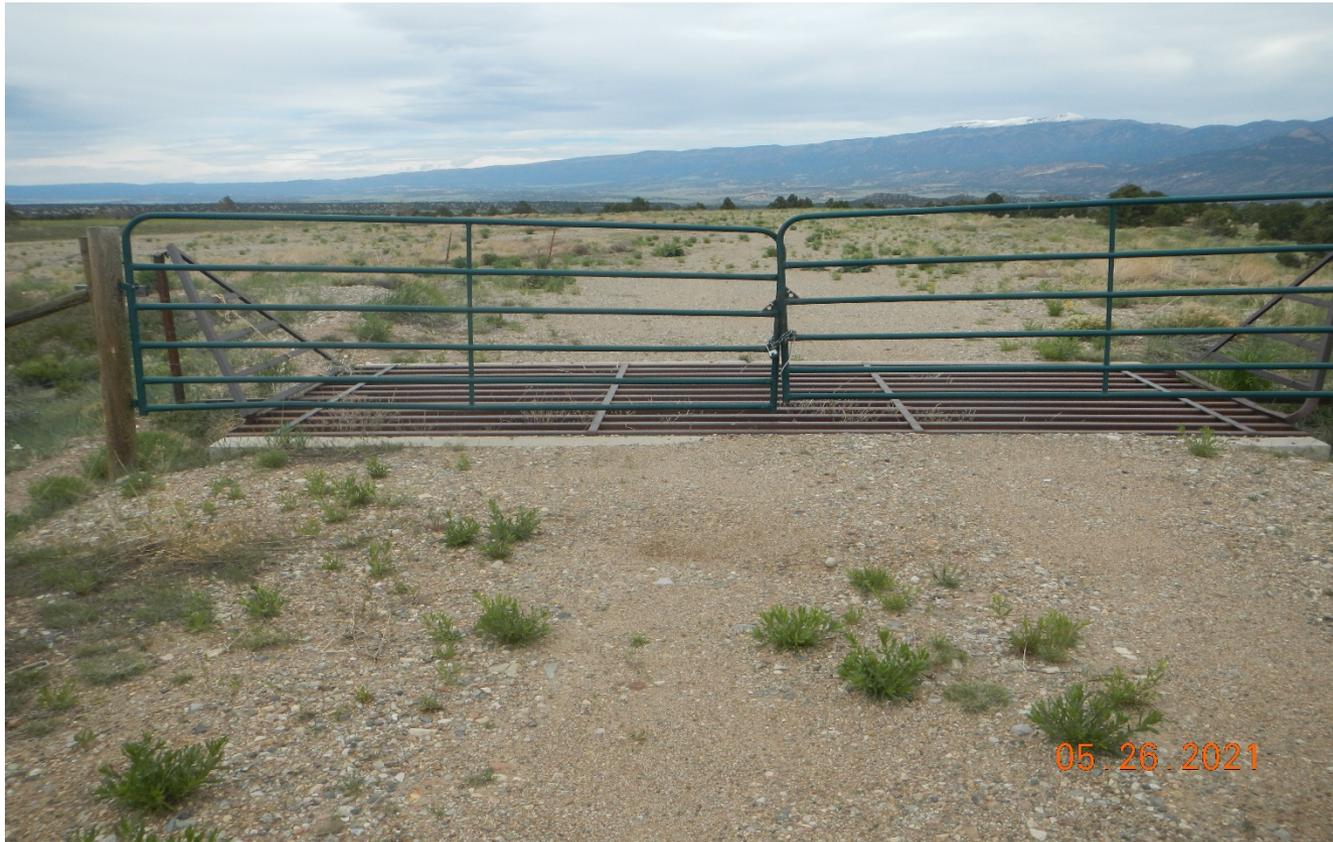
Photo 1. Facing north toward the location. The access road has not been reclaimed. The cattle guard, gates, and fence remain.

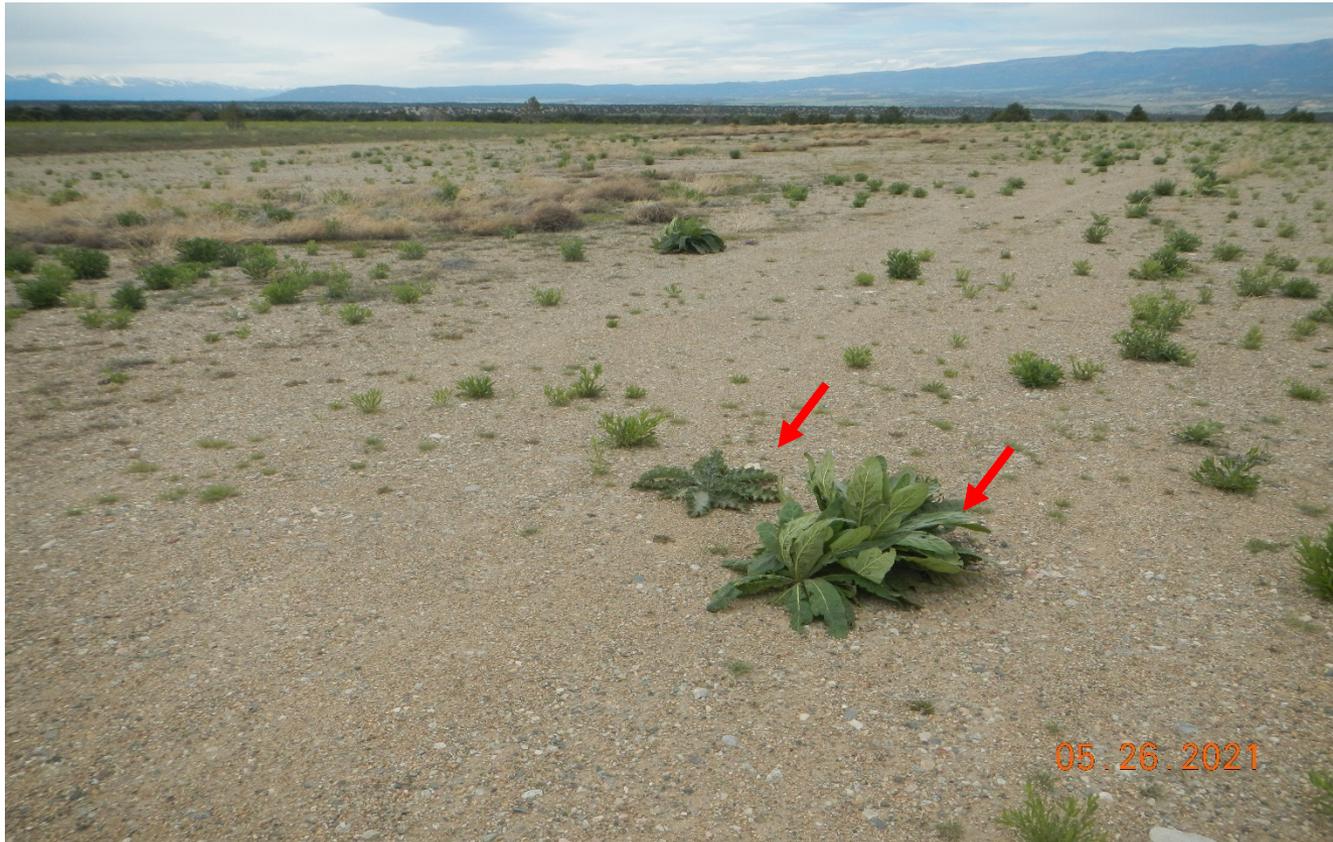
Photo 2. Facing northwest toward the location. This portion of the location has not been recontoured and reclaimed. There are undesirable and noxious weeds growing throughout the location which have not been controlled. Red arrow points to Scotch thistle and Common mullein.

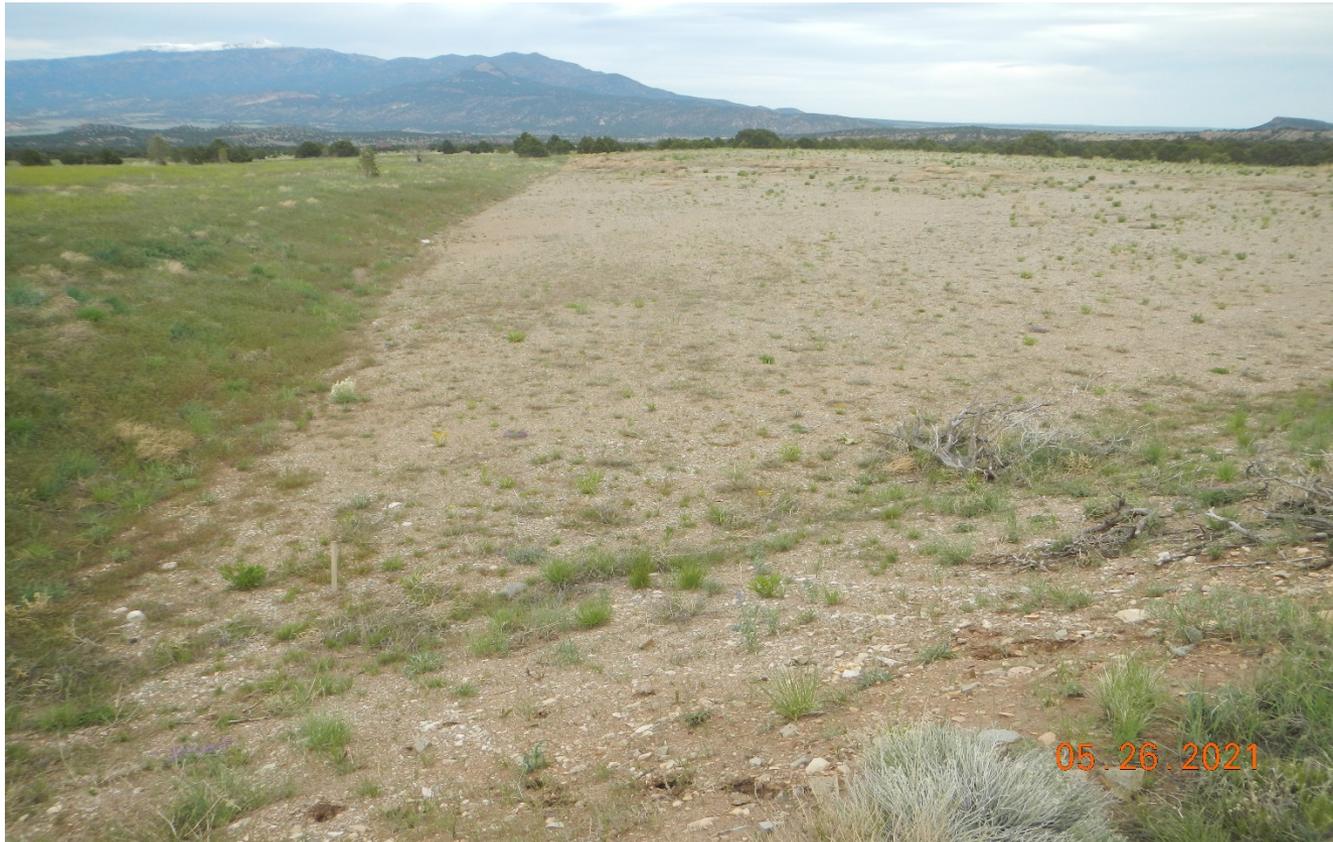
Photo 3. Facing north toward where the gravel pad remains.

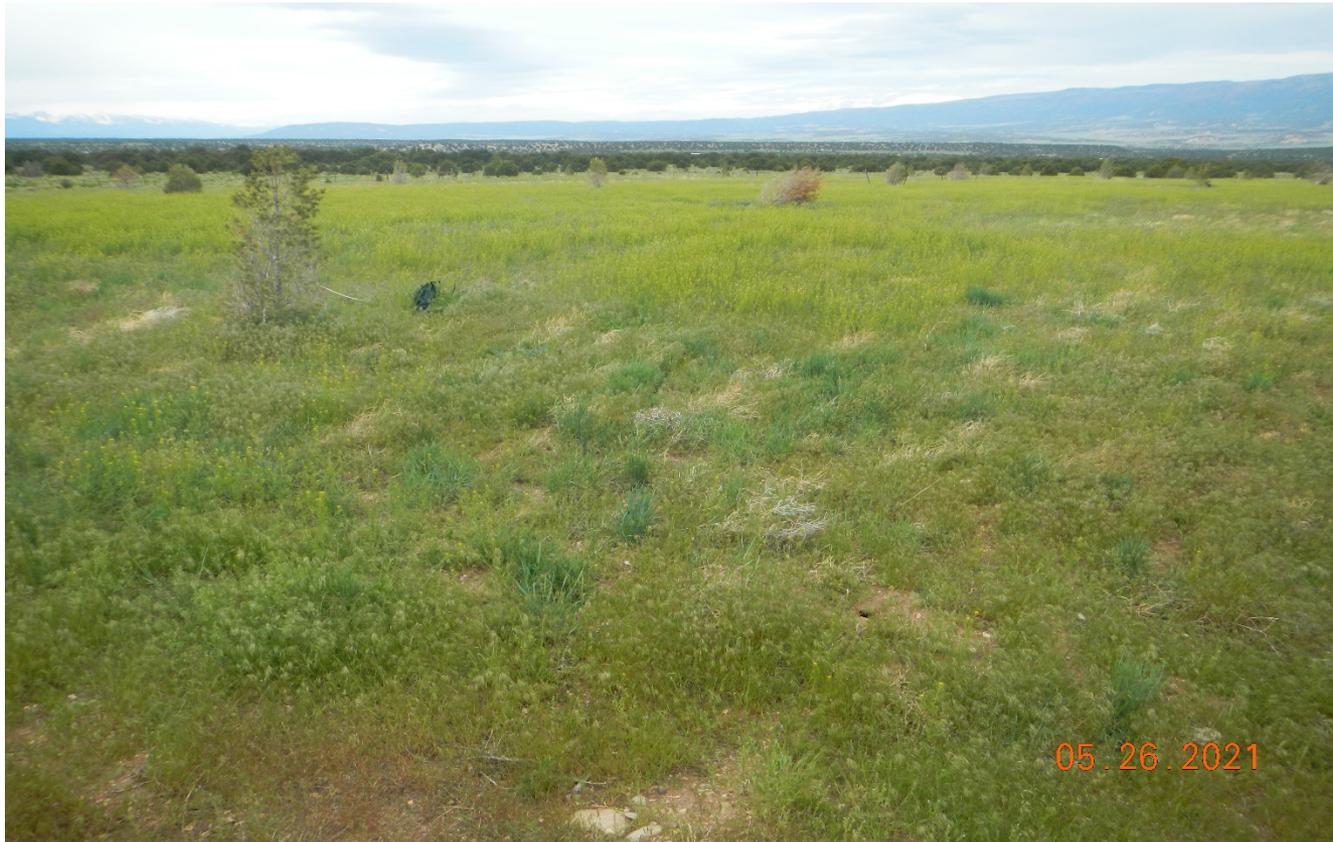
Photo 4. Facing northwest at the location. The reclaimed area consists of mostly undesirable weeds due to lack weed management.

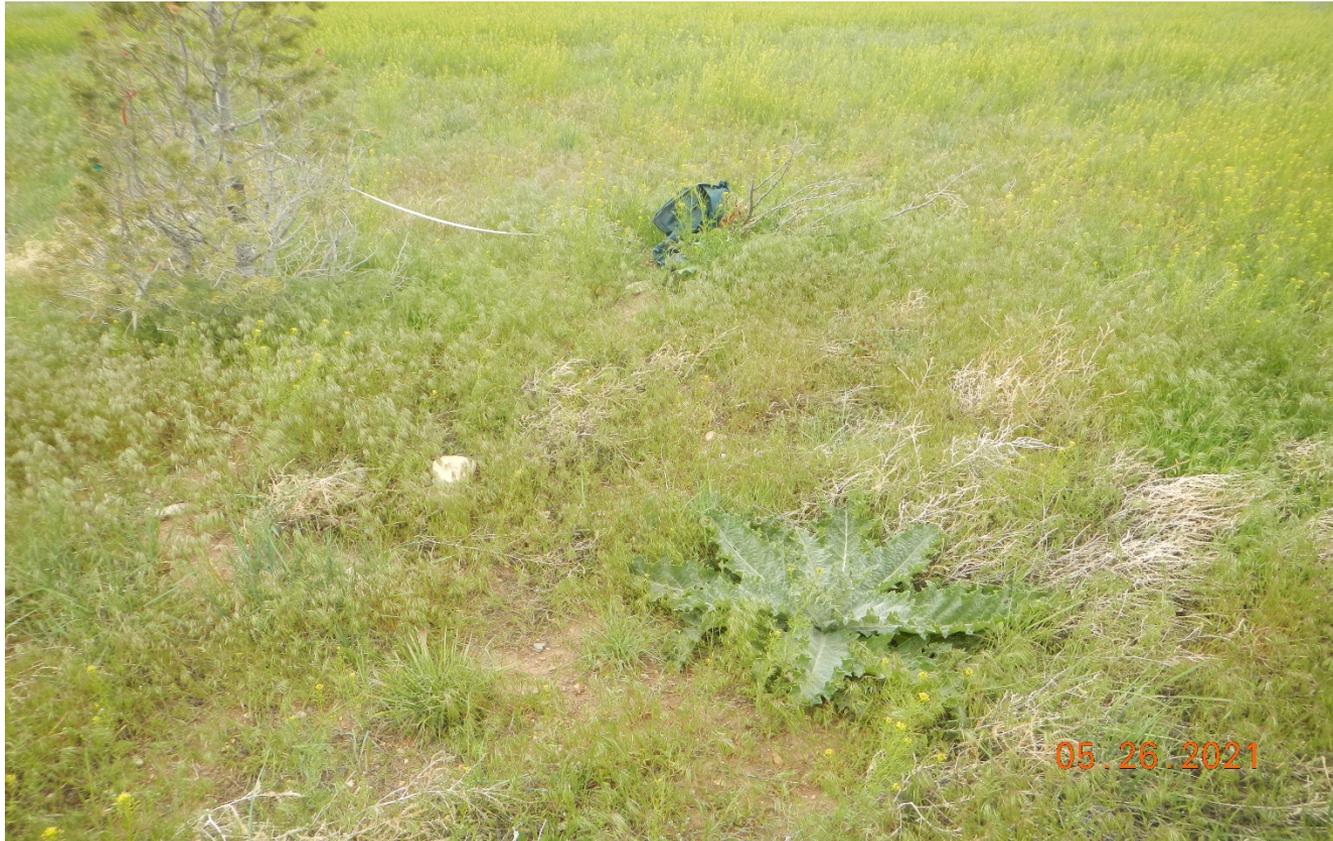
Photo 5. There is undesirable and noxious weeds throughout the location which have not been controlled. Photo shows various weed including Scotch thistle, Cheat grass, and Tansy mustard.

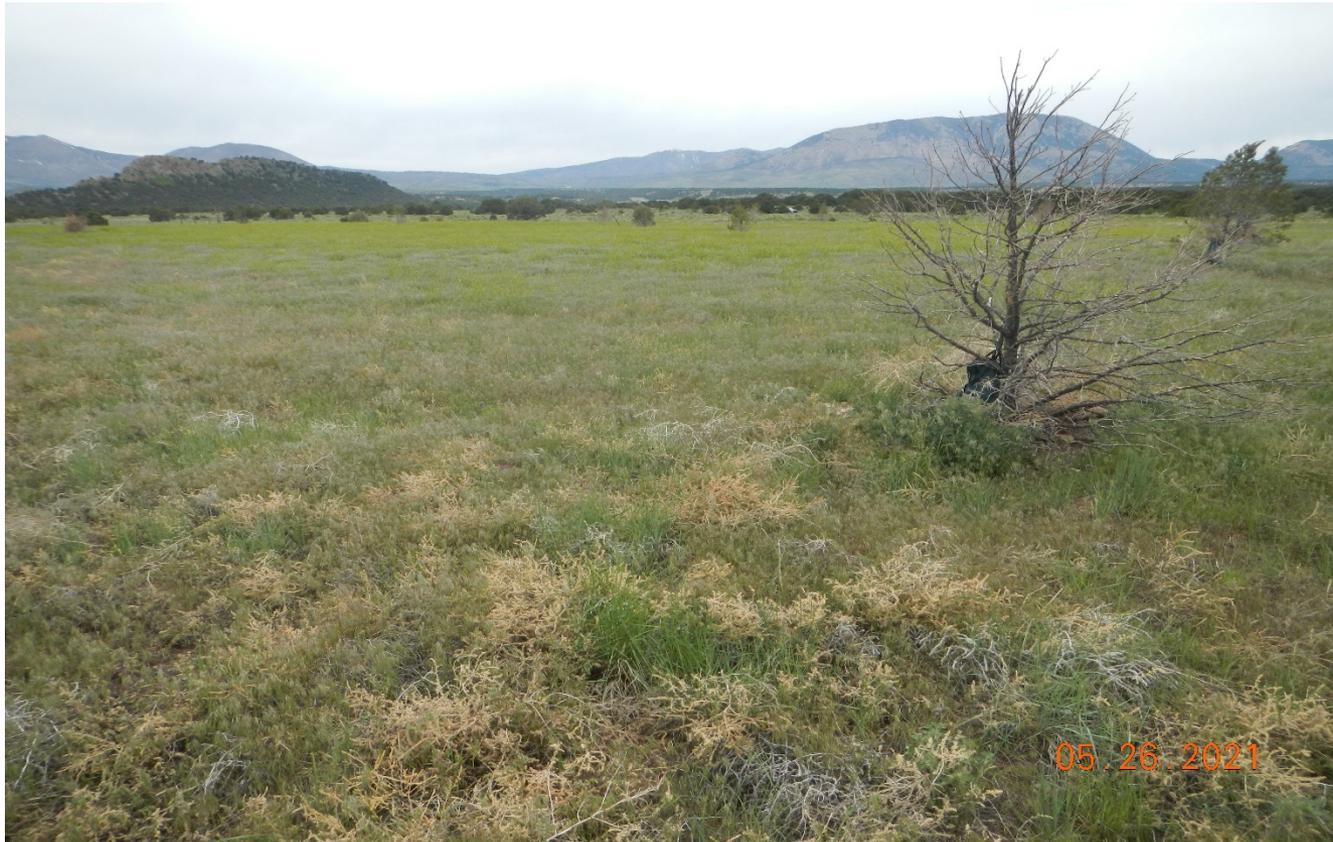
Photo 6. Facing southwest at the location. There are dead trees that were planted and have not been removed and replaced.

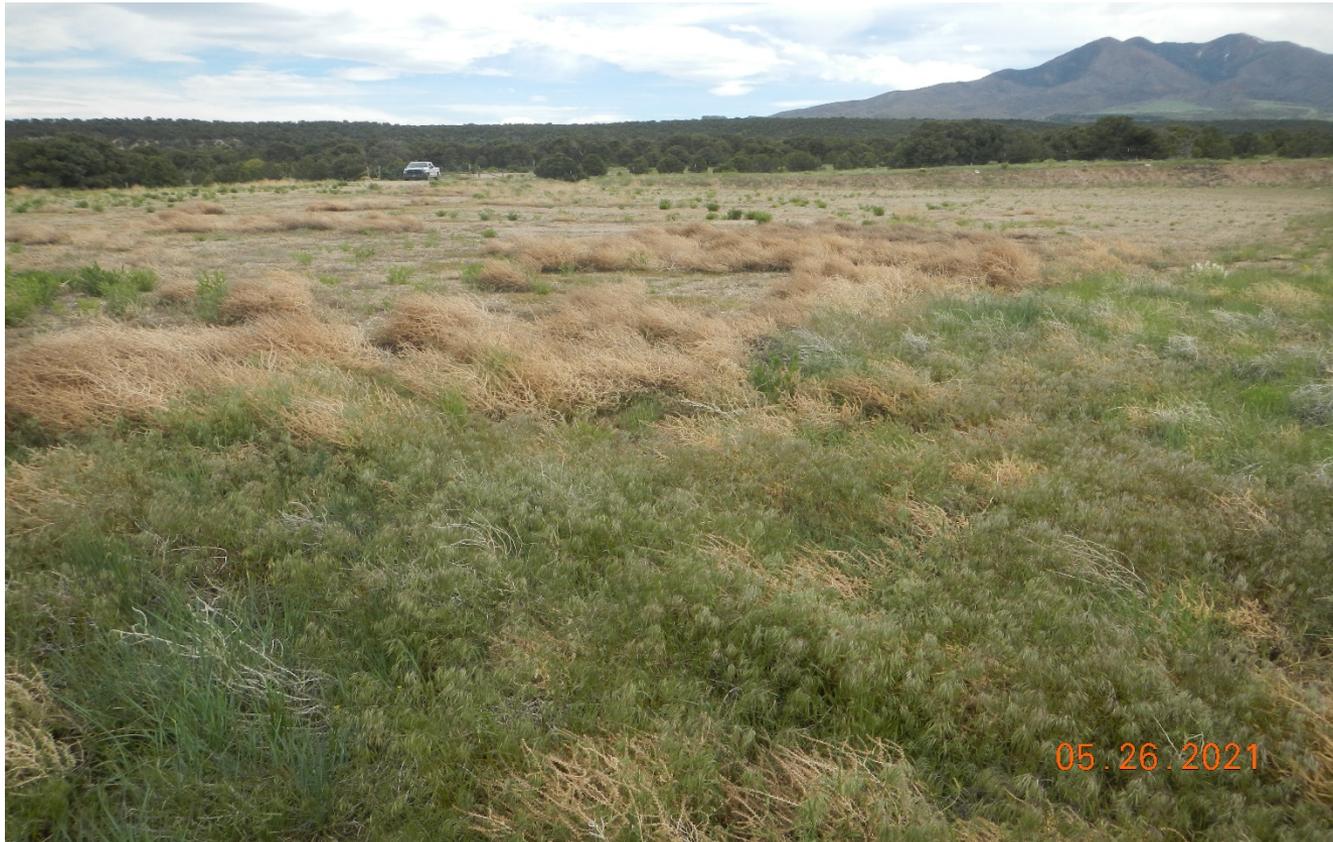
Photo 7. Facing southeast at the location. This portion of the location was not reclaimed and gravel remained on this flat portion. There are undesirable weeds throughout this area.

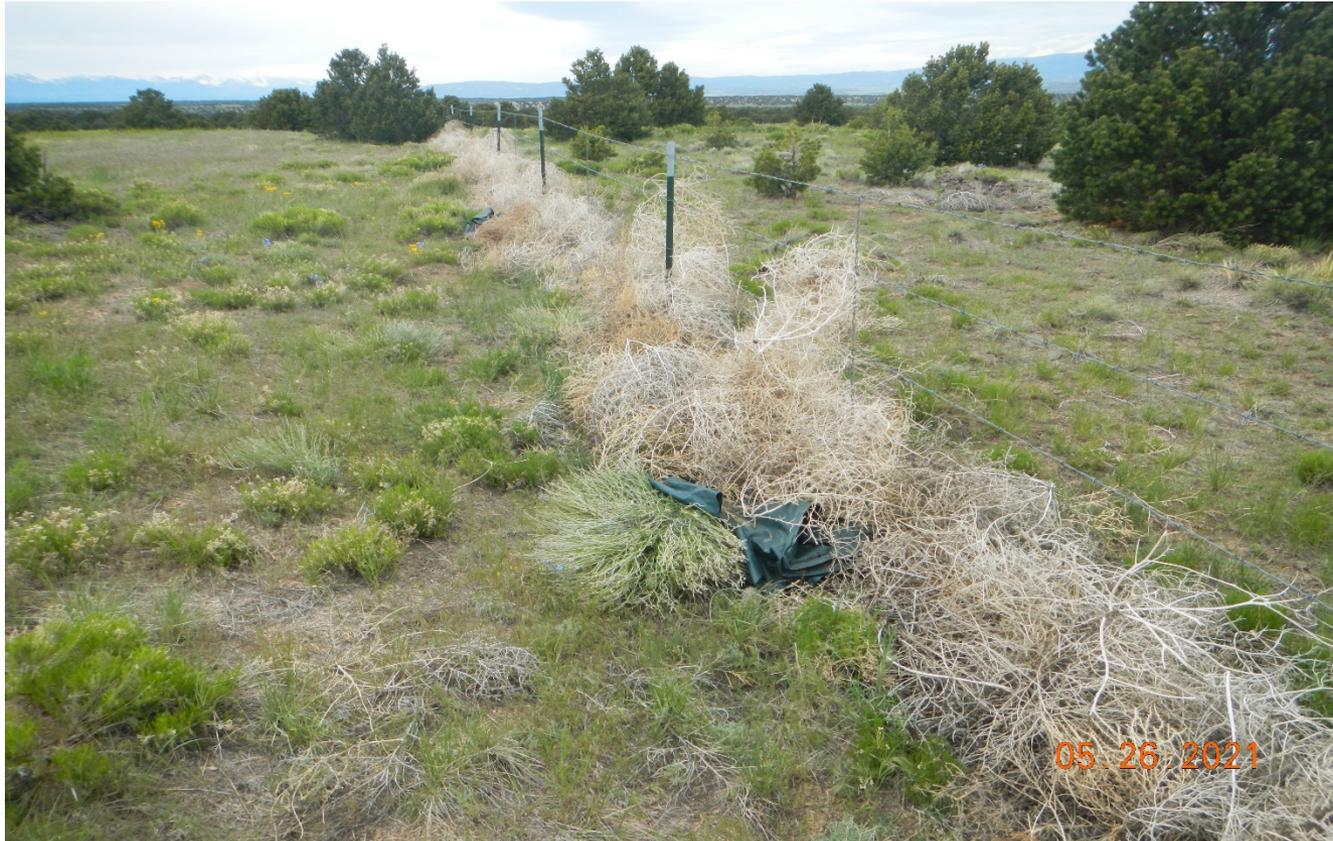
Photo 8. There are undesirable weed debris that has accumulated along the perimeter fence line.

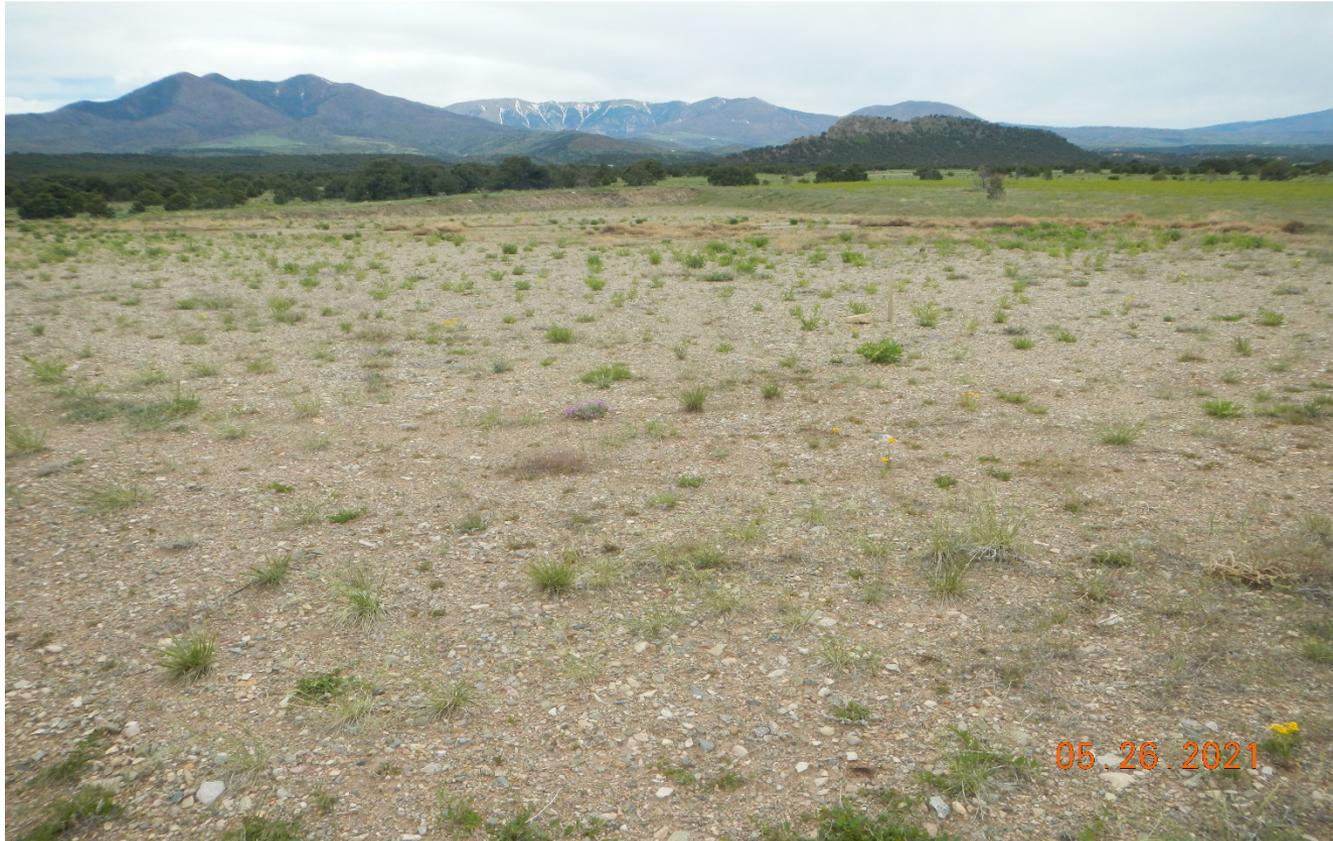
Photo 9. Facing southwest at the east side of the location. This area of the location has not been recontoured and reclaimed and gravel remains within this area.

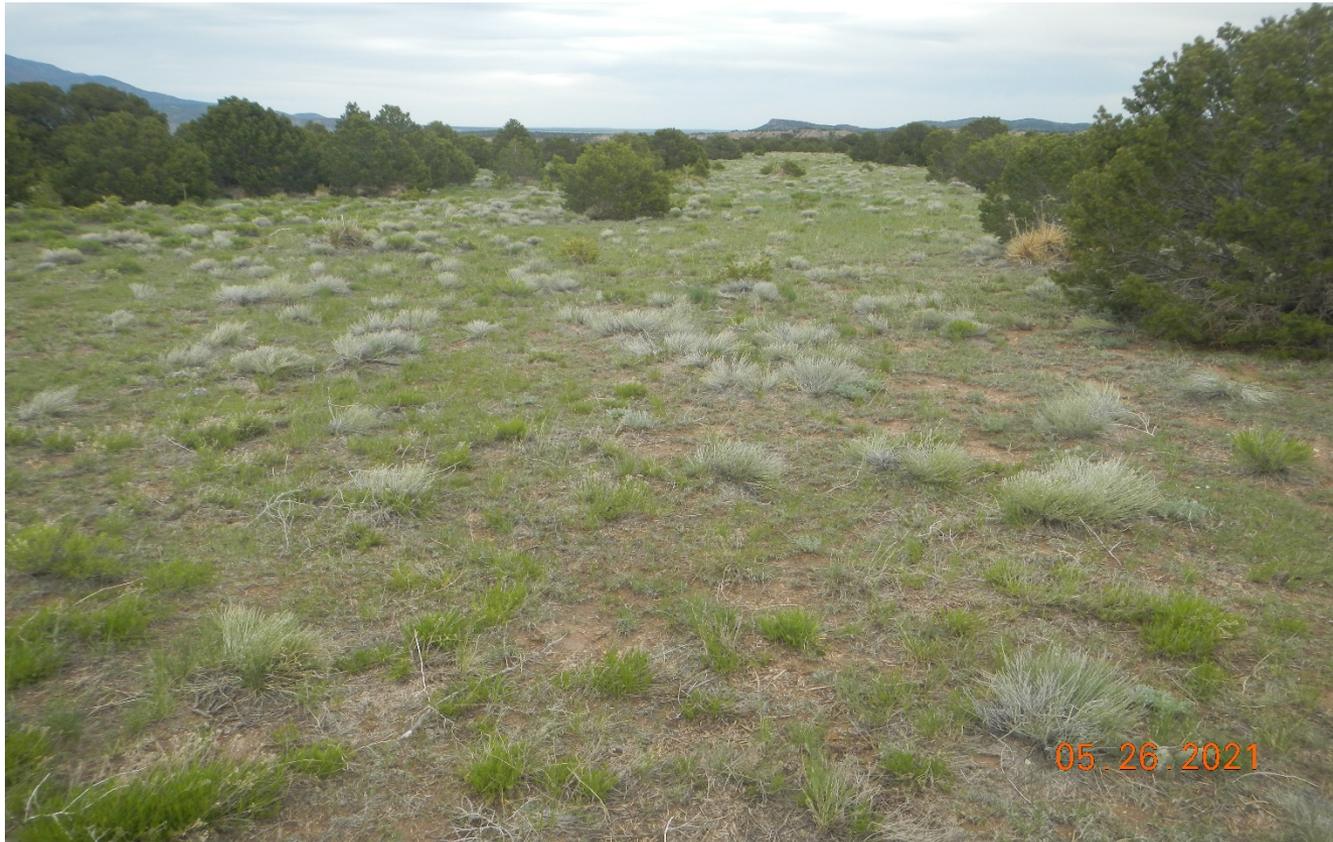
Photo 10. Facing east toward the surrounding undisturbed reference area which consists of Pinyon Juniper woodland and native grassland.
