Inspection Photos

API: 073-06501

Operator: GRAND MESA OPERATING CO

Inspection Date: 6/2/2021

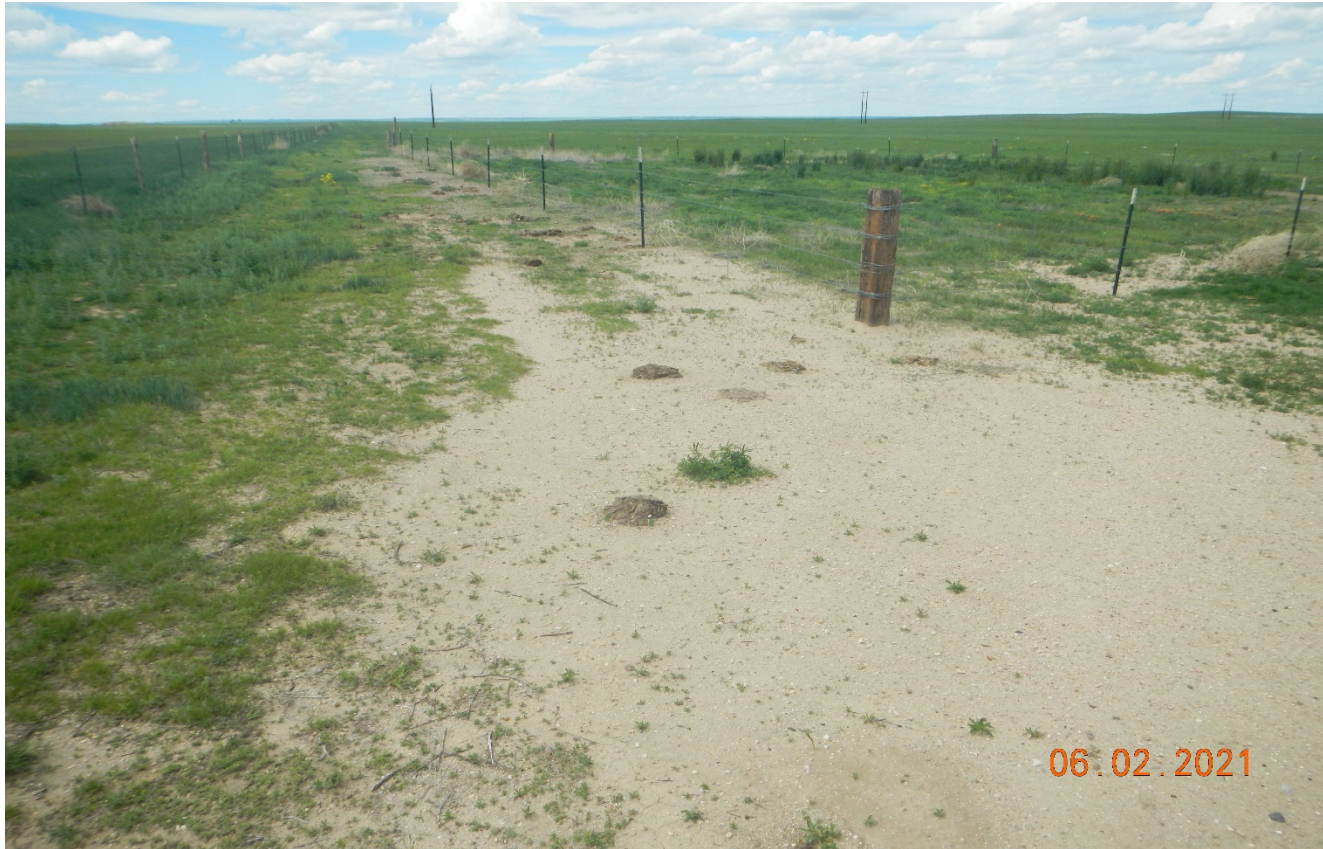
Photo 1. Facing north long the access road toward the abandoned tank battery facility which was reclaimed and fenced. The disturbed area adjacent to the fence appears to need additional reclamation.

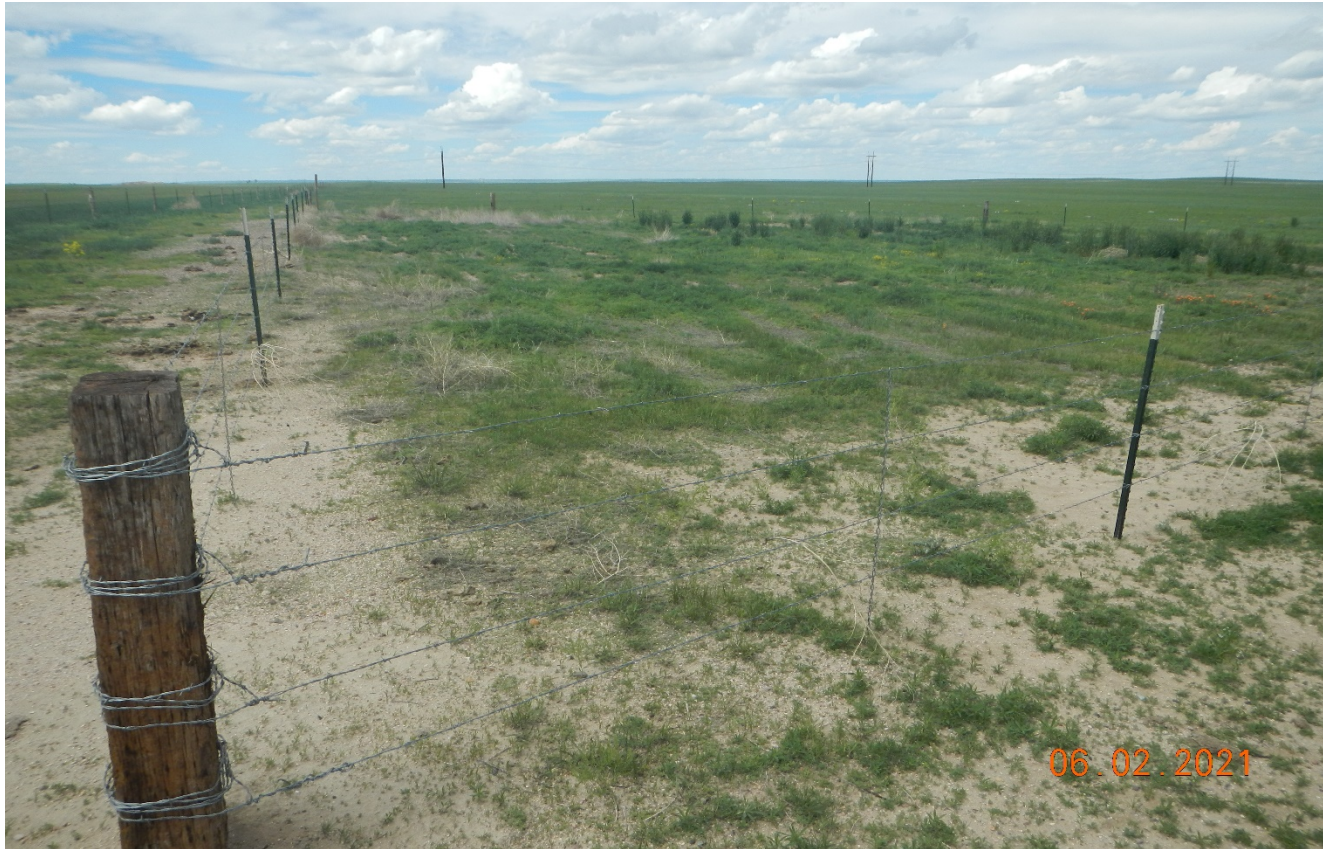
Photo 2. The vegetation inside the fenced area consists mostly of undesirable weeds. Weed control will need to be performed and additional reseeding may be needed.

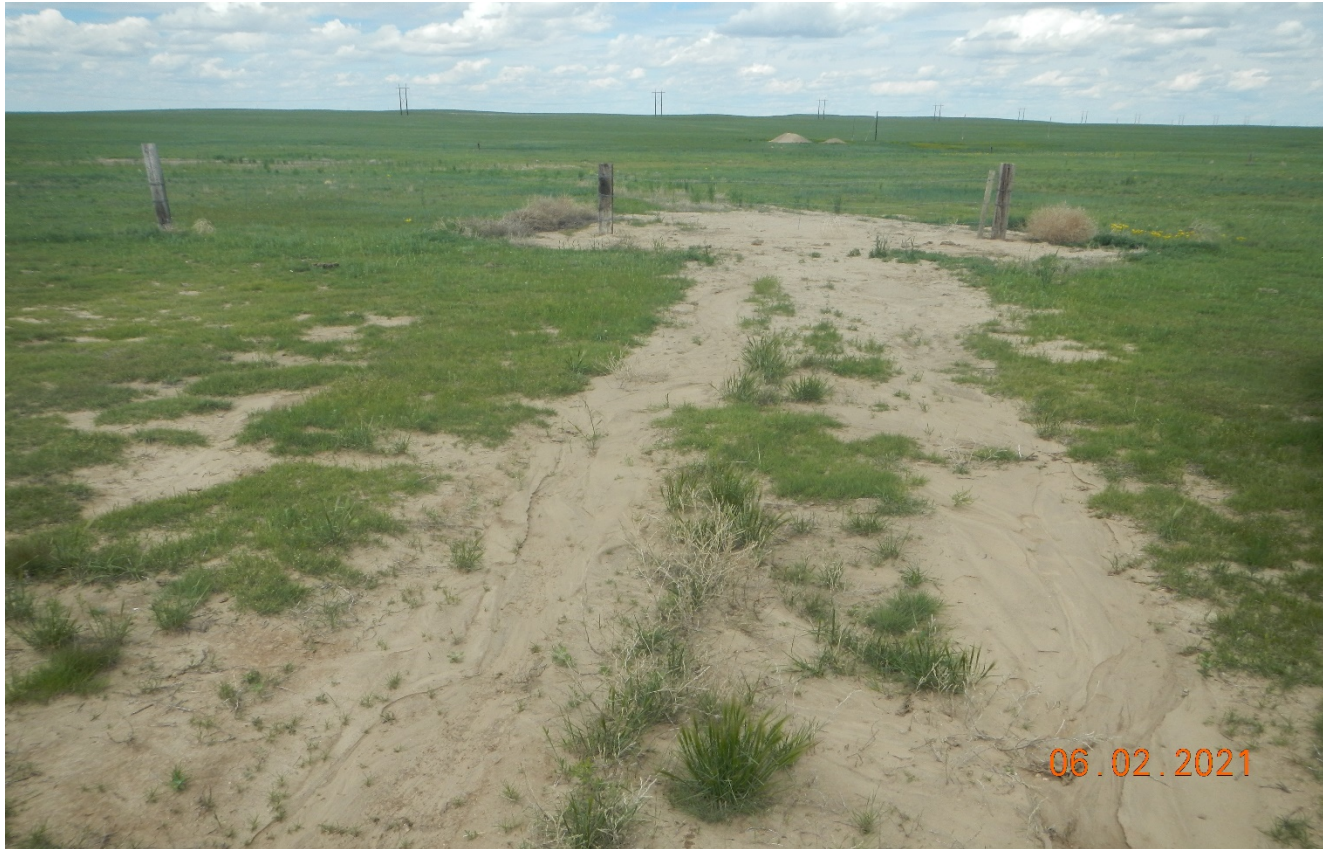
Photo 3. Facing northeast along the access road. Additional reclamation is needed along this area of the access road. A pre-existing road appeared to travel thru the location however the location has been fenced off.

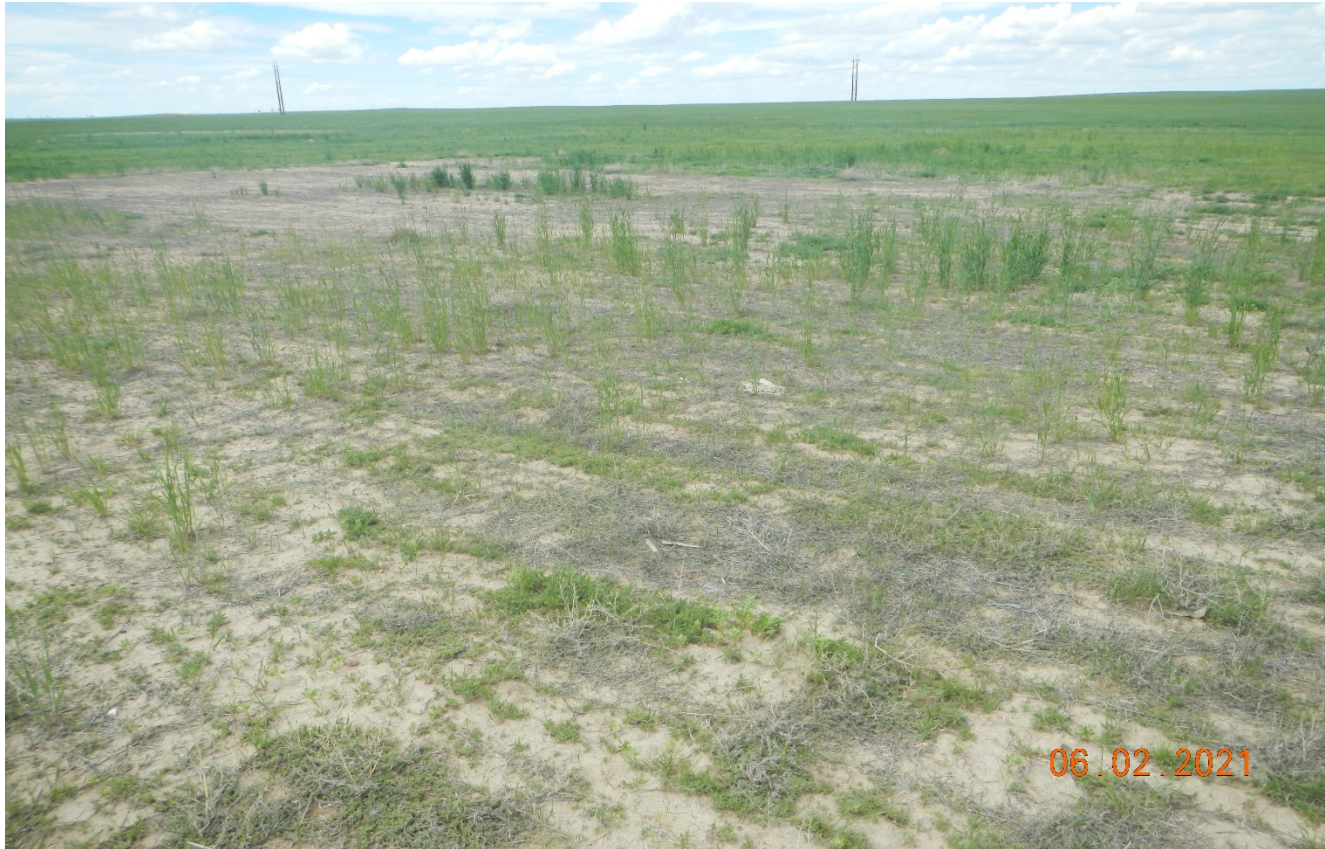
Photo 4. Facing northeast at the location. It does not appear revegetation is progressing in areas of the location.

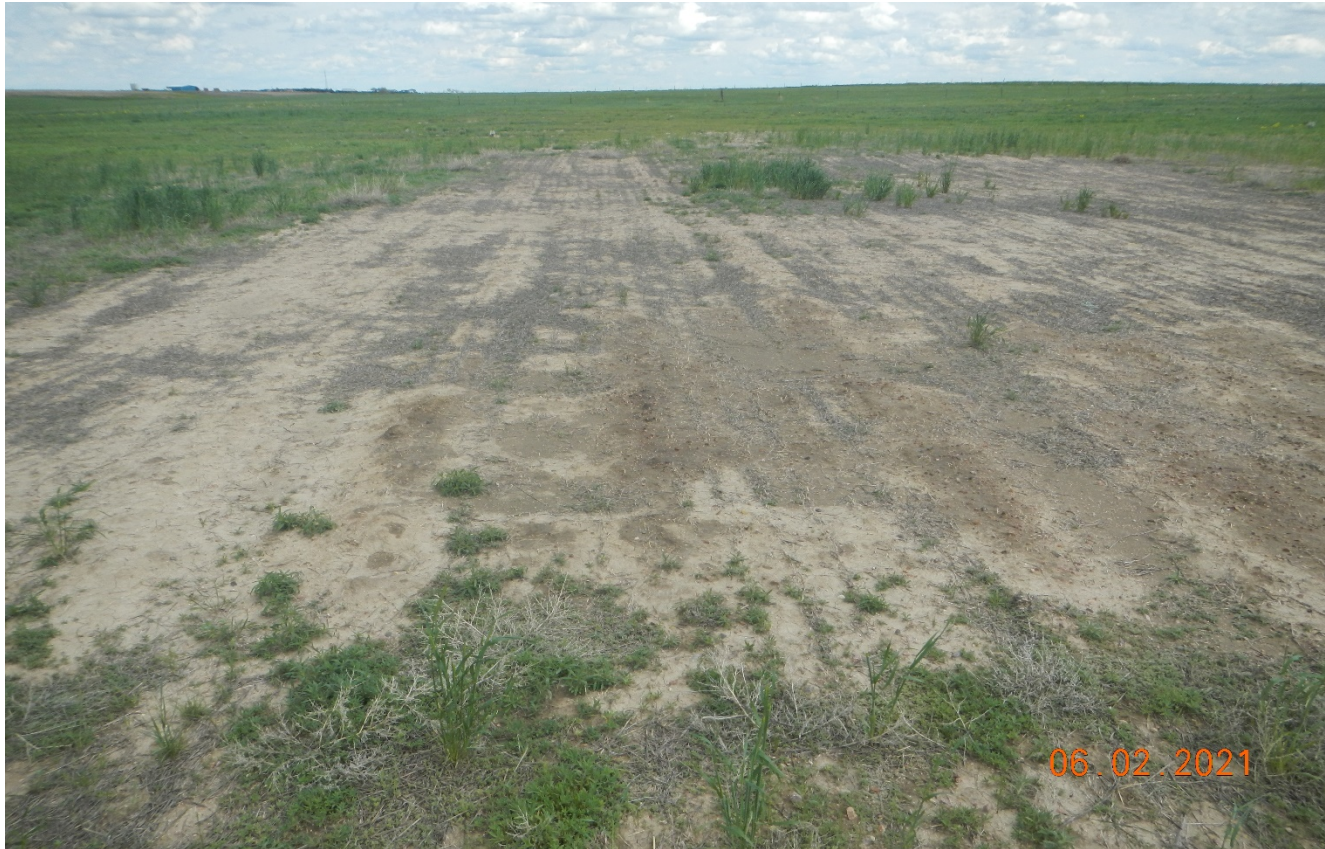
Photo 5. Facing south at the location. It does not appear revegetation is progressing in areas of the location.

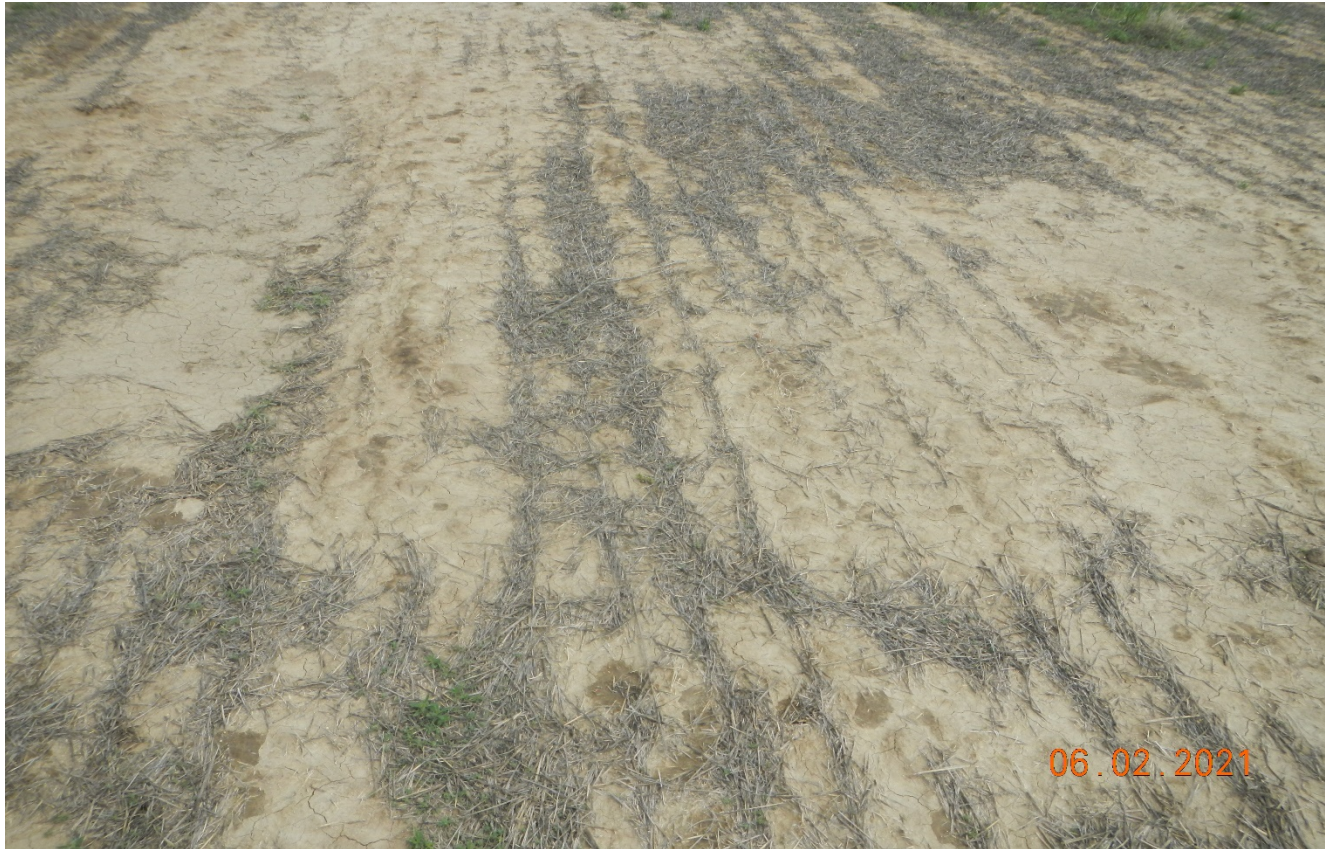
Photo 6. View of ground cover shows crimped straw. With the abundant spring moisture areas of the location should be establishing vegetation. Additional reseeding and weed control will need to be performed.

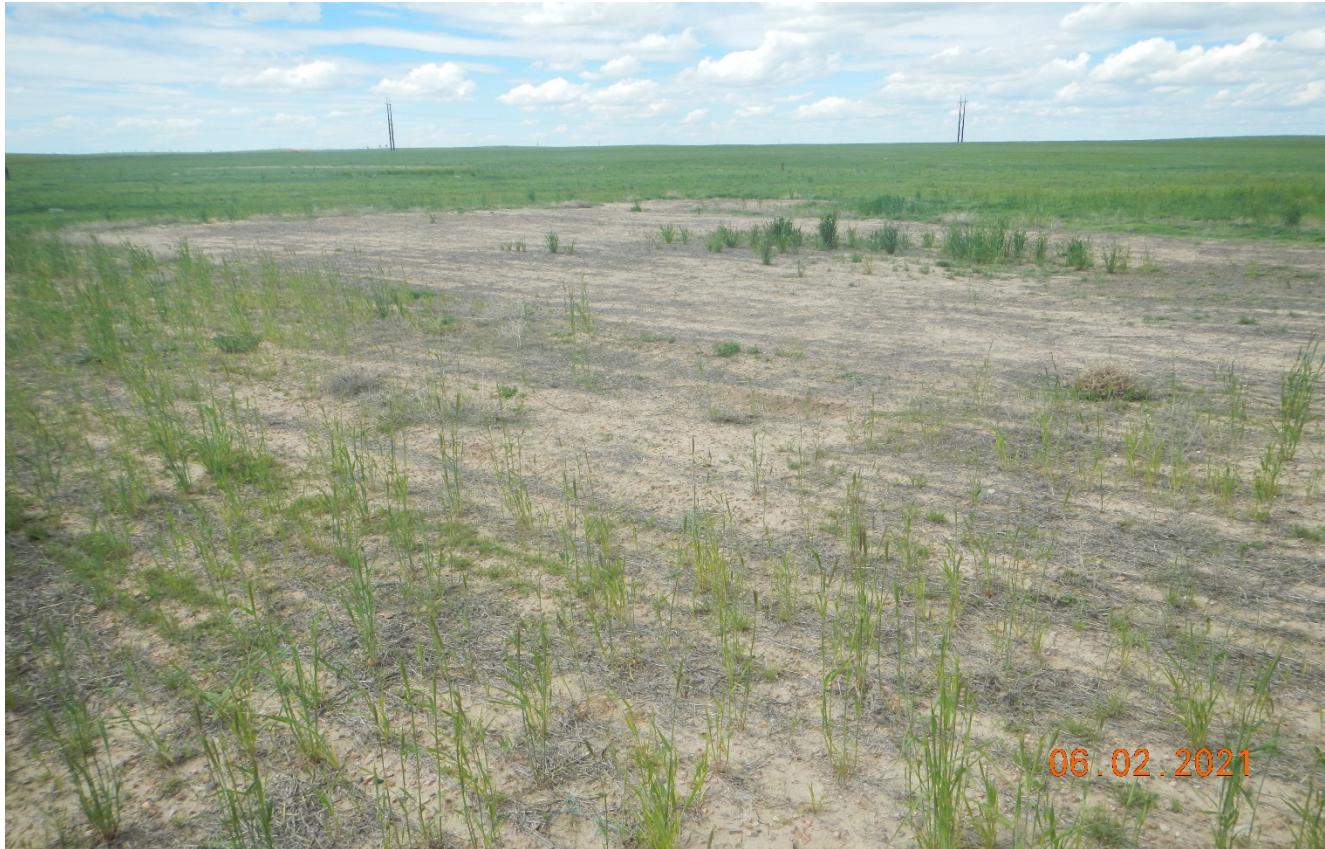
Photo 7. Facing southwest at the location. It does not appear revegetation is progressing in areas of the location.

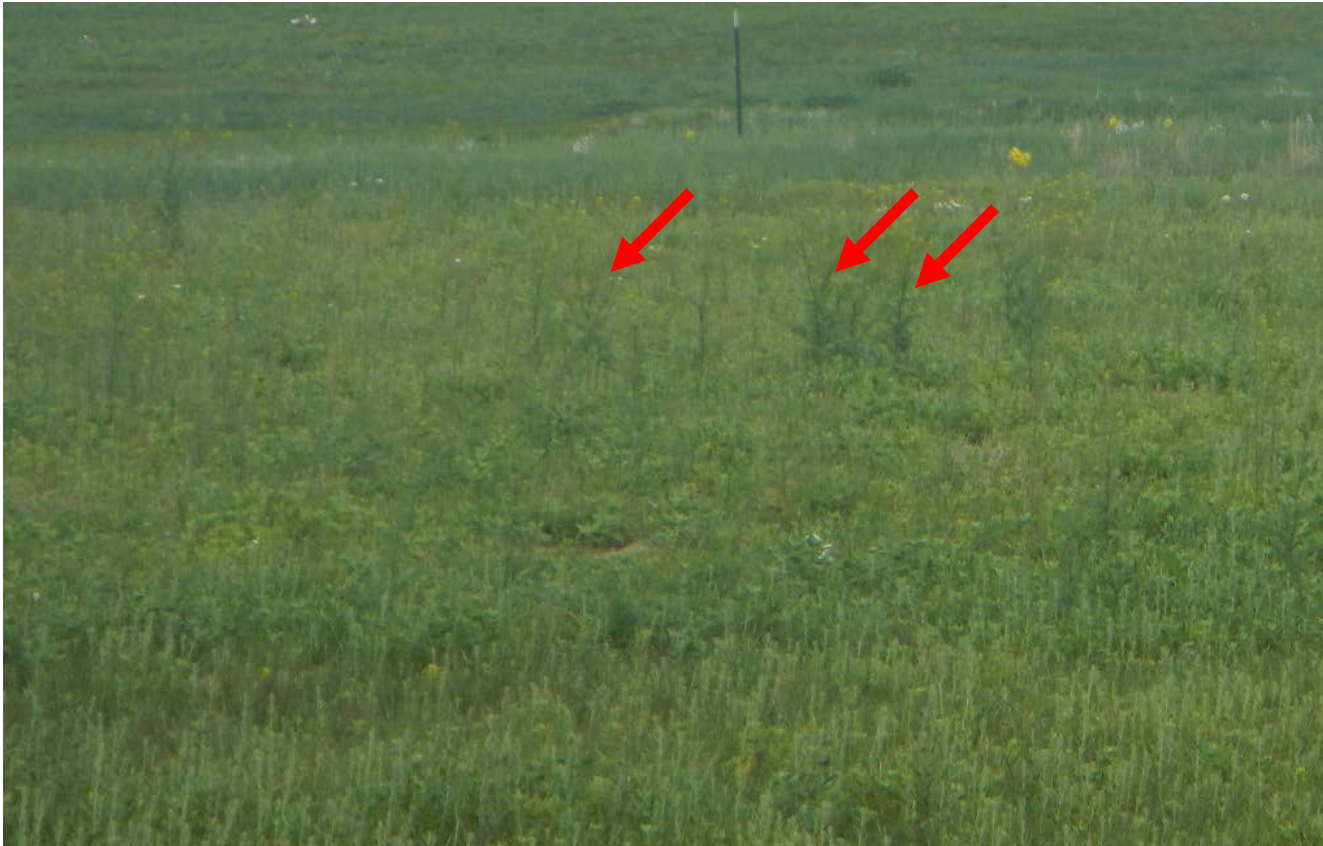
Photo 8. It was observed in the photos that there is potential noxious weeds (Russian knapweed). The location needs to be evaluated for both undesirable and noxious weed control.

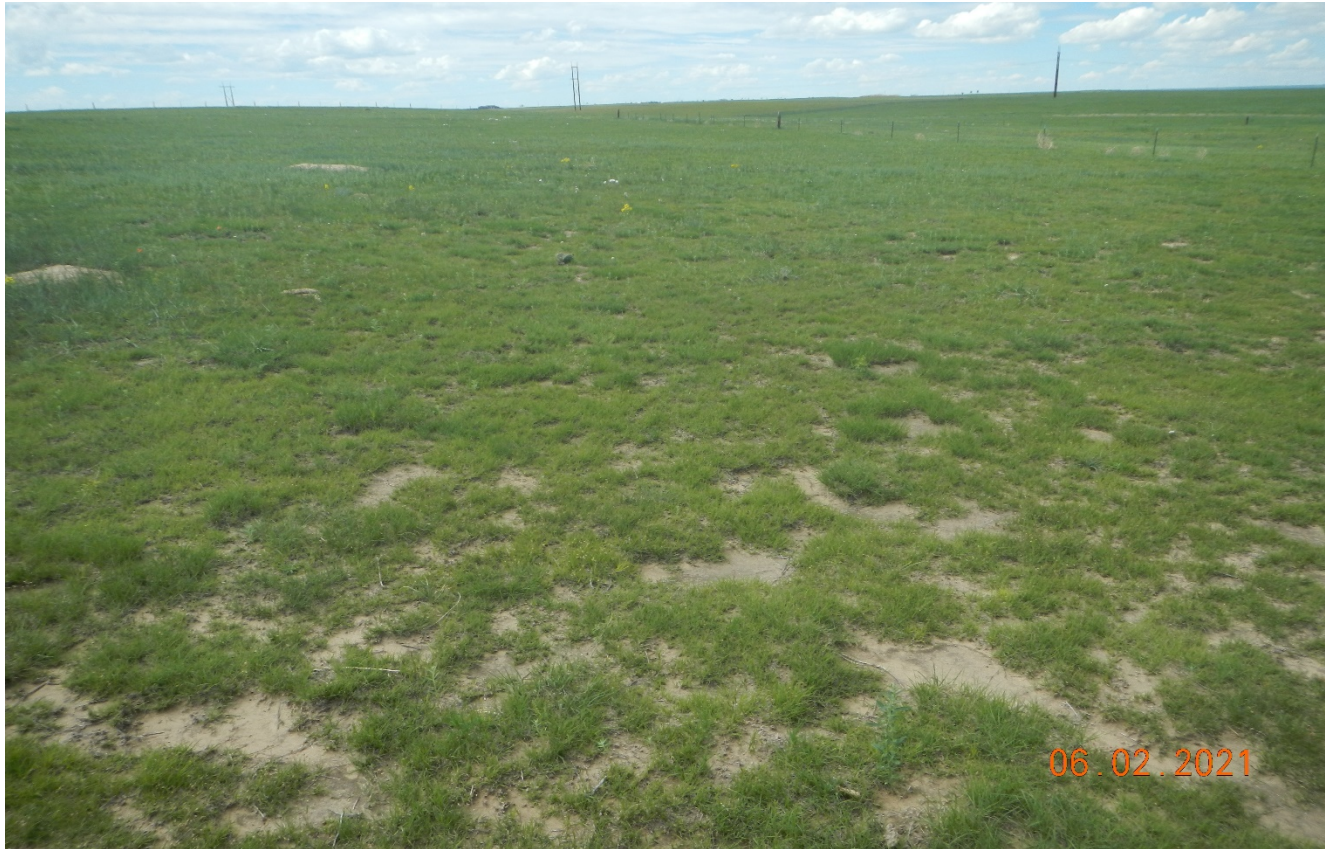
Photo 9. Facing west toward the undisturbed surrounding rangeland which consists of Blue grama, Sand dropseed among other native vegetation.
