## Inspection Photos

Location Name: CAERUS PICEANCE LLC SAVAGE-67S95W /20SESE

Location ID: 334996

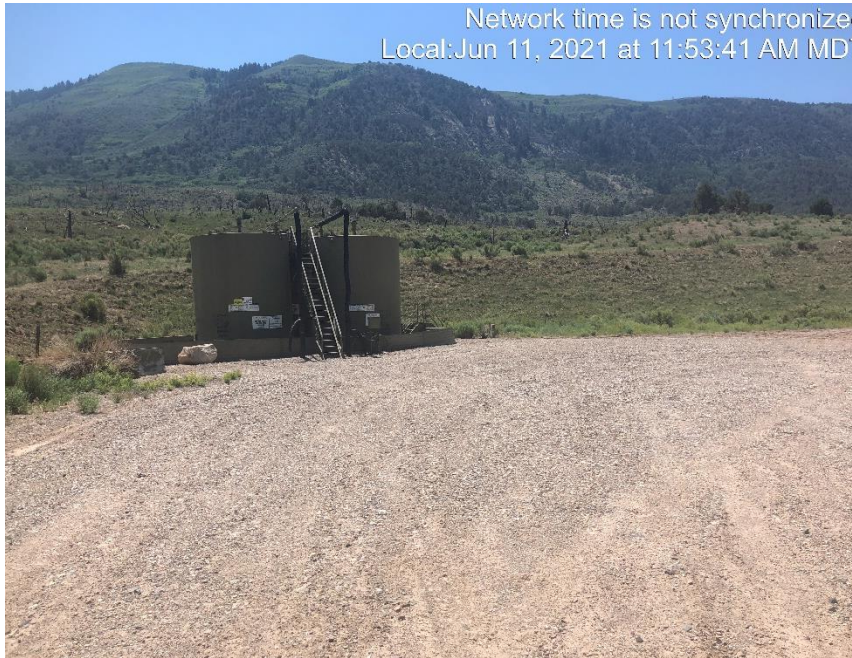
Photo #4063 from entrance to location.

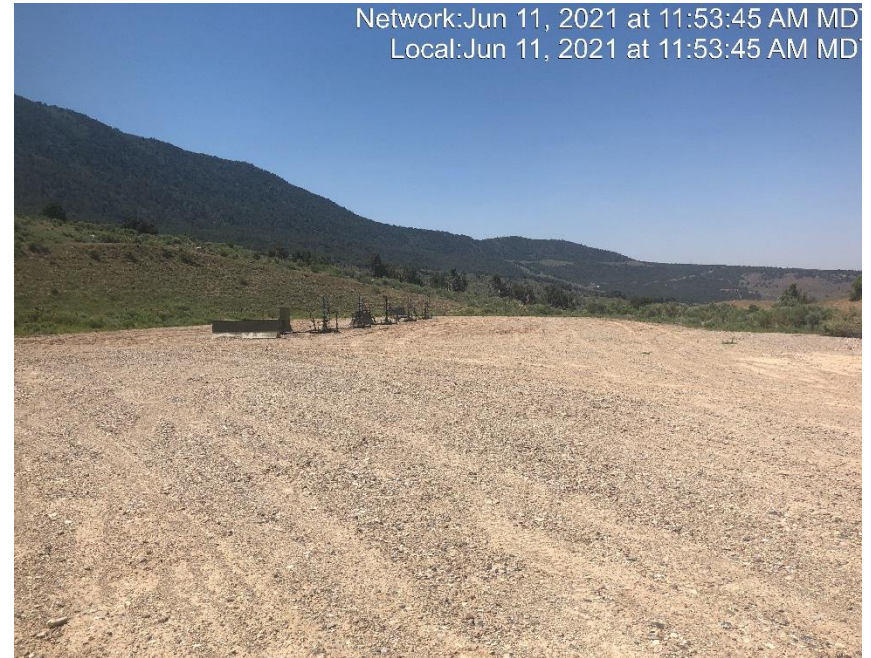
Photo #4064 from entrance to location.

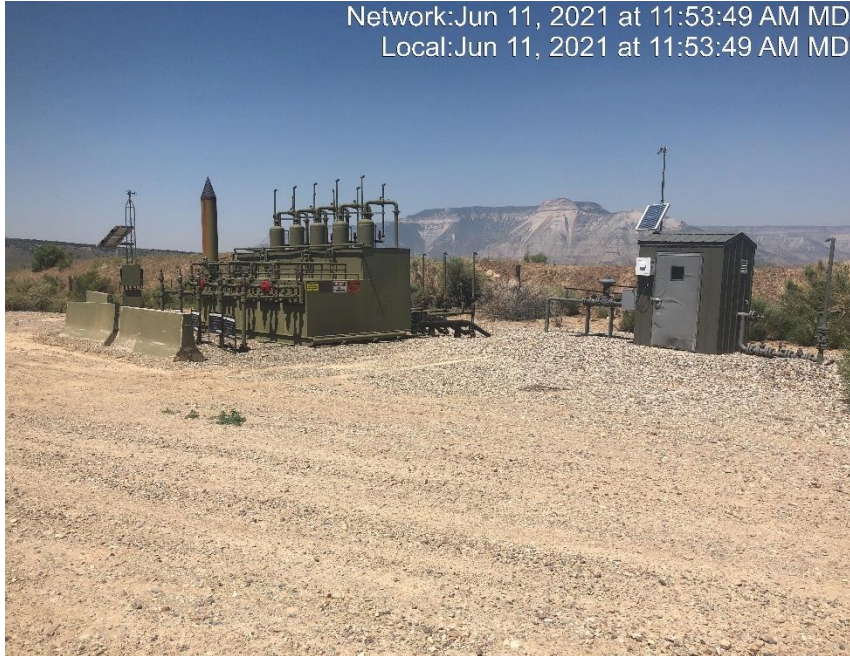
Photo #4065 from entrance to location.

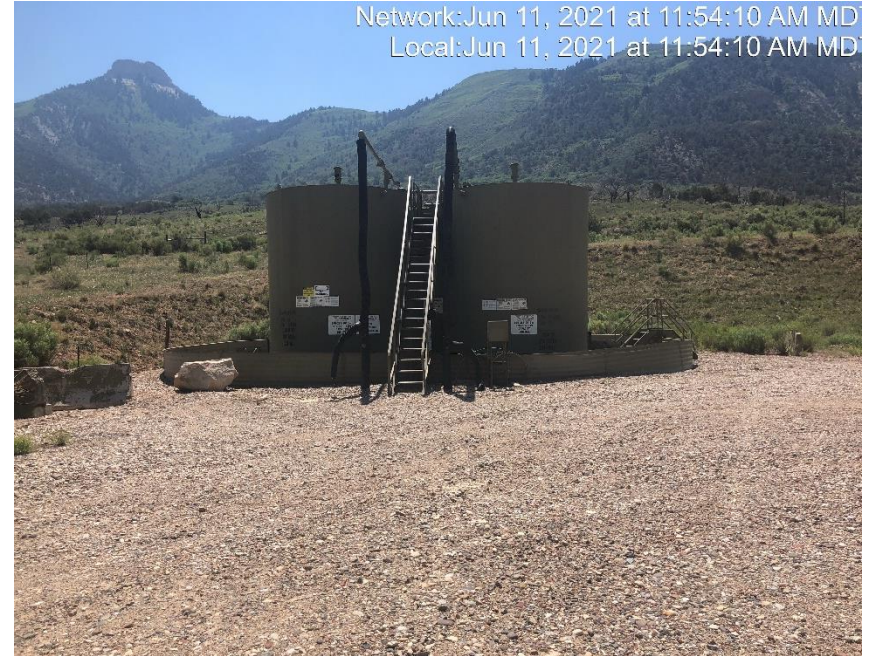
Photo #4066 No battery sign located at the tanks battery.

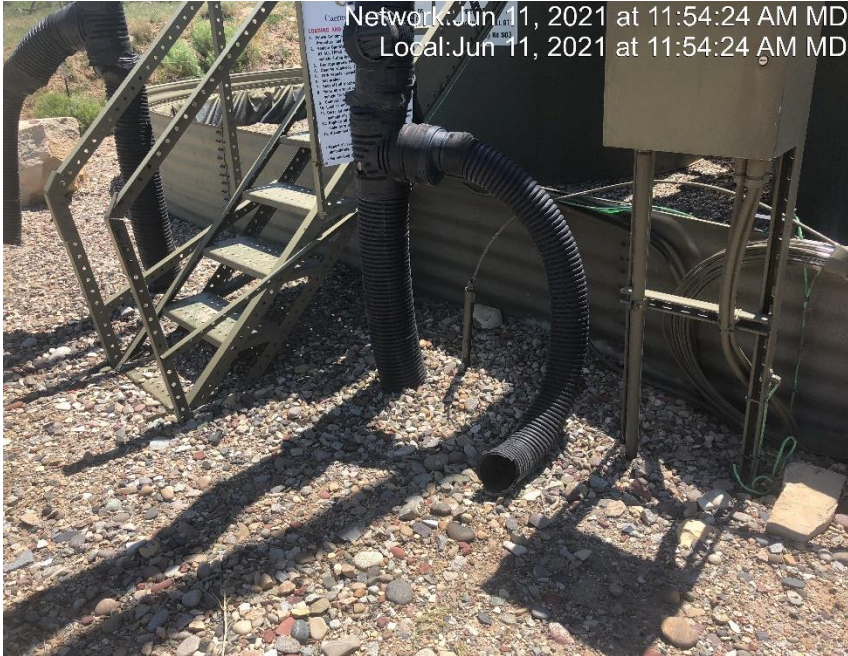
**Photo #4067 Multiple flow line heating insulation open ended and not capped.**

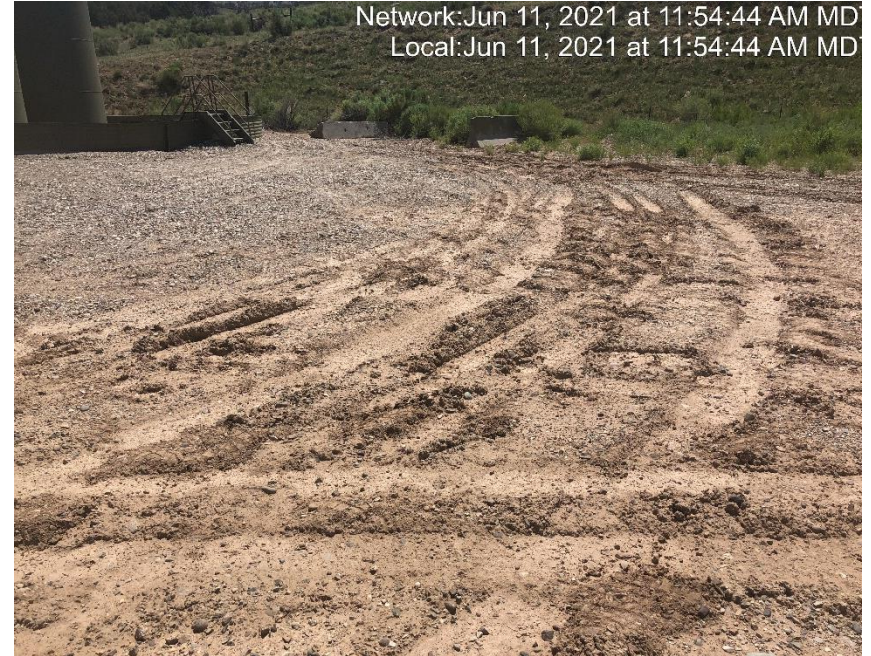
**Photo #4068 Location lacks stabilization.**

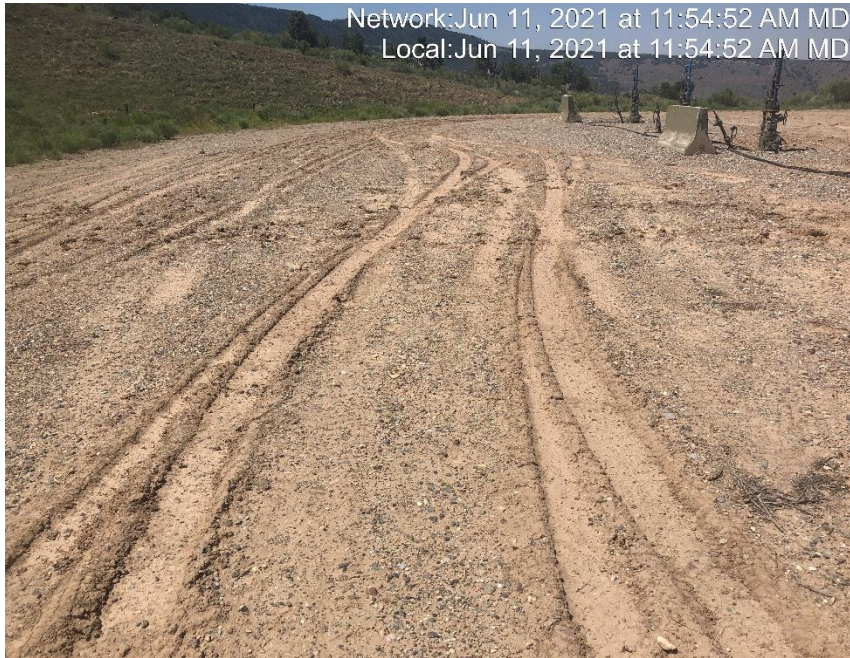
**Photo #4069 Location lacks stabilization.**

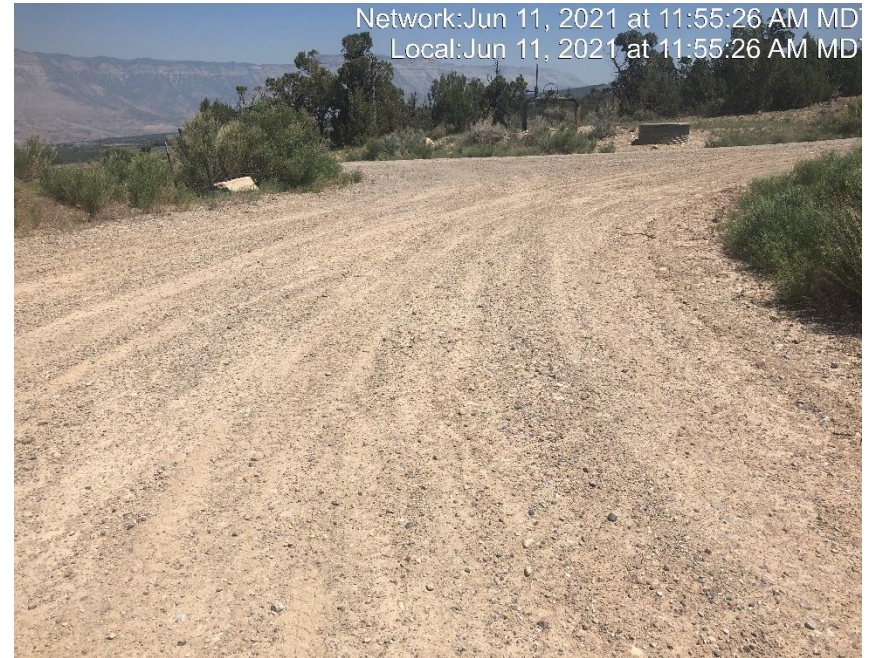
**Photo #4070 No form of tracking control located at the entrance to location.**
