Inspection Photos

API: 061-06590

Operator: OXY USA INC

Inspection Date: 6/9/2021

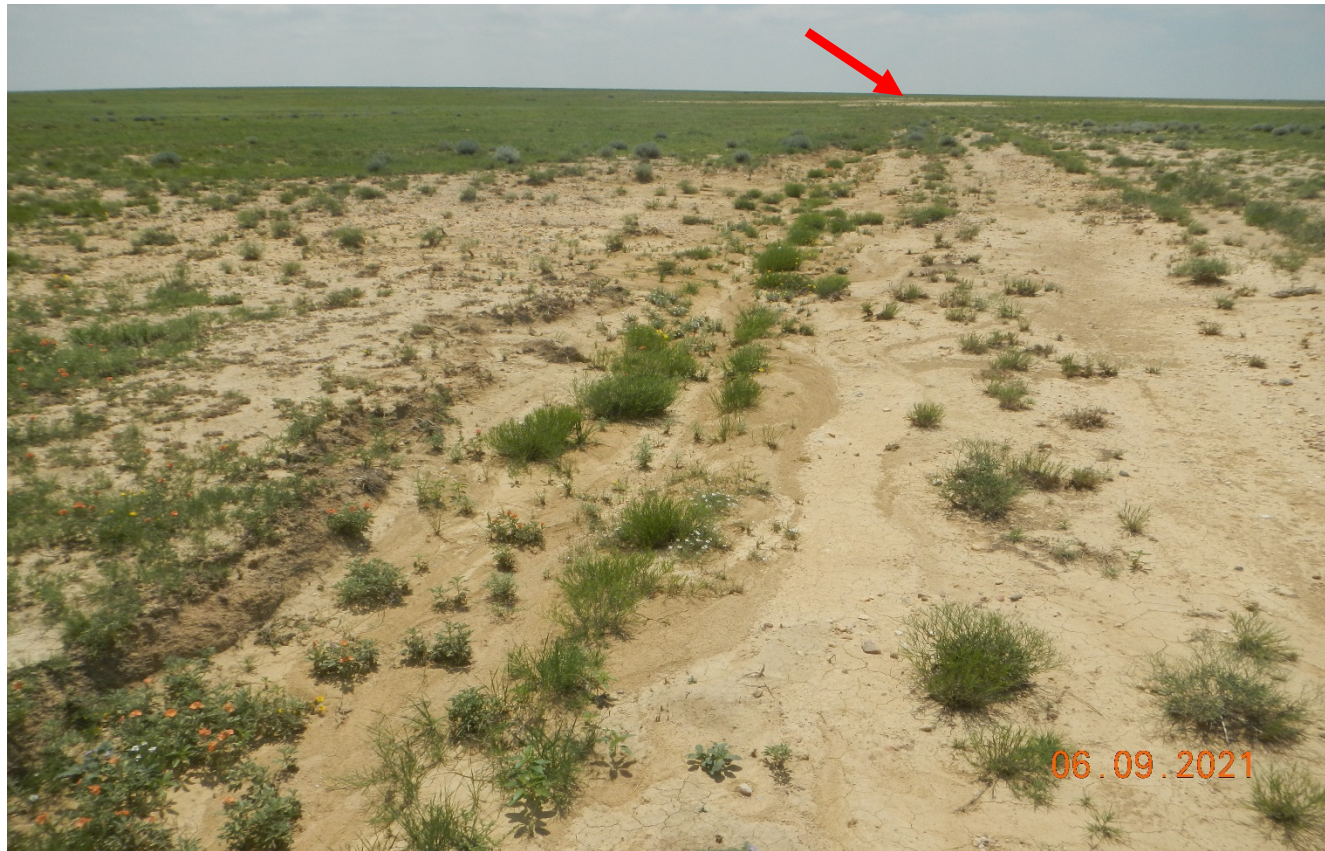
Photo 1. Facing southeast along the former access road. Vegetation has not re-established in this area and there s erosion. Location is shown at red arrow.

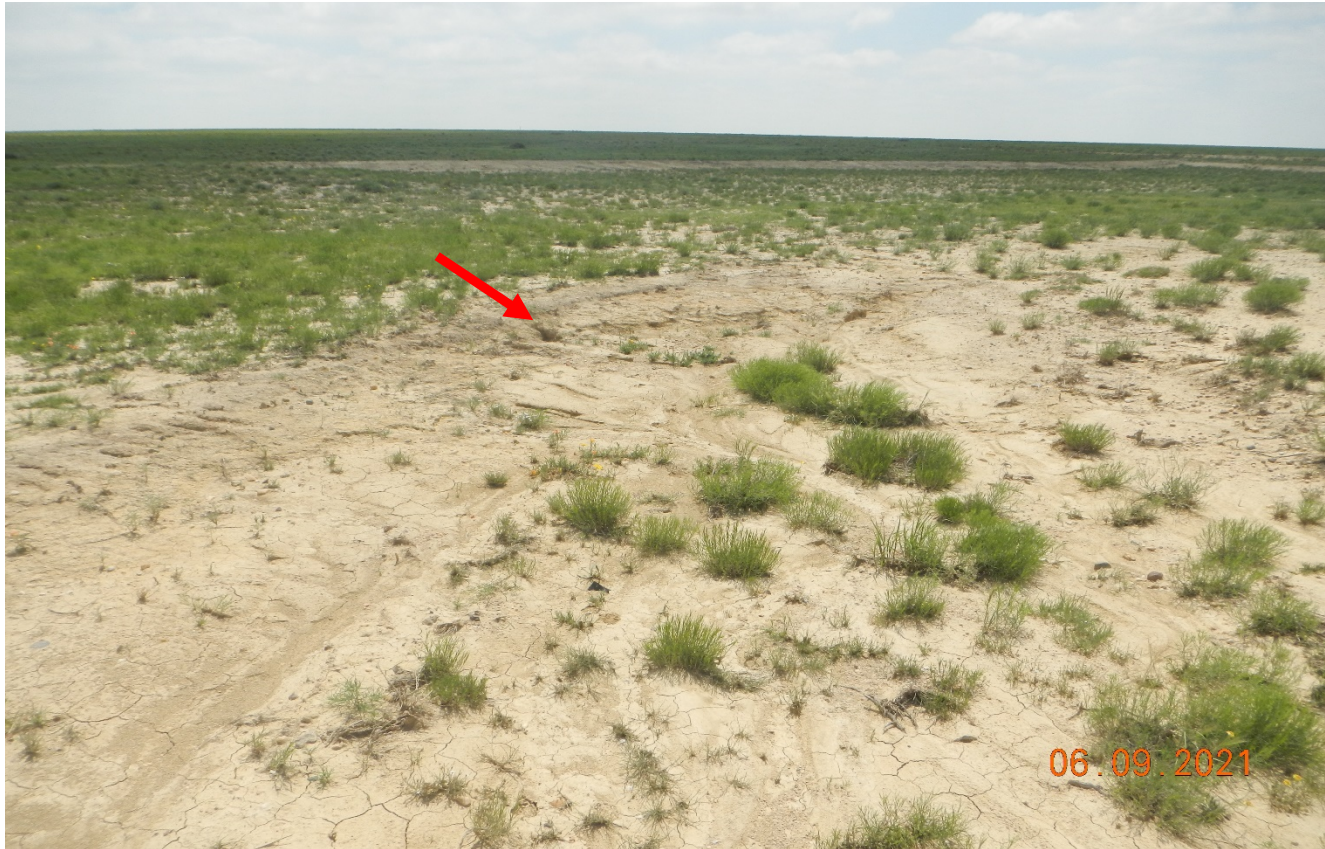
Photo 2. Facing southeast toward the location. This area is not stabilized and there are signs of erosion.

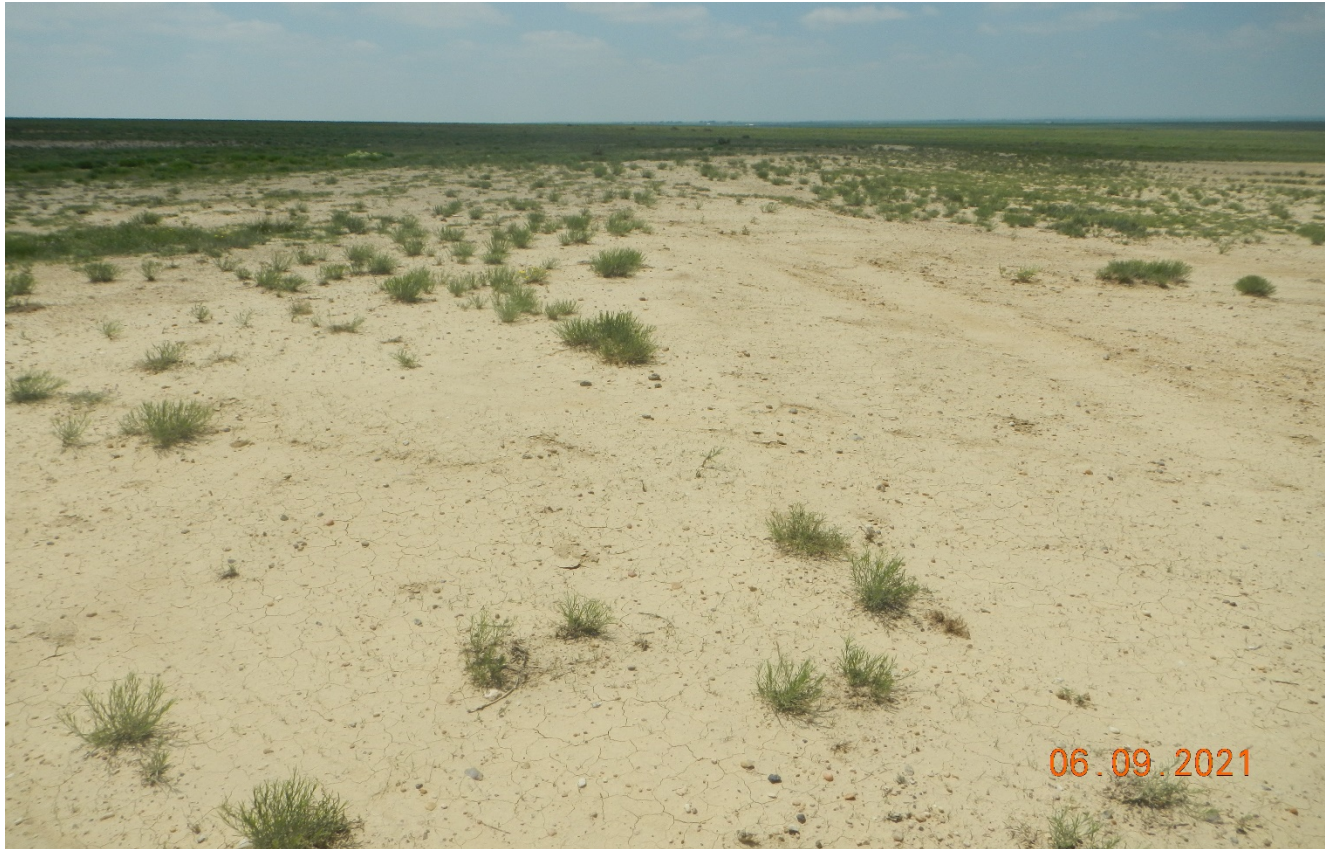
Photo 3. Facing southwest at the location. The fill slope has not been recontoured. There is no vegetation growth along this area.

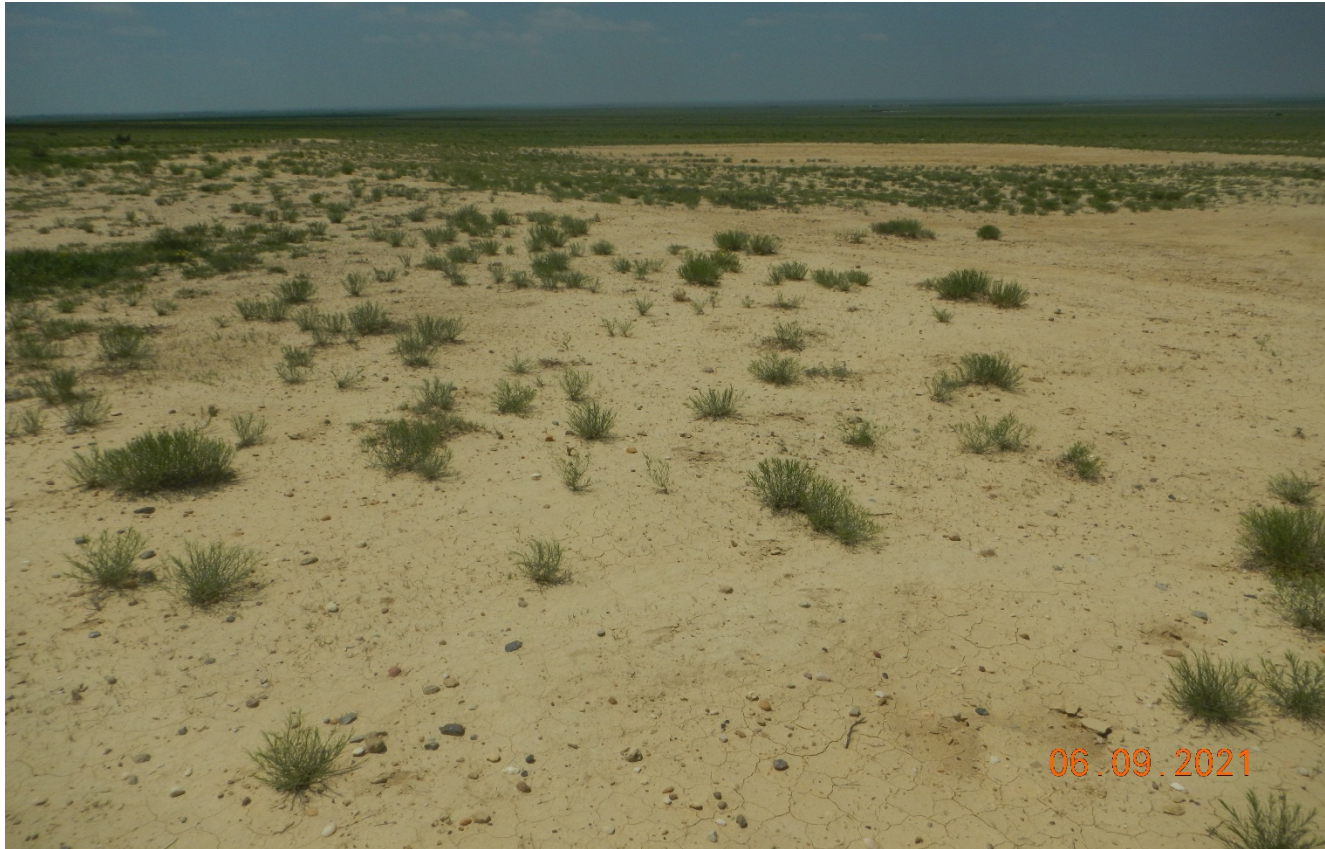
Photo 4. Facing west at the location. There is no vegetation observed in the bare areas. With adequate spring moisture, there should be more germination in these areas were seeded. There may be soil issues preventing vegetation establishment.

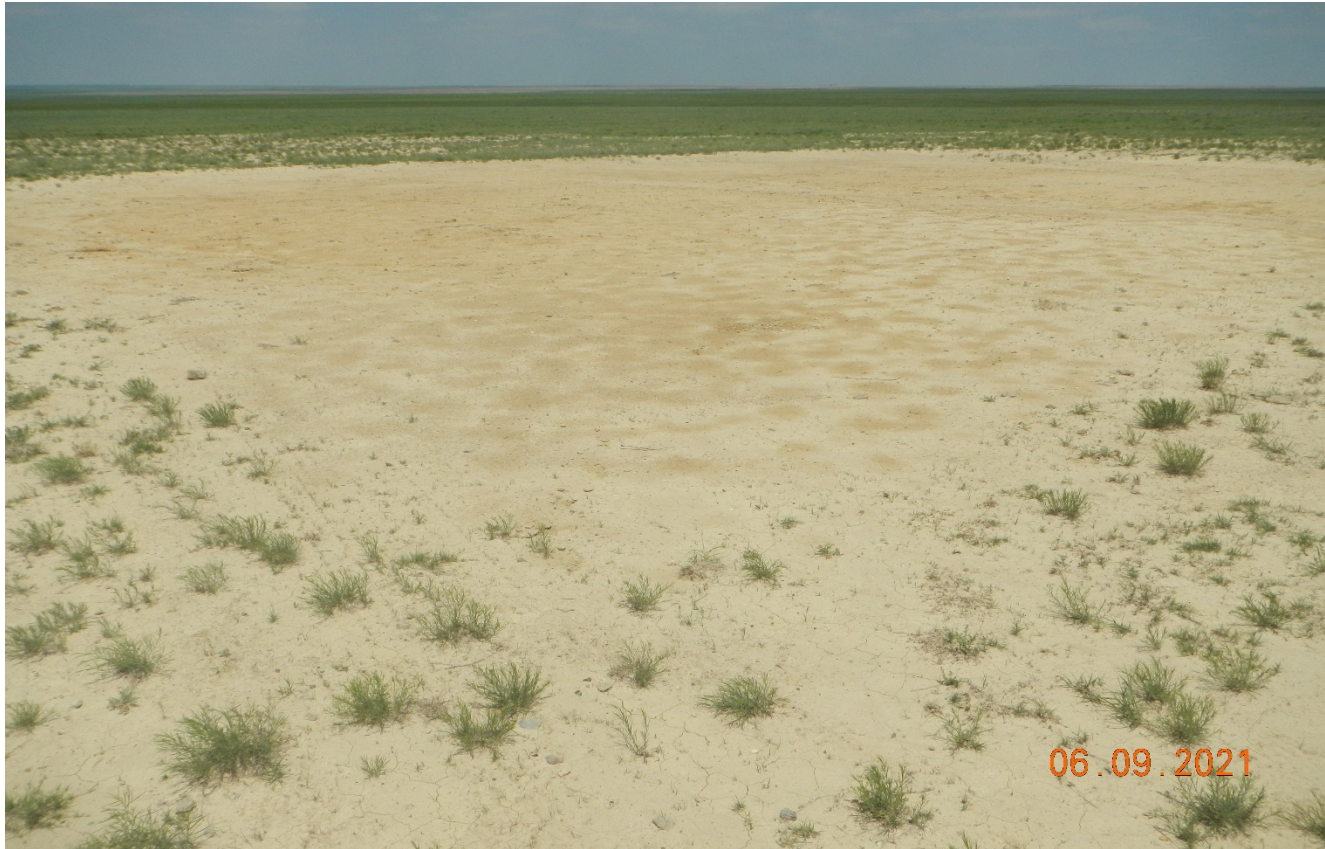
Photo 5. Facing northwest at the location. There is no vegetation observed in this bare area approximately 120'x120'. With adequate spring moisture, there should be more germination in this area if it was seeded. There may be soil issues preventing vegetation establishment.

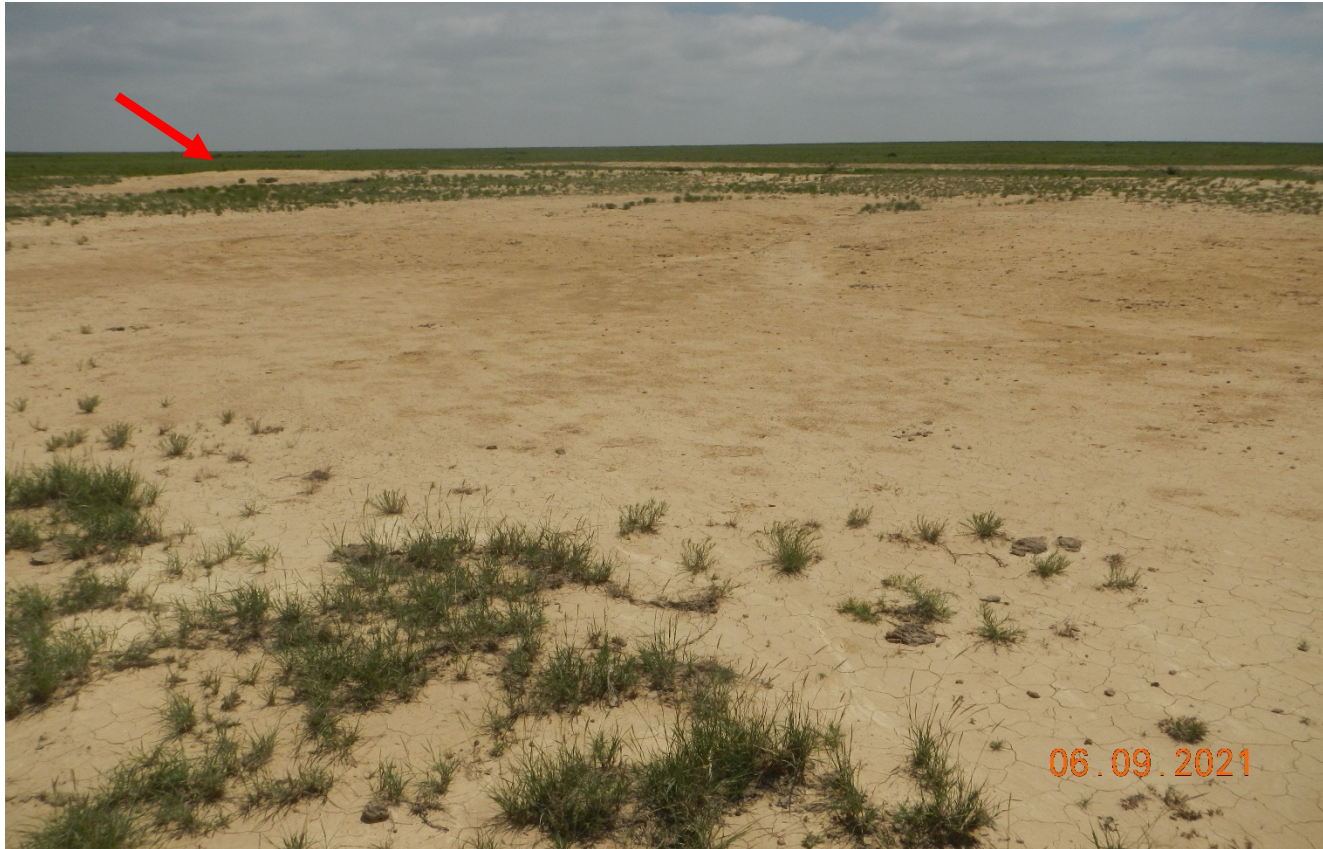
Photo 6. Facing southeast at the location. There is no vegetation observed in this bare area approximately 120'x120'. With adequate spring moisture, there should be more germination in this area as it was seeded. There may be soil issues preventing vegetation establishment. Red arrow points to fill slope area shown in photo 3.

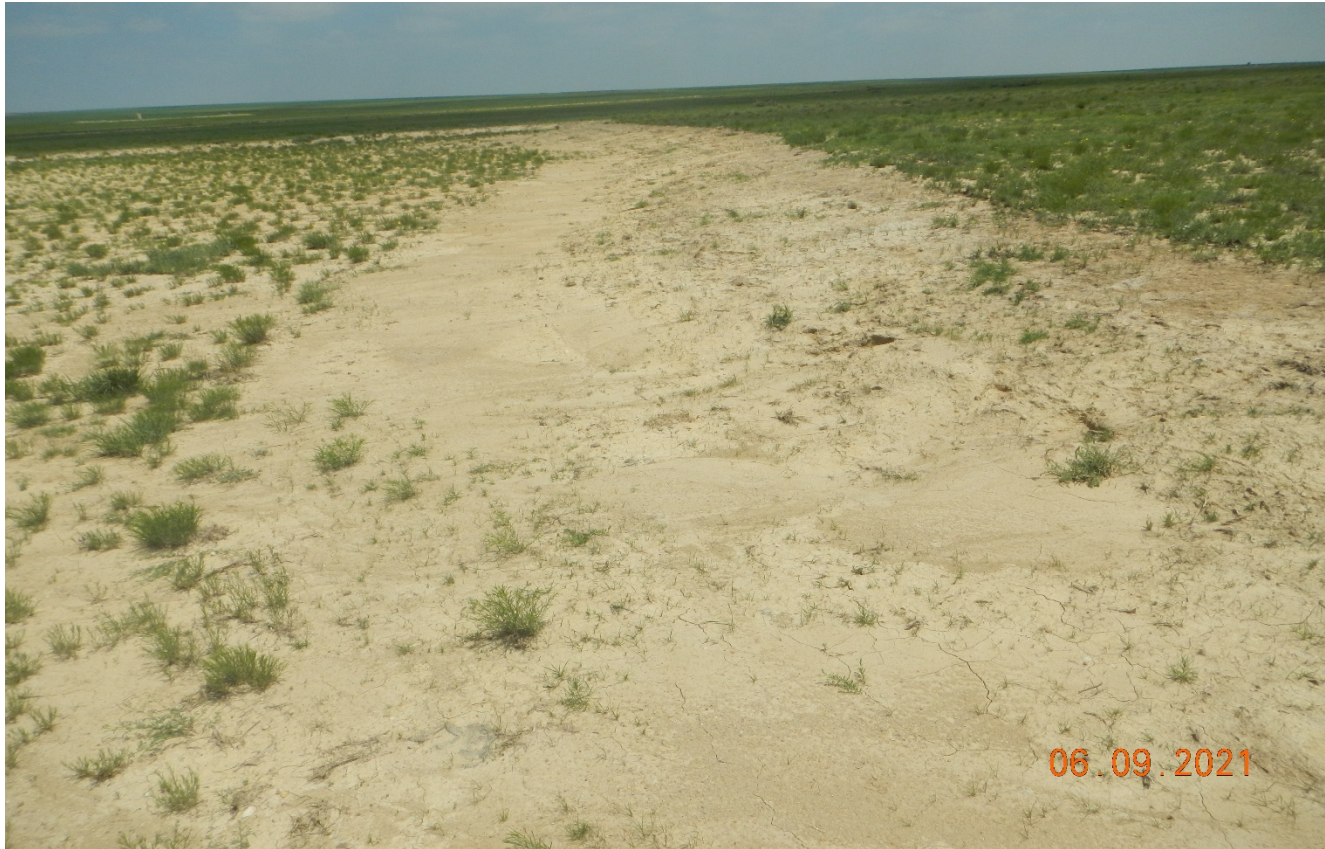
Photo 7. Facing northeast along the cut slope. Soil has been replaced along the cut slope. There are some signs of erosion and soils are not stabilized.

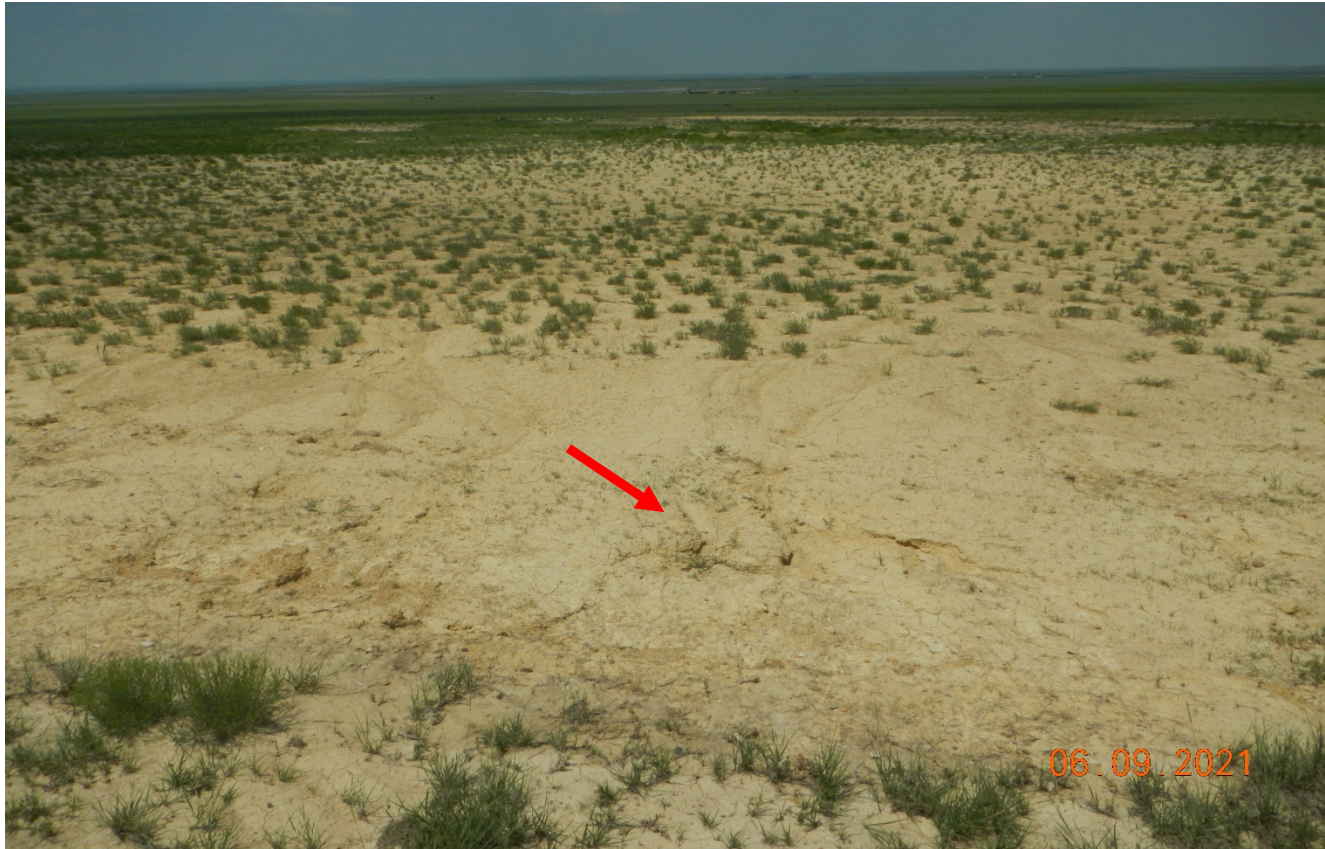
Photo 8. Facing north at the cut slope. Soil has been replaced along the cut slope. There is some signs of erosion and soils are not stabilized (Red arrow).
