Inspection Photos

Location Name: August Gittlein #1 and Spindle Consolidation Battery #6

Location ID: 317646

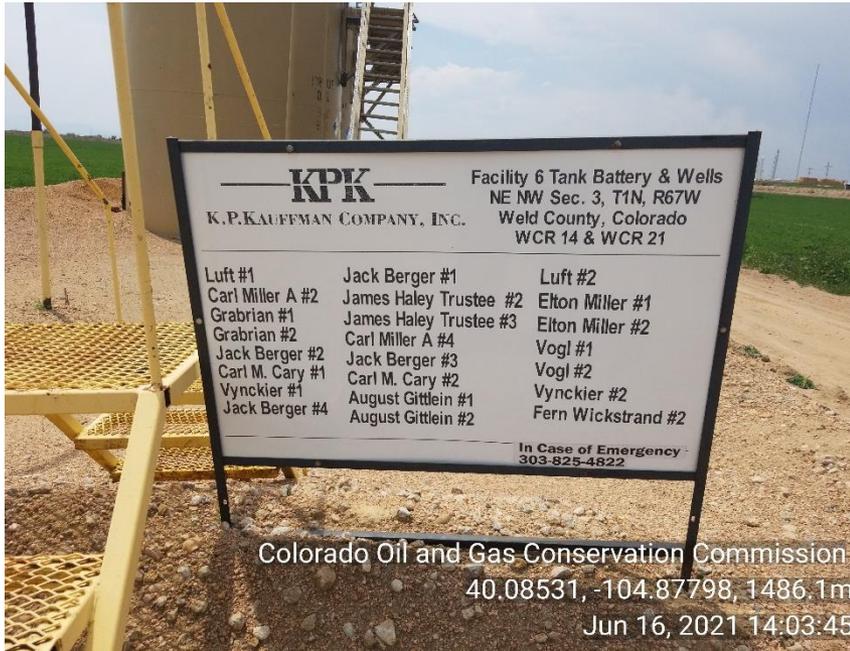
Photo 1 TNK BTRY sign

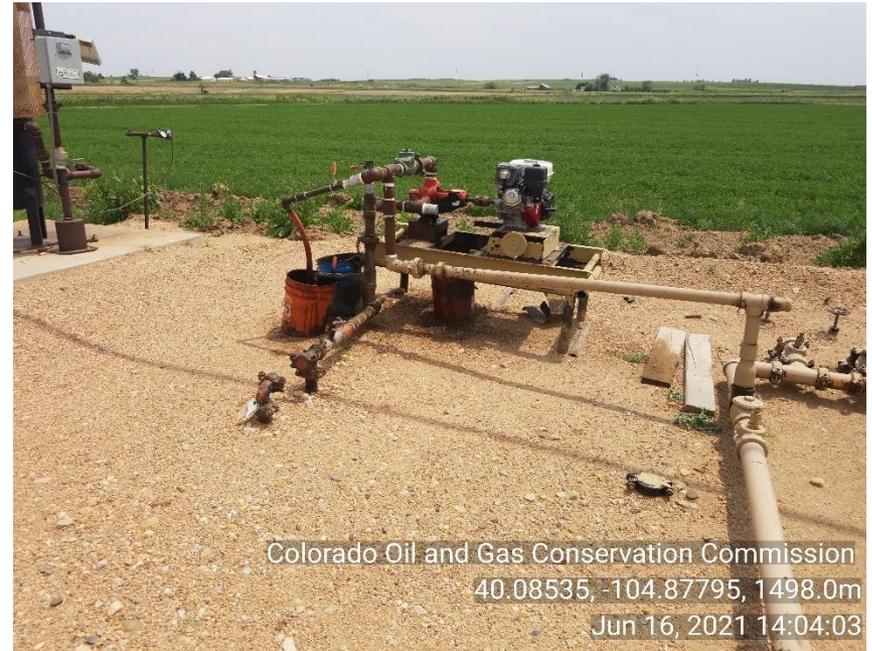
Photo 2 Recirc pump. Stained soil and mechanical issues.

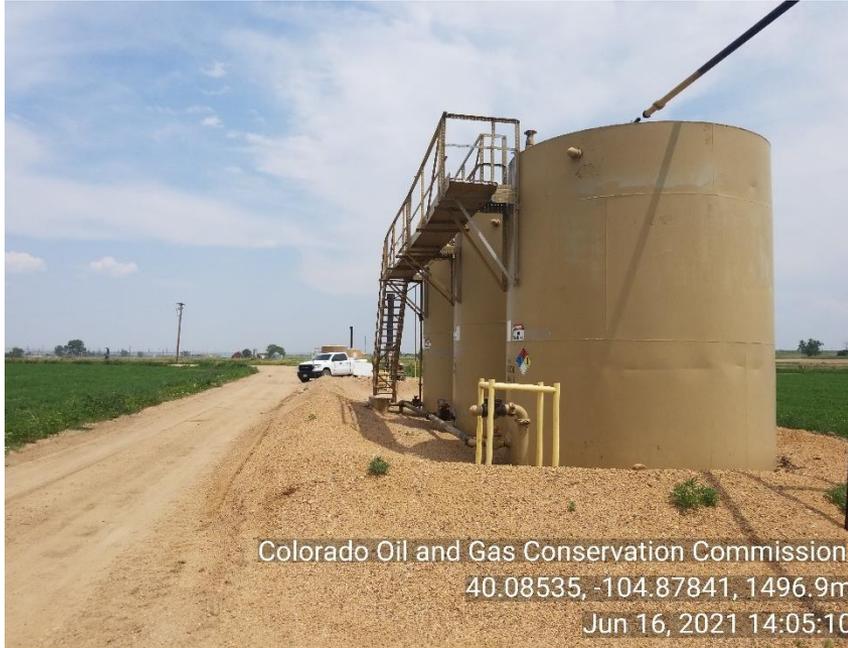
Photo 3 TNK BTRY

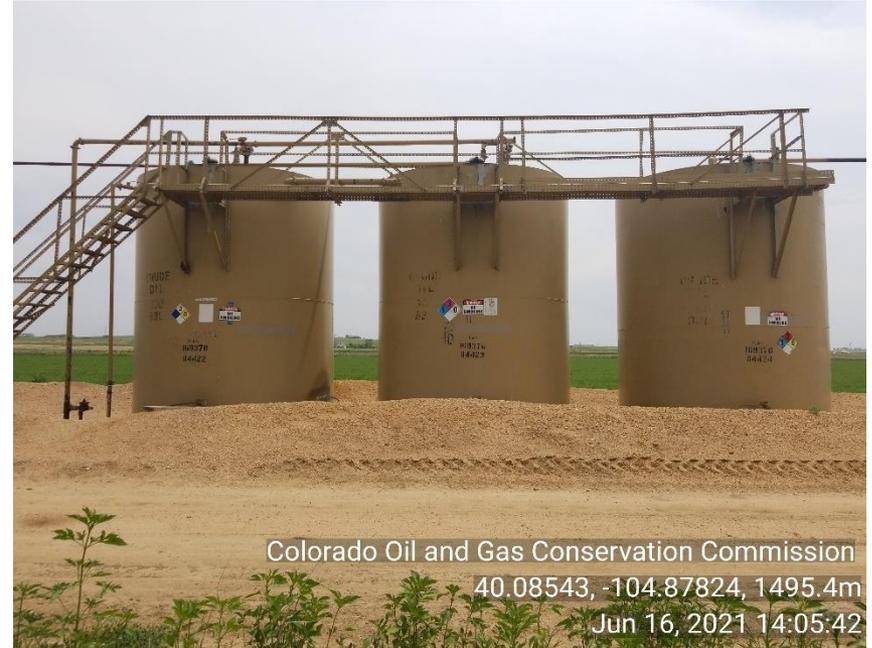
Photo 4 Labels and placards faded not readable.

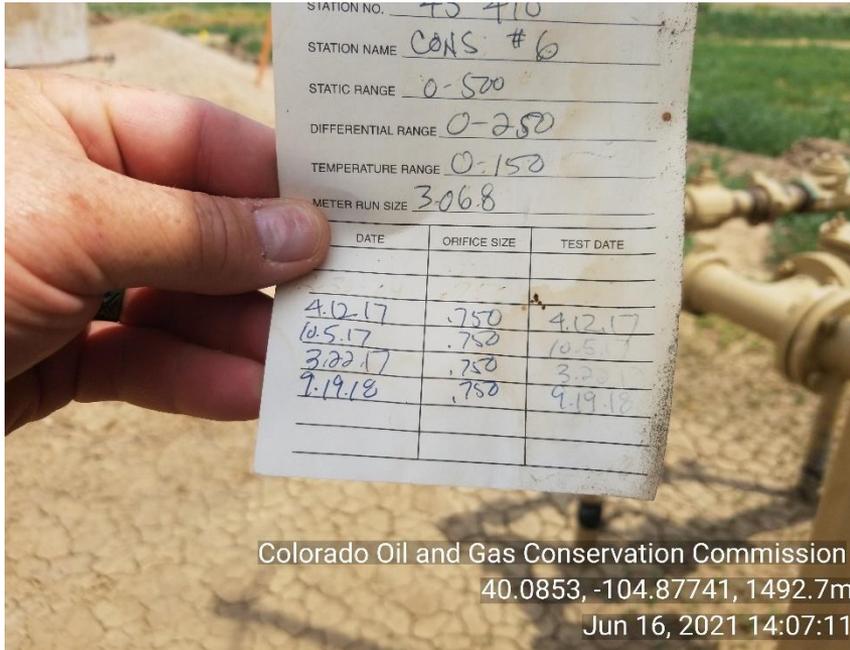
Photo 5 Meter calibration card out of date

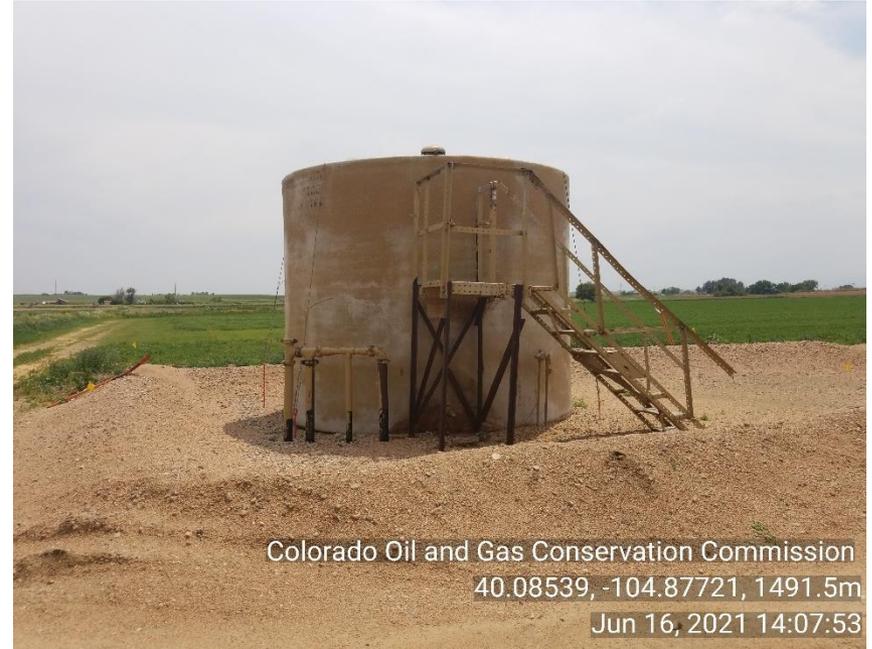
Photo 6 Produced water tank not placards or labels.

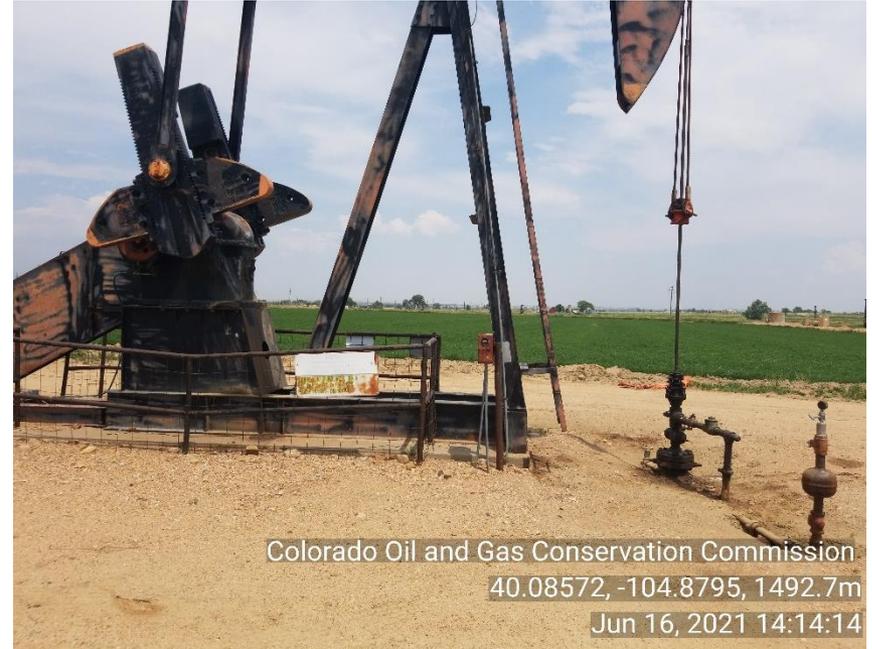
Photo 8 August Gittlein # 1 PU

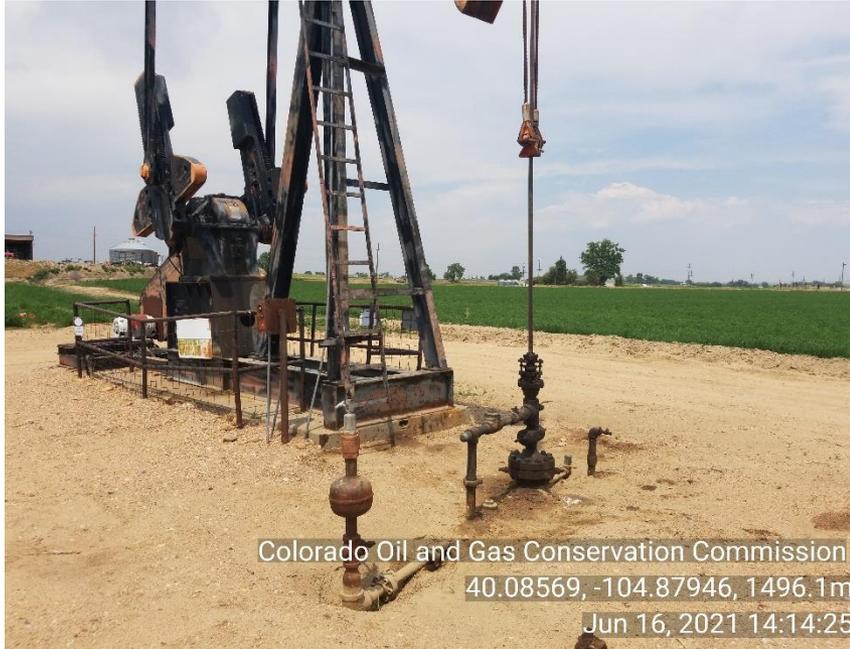
Photo 9 Stained soil around well head.

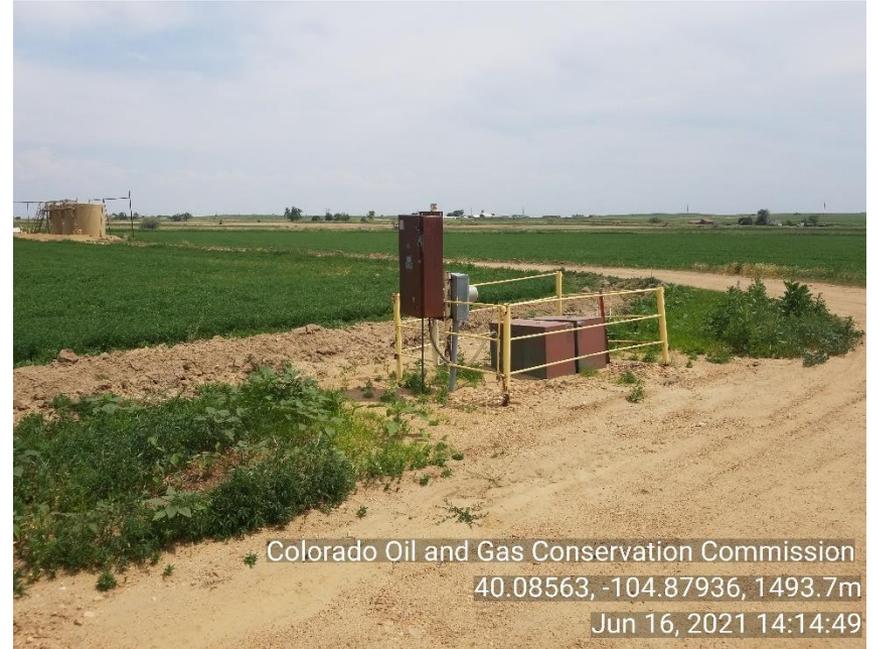
Photo 10 electric panel. Breaker in the on position.
