**Inspection Photos**  
**Location Name: Lilli Unit 8-1**  
**Location ID: 326969**

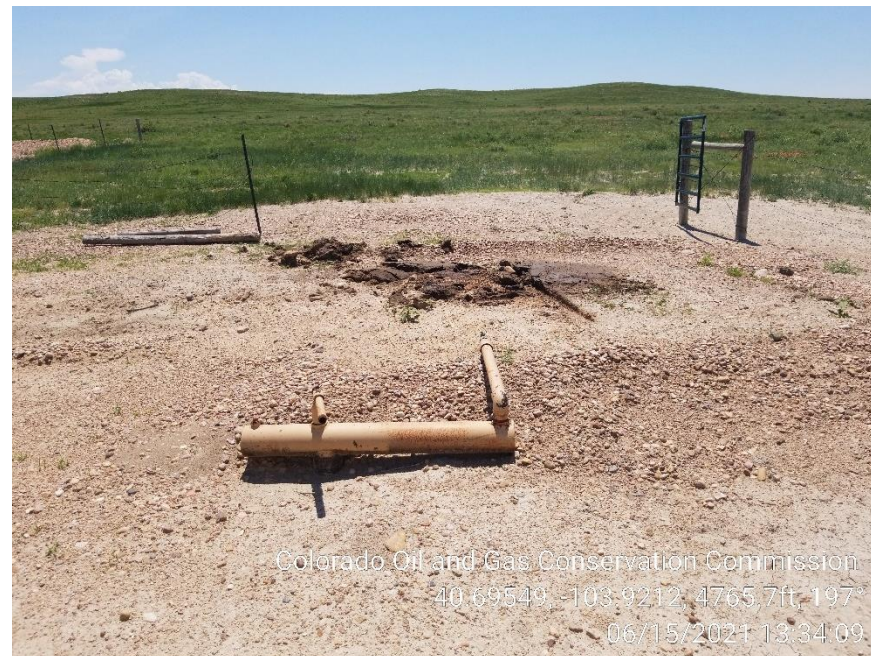
**Photo 2 – Stained Soil where Gas Engine was removed**
