Inspection Photos  
Location Name: Elkhorn Company B 6  
Location ID: 327714

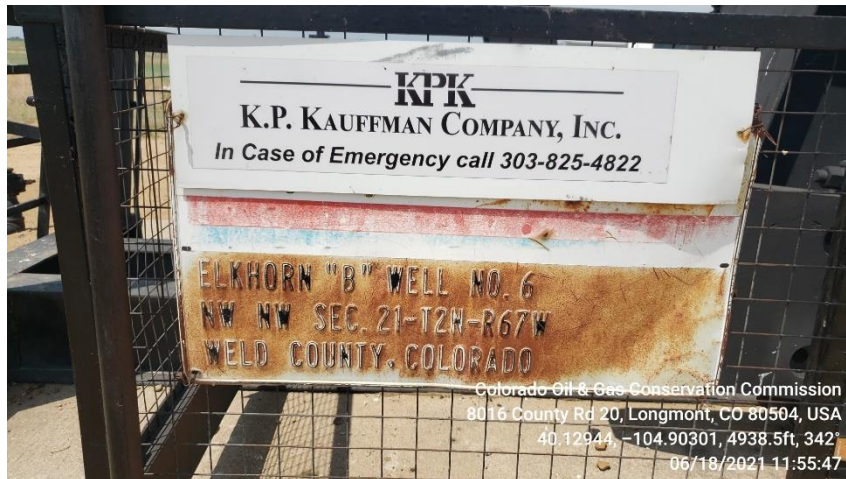
Photo 1 WH sign

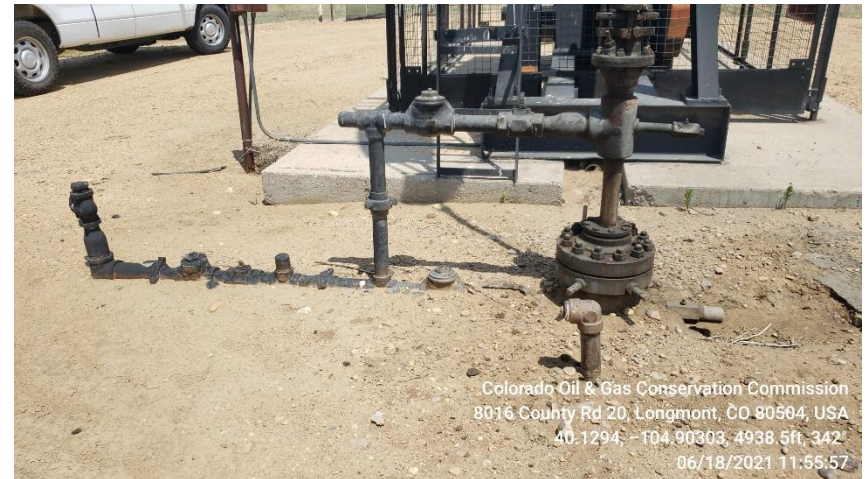
Photo 2 WH

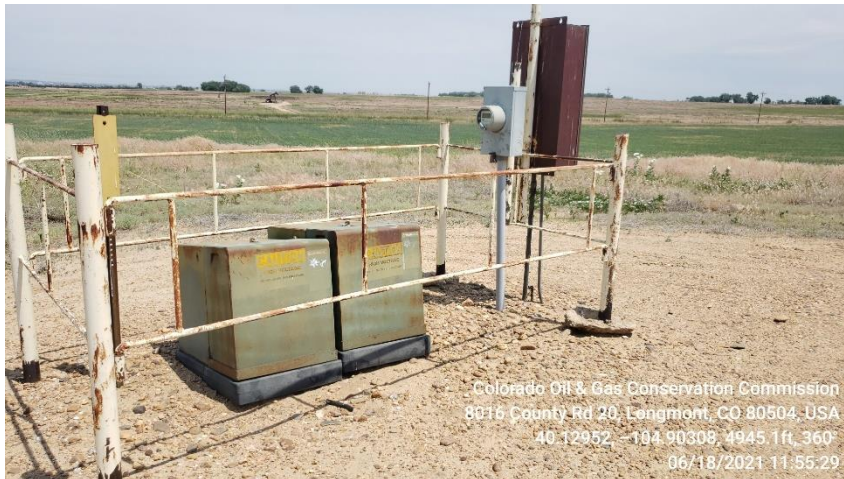
**Photo 3 ancillary equipment**

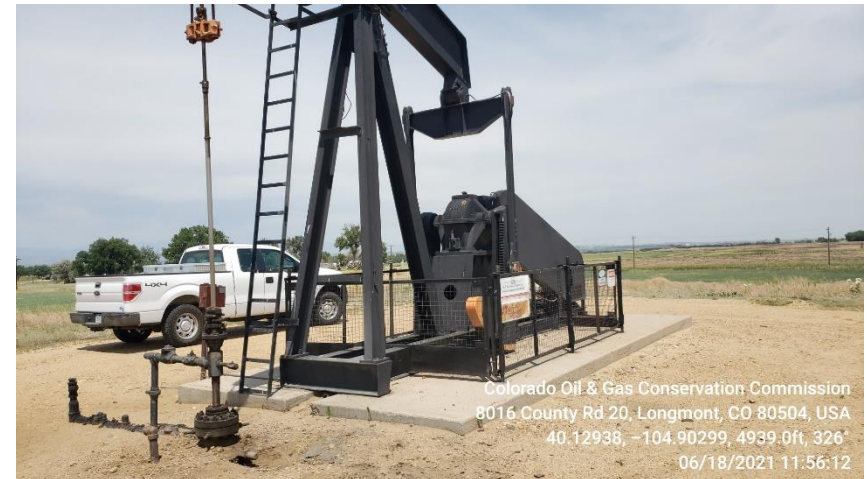
**Photo 4 pumpjack**

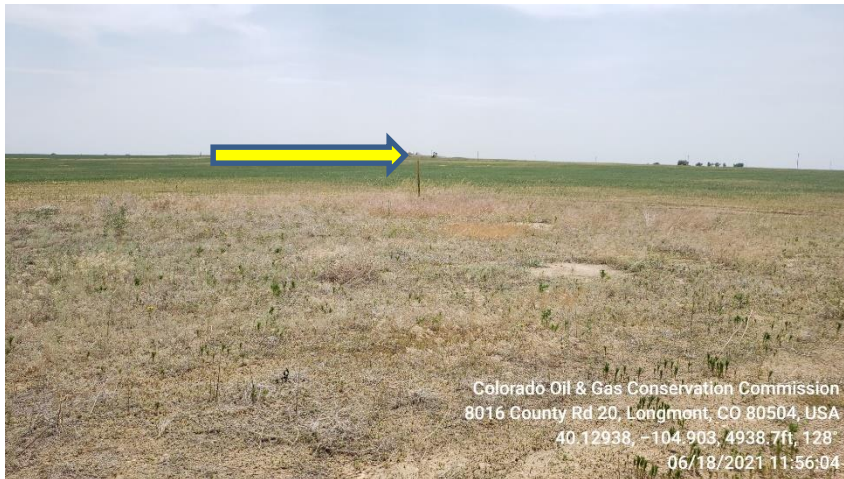
**Photo 5 weeds growing around location ROW & Deadman anchors.**

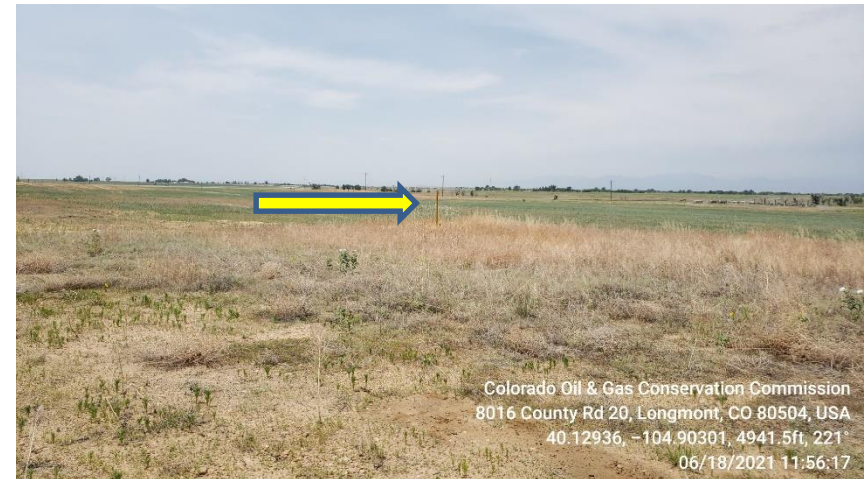
**Photo 6 weeds growing around location ROW & Deadman anchors.**

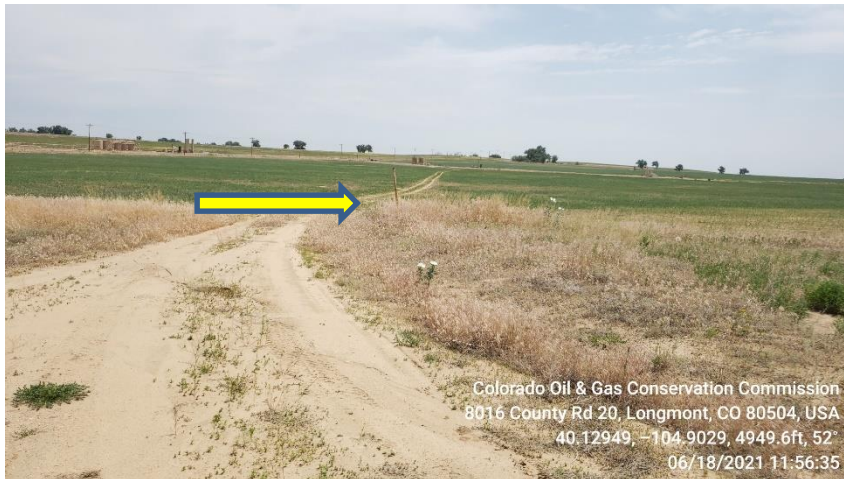
**Photo 7 weeds growing around location ROW & Deadman anchors.**

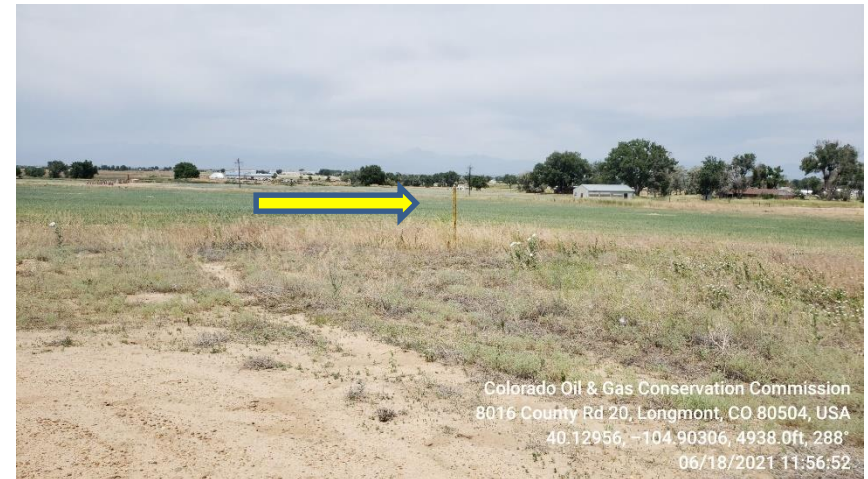
**Photo 8 weeds growing around location ROW & Deadman anchors.**

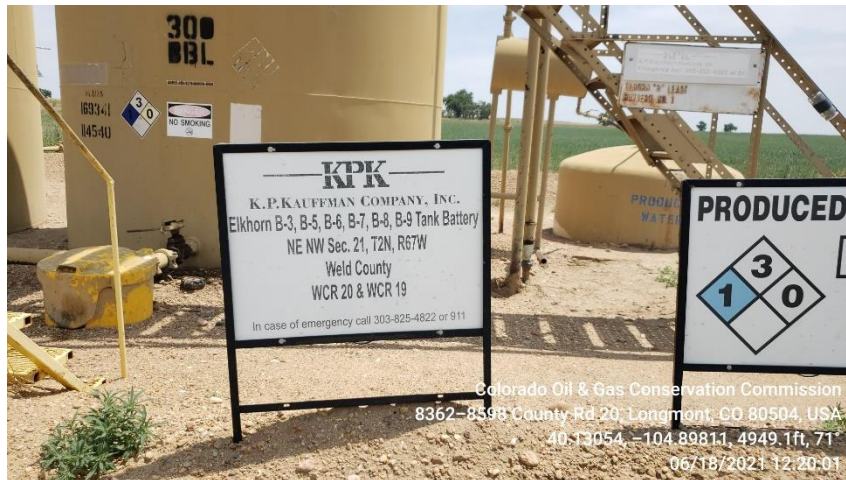
Photo 9 TB sign

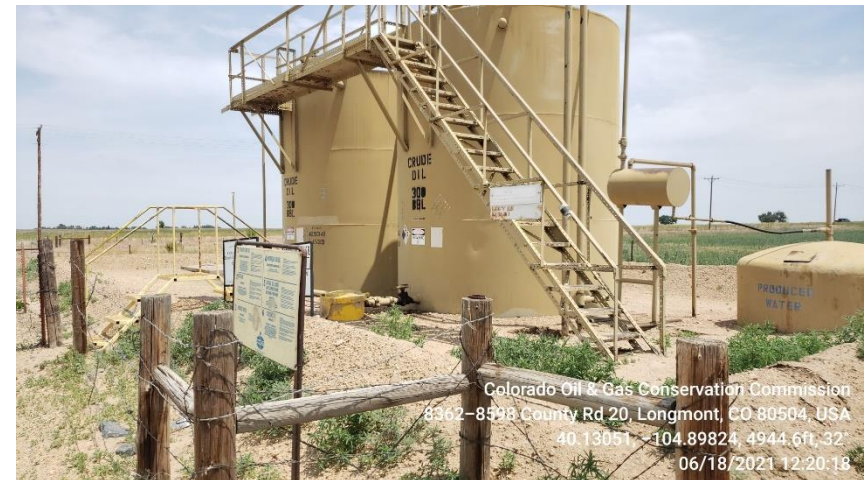
Photo 10 TB

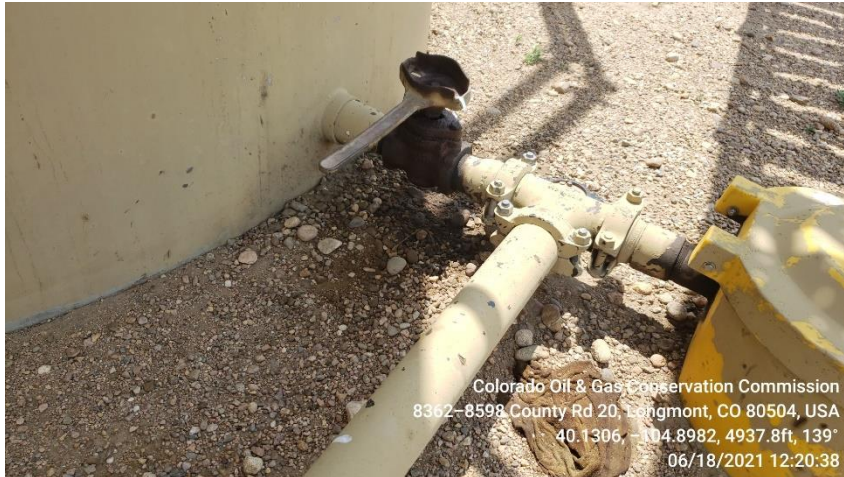
**Photo 11 stained soil by TB valve**

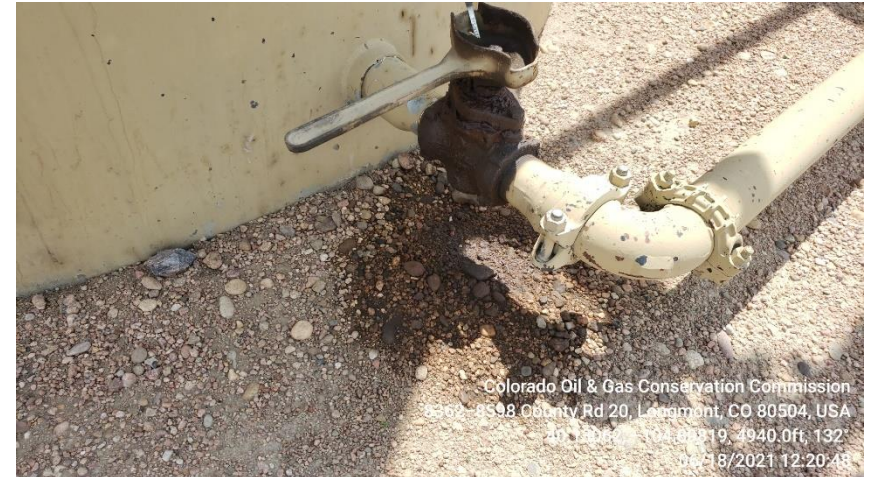
**Photo 12 stained soil by TB valve**

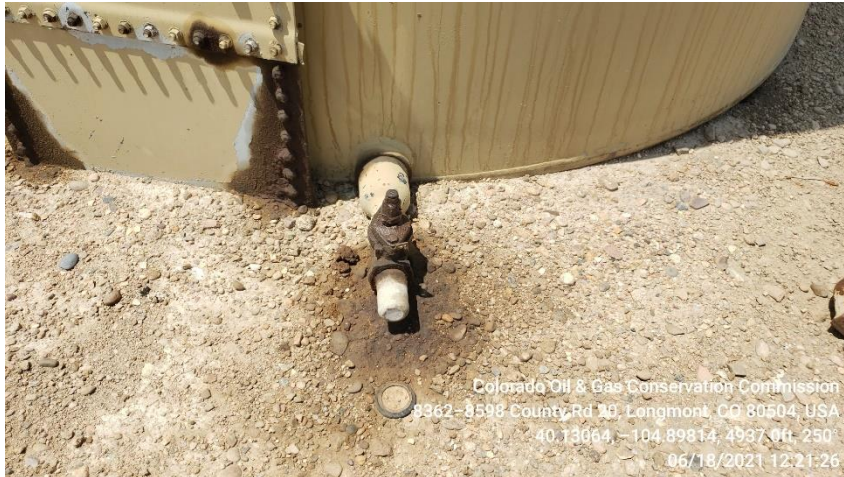
**Photo 13 stained soil by TB valve**

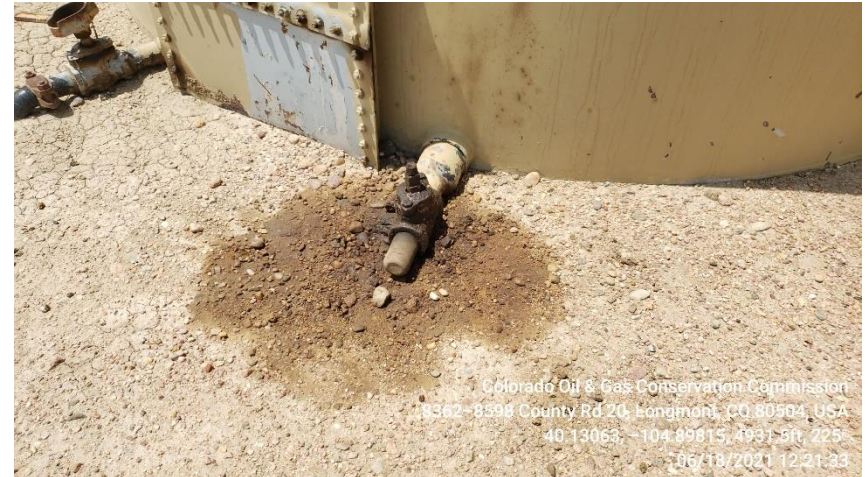
**Photo 14 stained soil by TB valve**

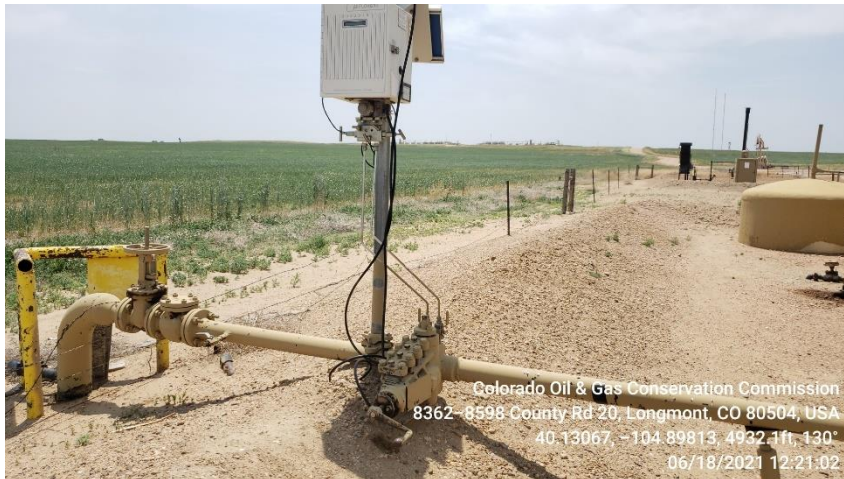
**Photo 15 Gas Meter Run**

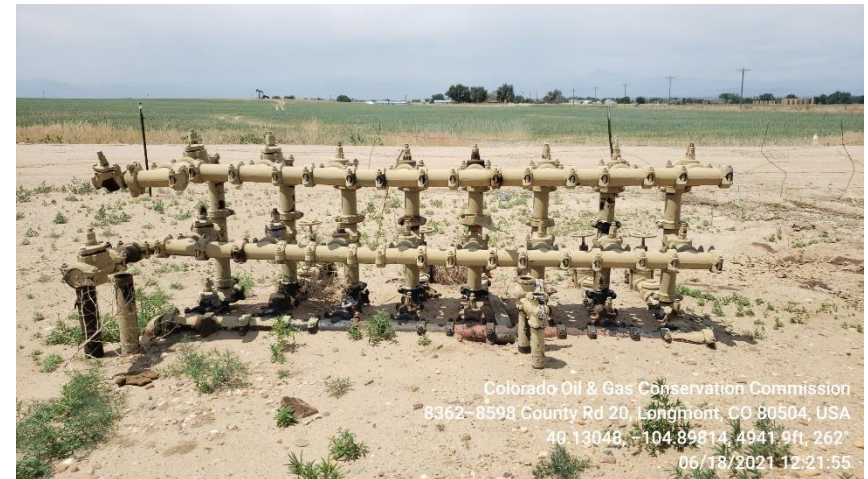
**Photo 16 Flow line manifold**

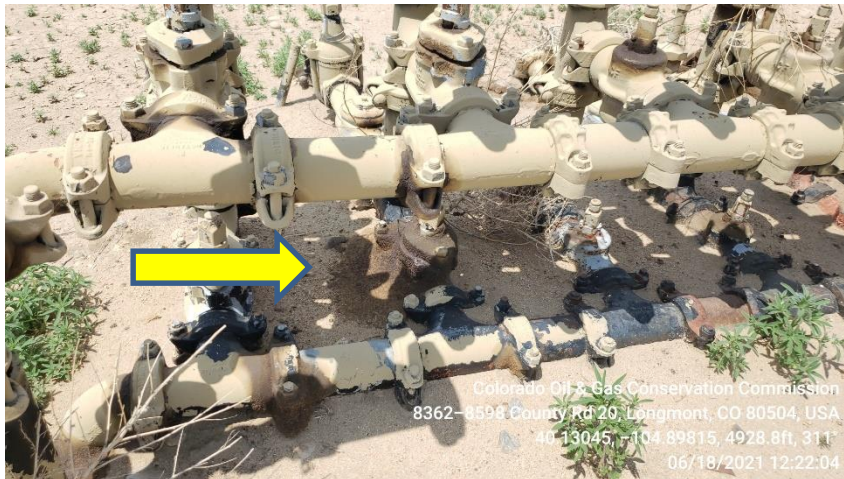
**Photo 17 Stained soil by flow line manifold**

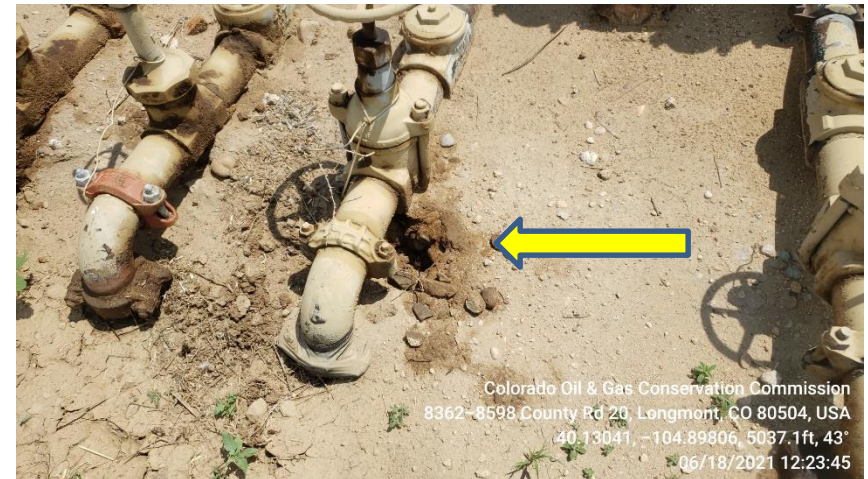
**Photo 18 Stained soil by flow line manifold**

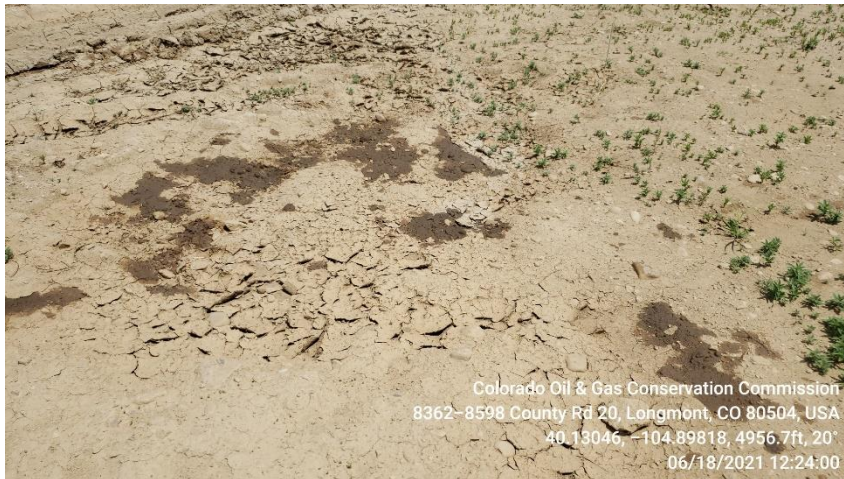
**Photo 17 Stained soil by flow line manifold**

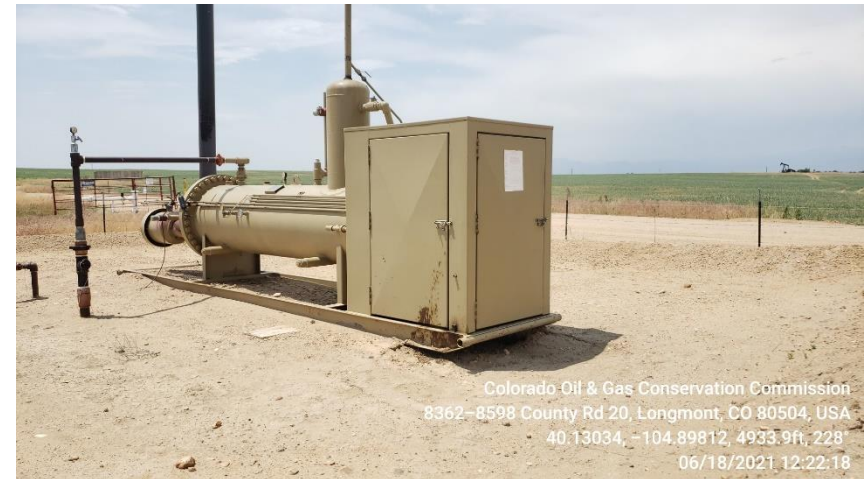
**Photo 18 Horizontal Heated Separator**

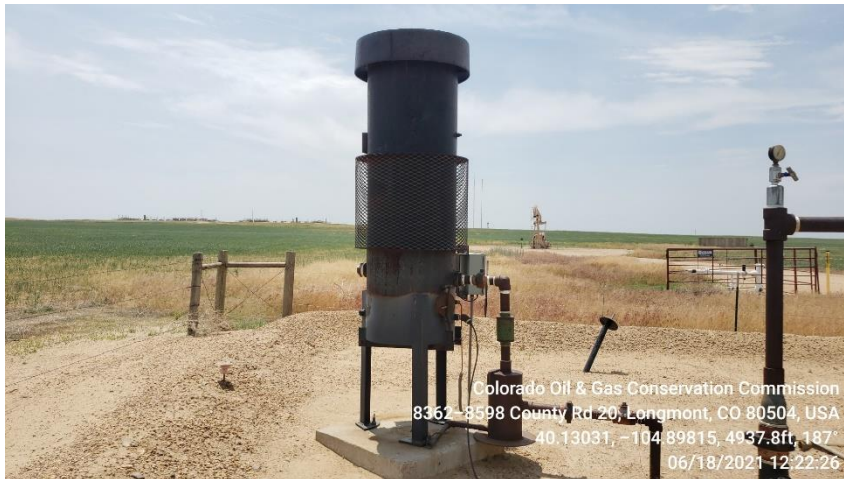
**Photo 19 ECD**
