XTO
T14X-13G
Location # 316259

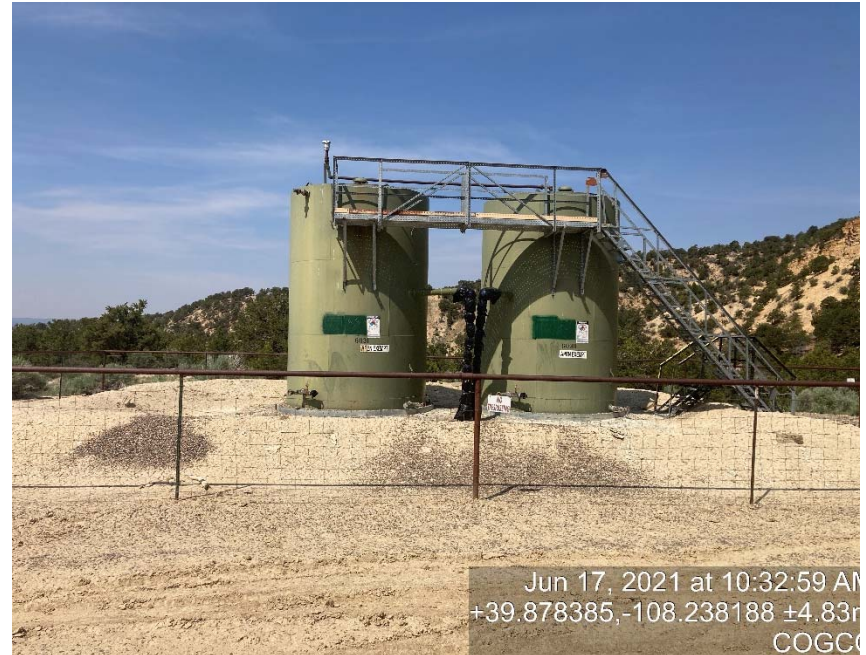
location/lack of battery signage

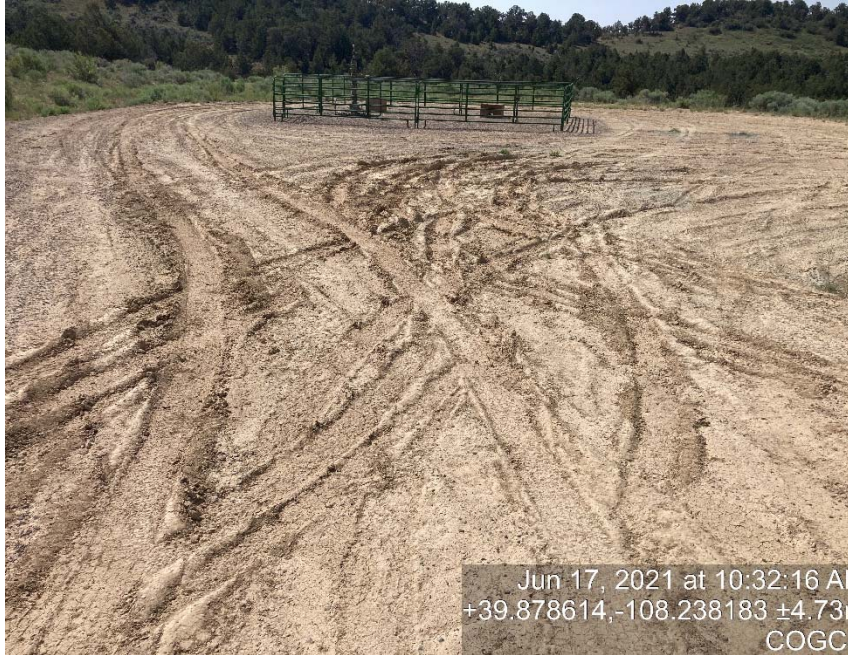
Lack of stabilization/compacted

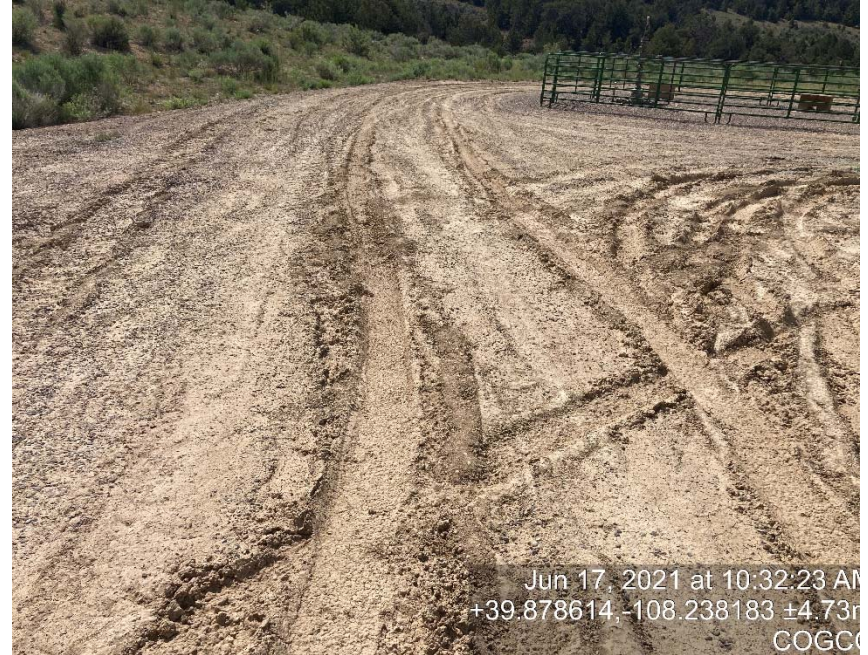
Lack of stabilization/compacted

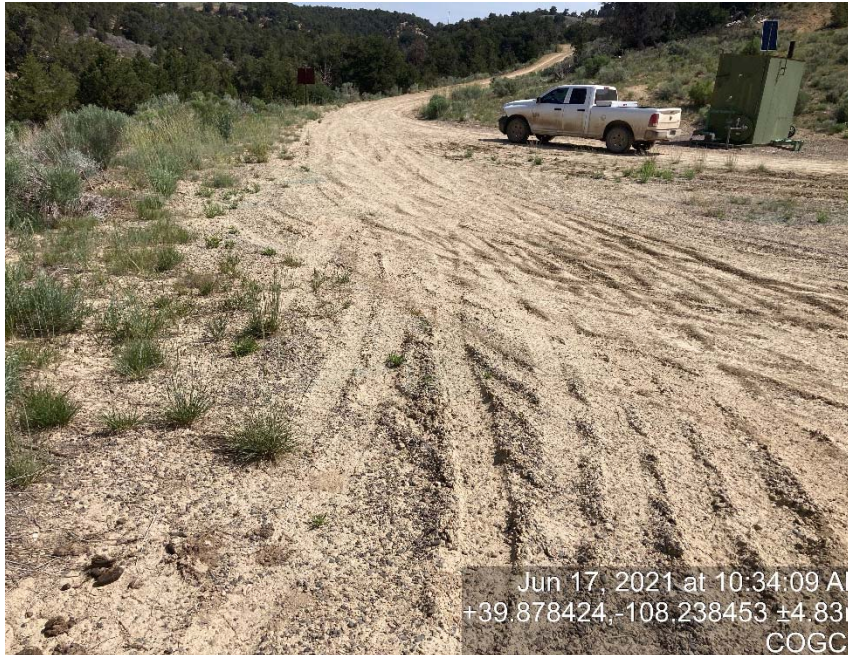
Lack of stabilization/compacted

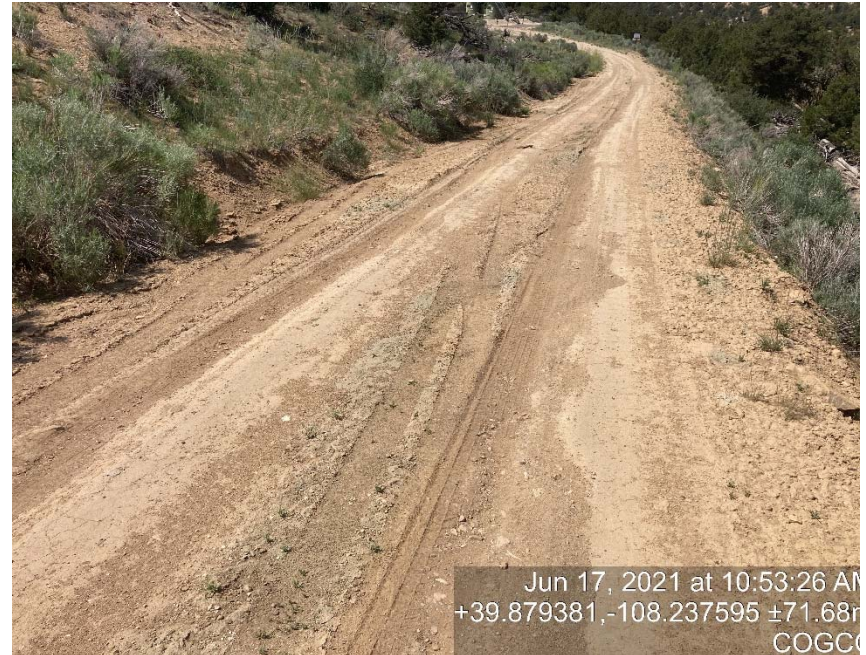
Erosion is occurring on access road and not stabilized/compacted

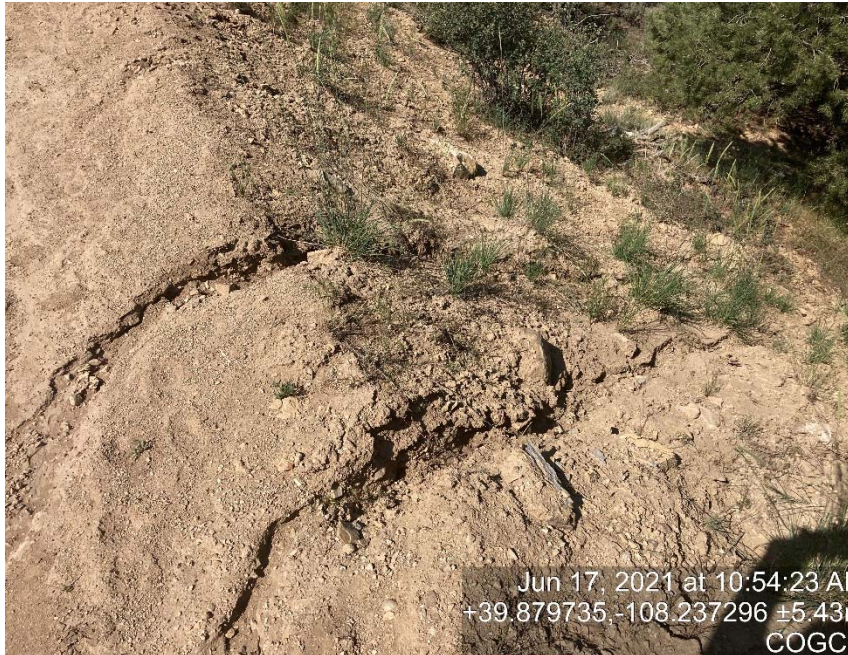
Erosion is occurring on access road

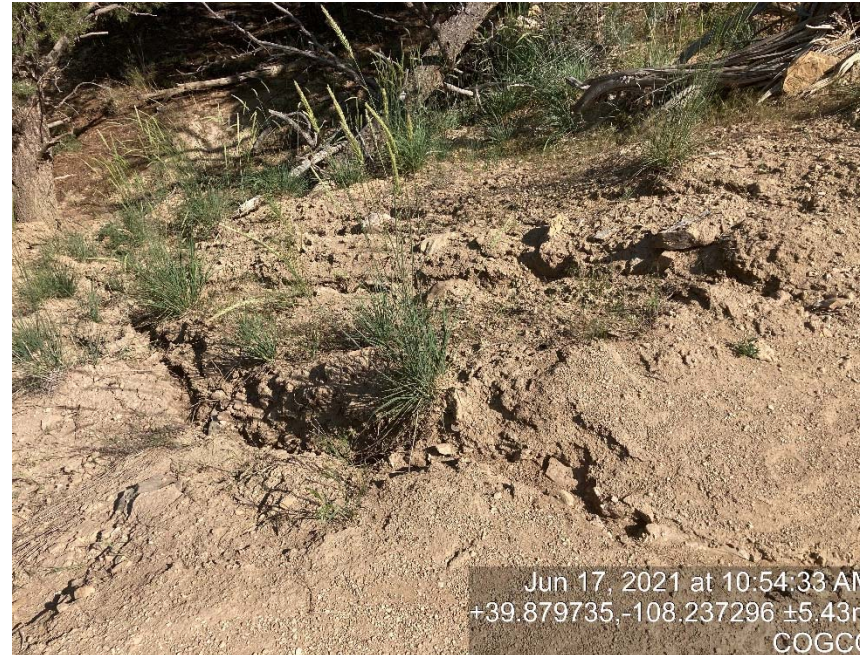
Erosion is occurring on access road
