# Inspection Photos

API: 009-06081

Operator: DOVER ATWOOD CORPORATION

Inspection Date: 6/21/2021

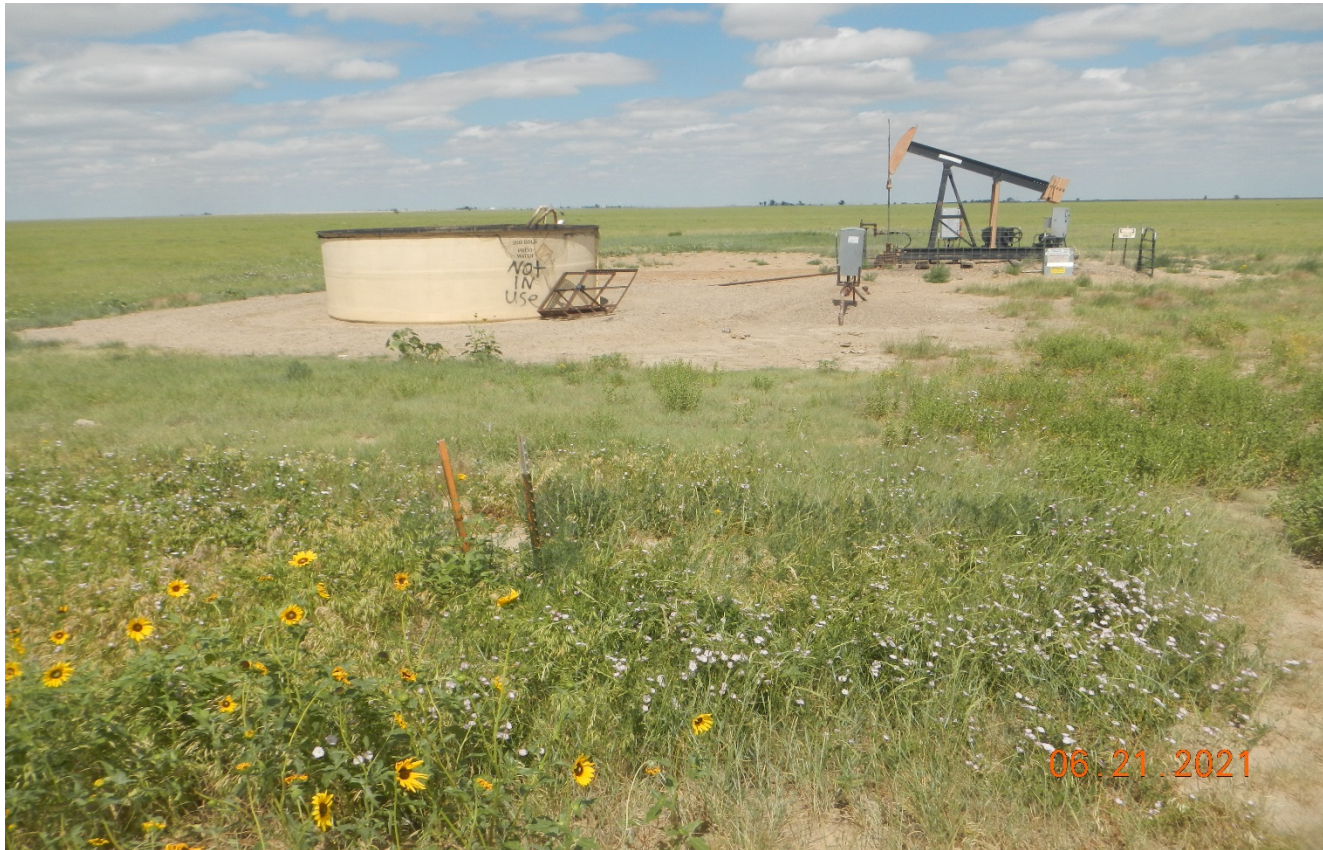
**Photo 1.** Facing east toward the location..

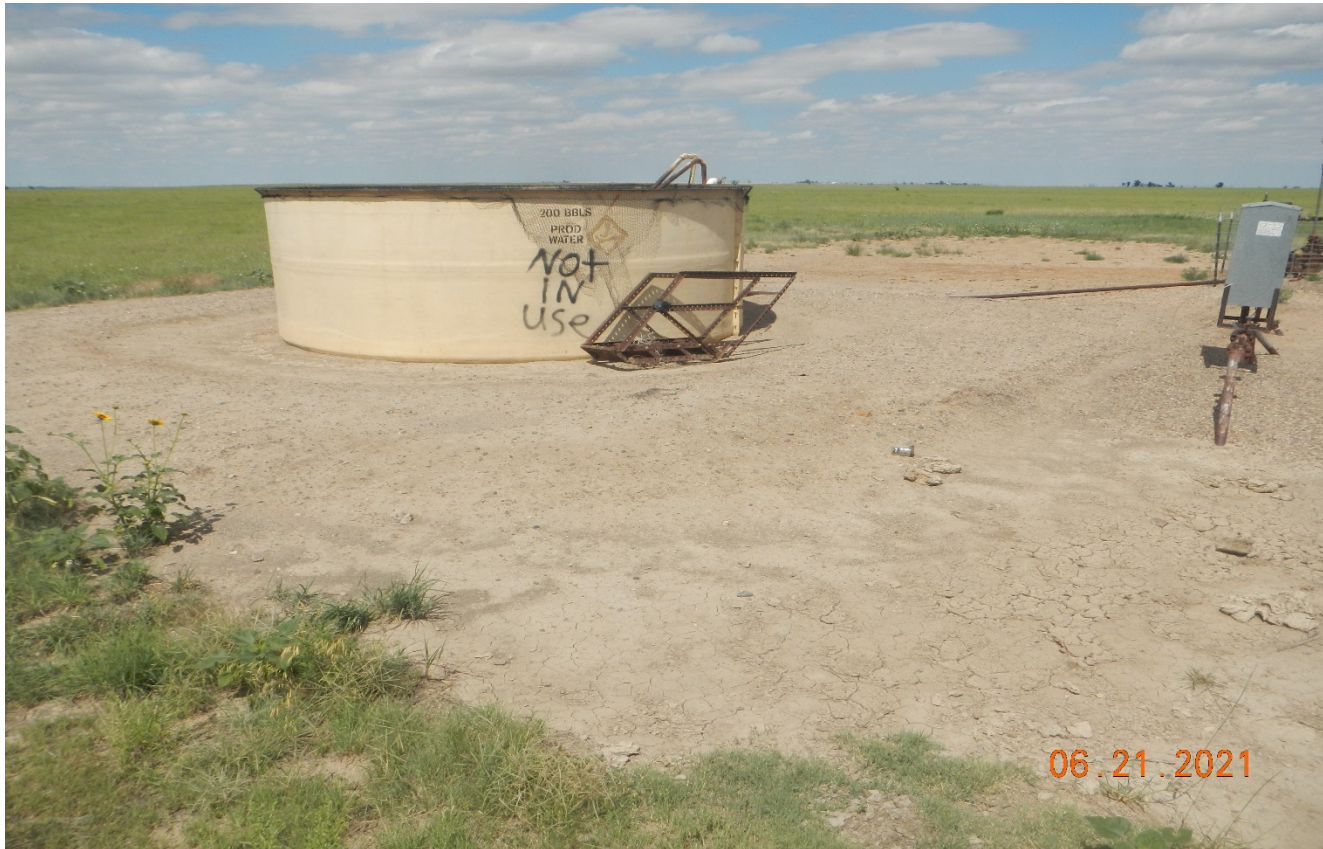
**Photo 2.** The tank is marked as not in use and labeled Produced Water. Next photo shows oily fluids inside the tank which apparently the tank is in use. Secondary containment is inadequate to contain 150% of the volume of the tank.

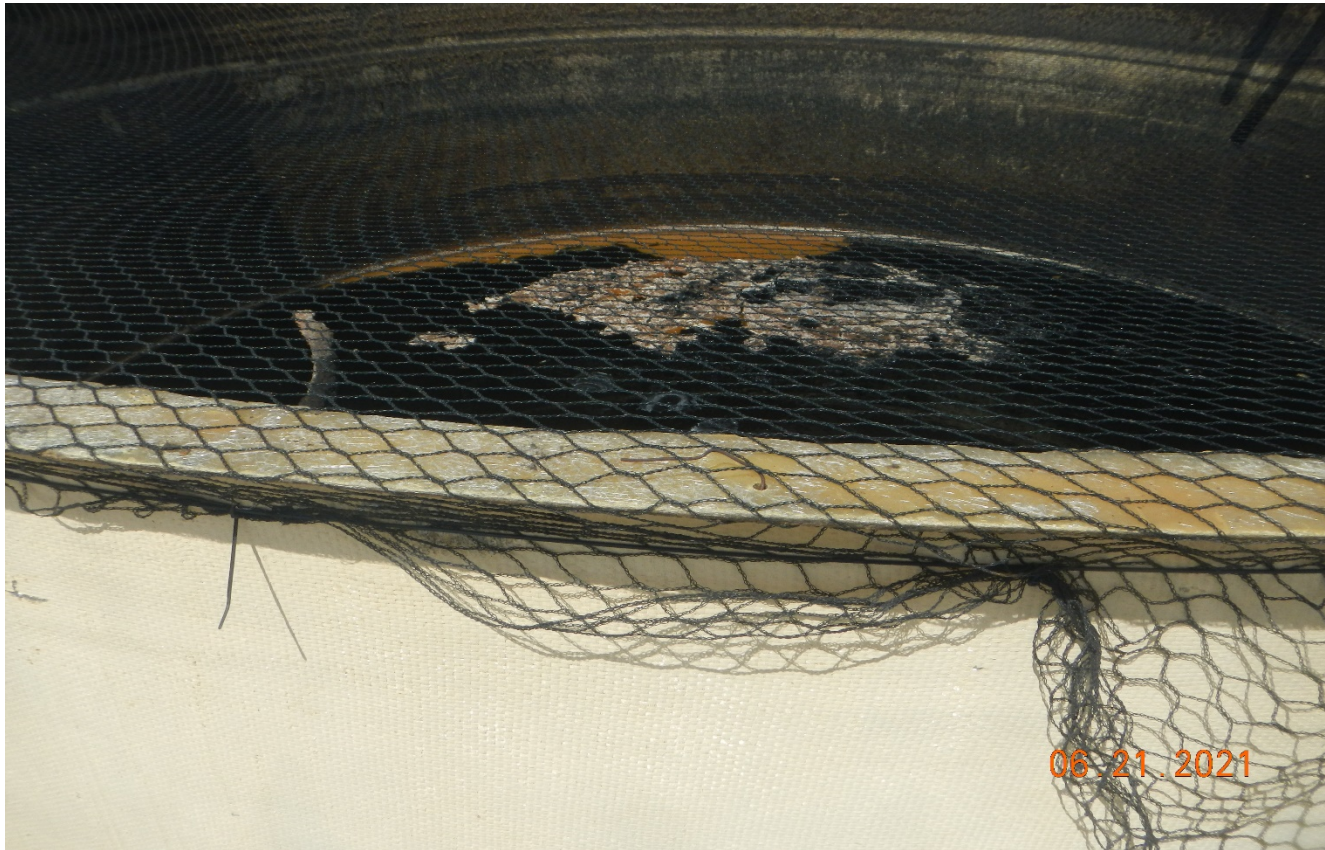
**Photo 3.** View of oil fluids inside the tank. Tank is labeled Produced Water which is not accurately labeled.

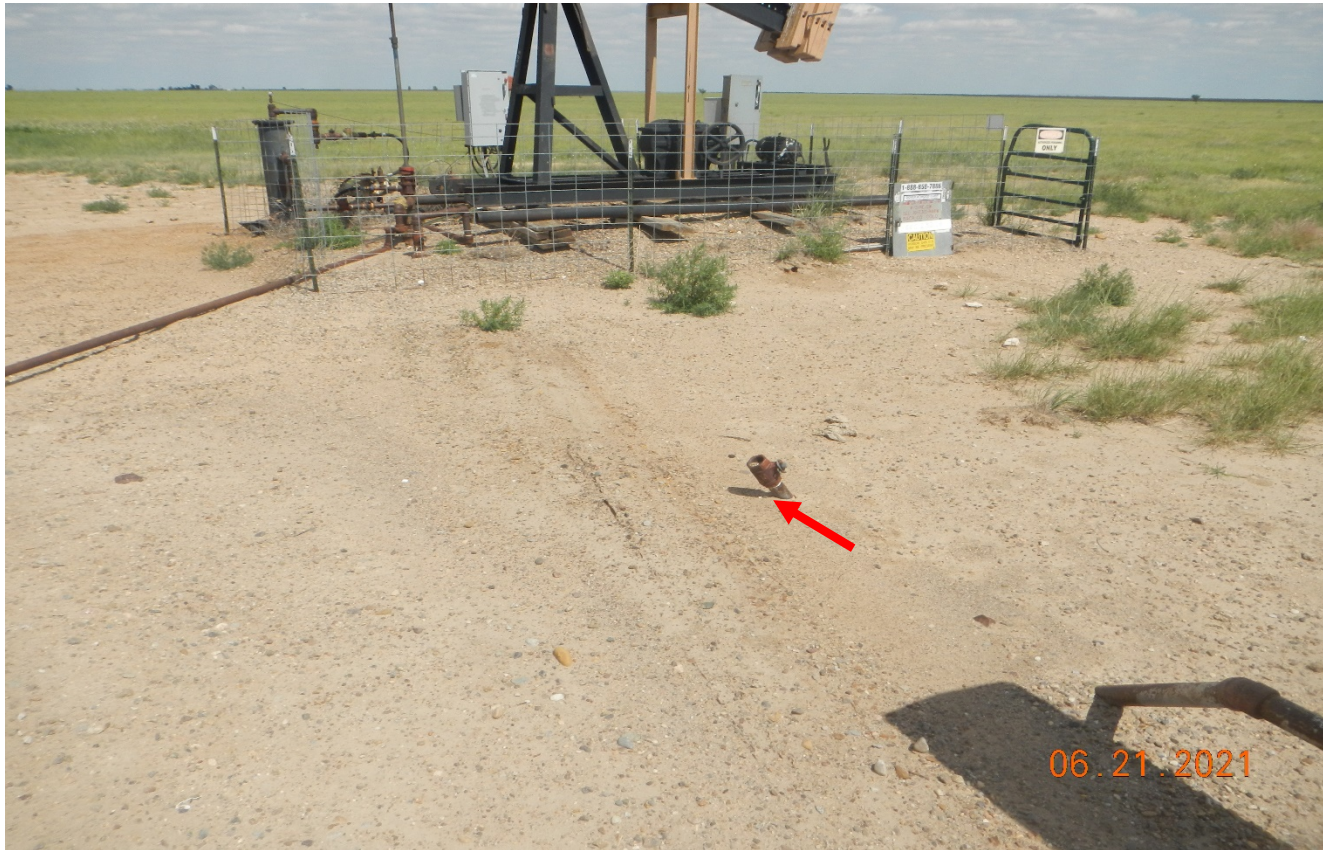
**Photo 4.** There is a pipe riser shown at red arrow with no LOTO.

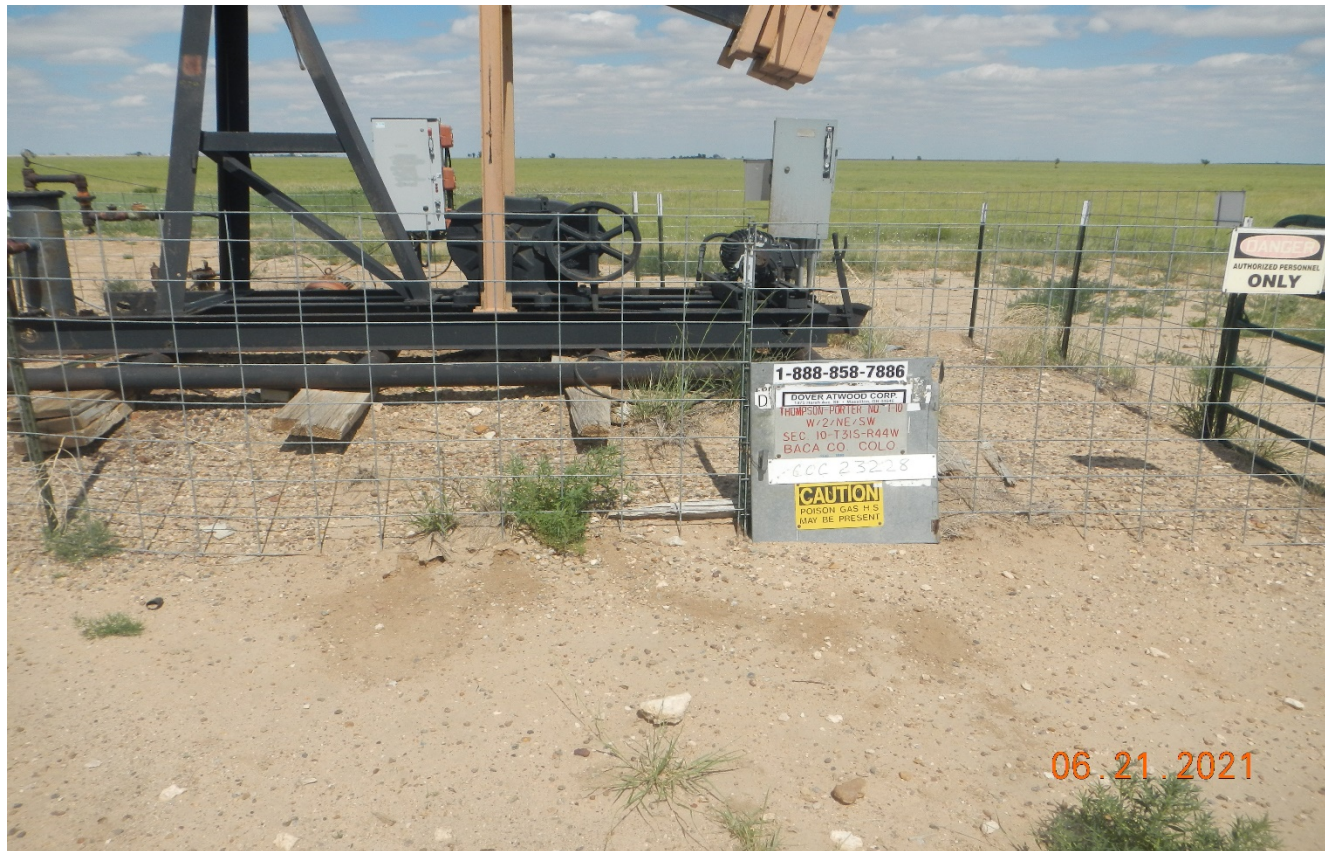
**Photo 5.** The well sign does not comply with 605. Incorrect Operator Emergency number and missing information. Name and lettering was updated.
