Inspection Photos

API# 009-06189

Operator: DOVER ATWOOD CORPORATION

Inspection Date: 6/21/2021

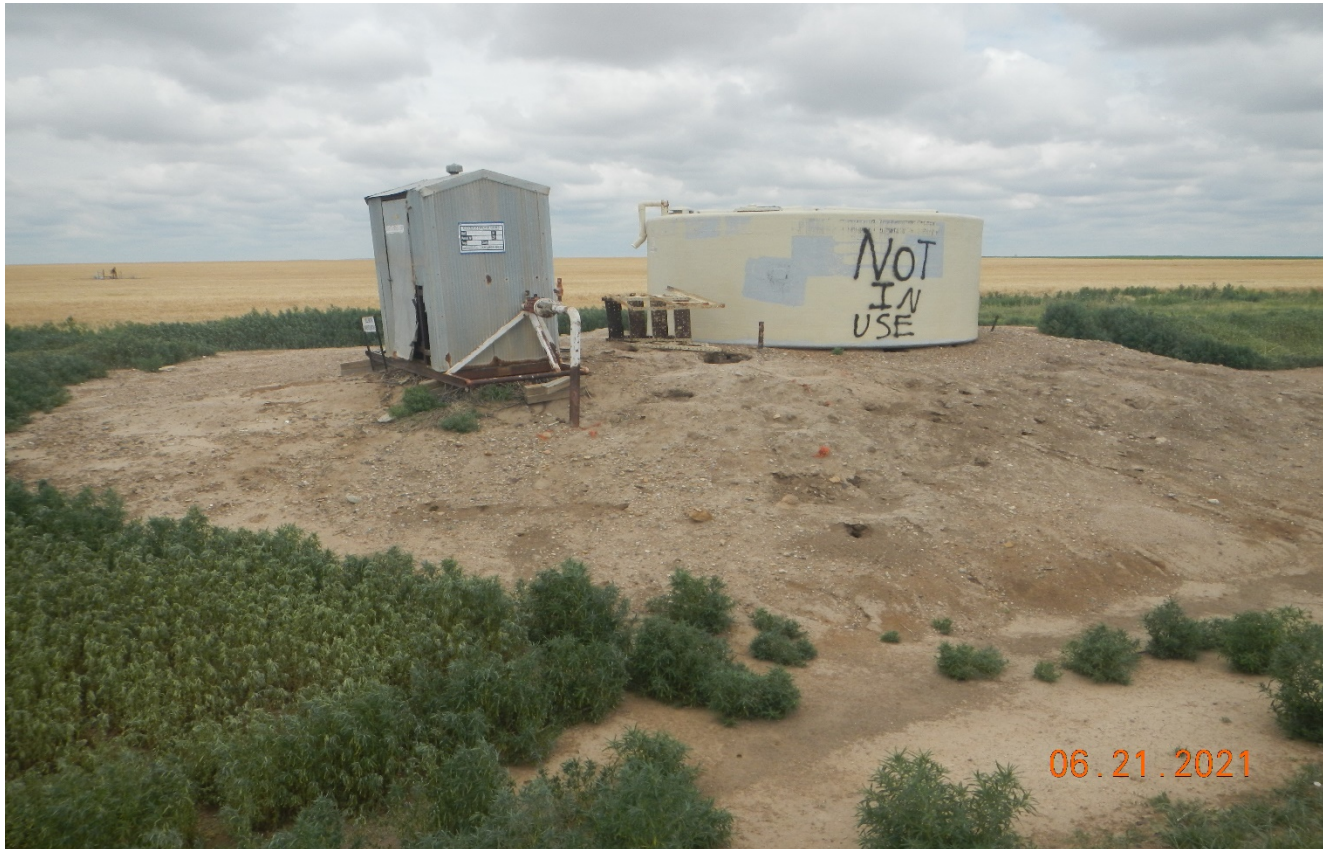
Photo 1. Facing west toward the PW tank and meter shed located adjacent to CR-49 and 575' east of the well. No operator sign is visible from the county road but a sign was observed on backside of tank. Meter shed still appears to be unstable and there is no berm around the tank. Corrective actions were not completed.

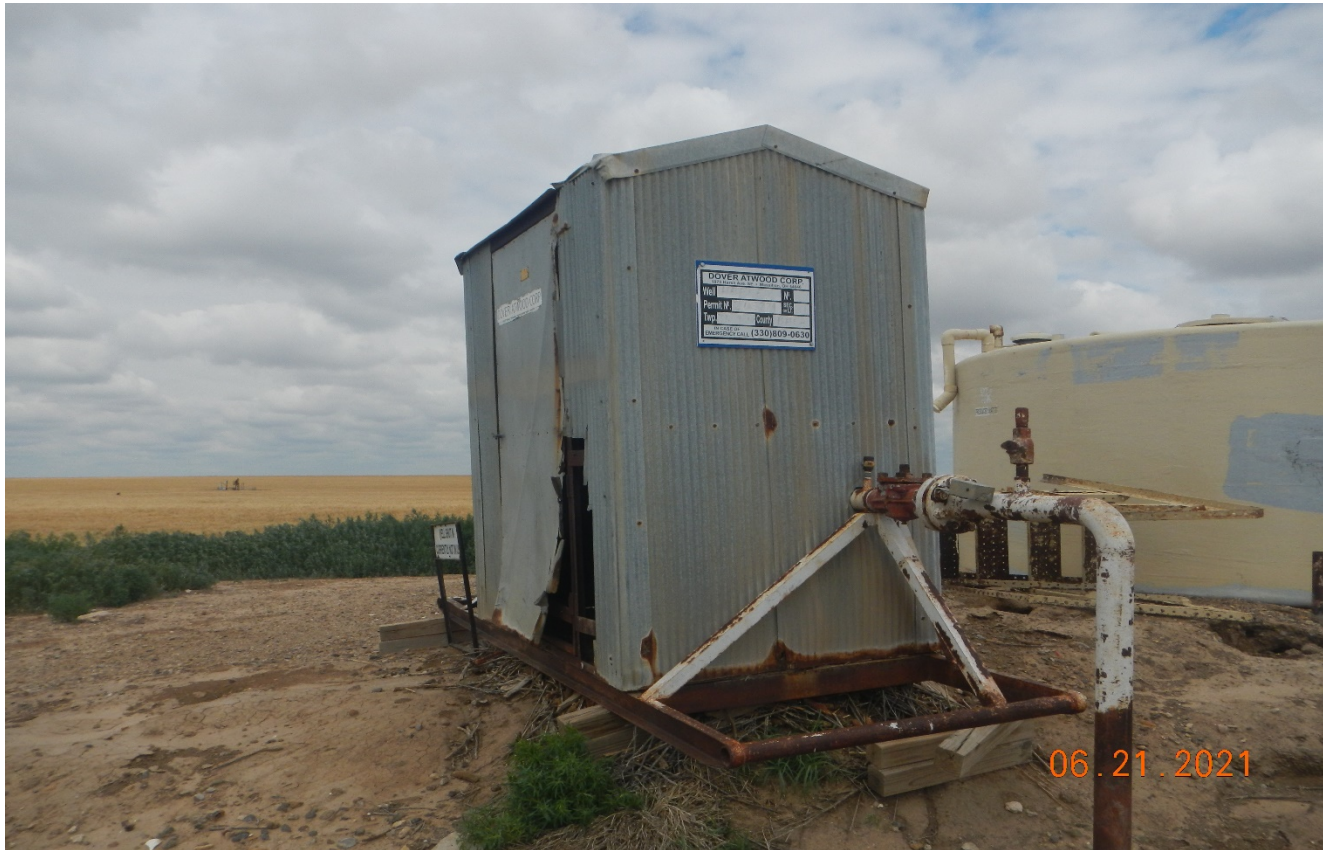
Photo 2. Sign is posted on the meter shed but is faded and not legible.

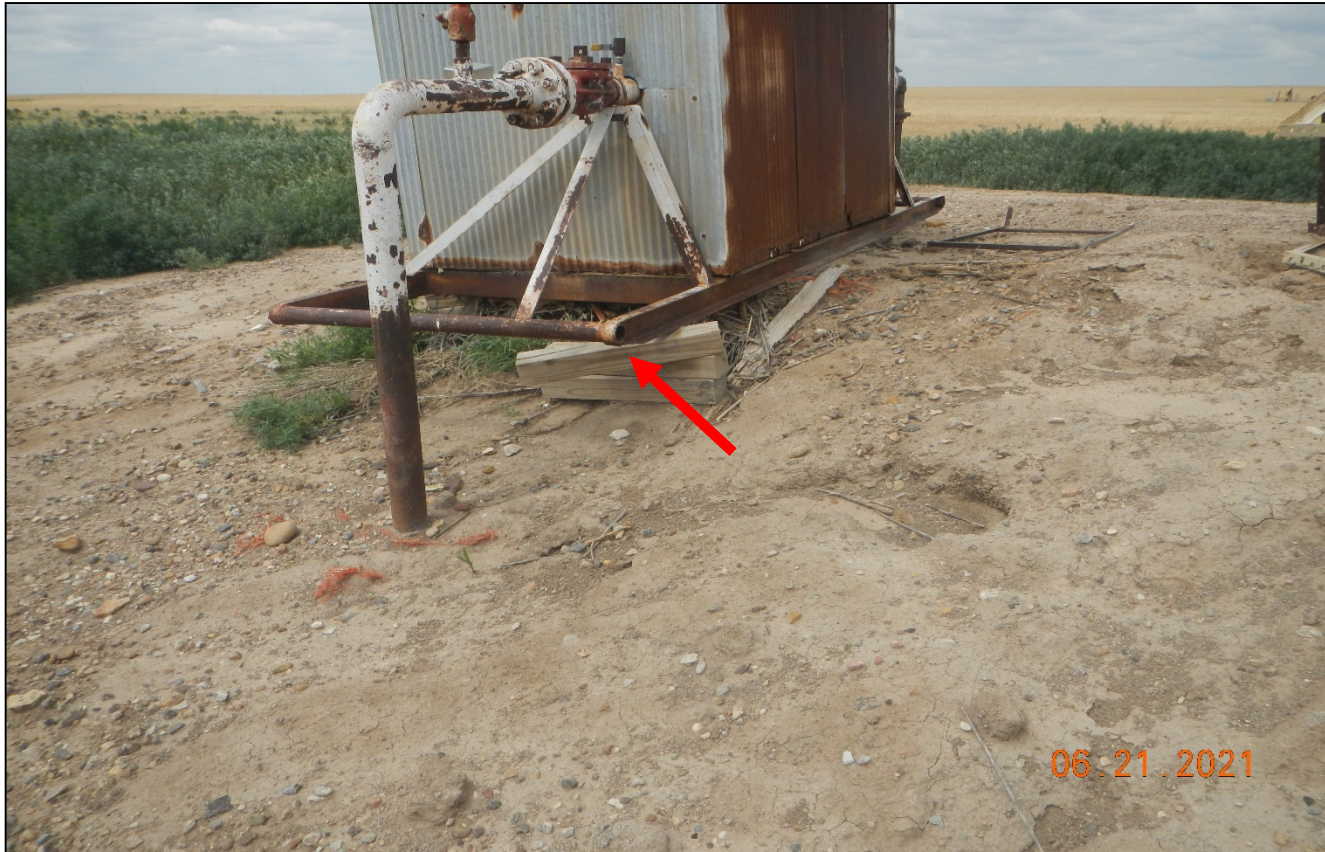
Photo 3. The meter shed is not maintained and remains unstable. Erosion has occurred underneath the meter shed which is a safety concern. Wood blocks are ready to fall over shown at red arrow.

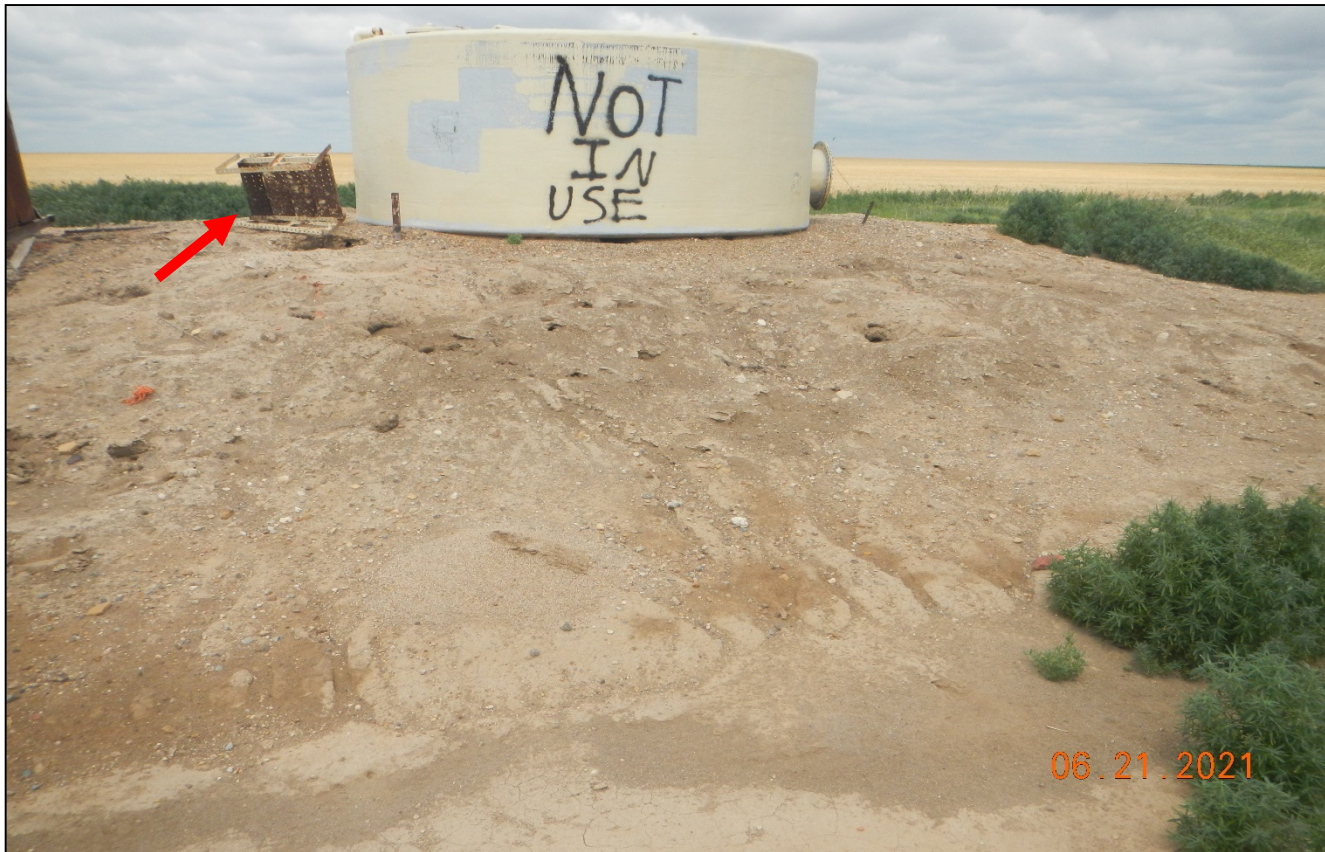
Photo 4. Corrective actions of the previous inspection were not performed. There is no berm around the 200 bbls tank. There is unused equipment at the location (red arrow). There is erosion occurring around the tank area.

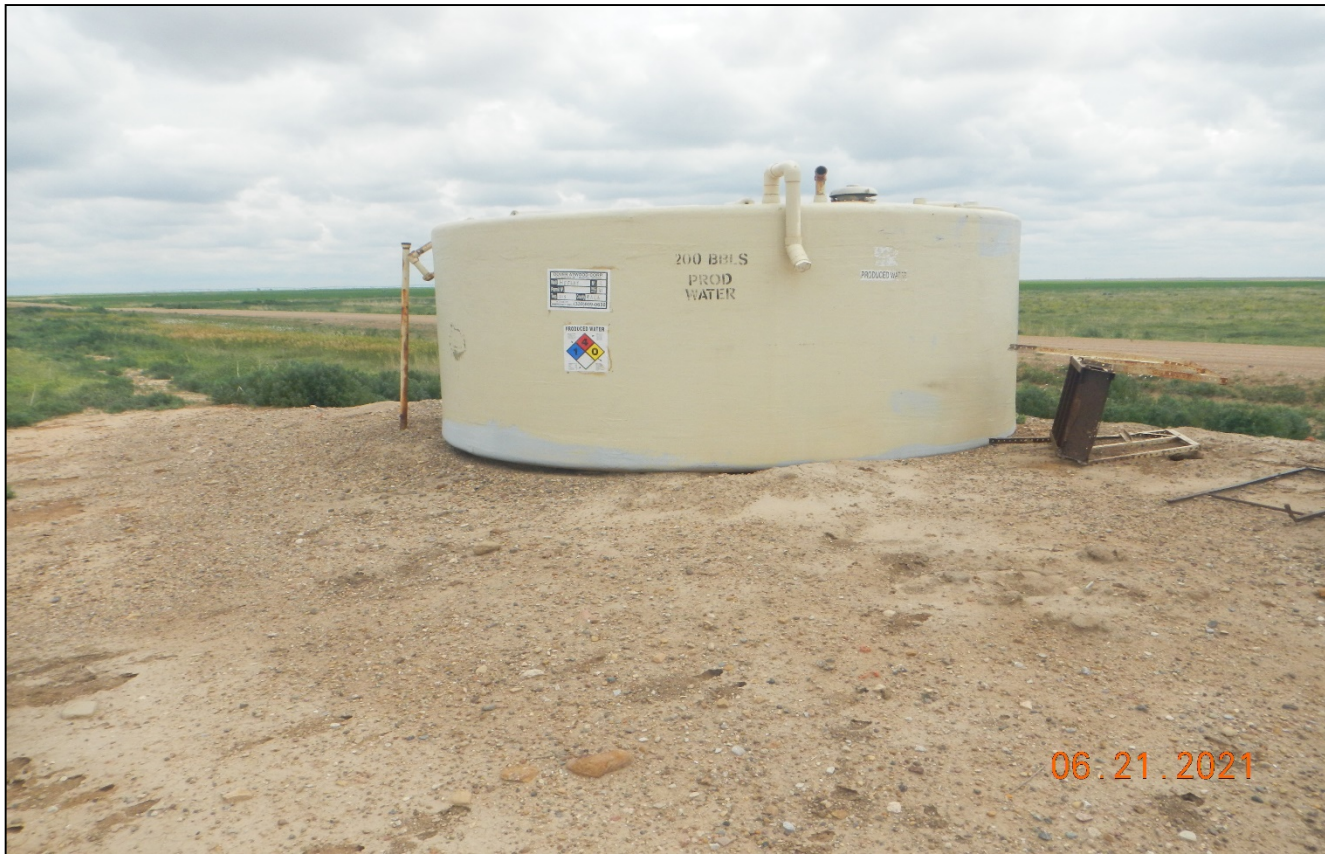
Photo 5. The tank sign and NFPA label are installed on backside of the tank which is not readily visible from the front side along the county road.

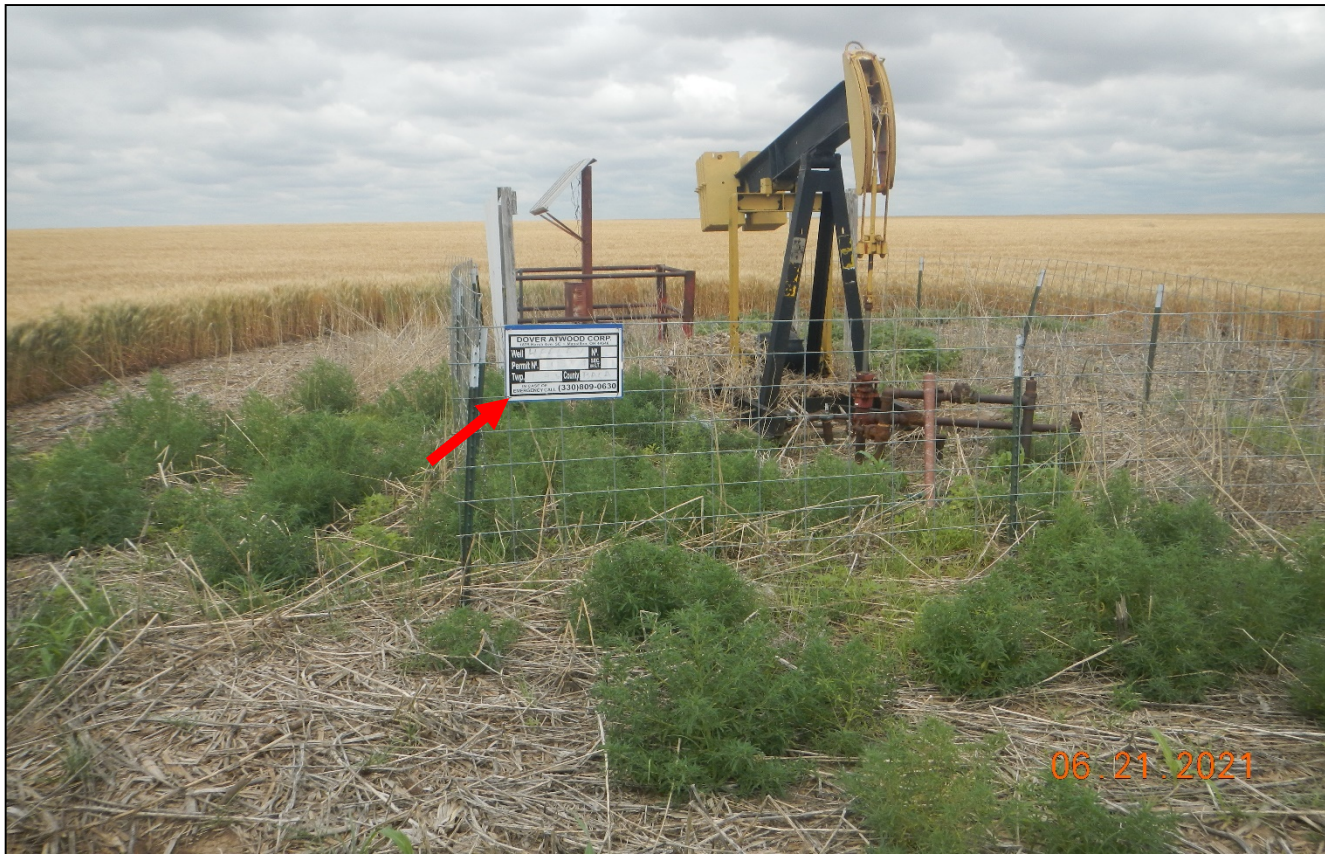
Photo 6. Facing east toward the well. A sign has been posted but is faded and not legible.

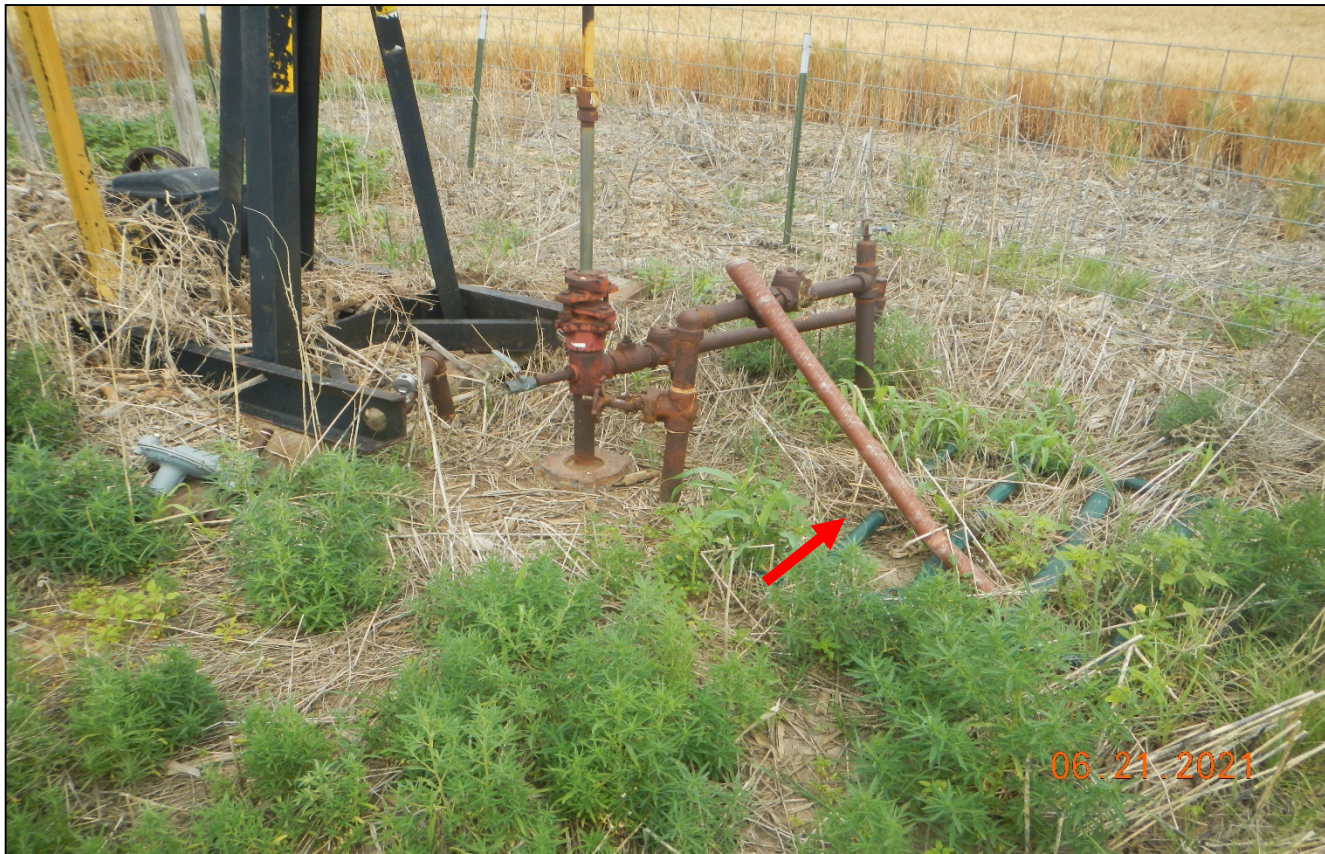
Photo 7. The gate is lying on the ground and the fence around the well is not maintained.

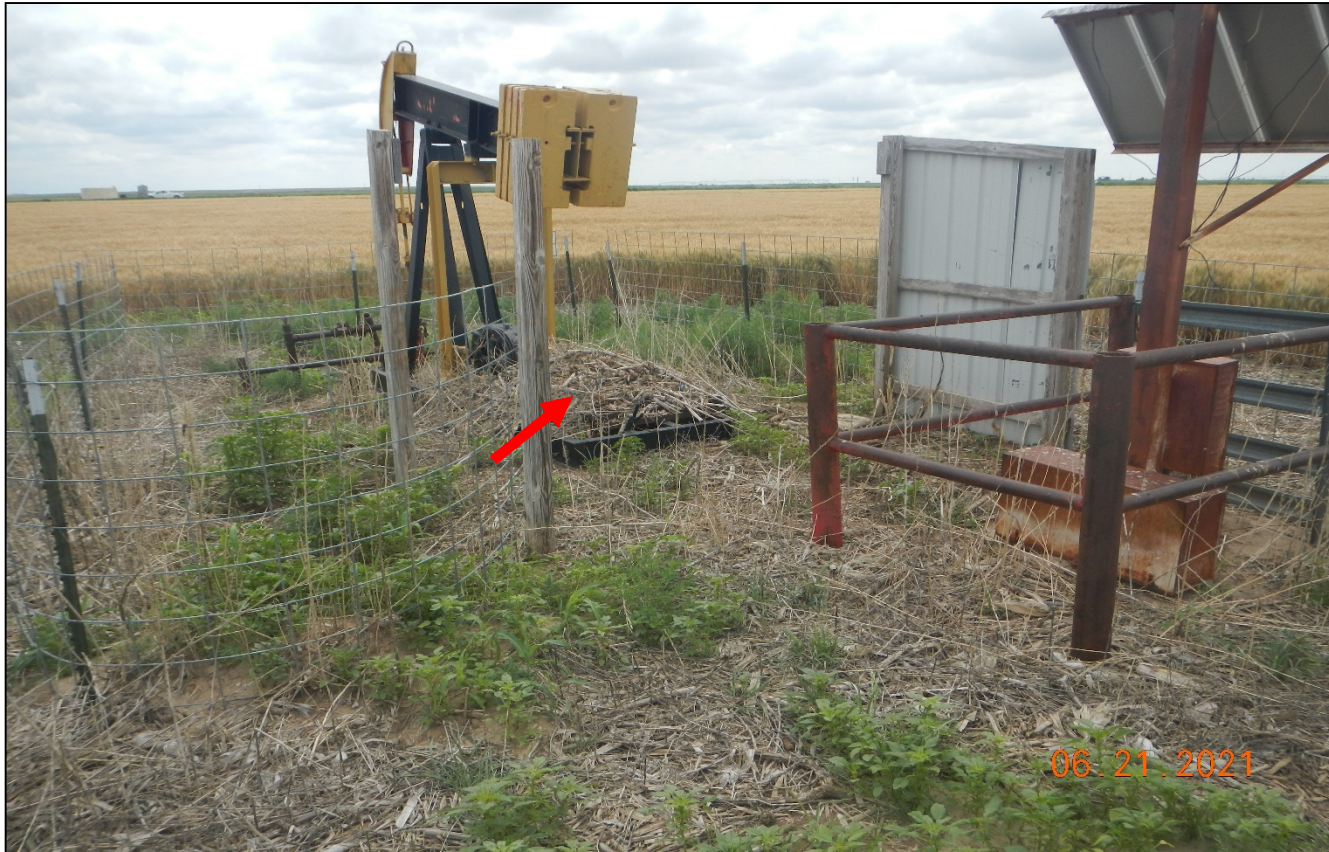
Photo 8. The metal panel debris has been removed but there is vegetative debris in the pumpjack which is a fire hazard.
