Inspection Photos

API: 009-06341

Operator: SCHREIDER & COMPANY

Inspection Date: 6/21/2021

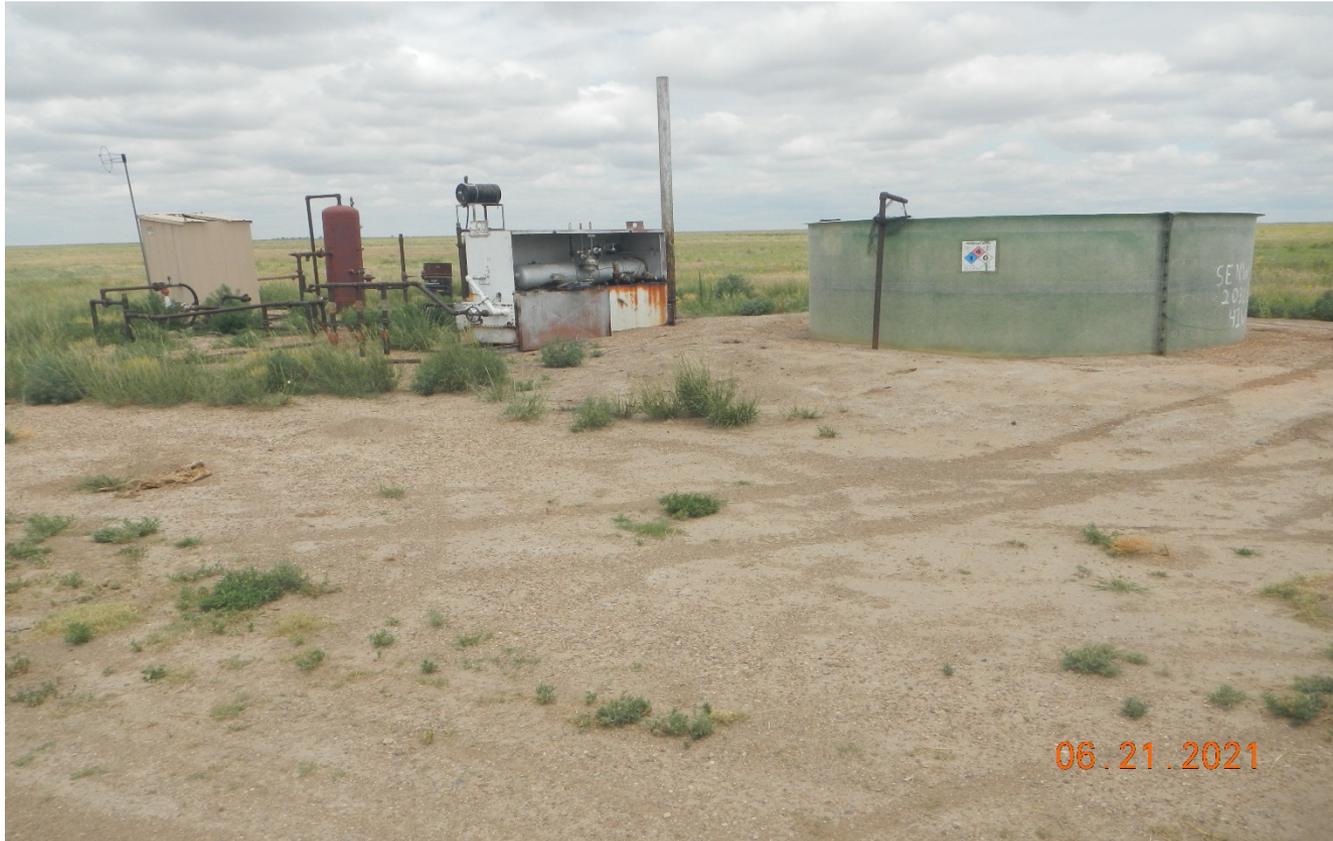
Photo 1. Facing toward the associated facility along CR 55.5 approximately 900' southeast of the Hume 1-20 abandoned well site. All equipment at the associated facility needs to be removed and disturbance reclaimed.

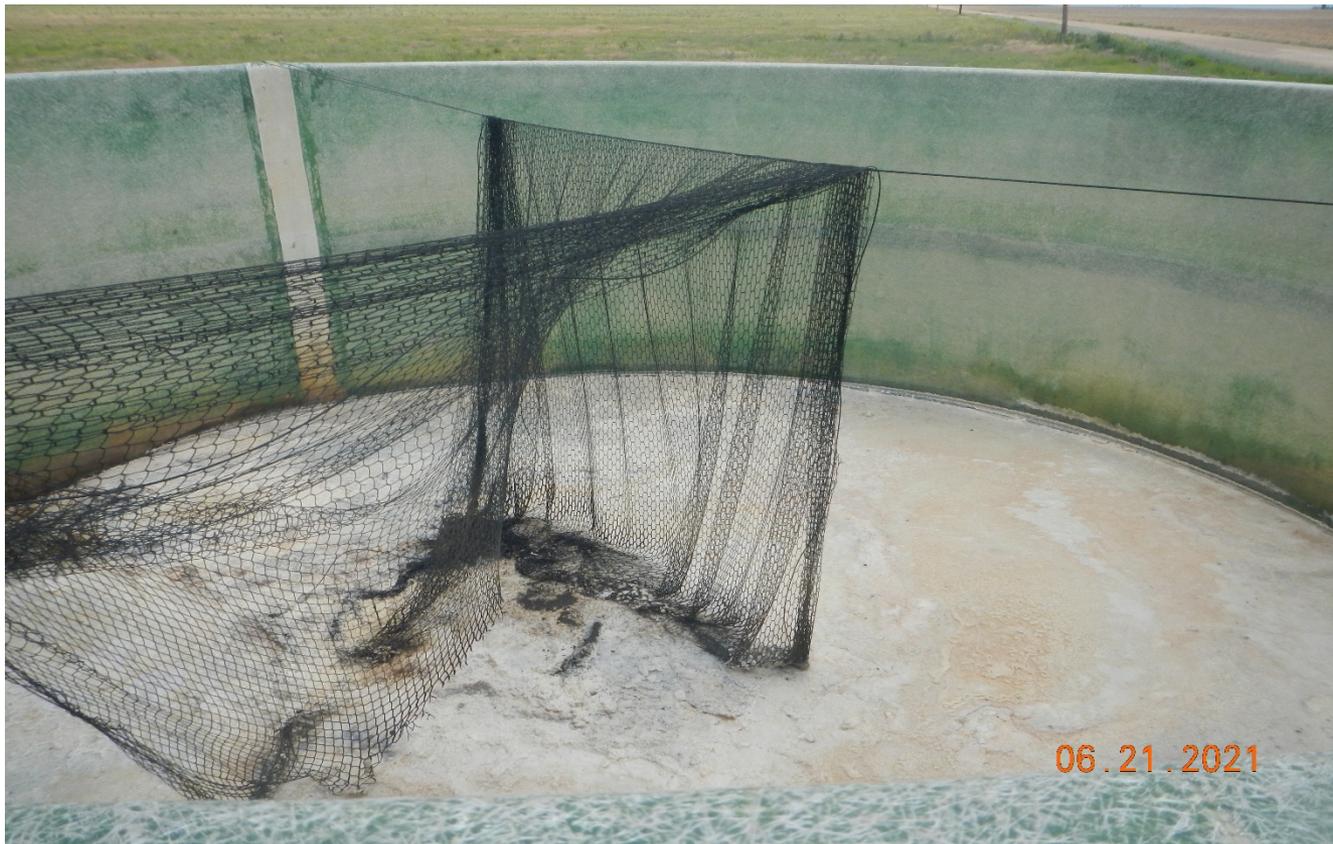
Photo 2. There is a solidified substance in the tank and the netting is not maintained.

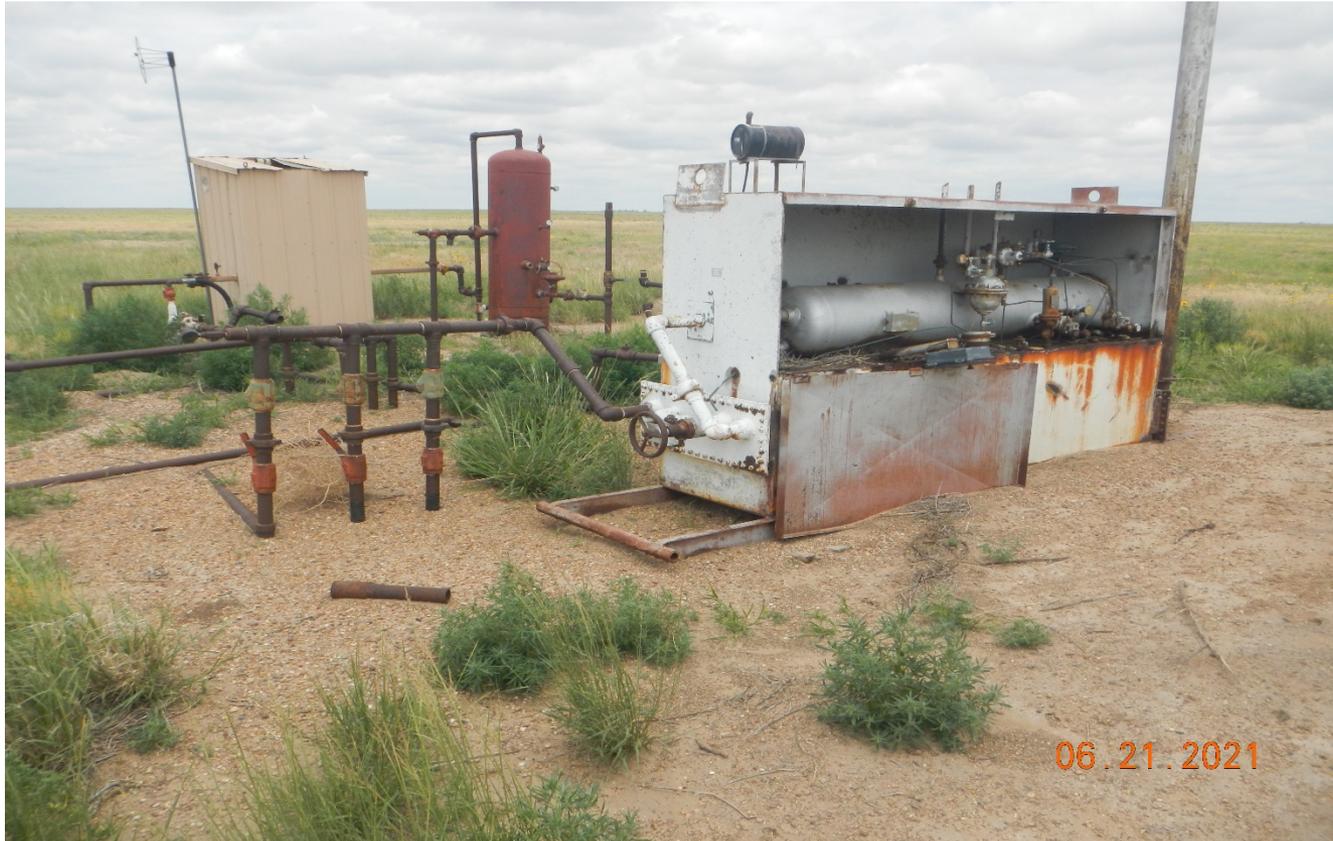
Photo 3. All equipment needs to be removed.

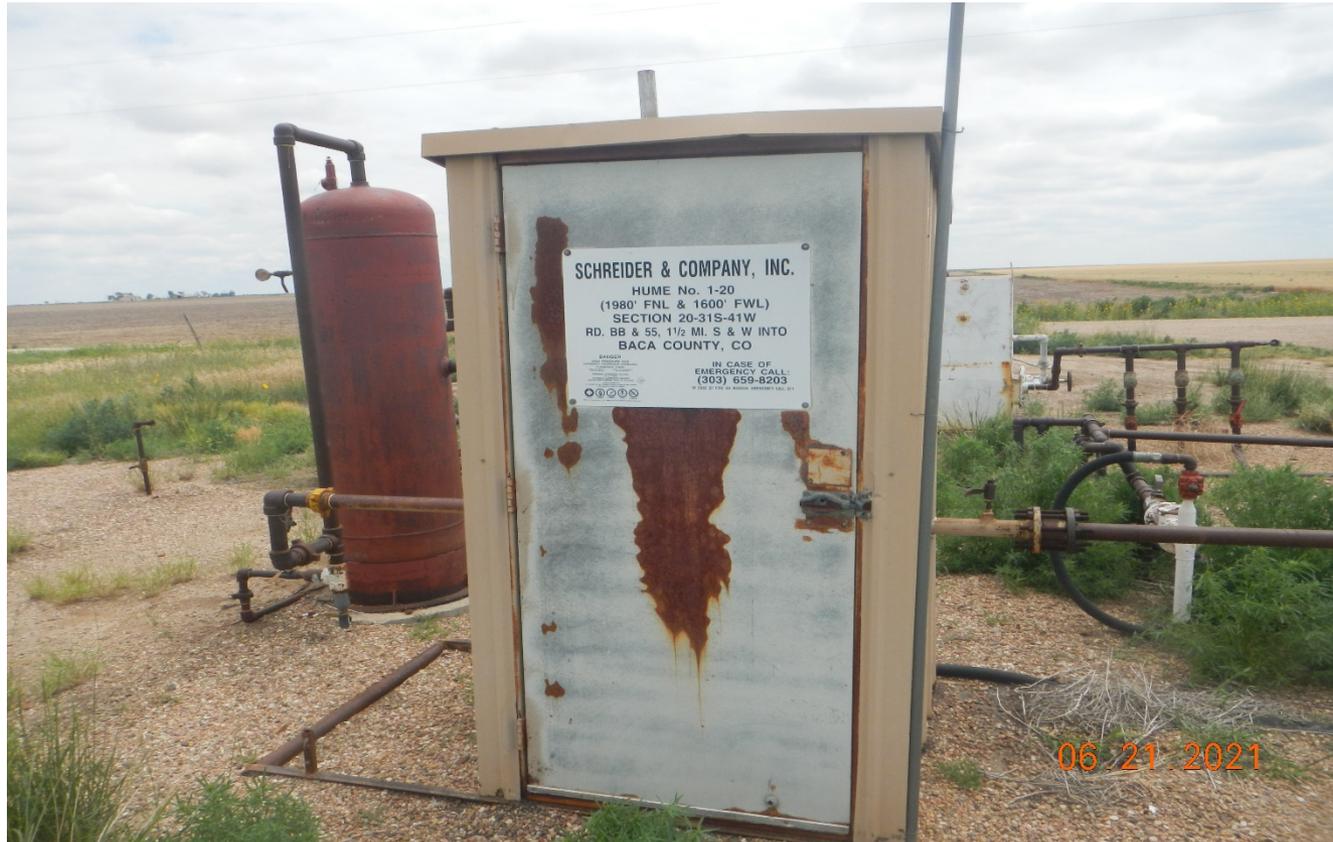
Photo 4. Sign posted at the facility is listed as the Hume 1-20 which the well was plugged and abandoned in 2005. All equipment should've been removed within 3 months of abandonment.

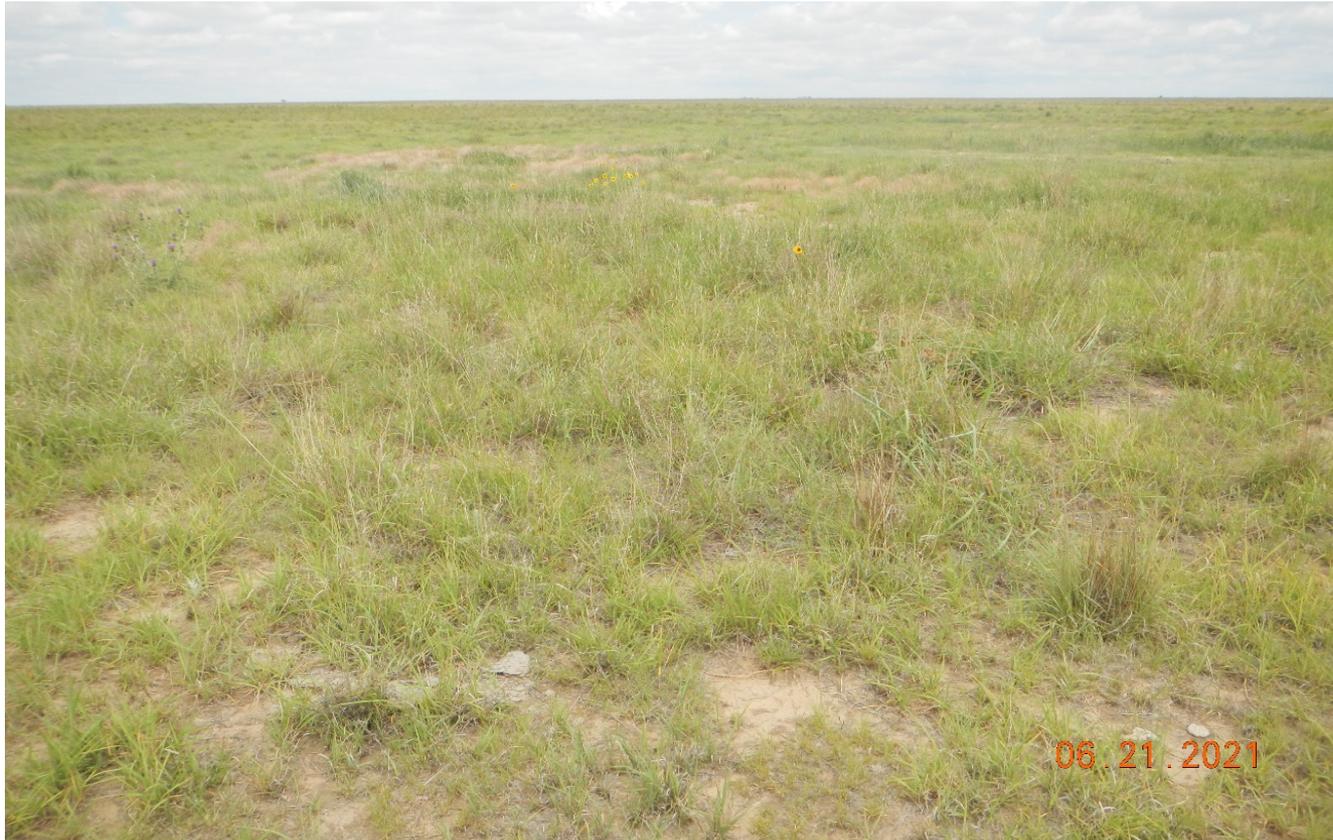
Photo 5. Facing north at the plugged and abandoned wellsite. All equipment has been removed at the well site and the vegetation has re-established.

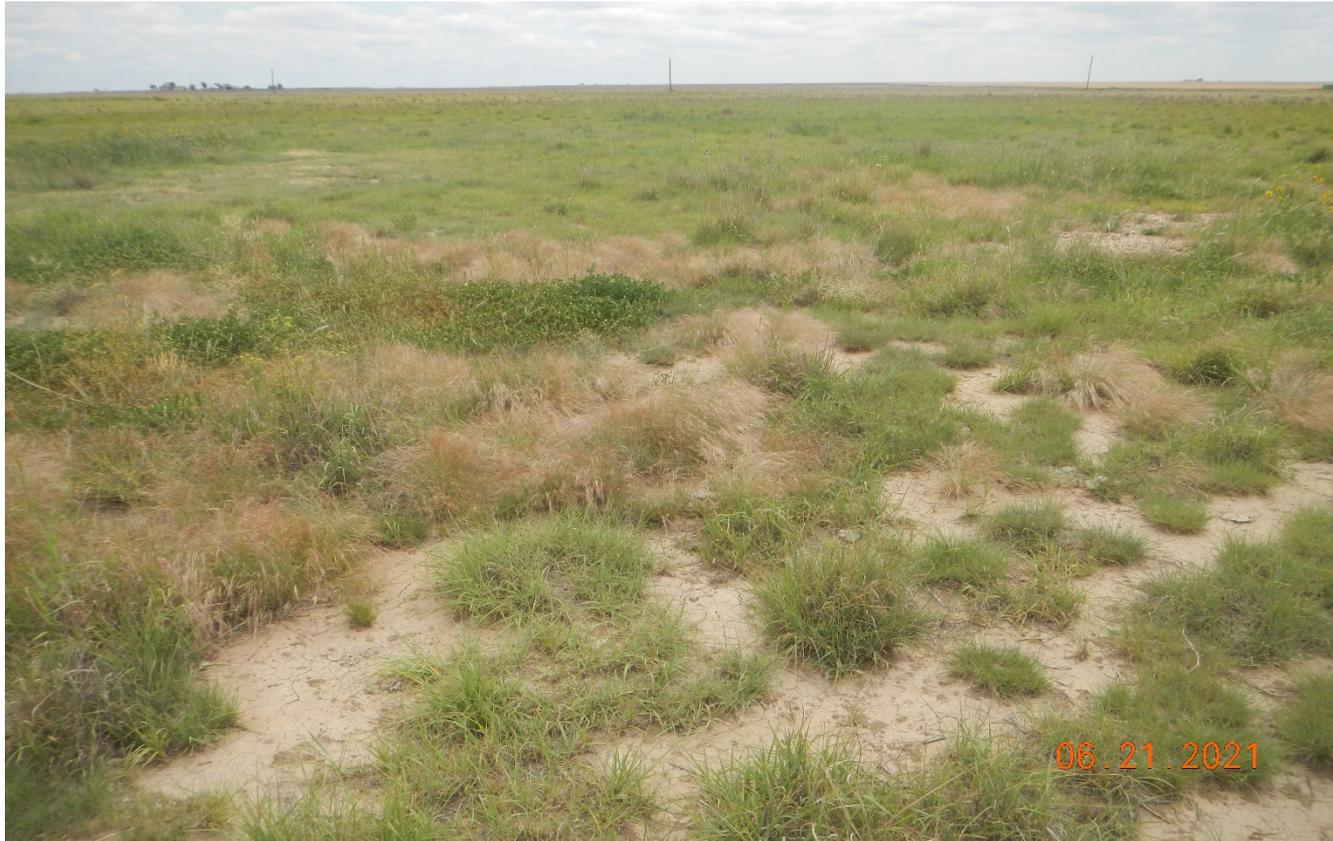
Photo 6. Facing south at the plugged and abandoned wellsite. All equipment has been removed at the well site and the vegetation has re-established.
