Inspection Photos

API: 009-06551

Operator: LORENTZ OIL & GAS

Inspection Date: 6/21/2021

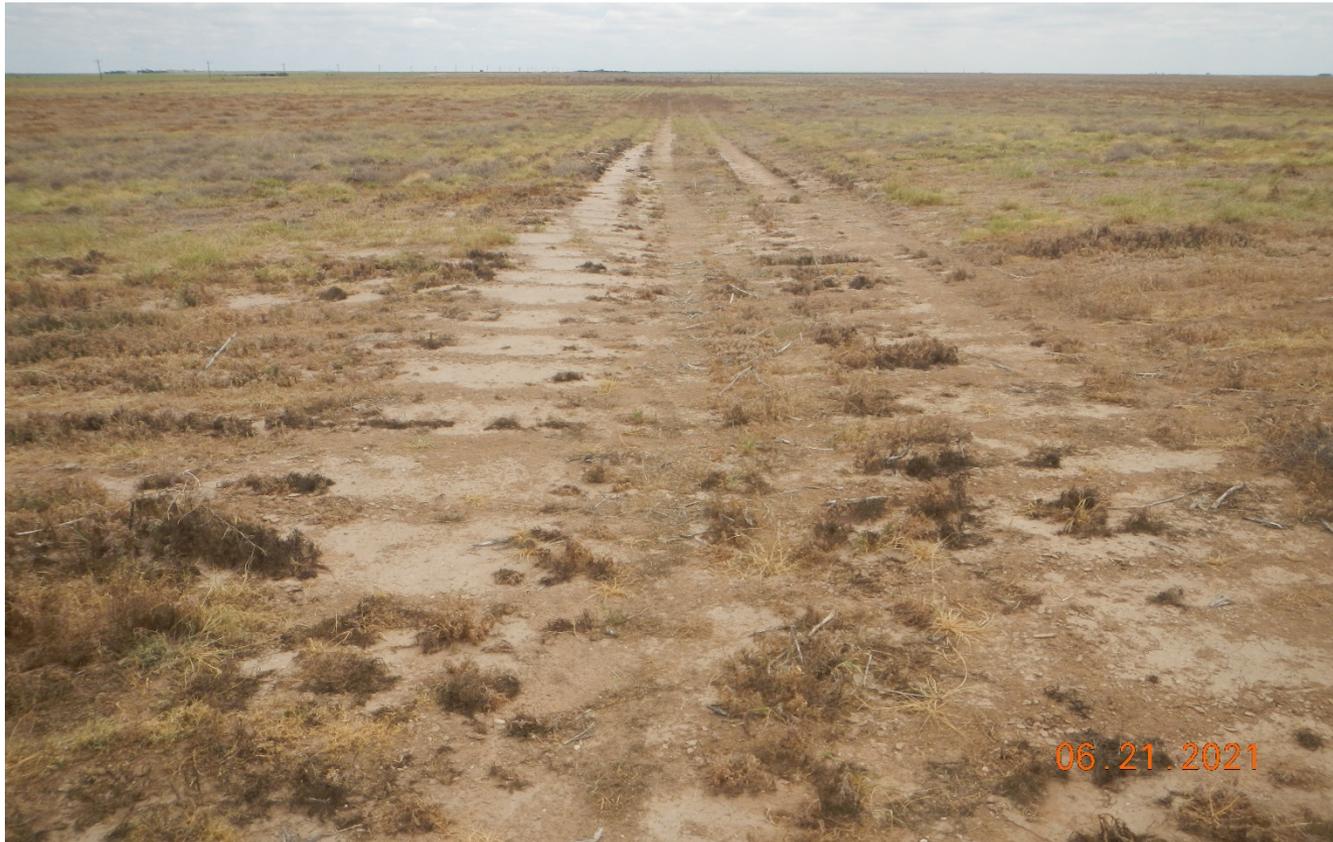
Photo 1. Facing east along the former access road. Vegetation has not re-established along the road.

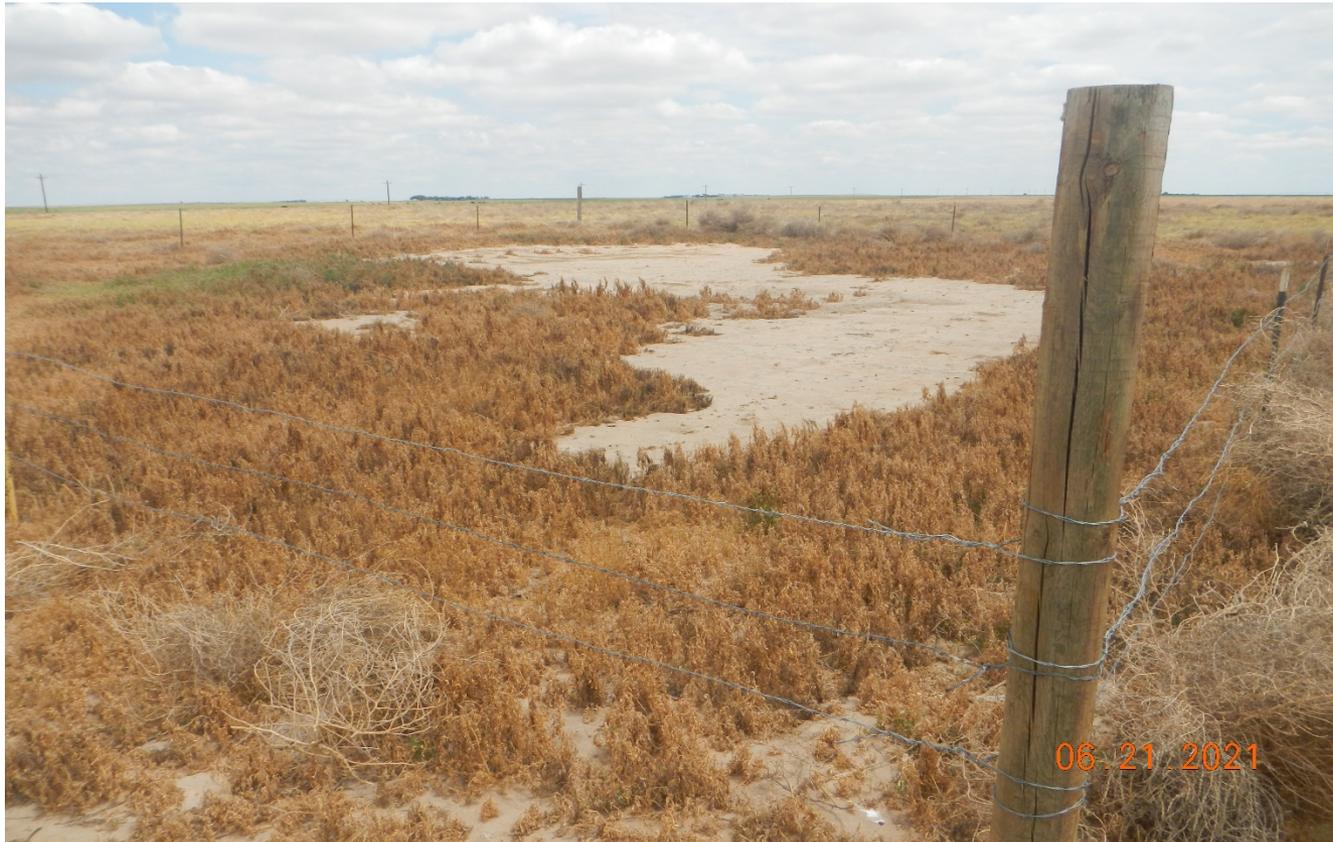
Photo 2. Facing northeast toward the location which has a perimeter fence. Vegetation has re-established at the location.

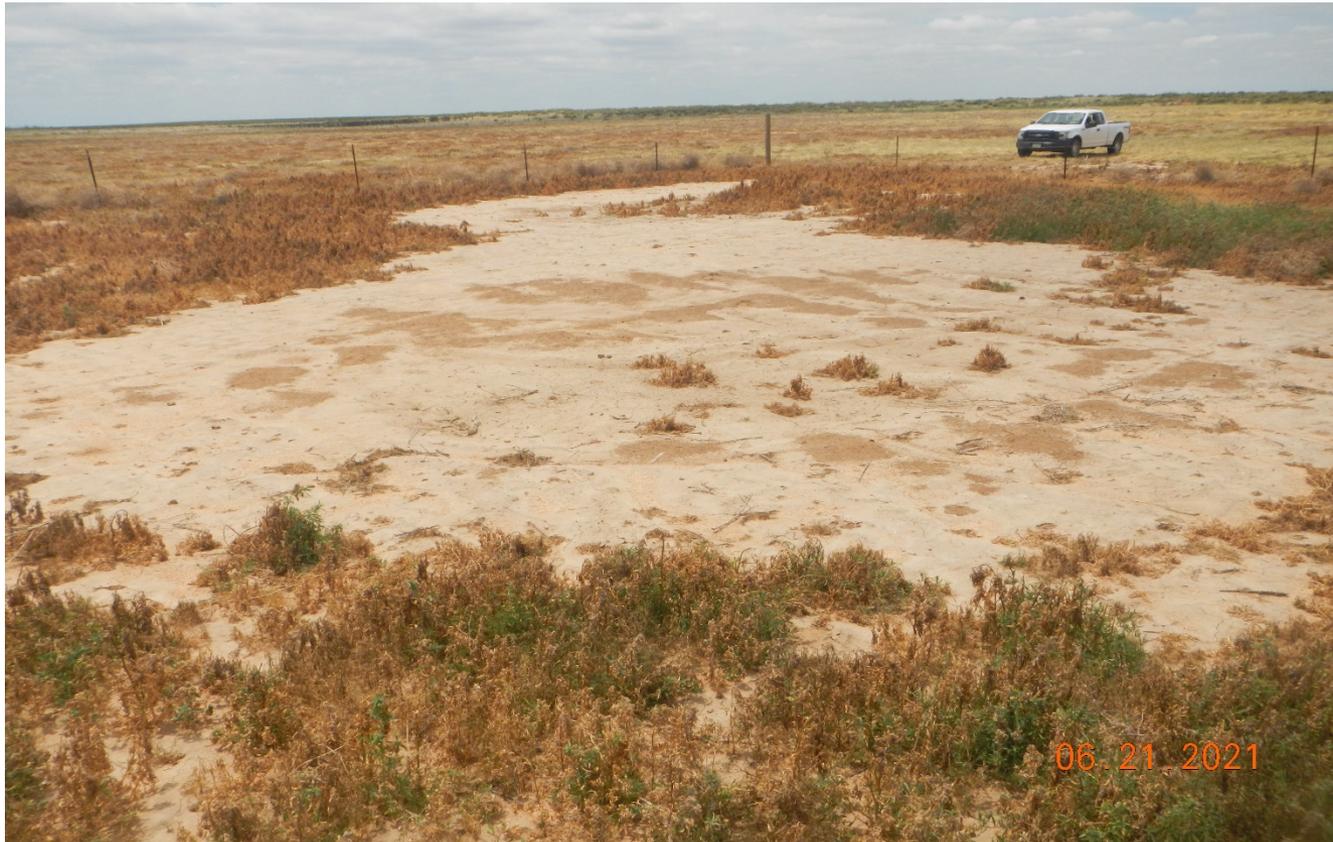
Photo 3. There is an area approximately 120'x50' with no vegetation growth. Soil issues may be impacting vegetation growth.
