# Inspection Photos

API: 009-06539

Operator: SANDLIN OIL CORP

Inspection Date: 6/21/2021

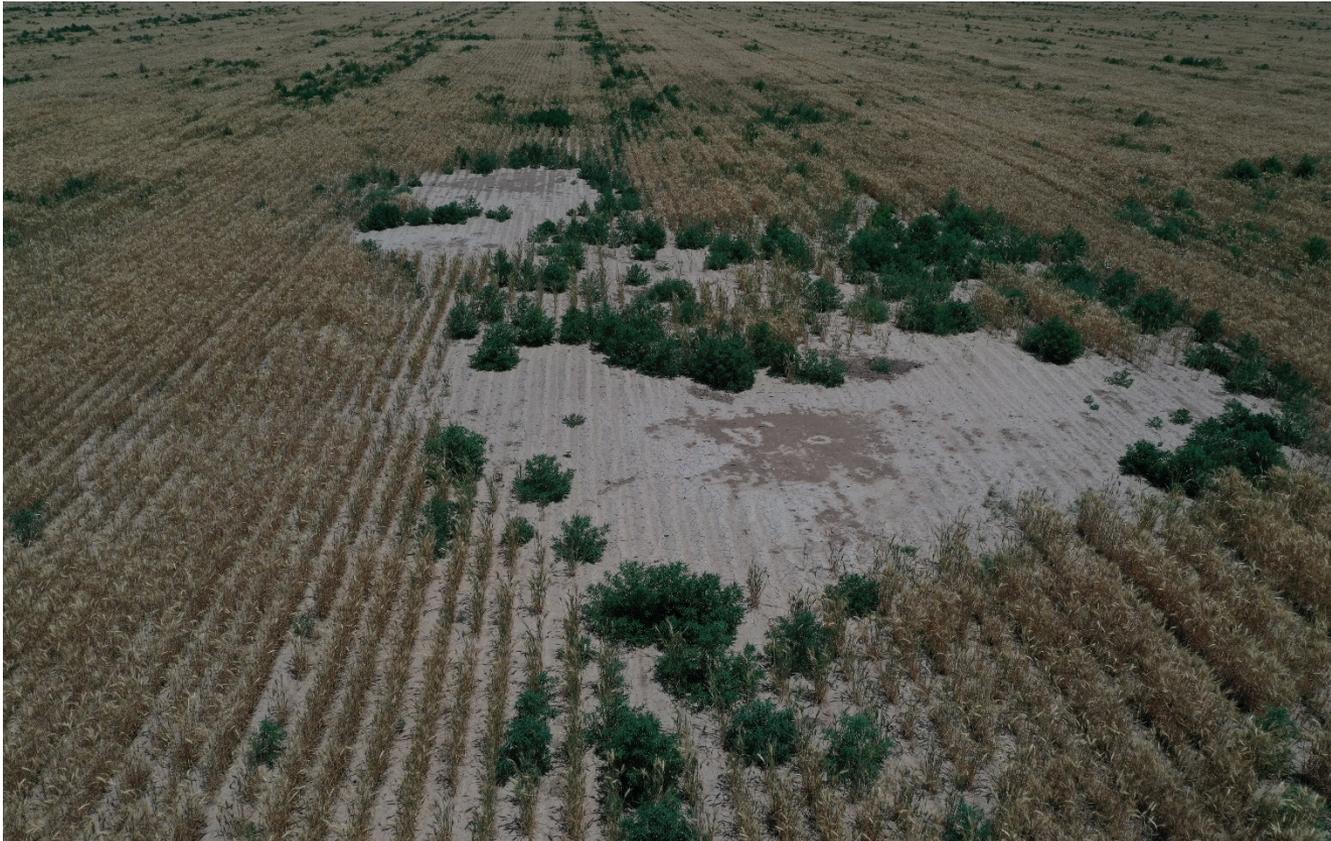
**Photo 1.** Facing east at former well site. The crop has not re-established in the area shown in photo. There is possible soil issues preventing crop establishment.

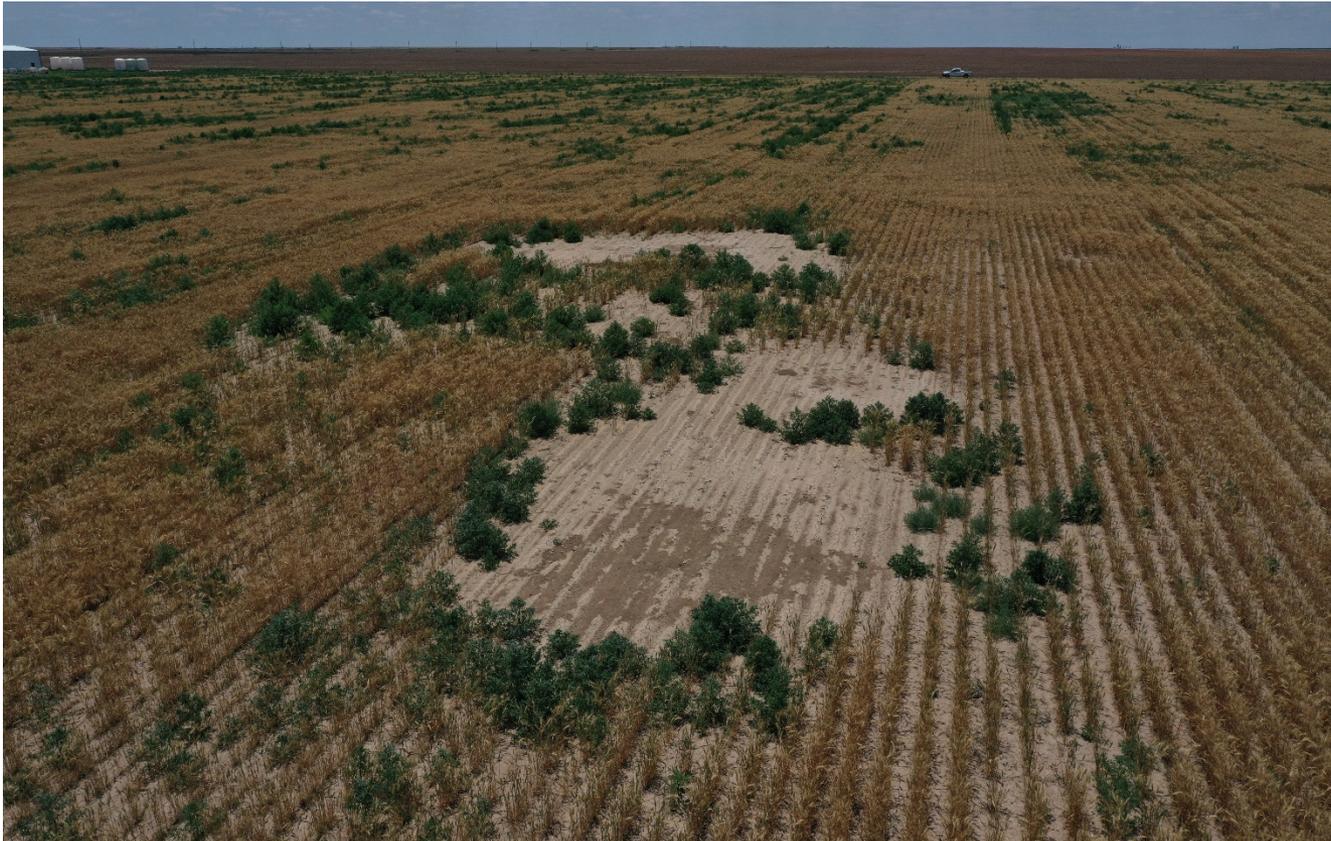
**Photo 2.** Facing back west at former well site. The crop has not re-established in the area shown in photo. There is possible soil issues preventing crop establishment.

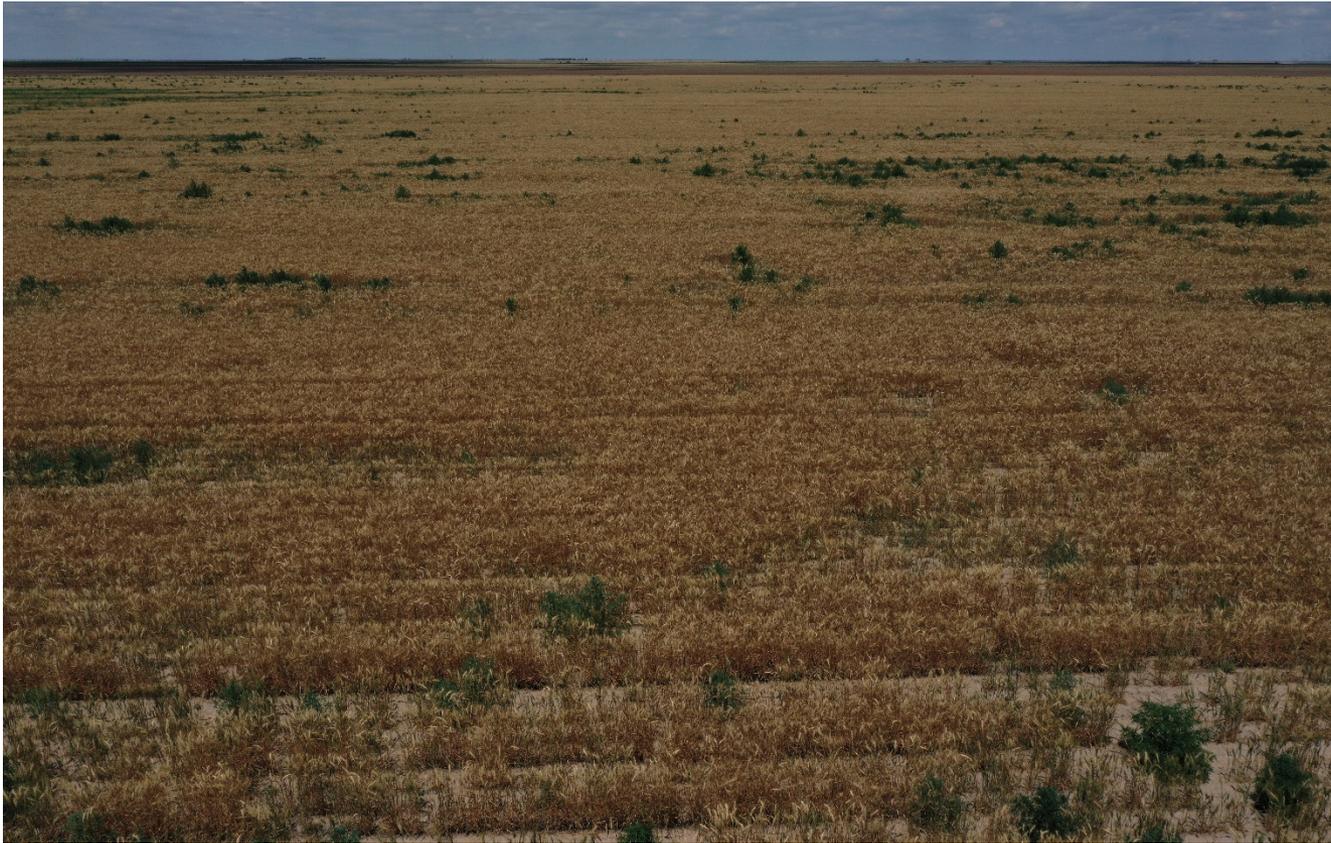
**Photo 3.** Facing north toward the surround crop vegetation cover.
