Inspection Photos

API: 009-06581

Operator: ENERGY ALLIANCE COMPANY

Inspection Date: 6/21/2021

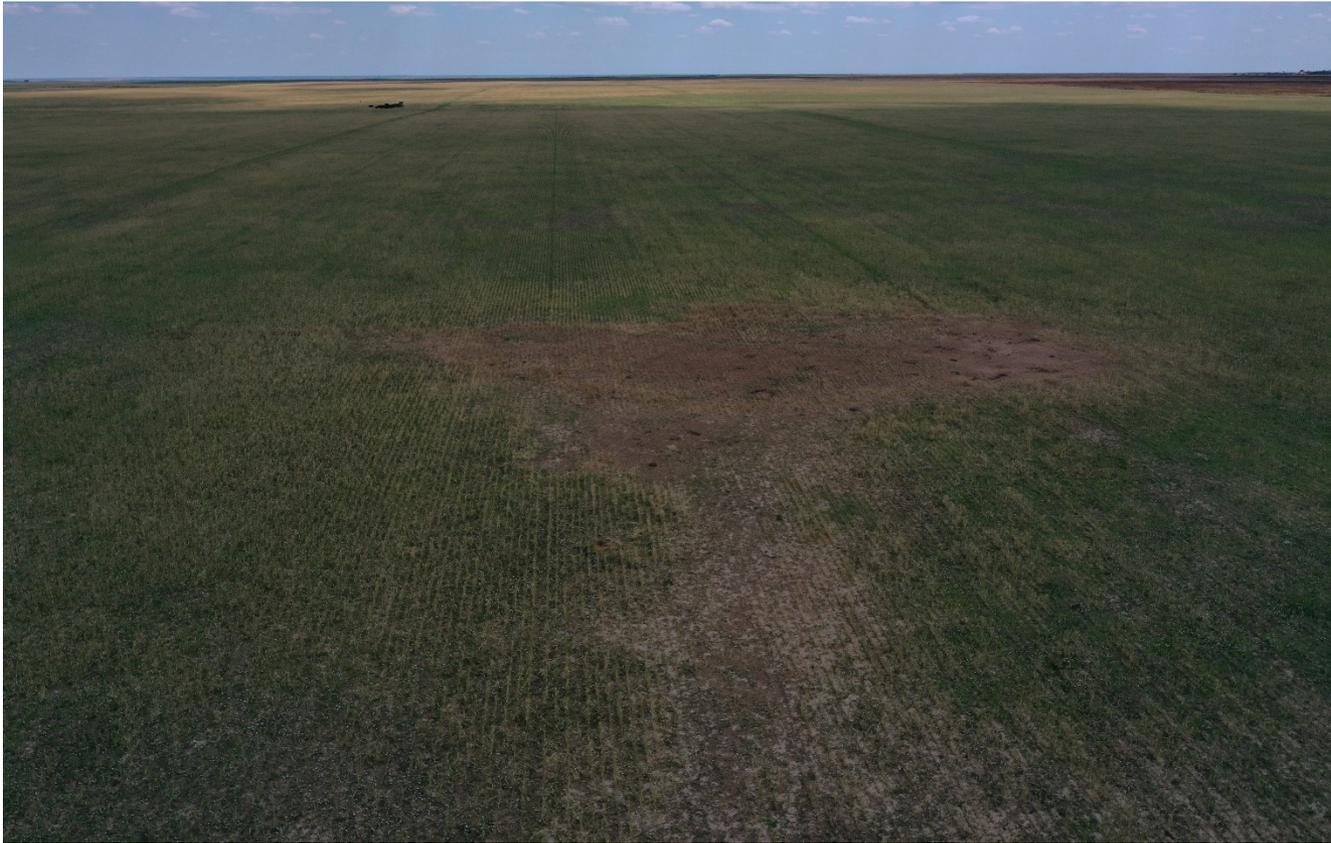
Photo 1. Facing south at the former well site. The crop has not re-established in the area shown in photo. There is possible soil issues preventing crop establishment.

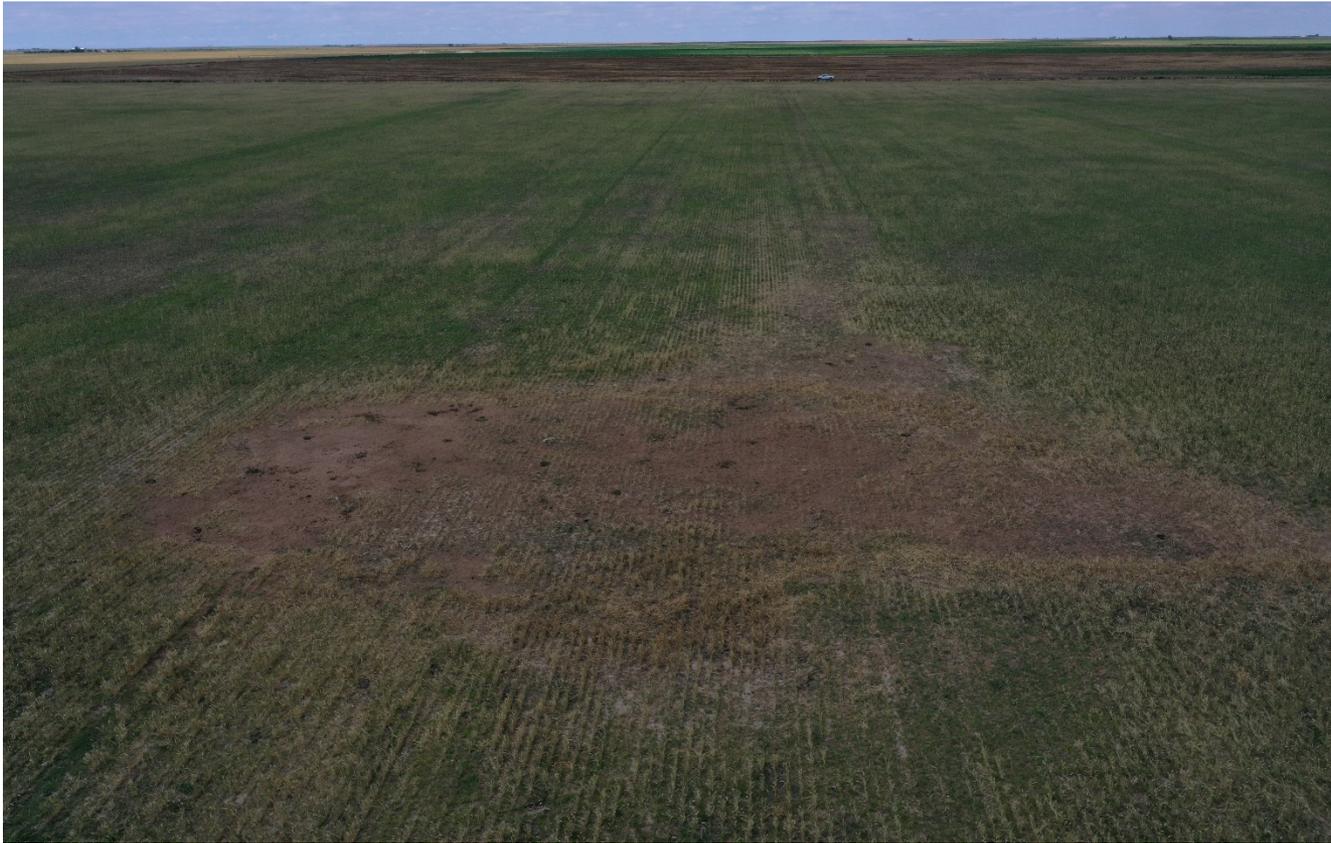
Photo 2. Facing back north at the former well site. The crop has not re-established in the area shown in photo. There is possible soil issues preventing crop establishment.

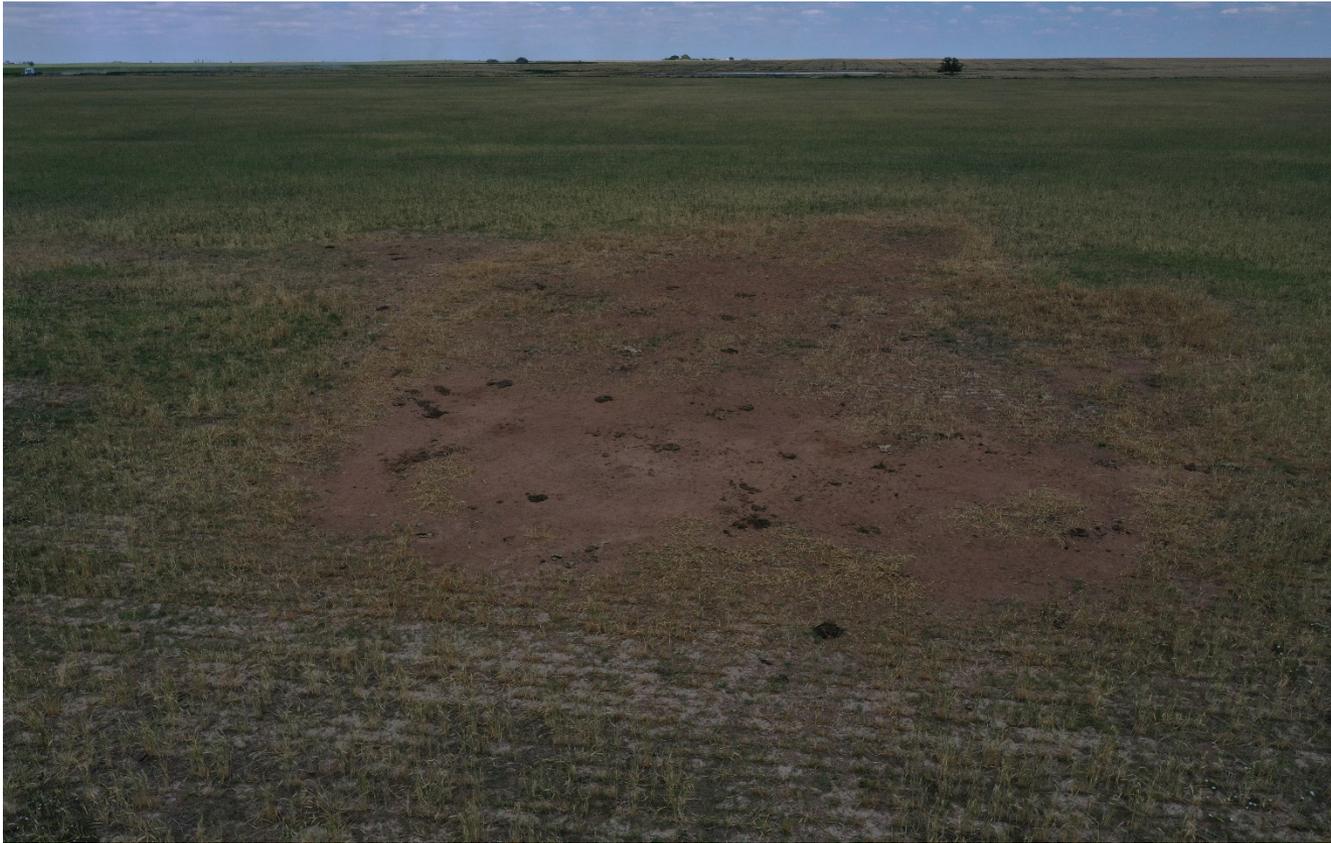
Photo 3. Facing east at the former well site. The crop has not re-established in the area shown in photo. There is possible soil issues preventing crop establishment.

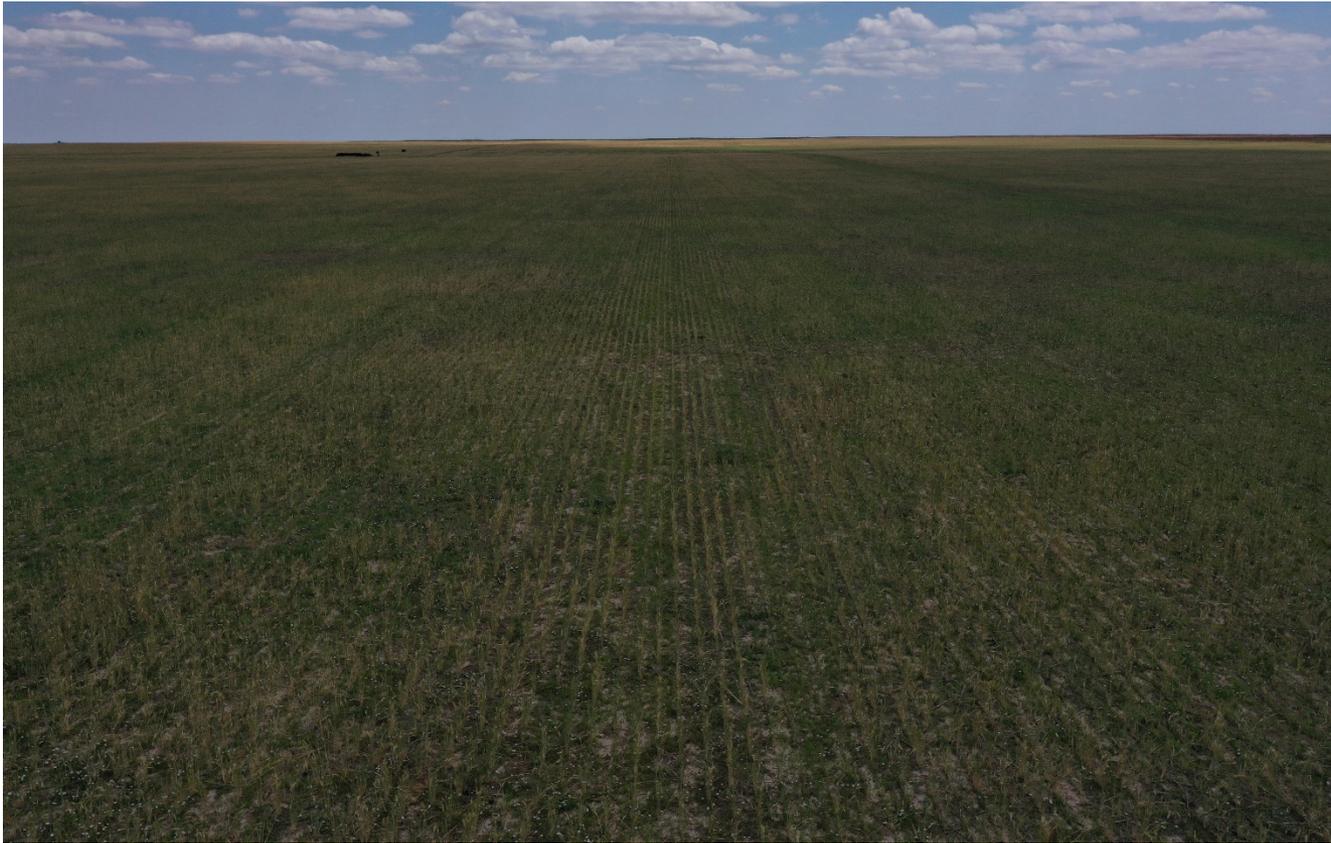
Photo 4. Facing north toward the surrounding uniform crop cover.
