COLORADO
Oil & Gas Conservation
Commission
Department of Natural Resources

Inspection Photos: Pan American PA USA Atlantic Ref API#0103-07077

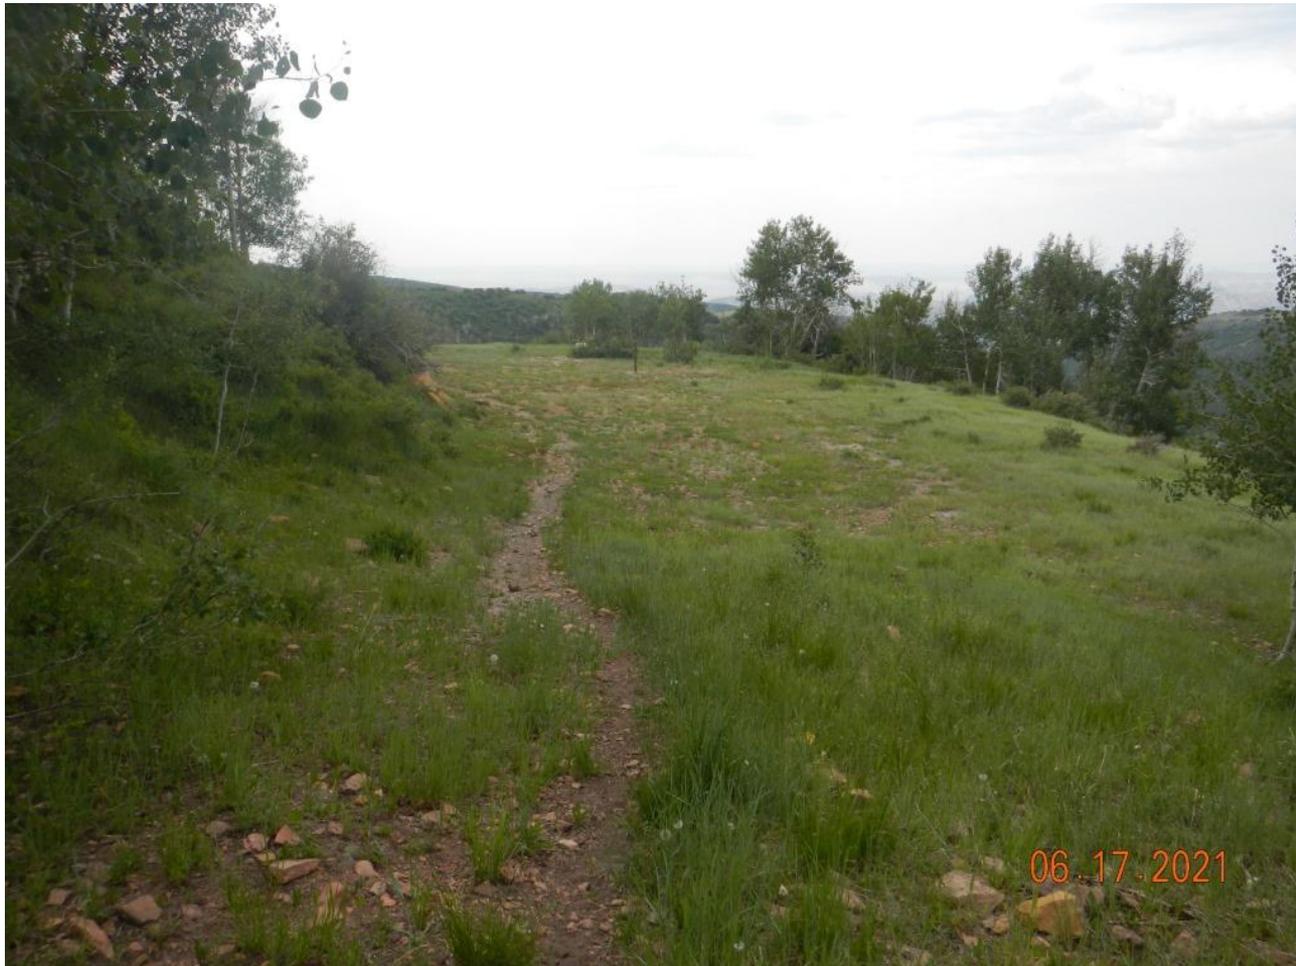
Photo#1:
Overview of Location from entry, view to Northwest.

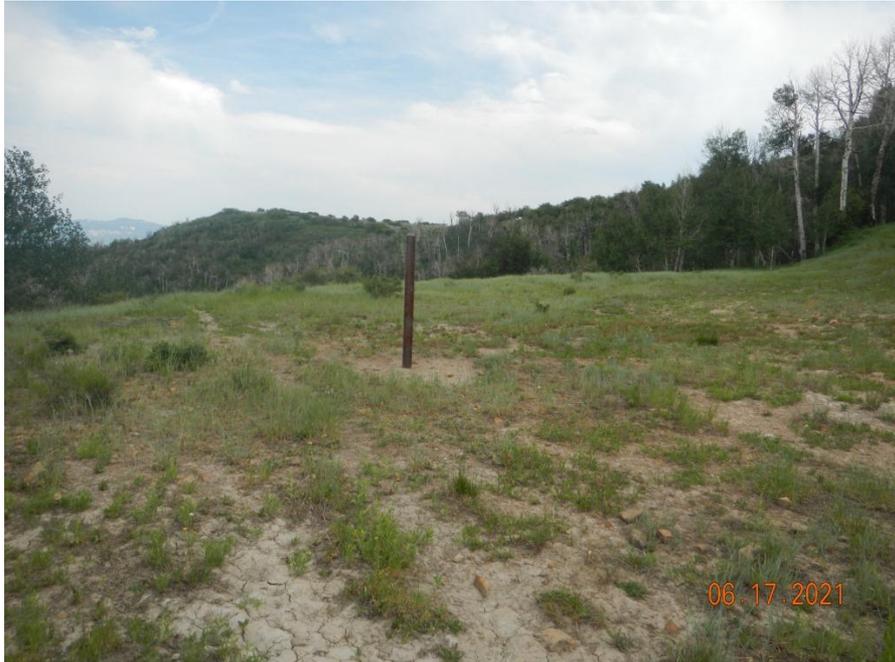
Photo#2:
View East over Location center.

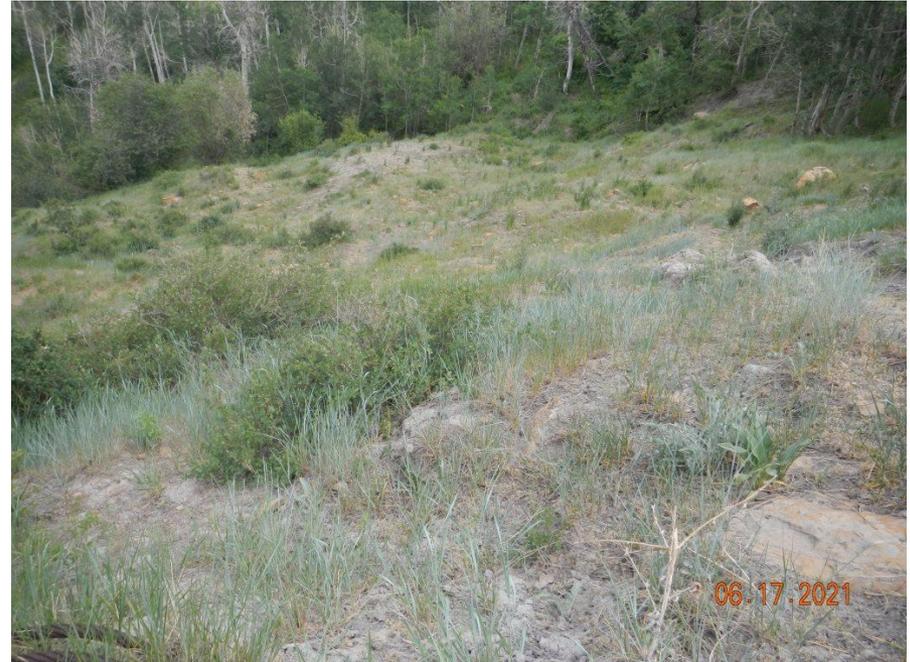
Photo#3:
East side fill slope .

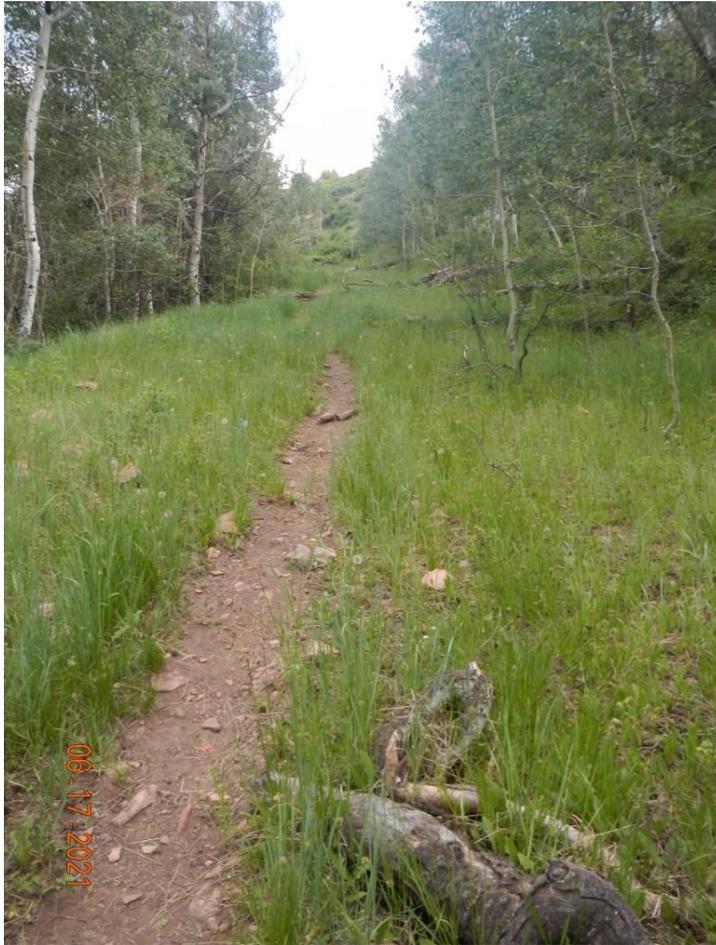
Photo#4:
Access road has grown in.

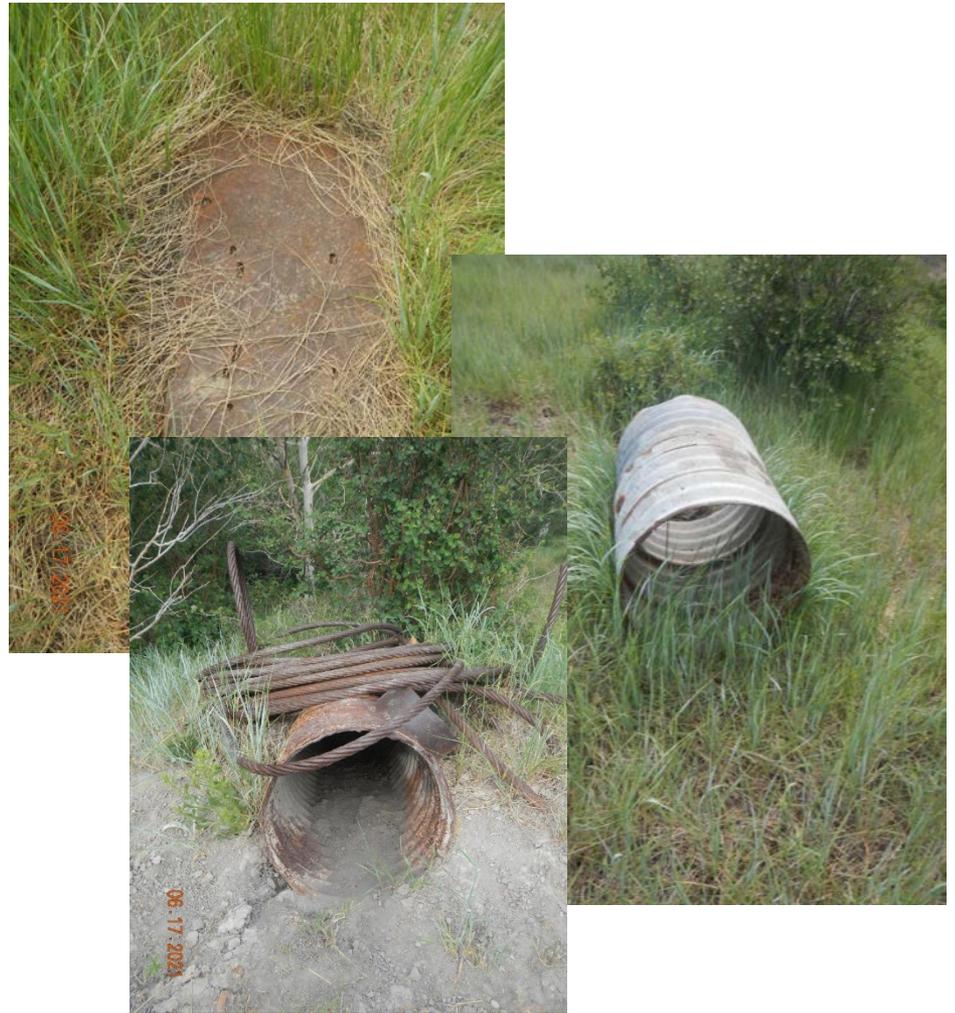
Photo#5:
Debris remaining on site.
