**Reportable Release Photographic Documentation**

North Carracas 32-4 #7F-3 – 6/23/2021

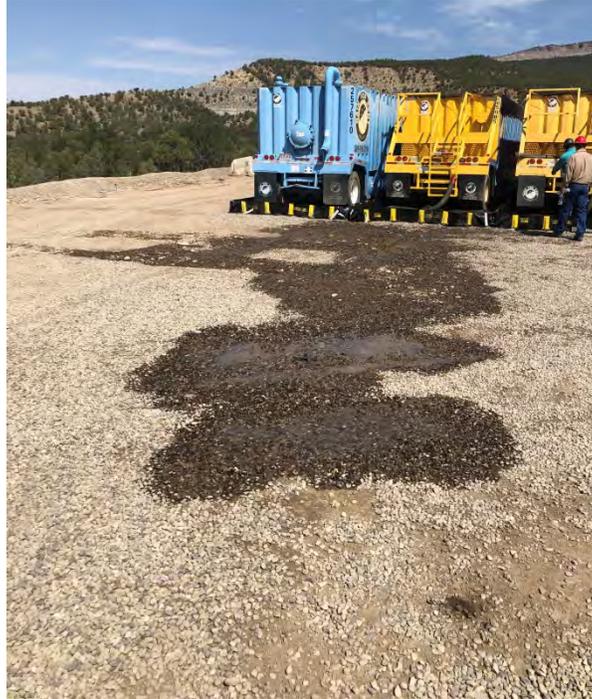
Looking North: Footprint of release that was outside of the flow back tank's secondary containment.

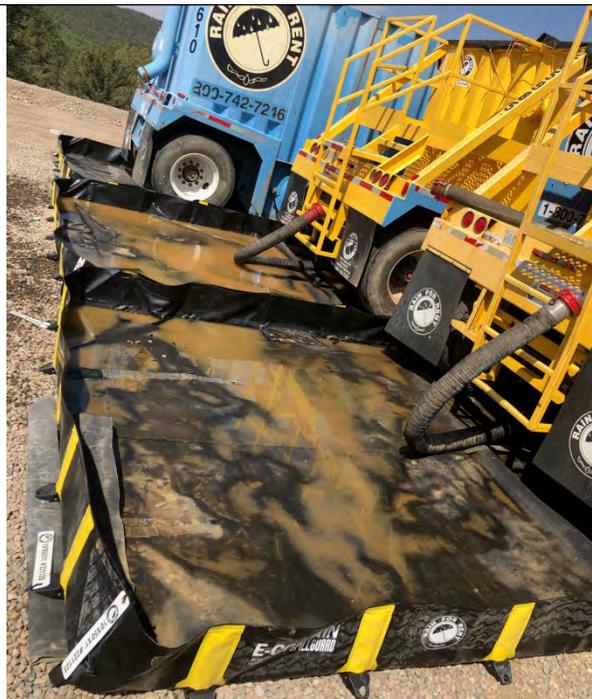
Looking West: Some of the release was contained within the flow back tank's secondary containment and was able to be recovered.
