Inspection Photos

Location Name: TEP ROCKY MOUNTAIN LLC UNOCAL-66S96W /33NWSE

Location ID: 335214

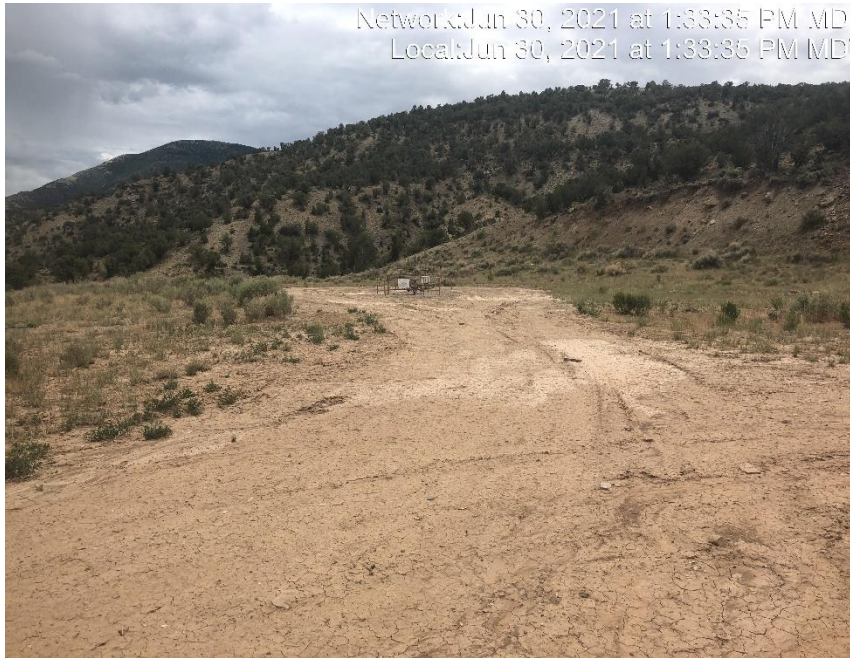
Photo #4245 from entrance to location.

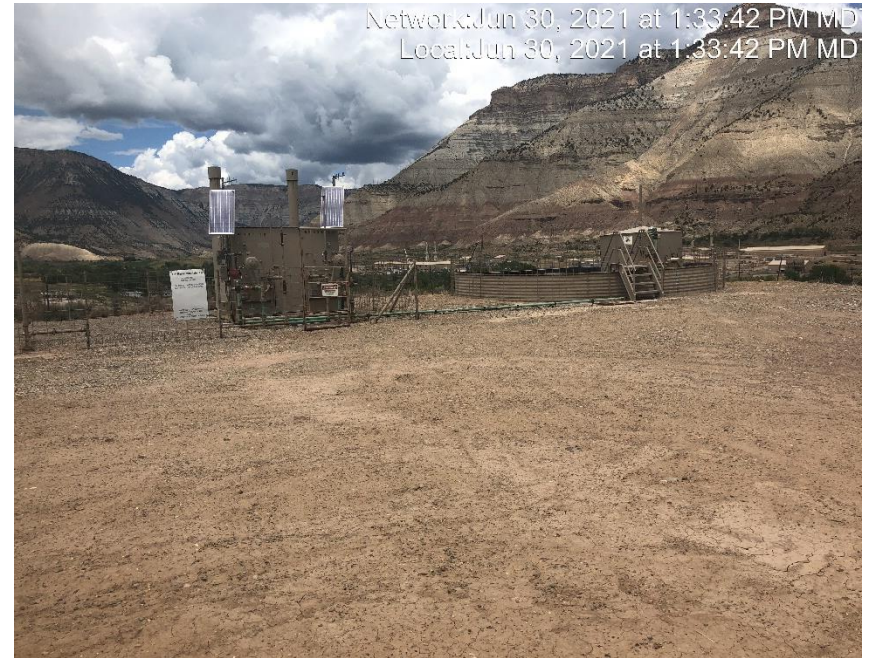
Photo #4246 from entrance to location.

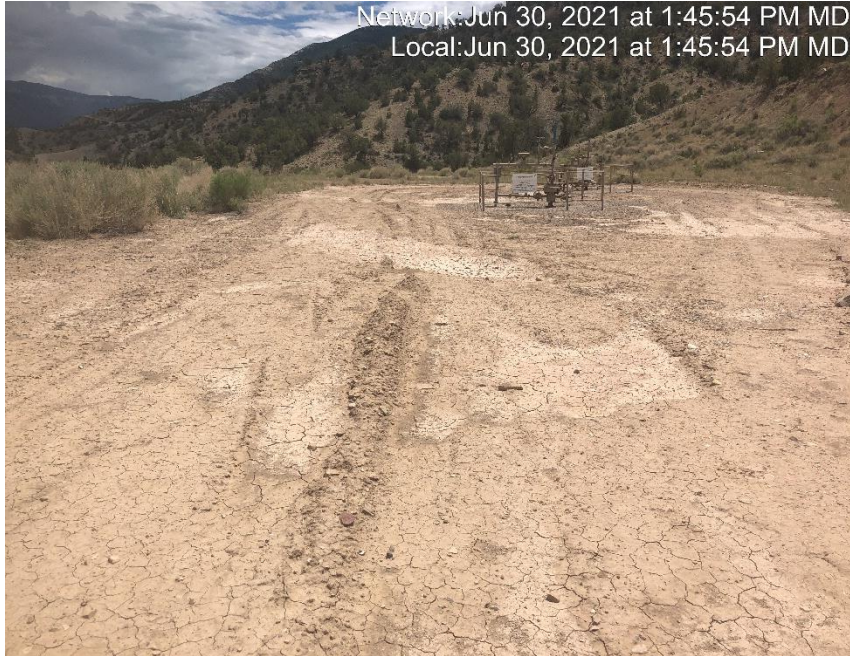
Photo #4248 Location lacks stabilization.

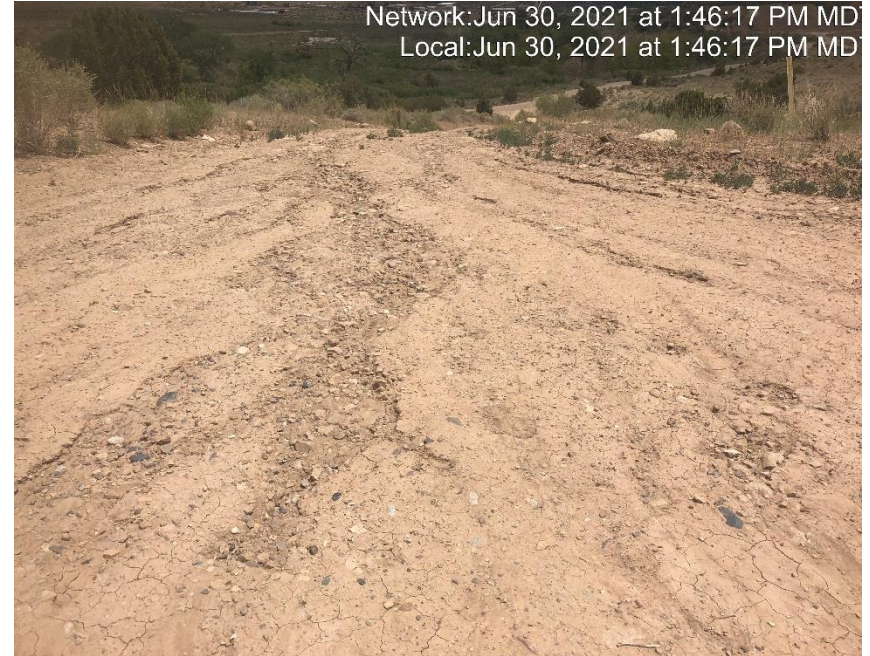
Photo #4249 No form of tracking BMP at entrance to location.

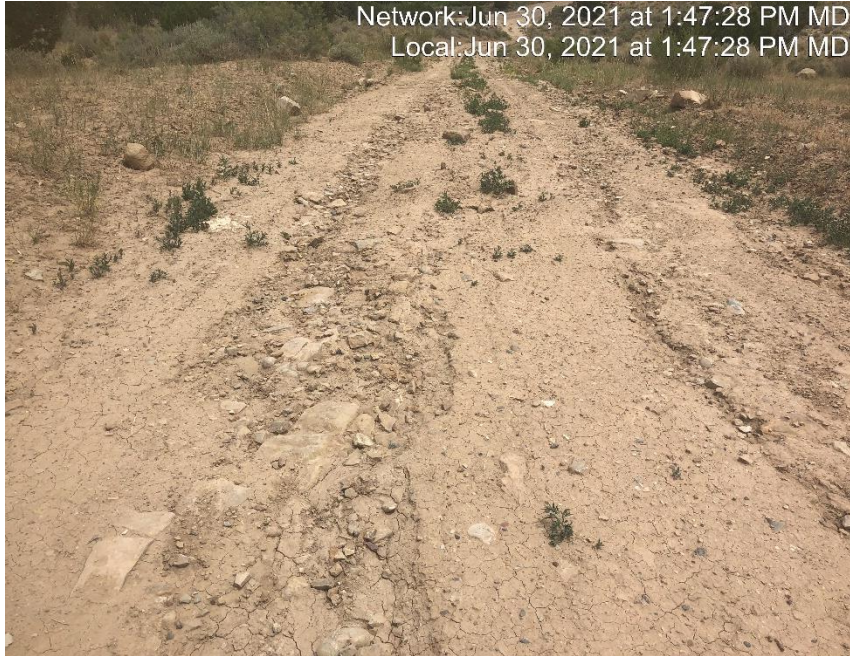
Photo #4250 Rill erosion occurring in center of access road.

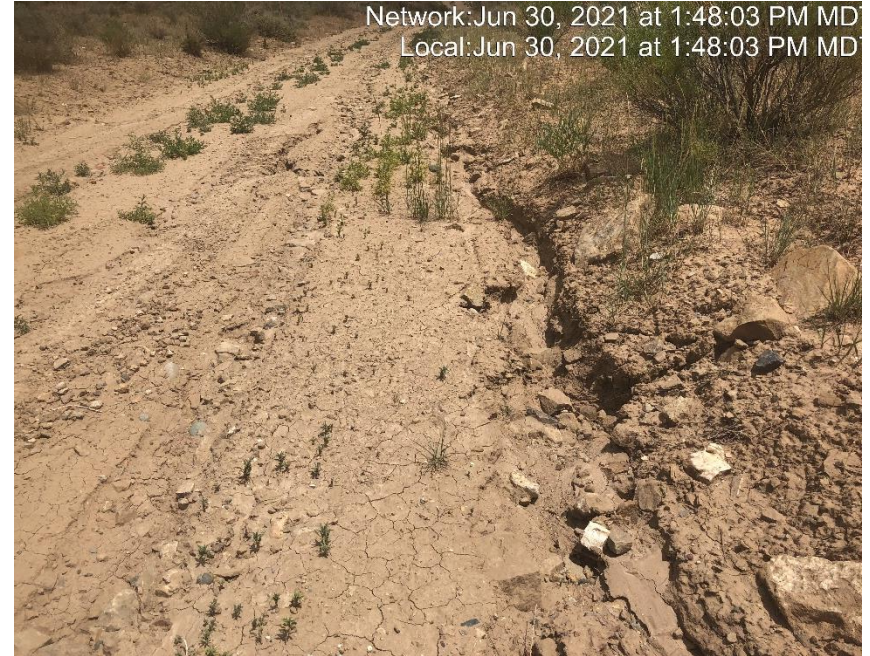
Photo #4252 Rill erosion occurring in access road ditches.

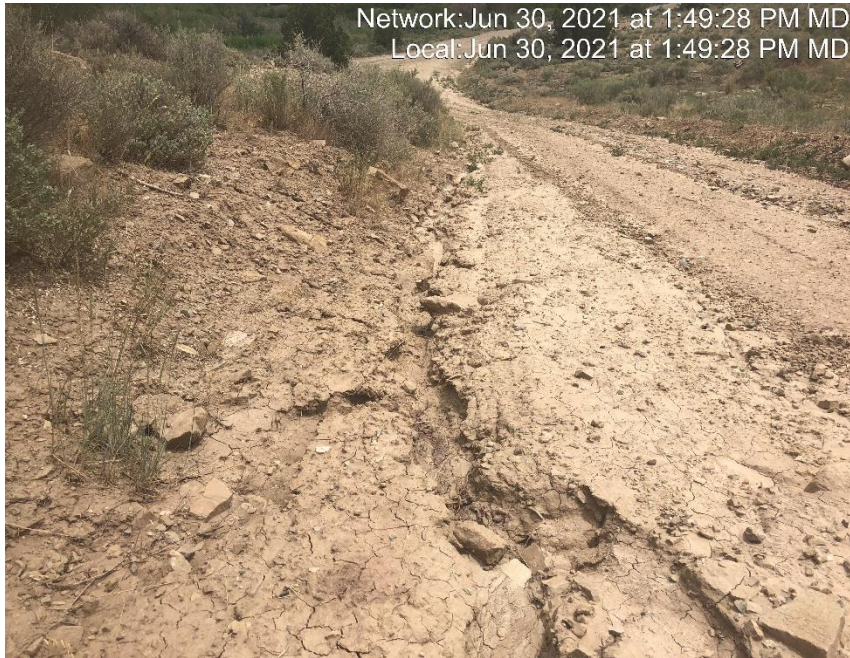
Photo #4253 No velocity checks located in access road ditches.

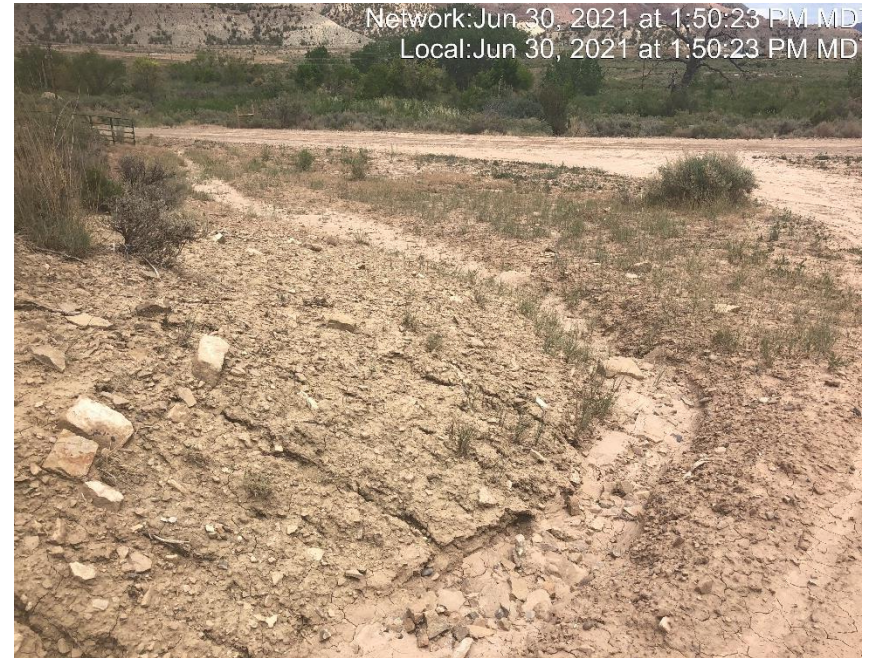
Photo #4254 Gully erosion occurring at entrance to access road.

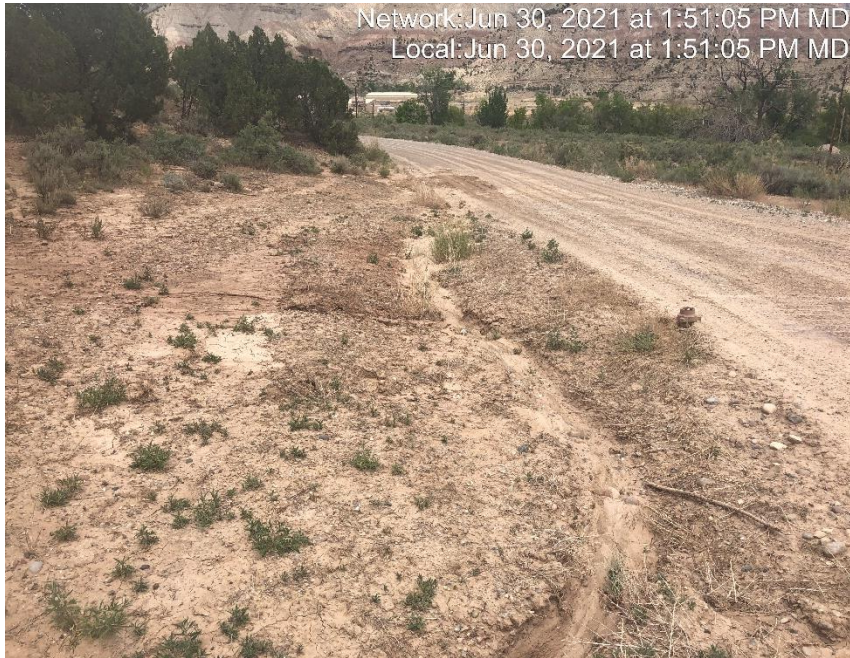
Photo #4255 Gully erosion.

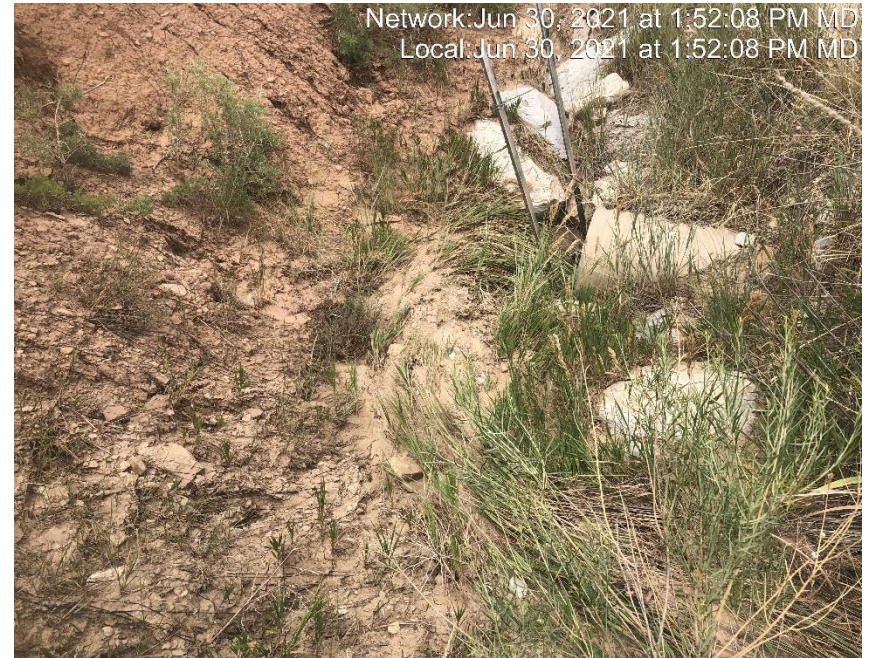
Photo #4256 Inlet of culvert that contributes to Parachute creek.

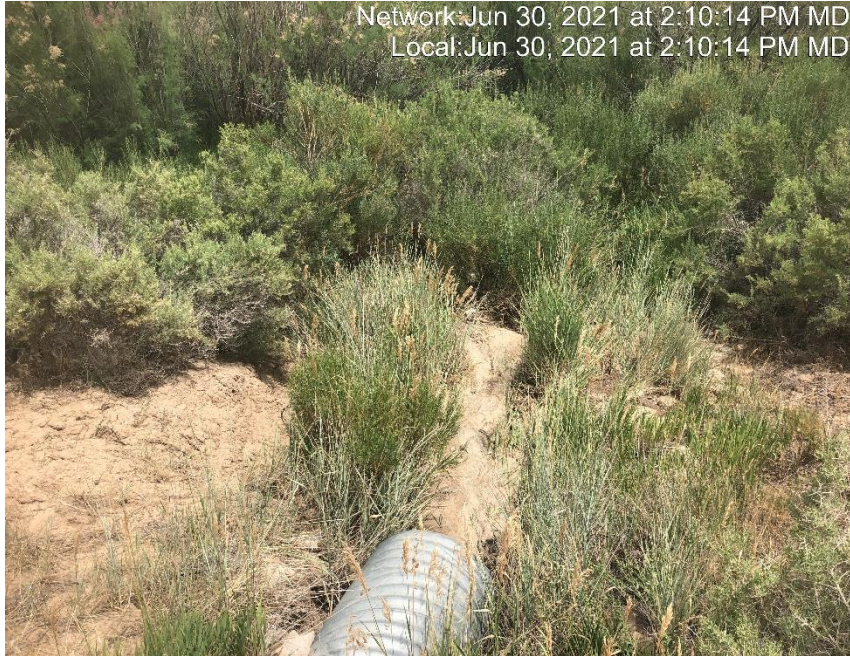
Photo #4260 Outlet of culvert that contributes to Parachute creek.

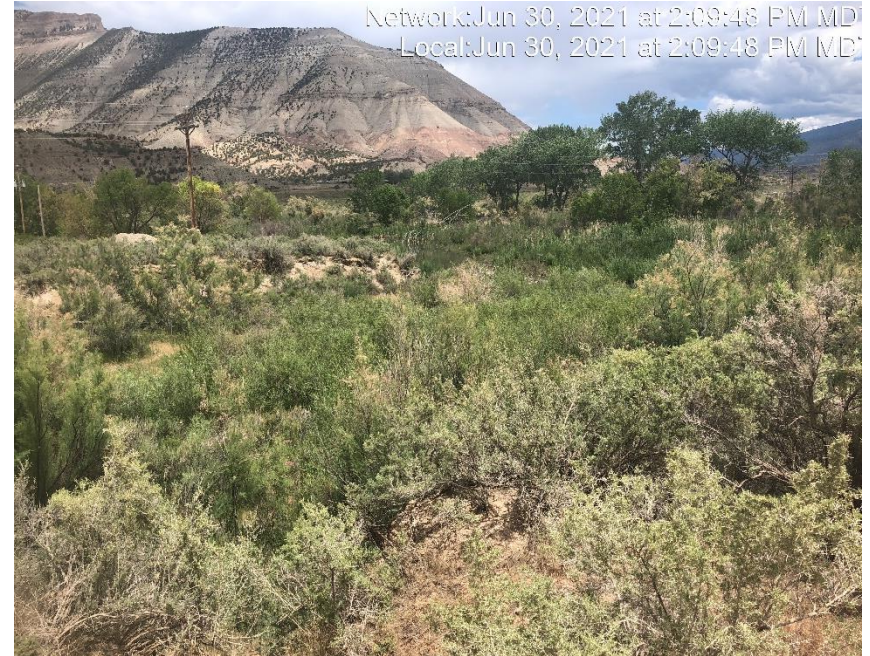
Photo #4259 Parachute creek from entrance to access road.

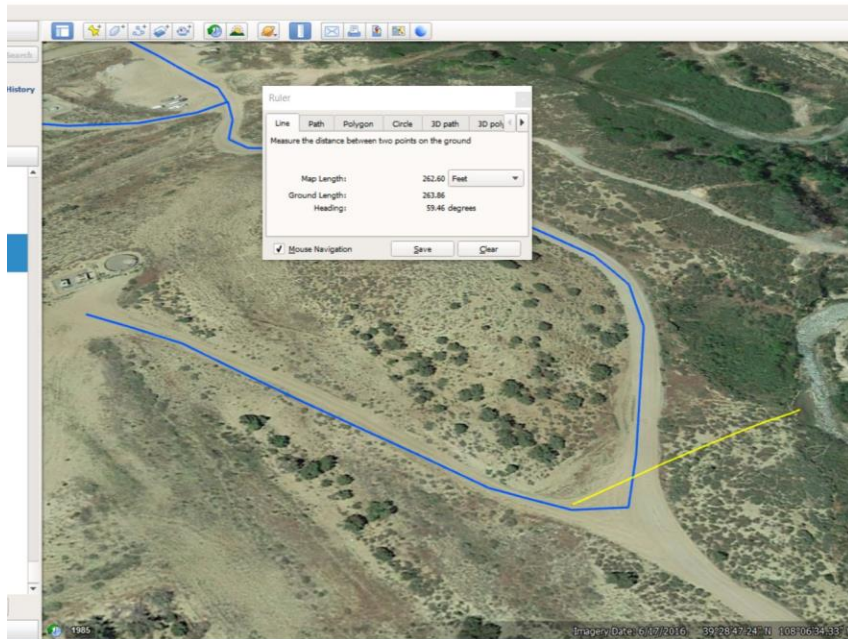
Approximate distance from location and access road to Parachute creek.
