Inspection Photos  
Operator: Morningstar Res.  
API: 007-06242  
Date: 6/29/2021

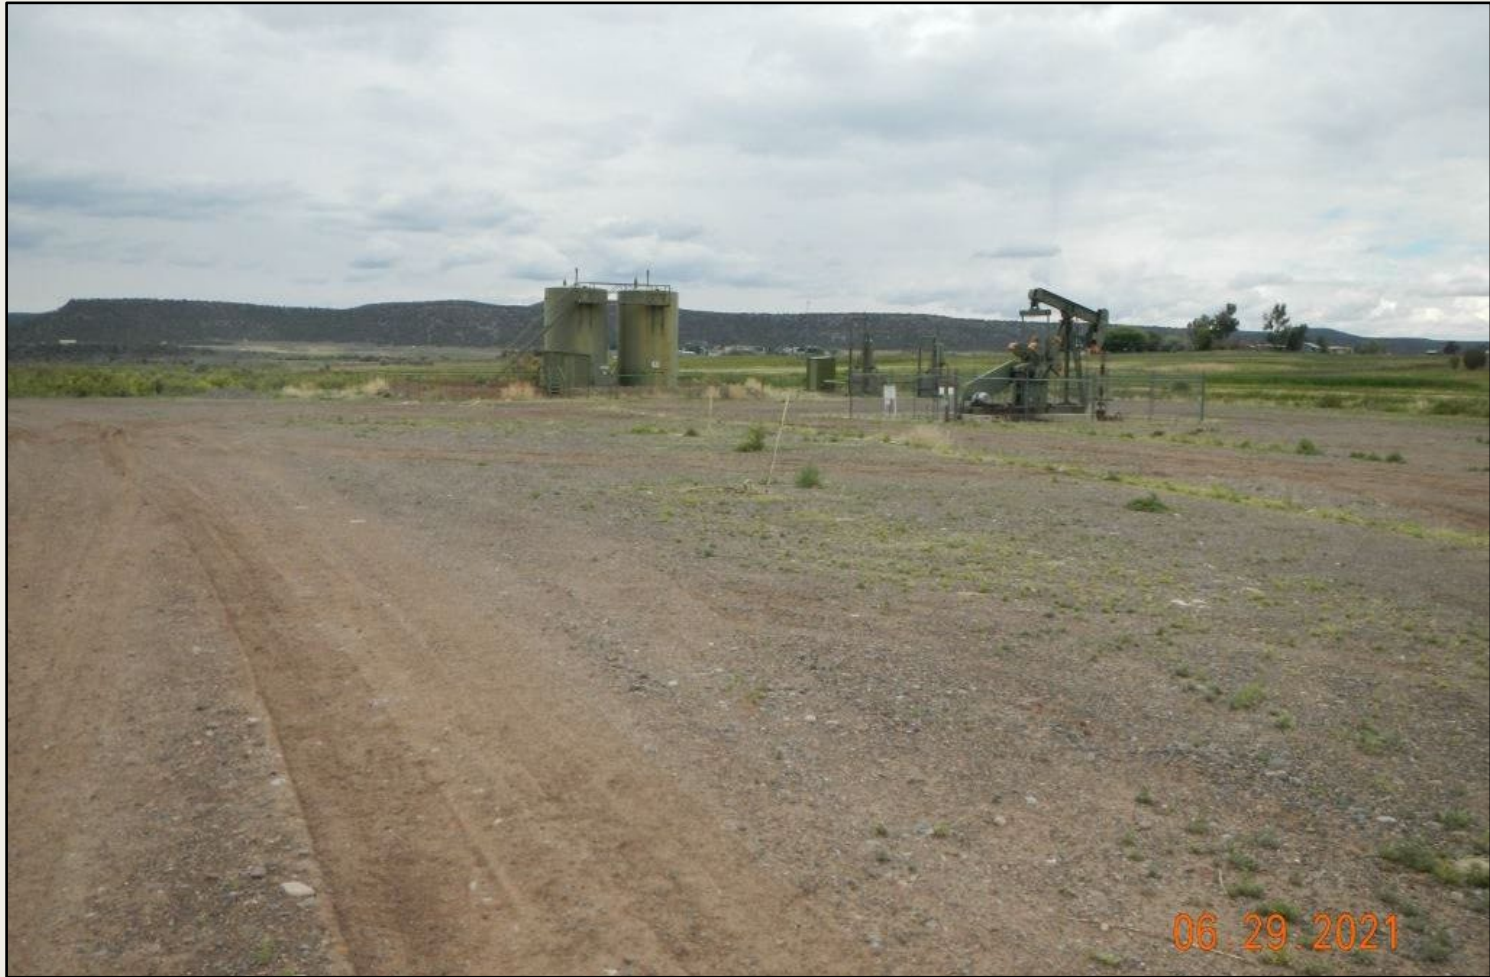
Photo 1. View the project area from the northeastern corner facing center.

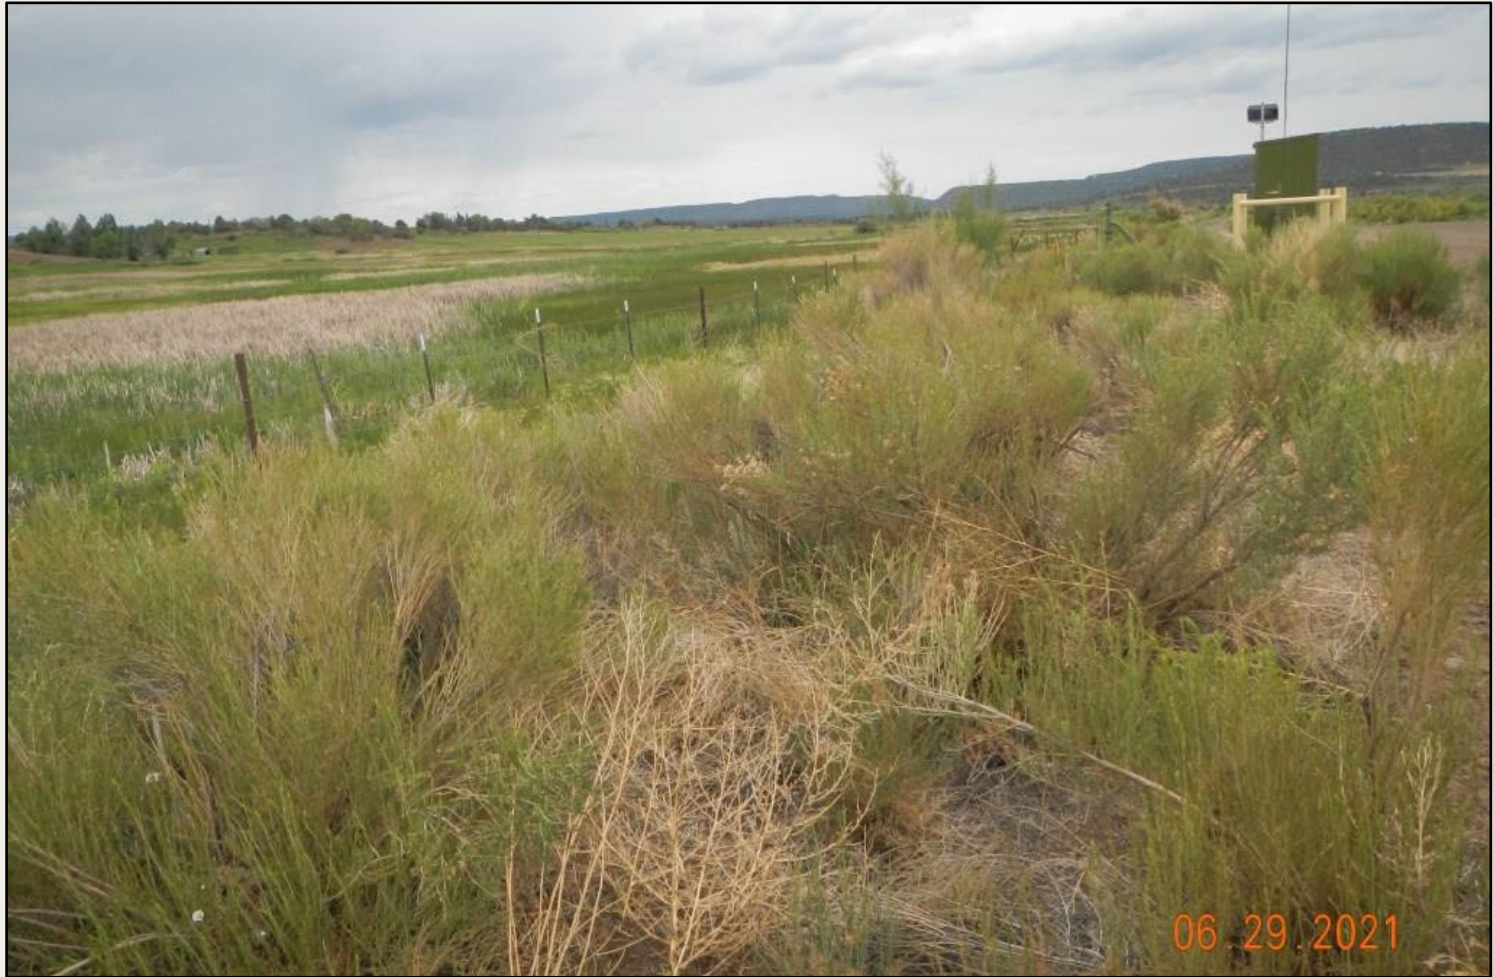
Photo 2. View the eastern project area from the northeastern corner facing southward. Revegetation is comprised of rubber rabbitbrush, crested wheatgrass, and western wheatgrass.

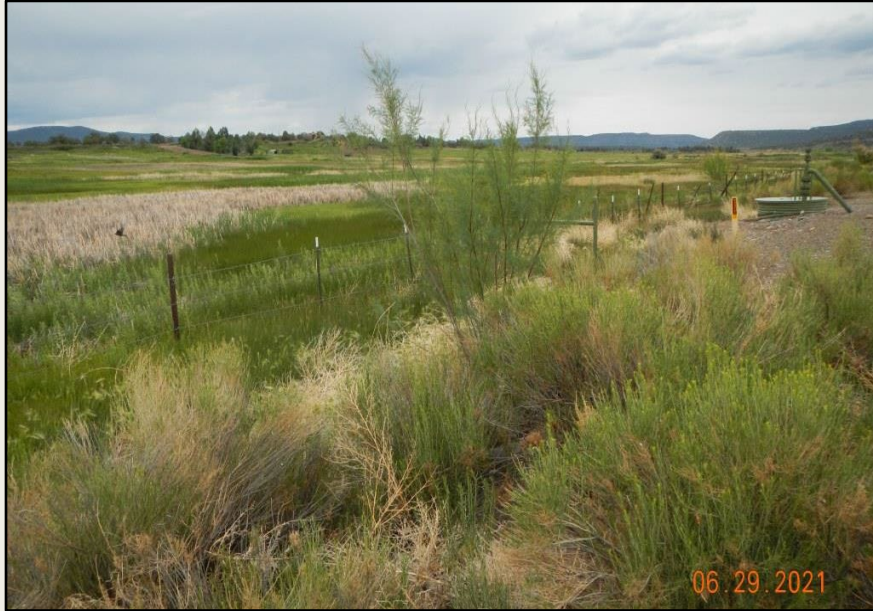
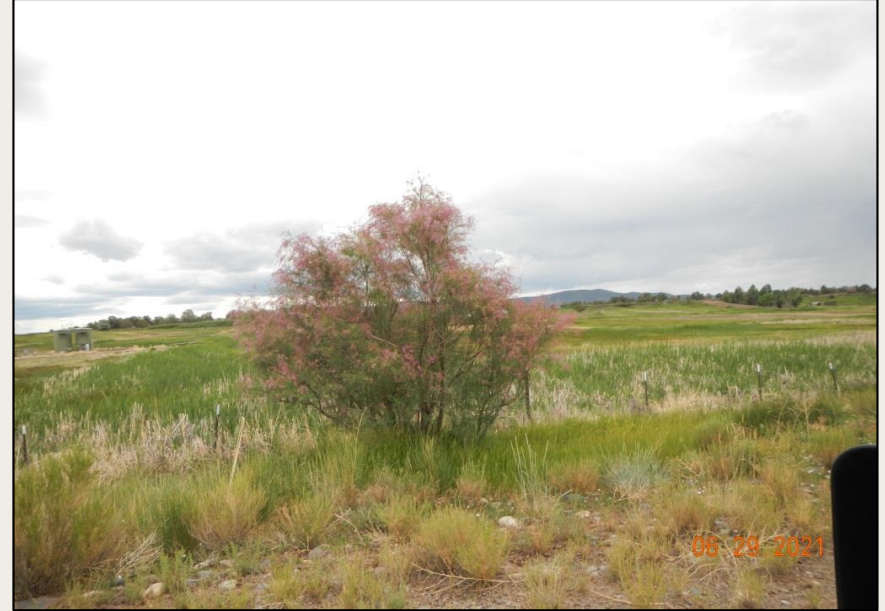
Photos 3/4. View of tamarisk trees (approx. 10) becoming established within the well pad disturbance and along the access road.

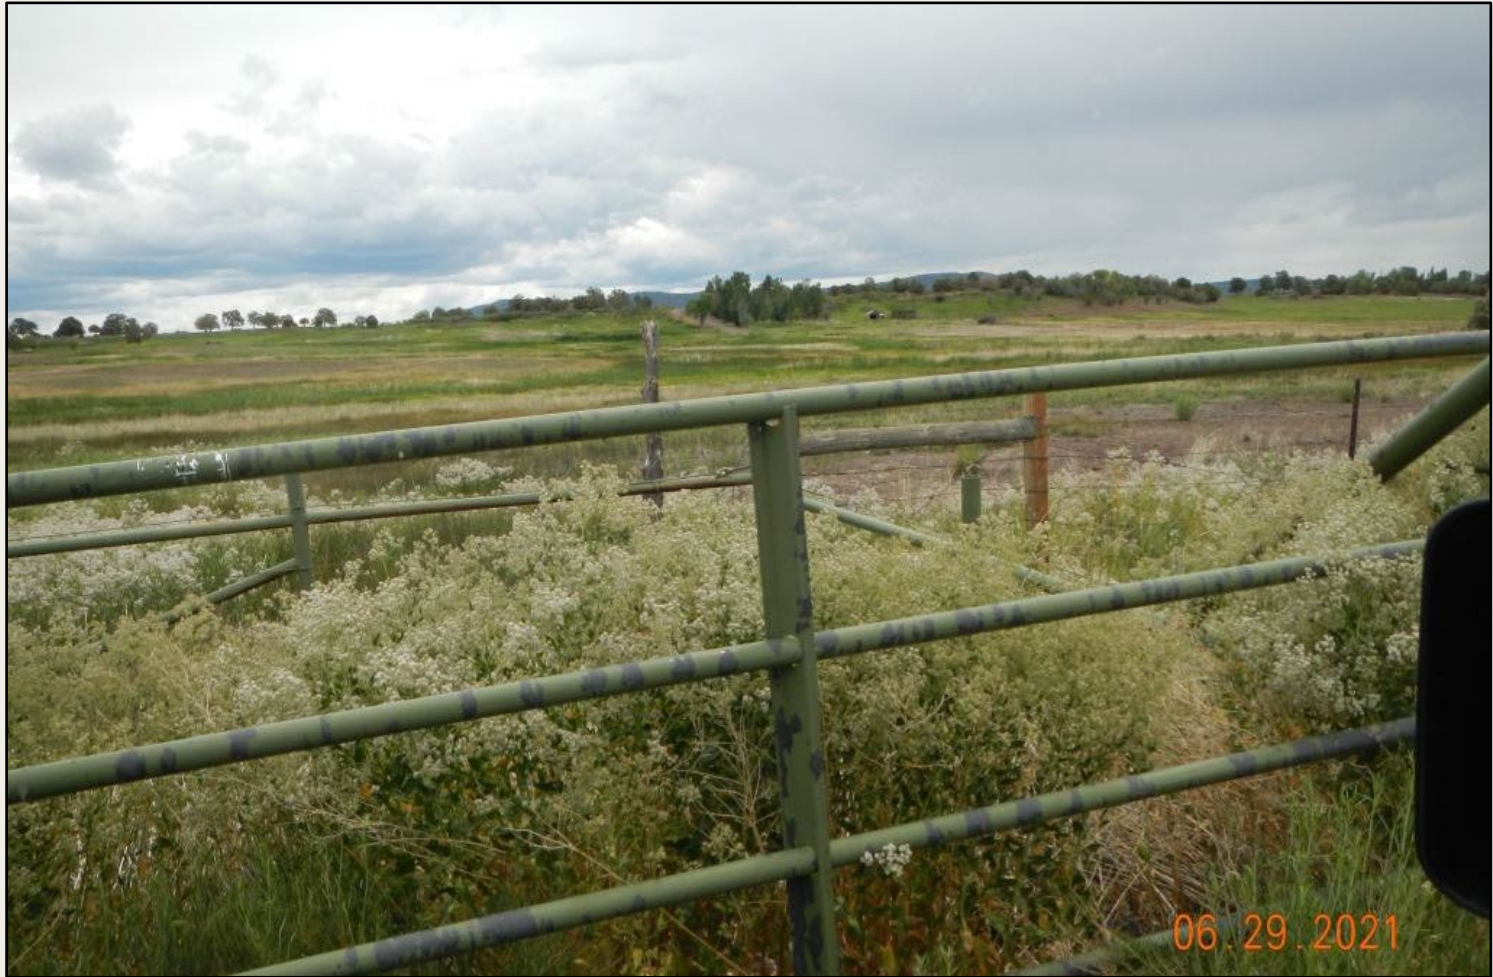
Photo 5. View of perennial pepperweeds along the access road that need to be controlled. Approximately 500 individuals observed.

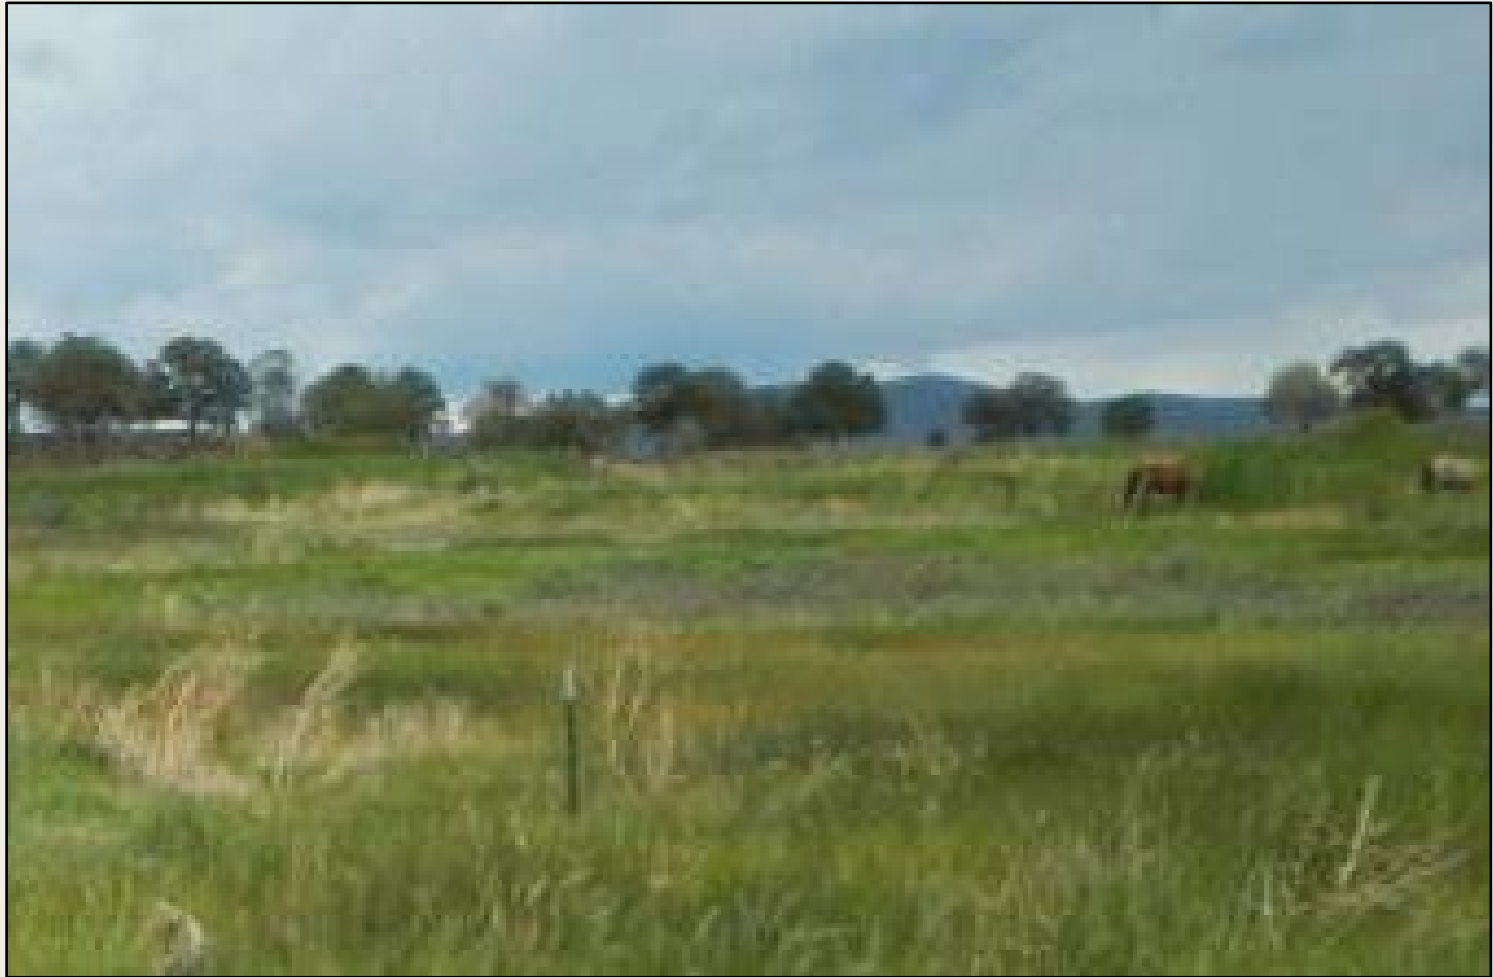
Photo 6. View of reference area comprised of irrigated grass field with grasses such as western wheatgrass, and foxtail barley, forbs such as wormwood, sedges, and cattails.
