Inspection Photos
Pit 117422
REM Project # 15107
Inspection Date: 6/14/2021
All Photos taken by Kris Neidel

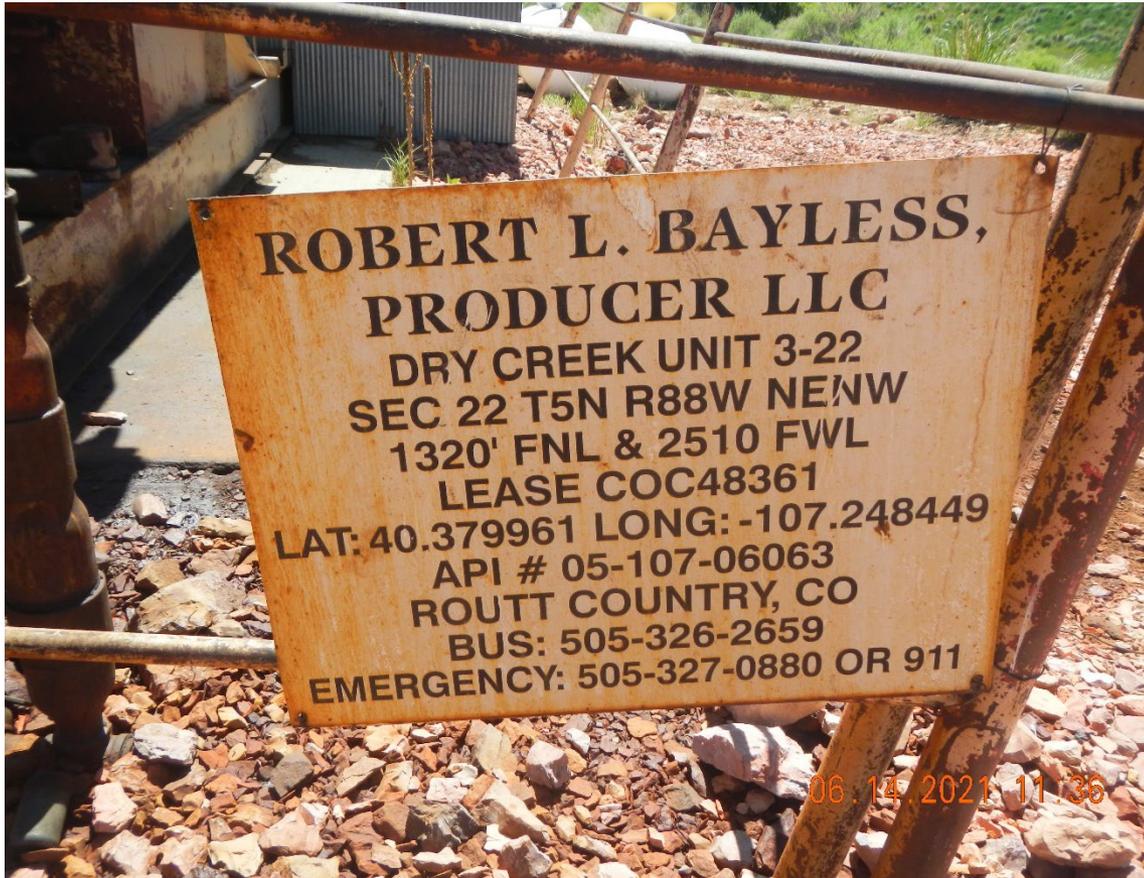
Photo #1 Sign at entry to location

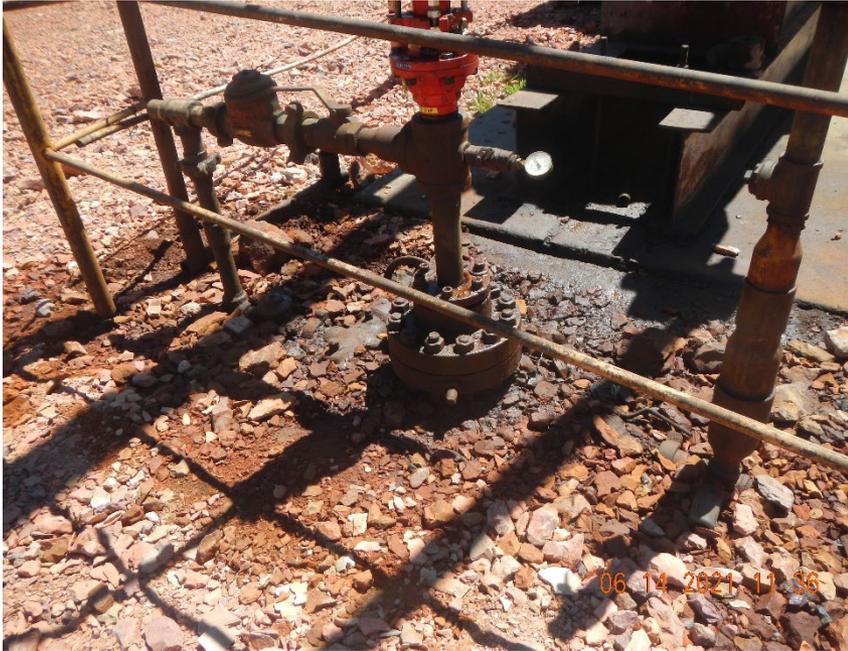
Photo #2 contaminated soil at wellhead.

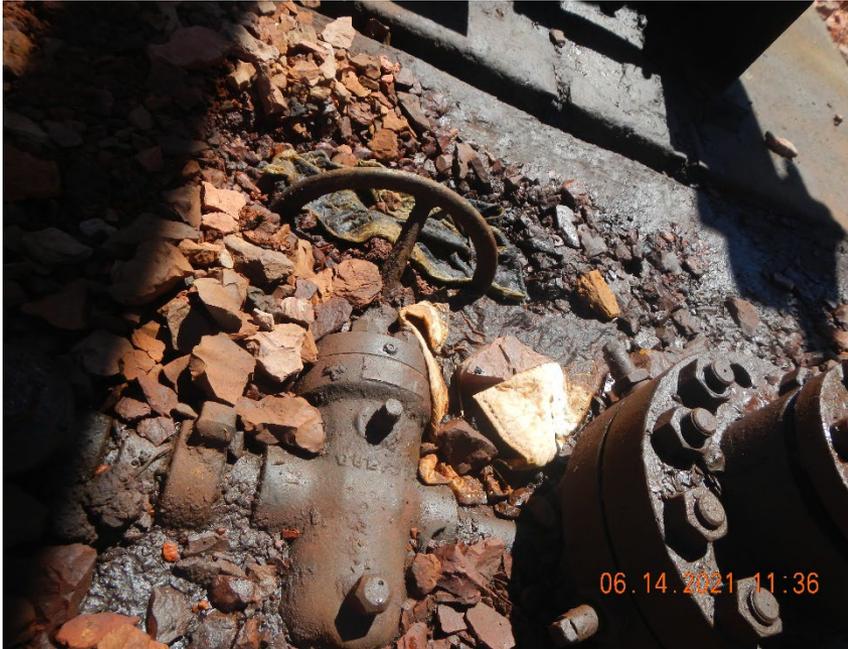
Photo #3 close up of wellhead.

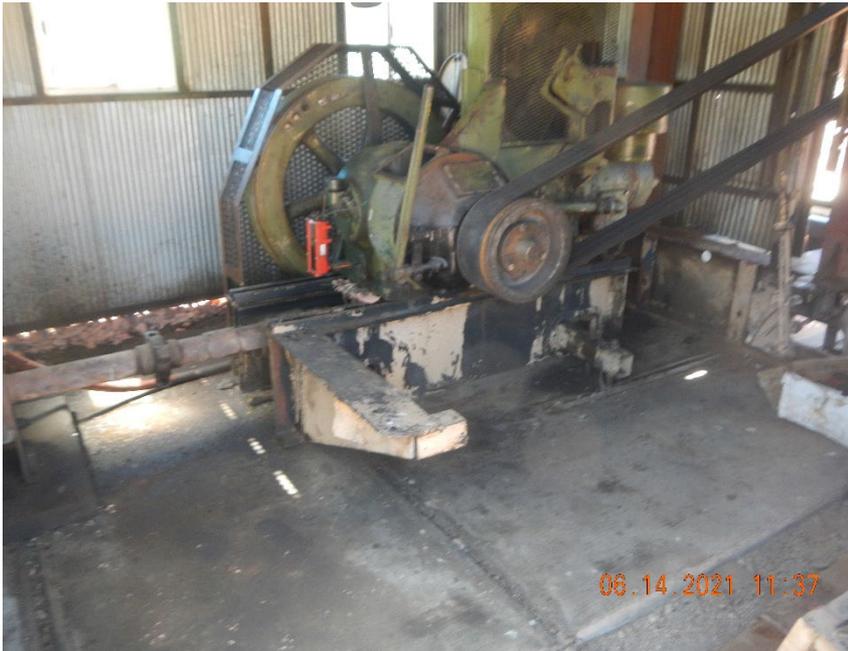
Photo #4 motor drive for Pumpjack.

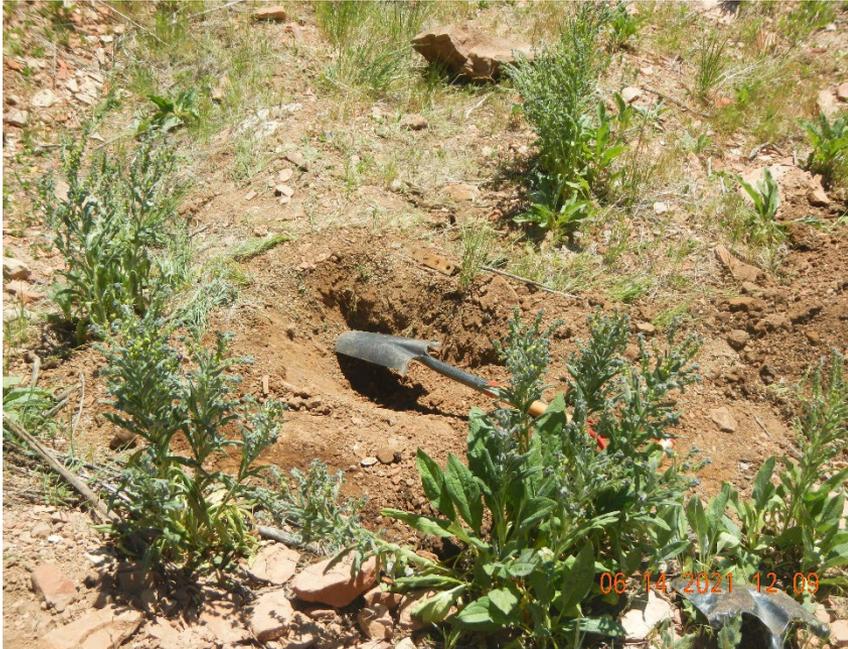
Photo #5 sample location inside pit

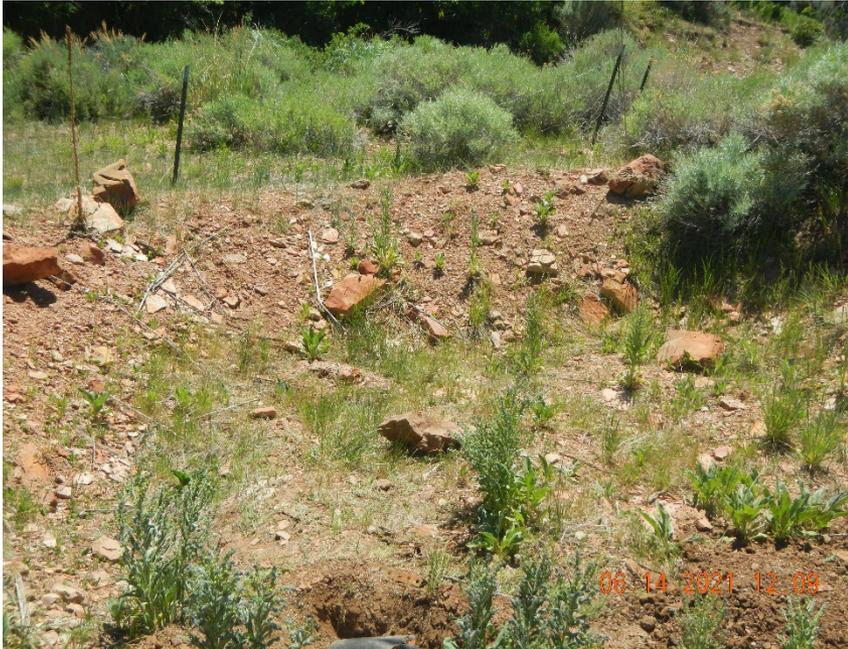
Photo #6 pit, note: old, downed fencing containing pit.

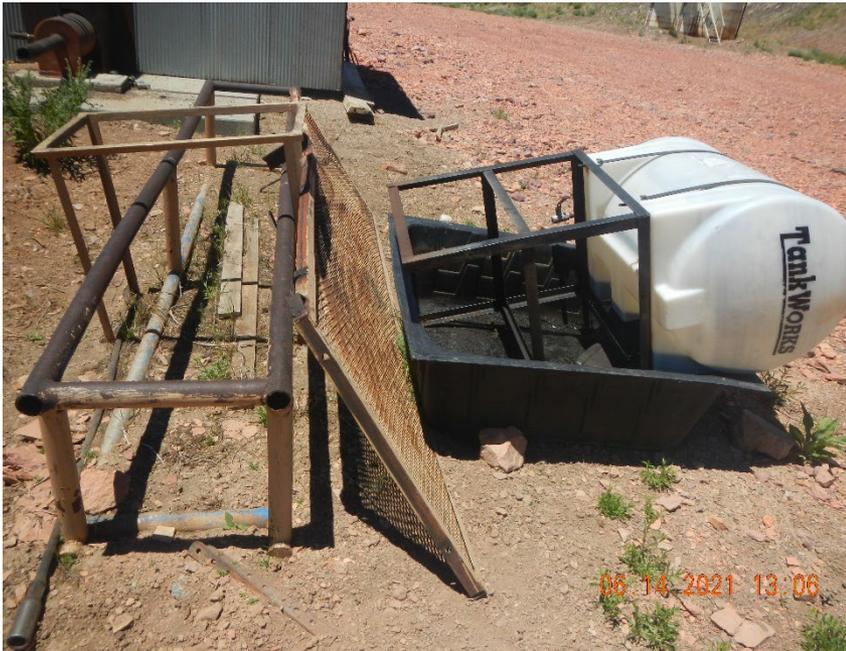
Photo #7 unlabeled tank and other stored equipment. Tank appeared to be empty.
