Inspection Photos
Location Name: Anderson 43-29
Location ID: 313194

COLORADO
Oil & Gas Conservation
Commission
Department of Natural Resources

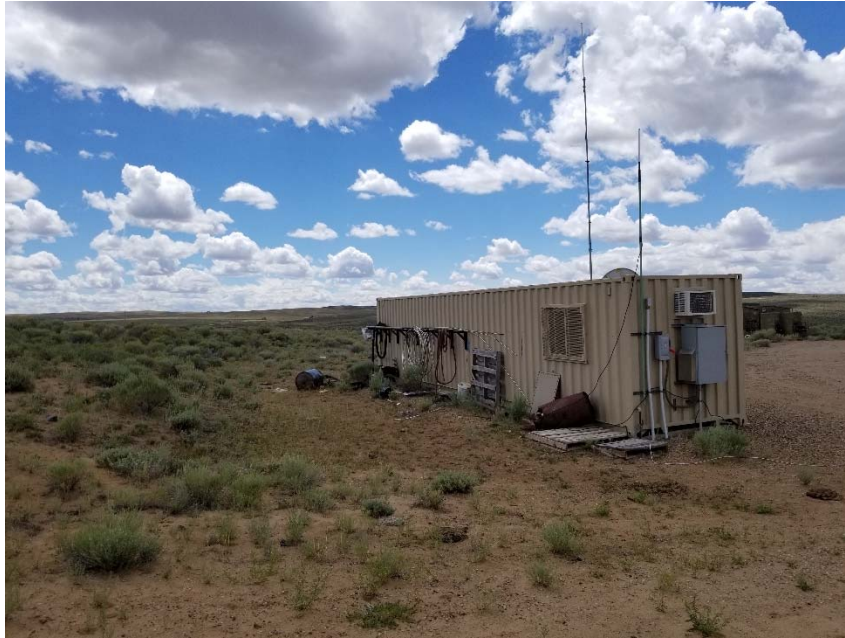
Photo 1. Debris migrating off location.

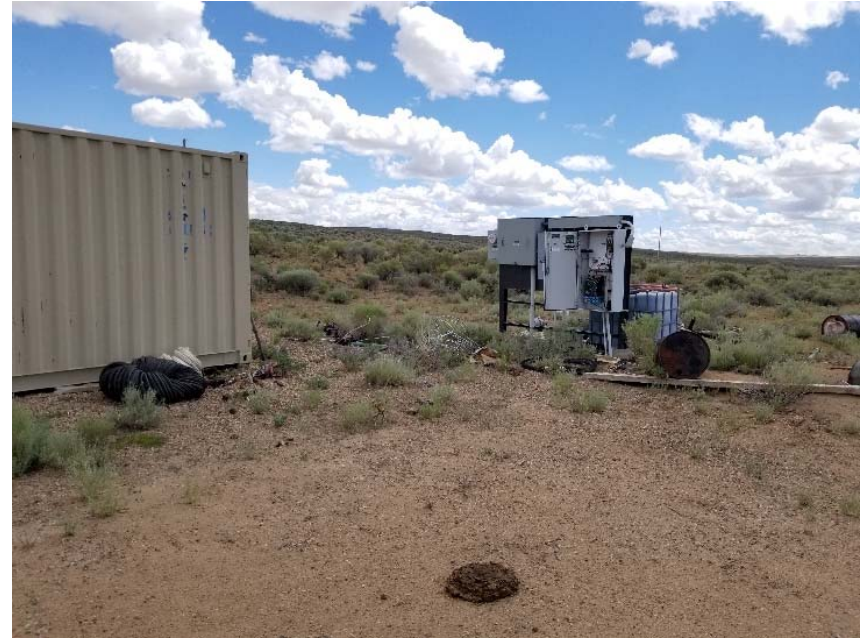
Photo 2. Debris on location.

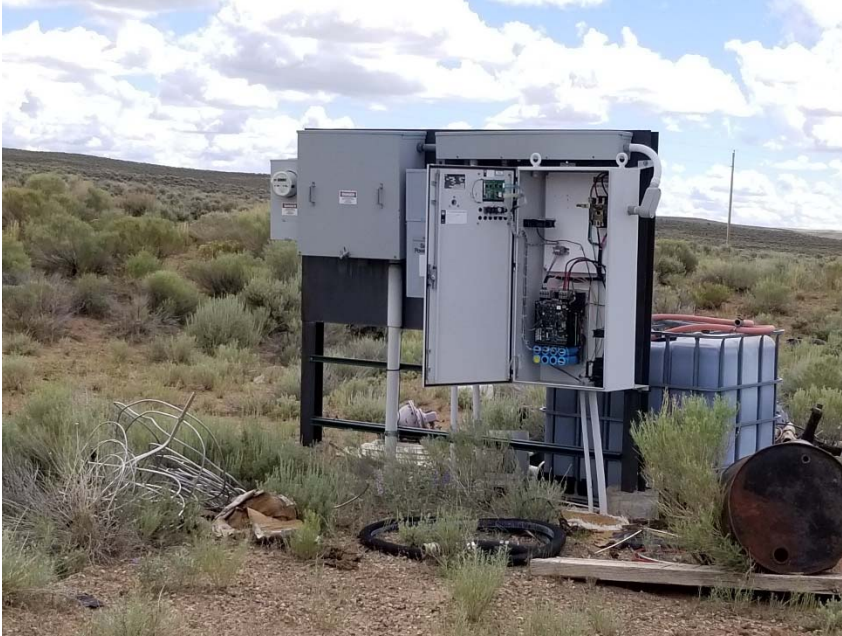
Photo 3. Debris on location.

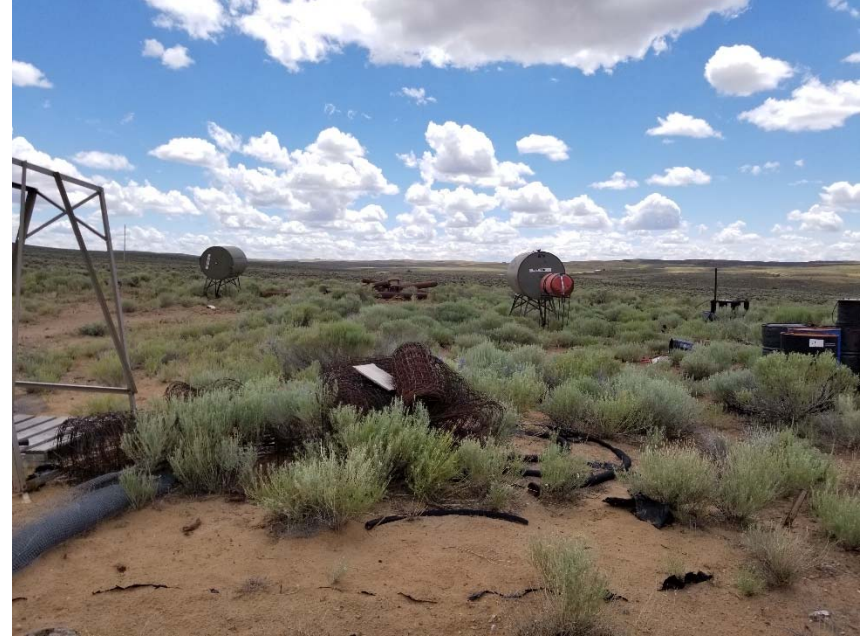
Photo 4. Debris and equipment storage on location.

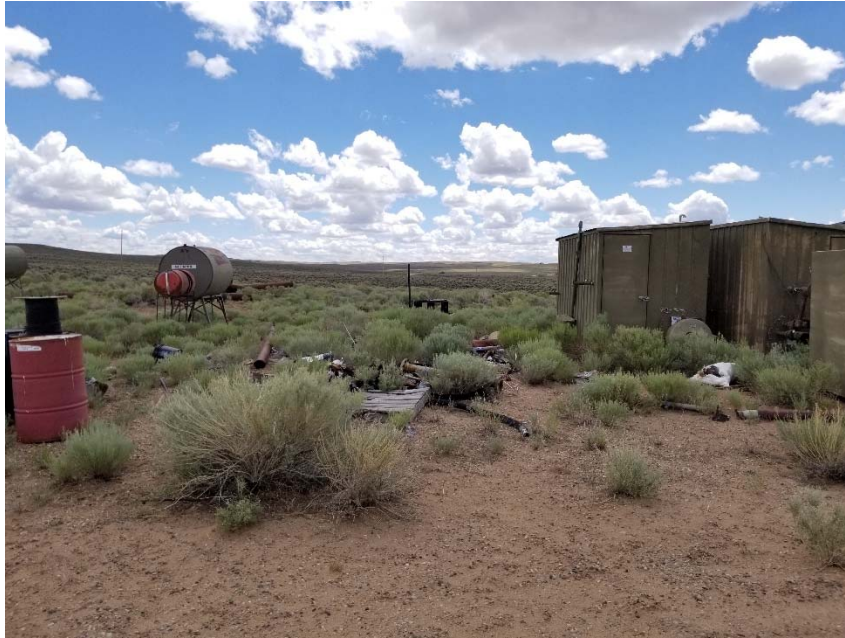
Photo 5. Debris and equipment storage on location.

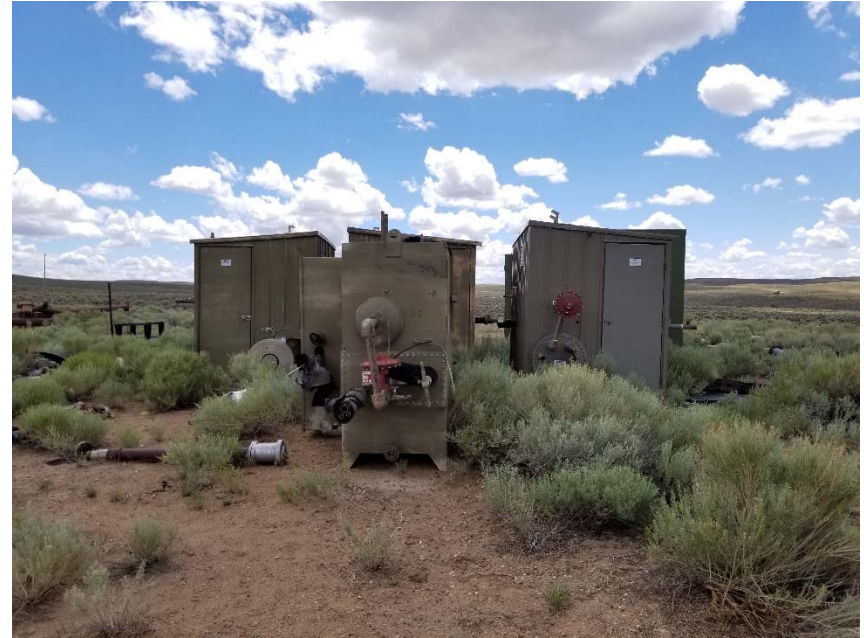
Photo 6. Debris and equipment storage on location.

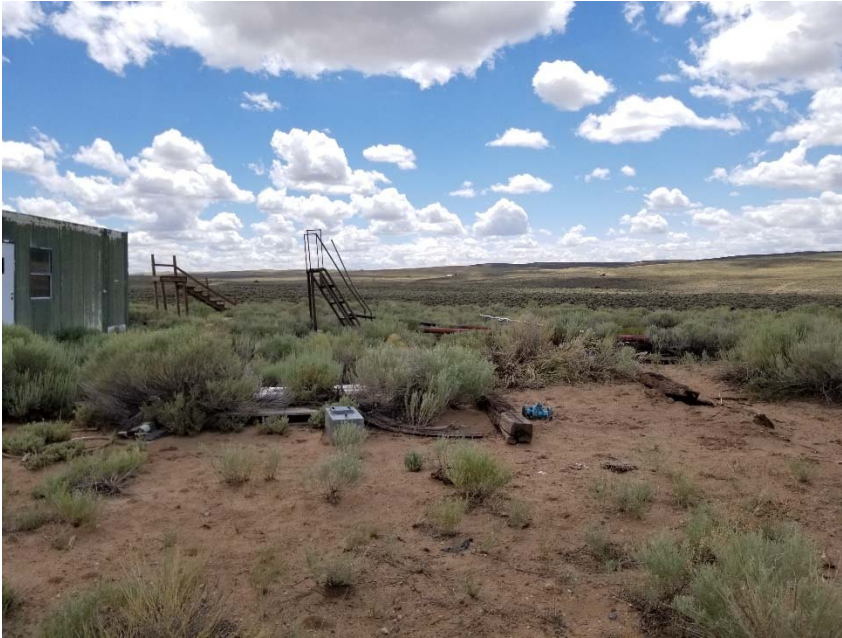
Photo 7. Debris and equipment storage on location.

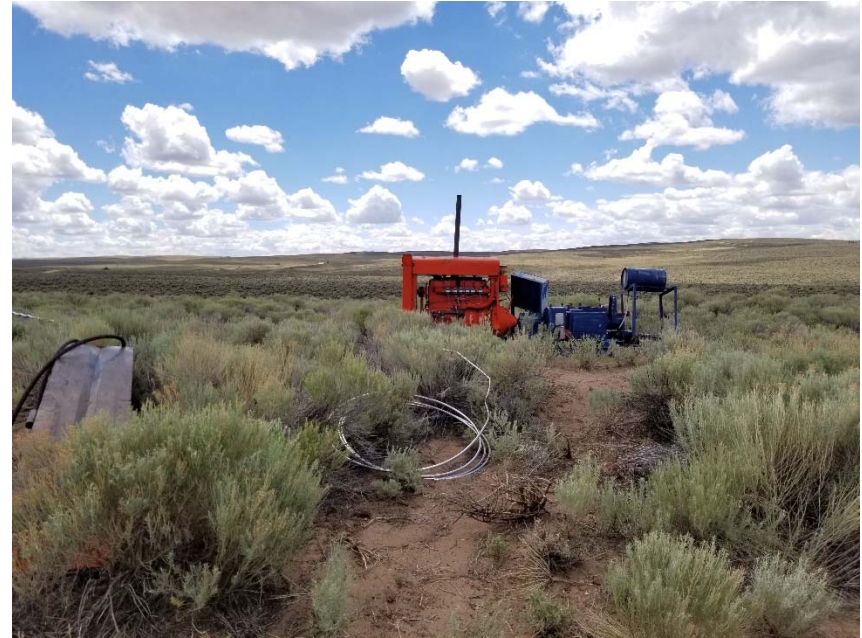
Photo 8. Debris and equipment storage on location.

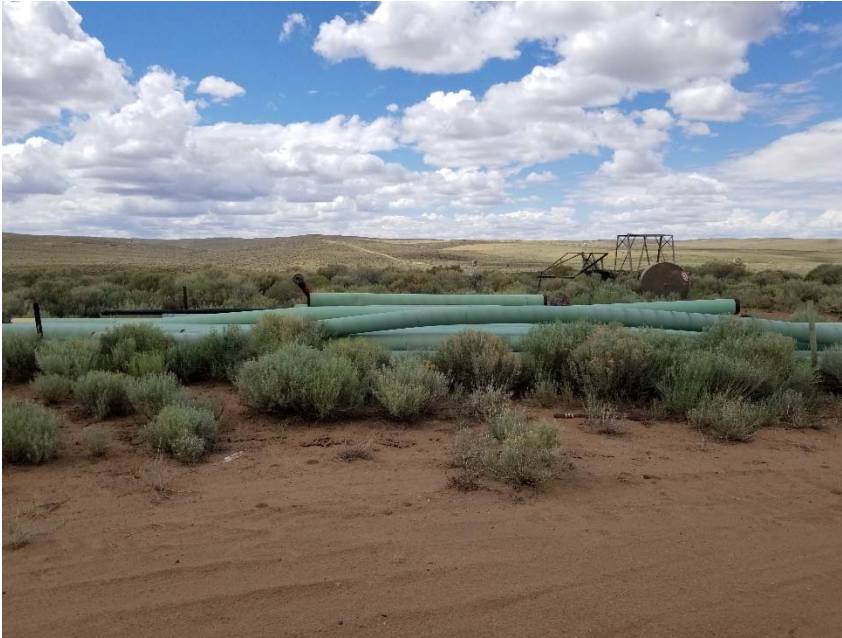
Photo 9. Debris and equipment storage on location.

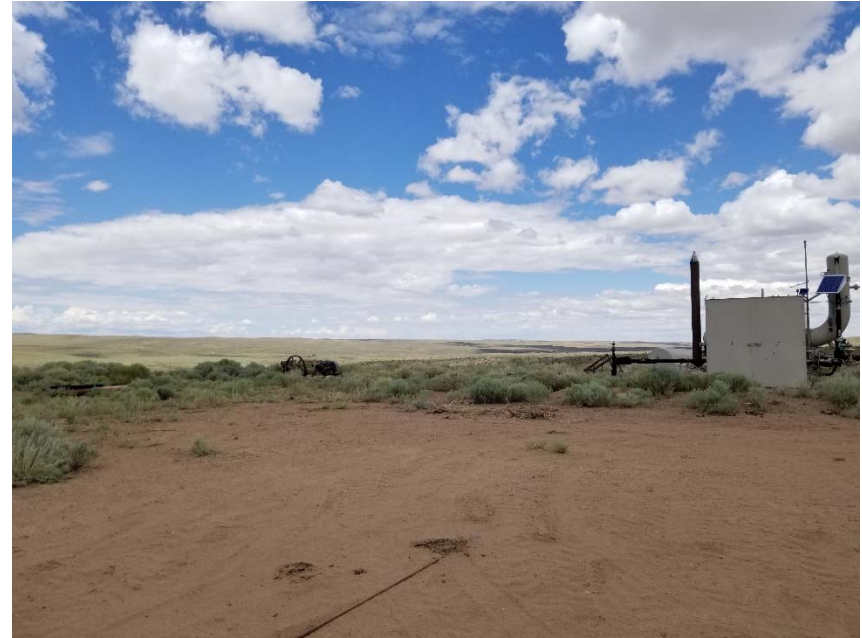
Photo 10. Debris and equipment storage on location.

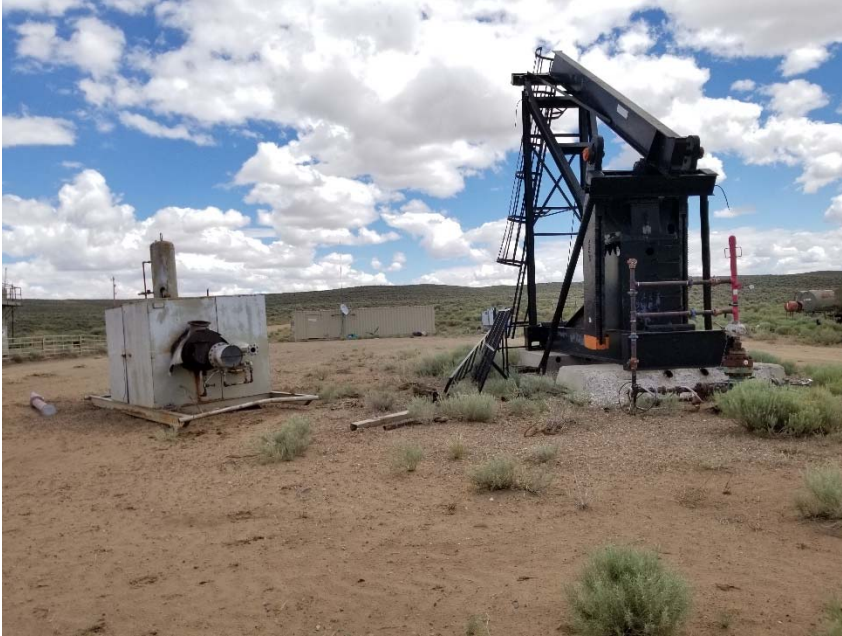
Photo 11. Debris and equipment storage on location.

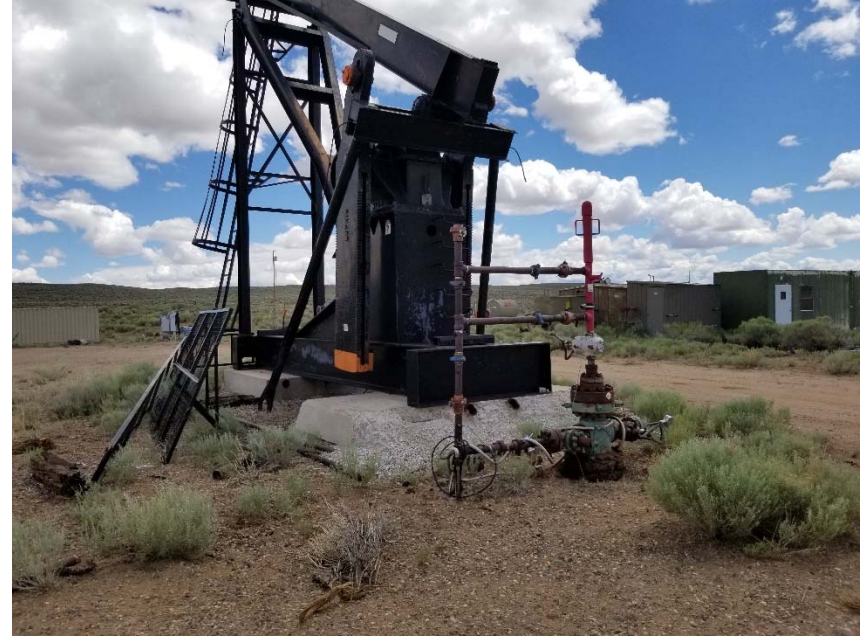
Photo 12. No wellhead sign. No bradenhead access apparent.
