Inspection Photos

7/12/2021

Operator: LARAMIE ENERGY LLC #10433

Location ID: 452807

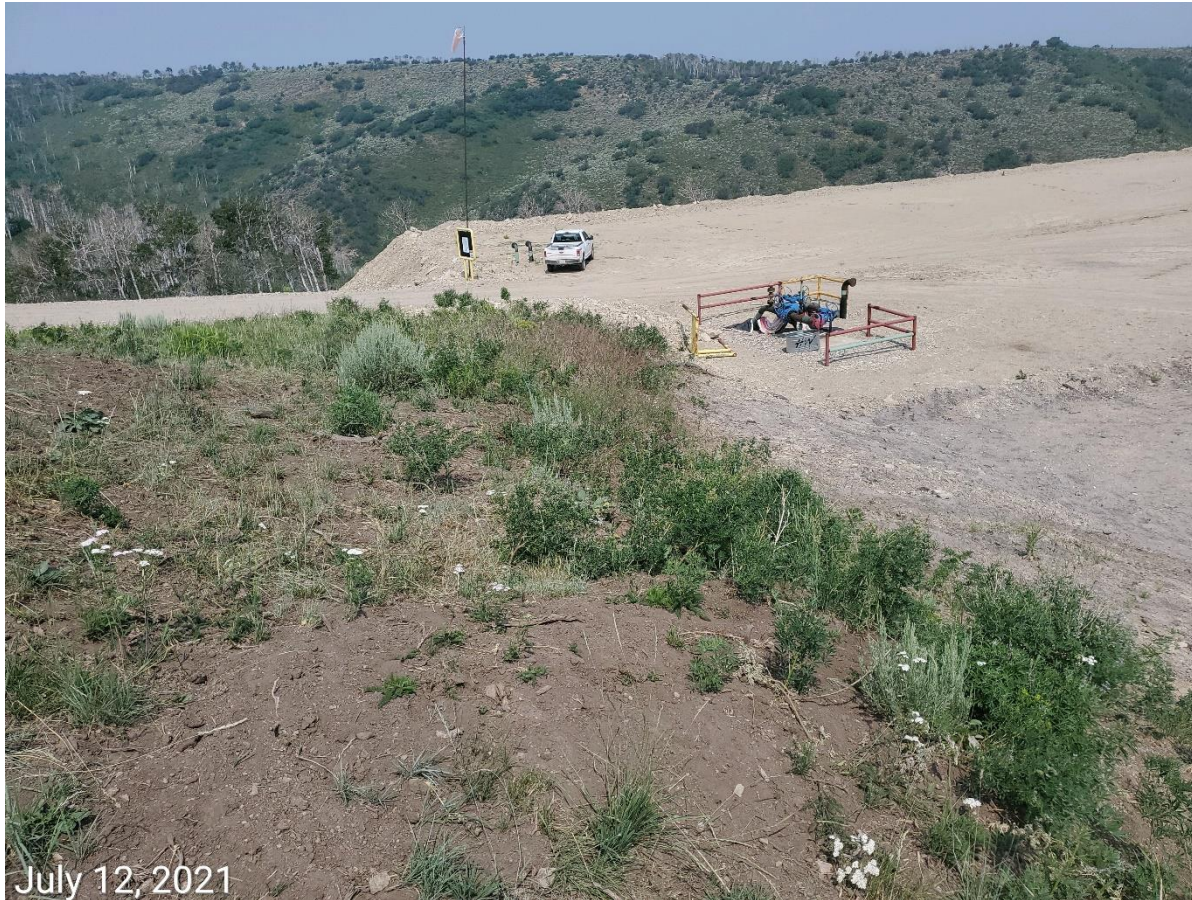
Photo 1: Photo taken from the south end of the Location, facing west. Photos 1-3 provide an overview of the Location from west, northwest, to northeast. Photos show interim reclamation of areas not needed for production on the Location has not been performed.

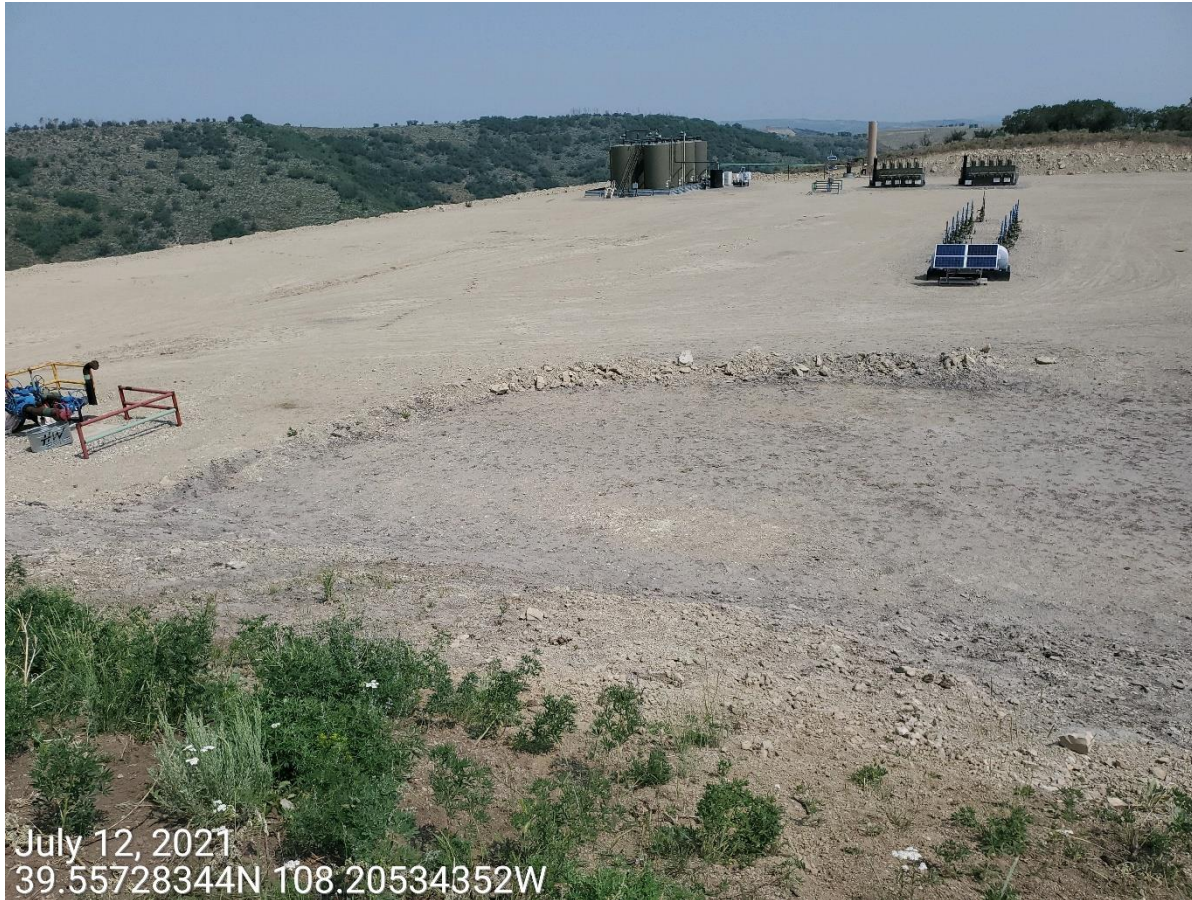
Photo 2: See comments under photo 1.

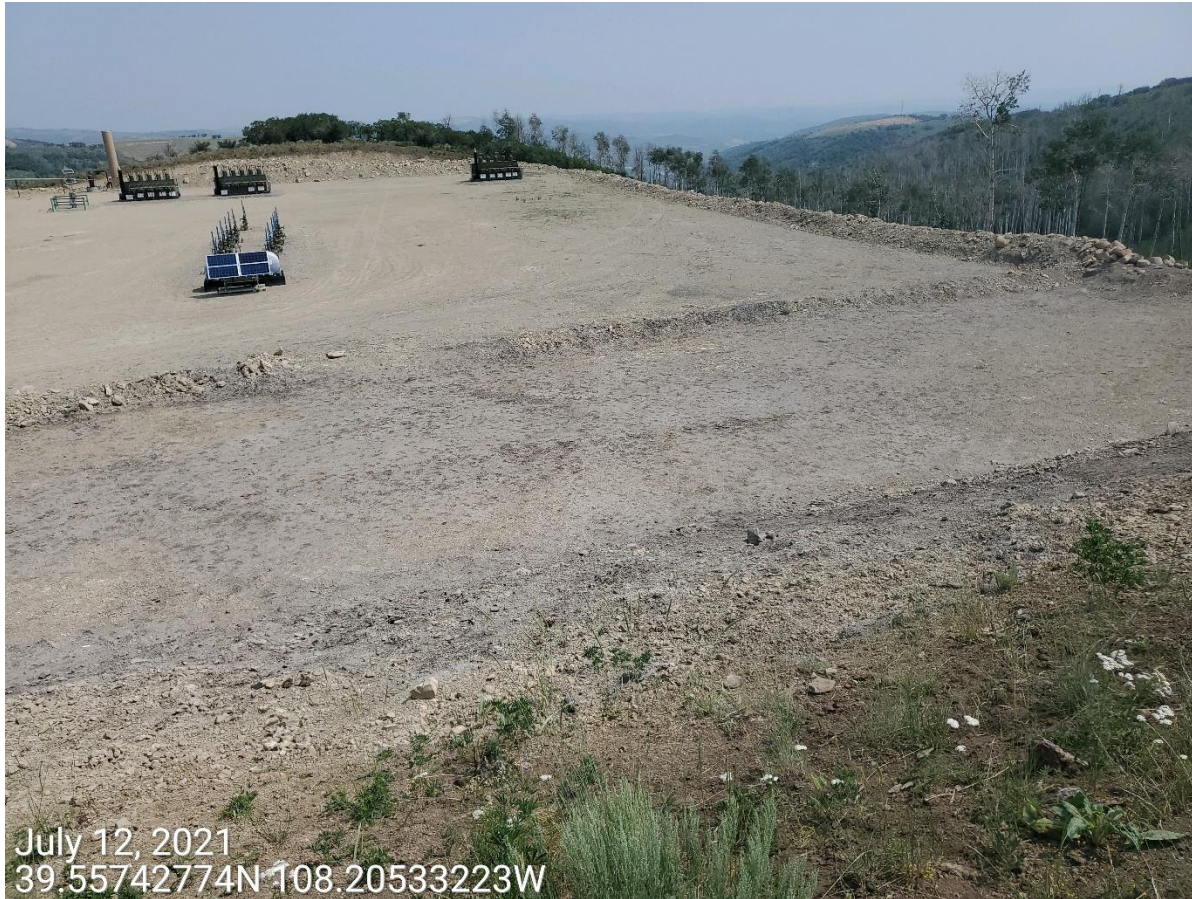
Photo 3: See comments under photo 1.

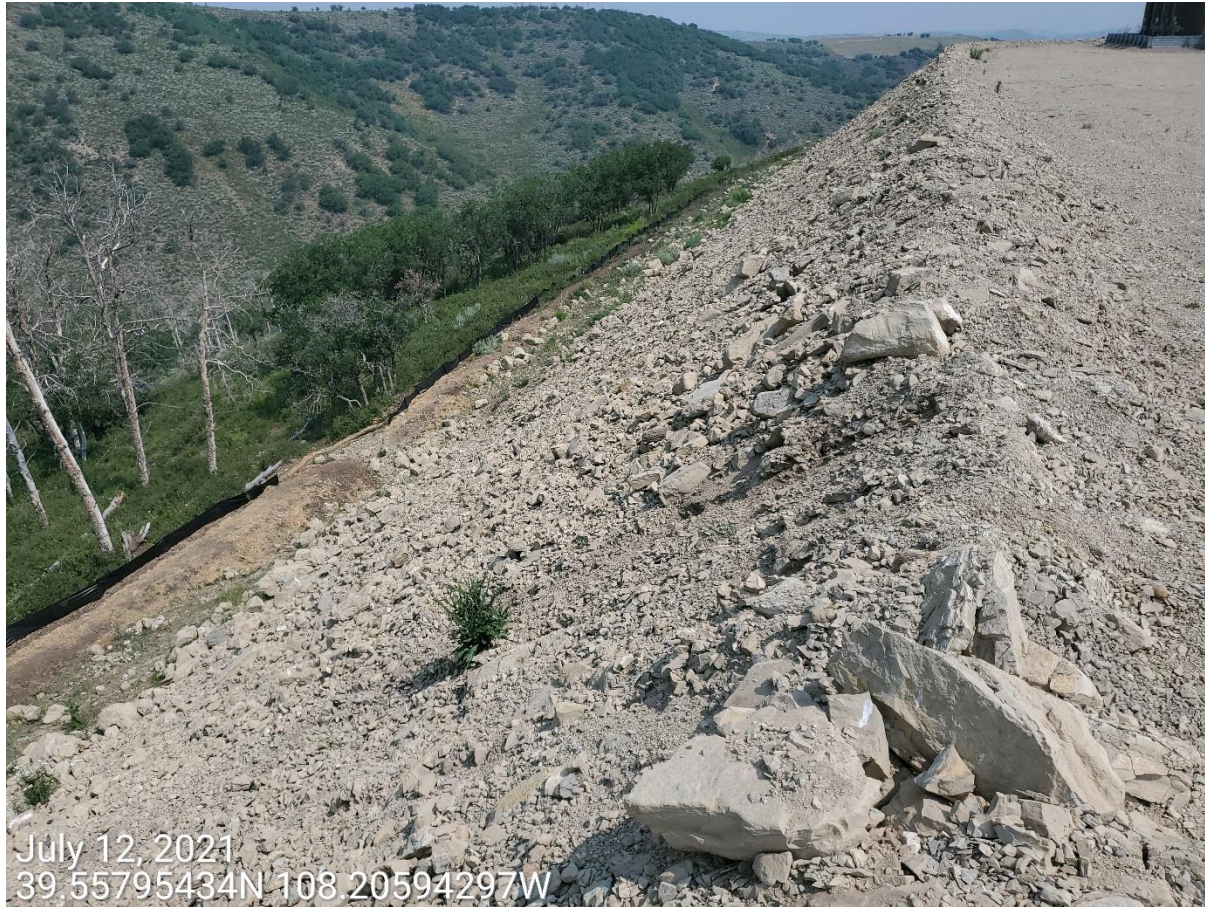
Photo 4: Photo taken from the west end of the Location, facing north. Photo shows control measures to protect and stabilize the fill slopes of the Location have not been installed. Slopes predominantly loose material.

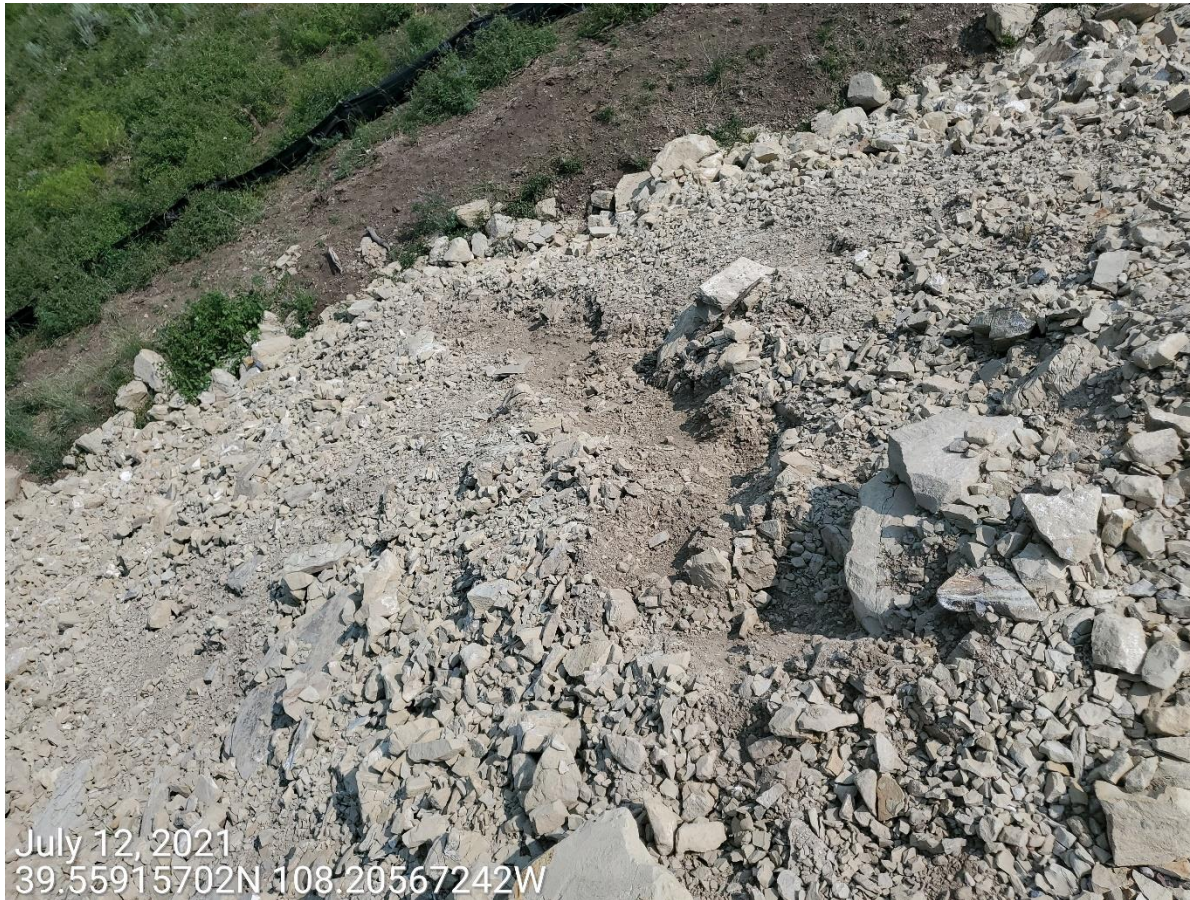
Photo 5: Photo shows control measures to protect and stabilize the fill slopes of the Location have not been installed. Slopes predominantly loose material; erosion degradation evident.

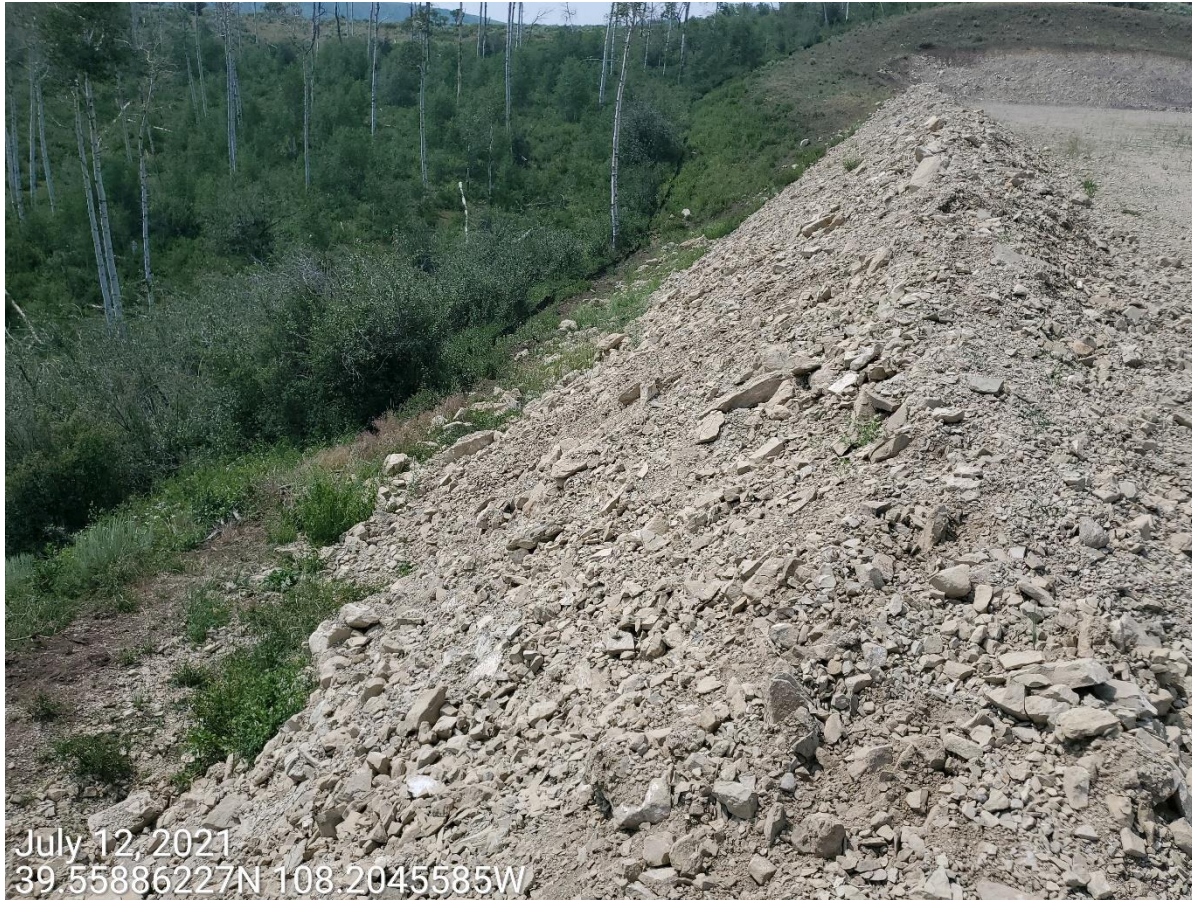
Photo 6: Photo taken from the east end of the Location, facing south. Photo shows control measures to protect and stabilize the fill slopes of the Location have not been installed. Slopes predominantly loose material

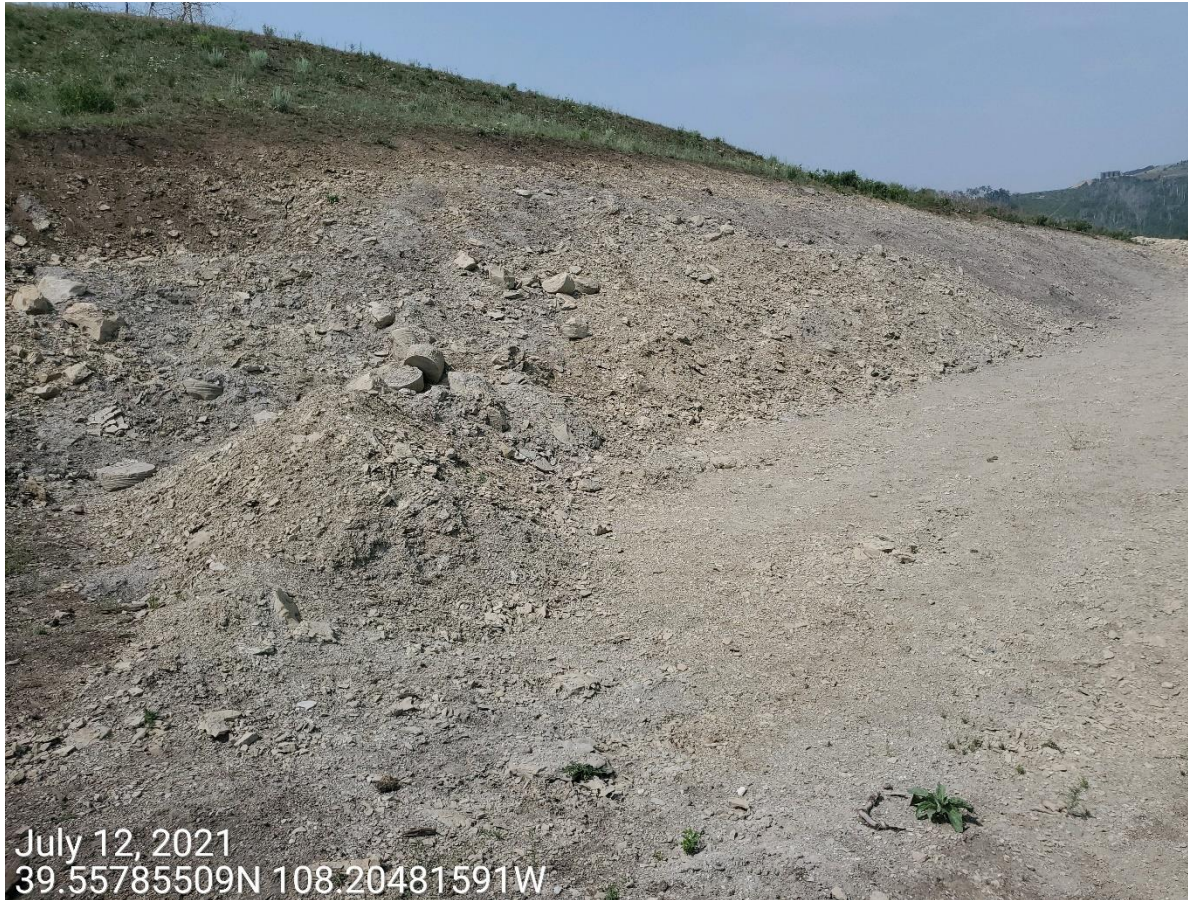
Photo 7: Photo taken from the southeast end of the Location, facing southwest. Photos 7-9 provide an overview of the Location from southwest, west to north. Photos show interim reclamation of areas not needed for production on the Location has not been performed.

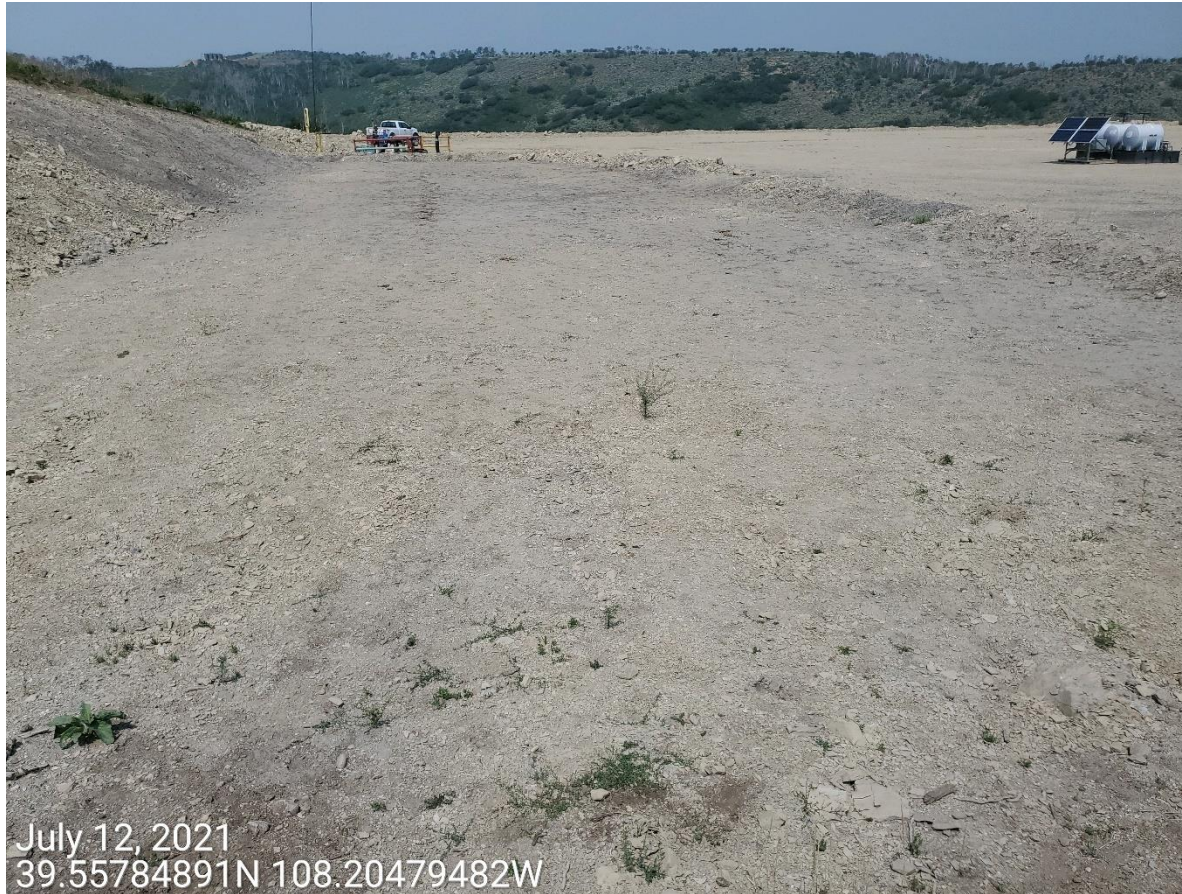
Photo 8: See comments under photo 7.

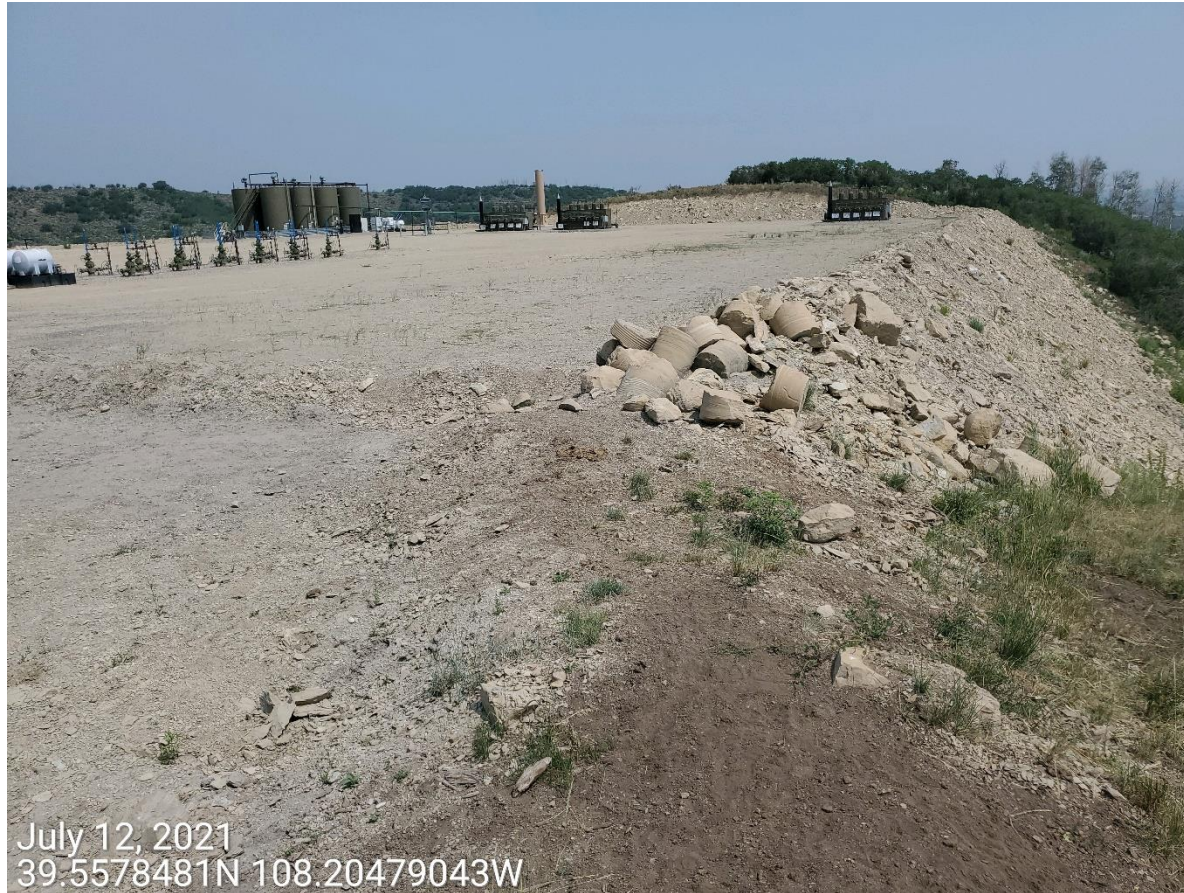
Photo 9: See comments under photo 7.

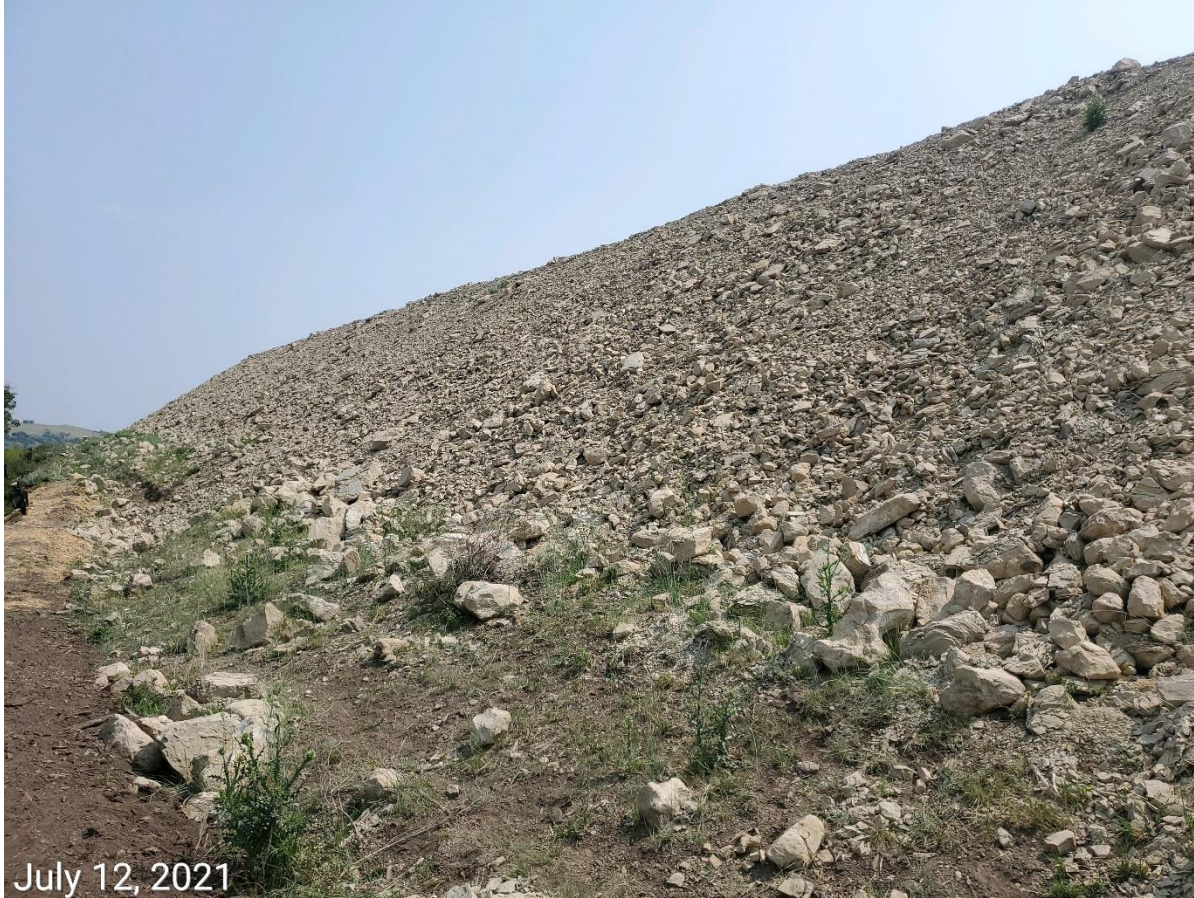
Photo 10: Photo taken from the west end of the Location, facing northeast. Photo shows control measures to protect and stabilize the fill slopes of the Location have not been installed. Slopes predominantly loose material

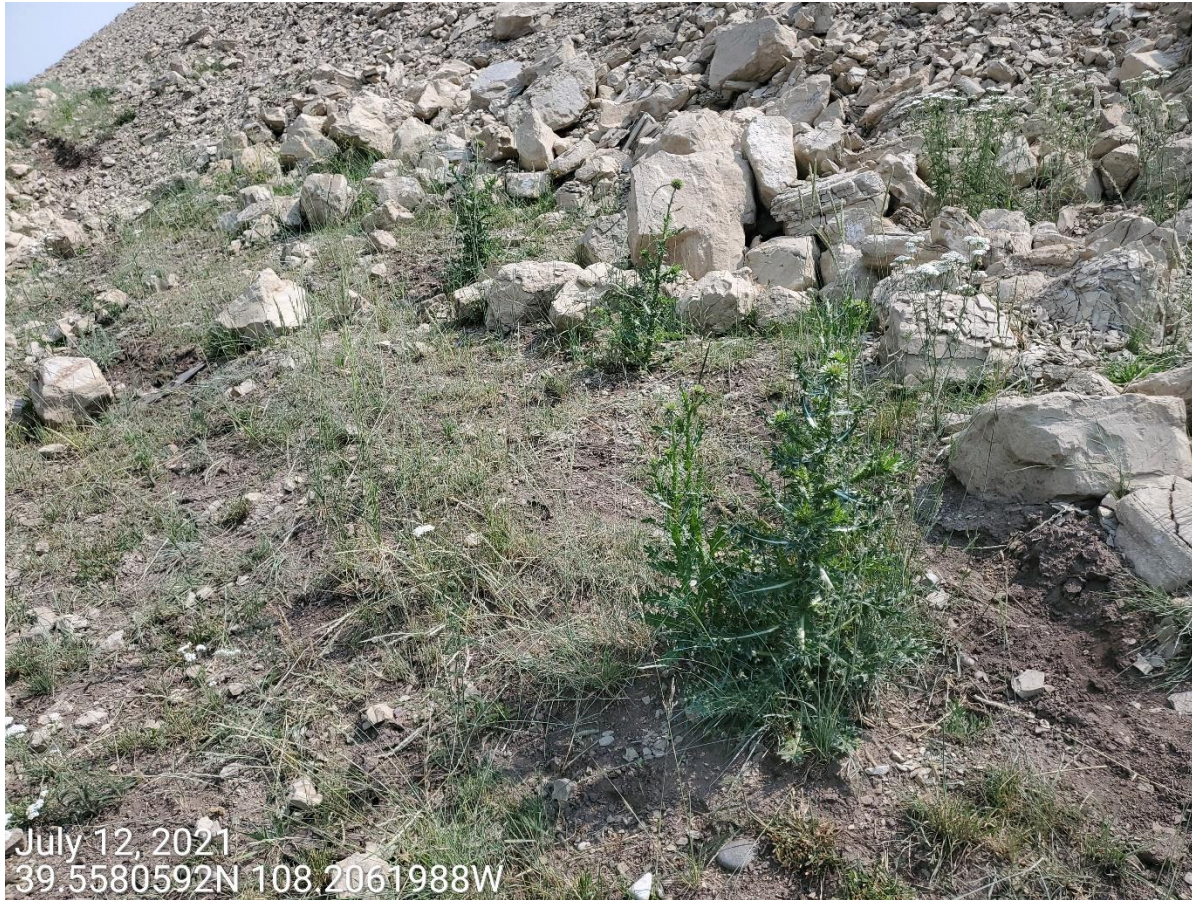
Photo 11: Photo taken from the west end of the Location, facing northeast. Photo shows example of noxious weeds (Musk thistle) observed on the location.

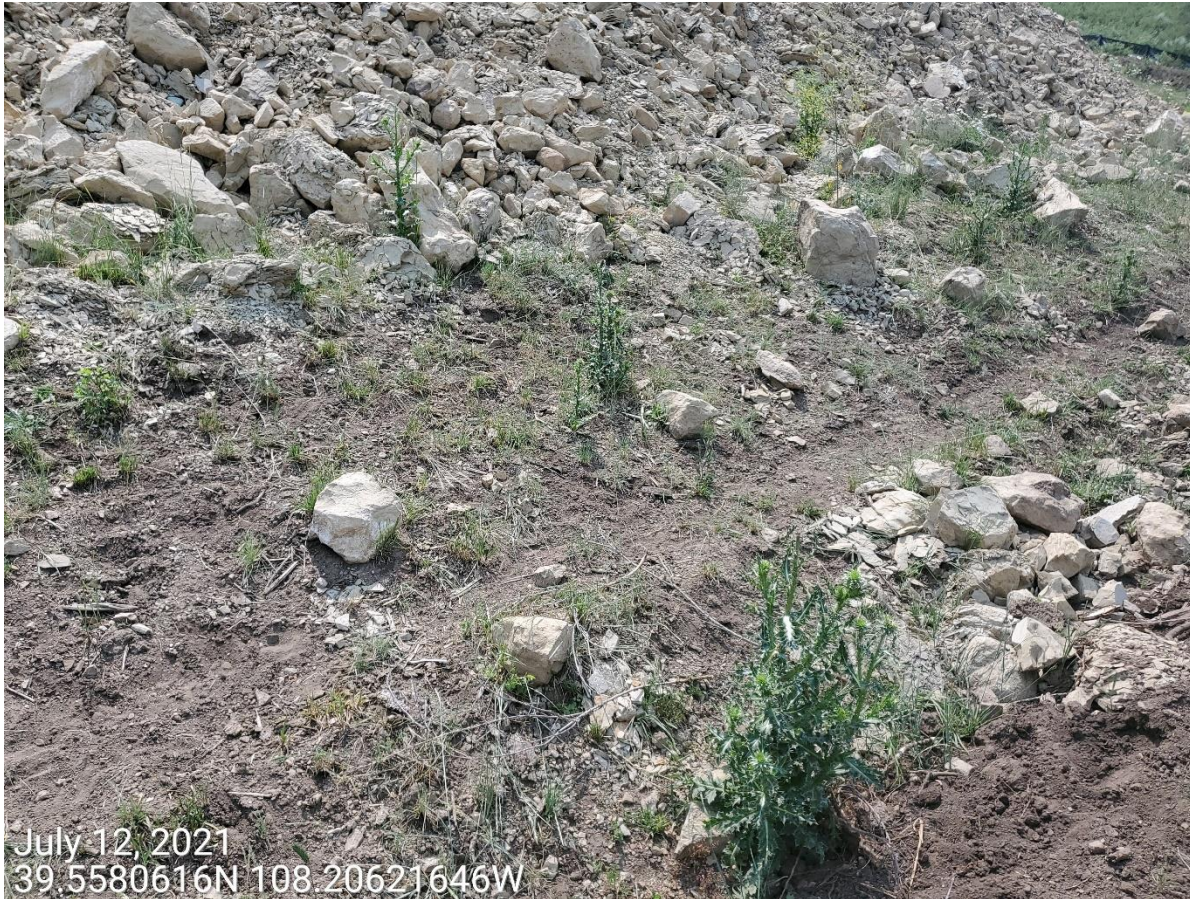
Photo 12: Photo taken from the west end of the Location, facing southeast. Photo shows example of noxious weeds (Musk thistle) observed on the location.

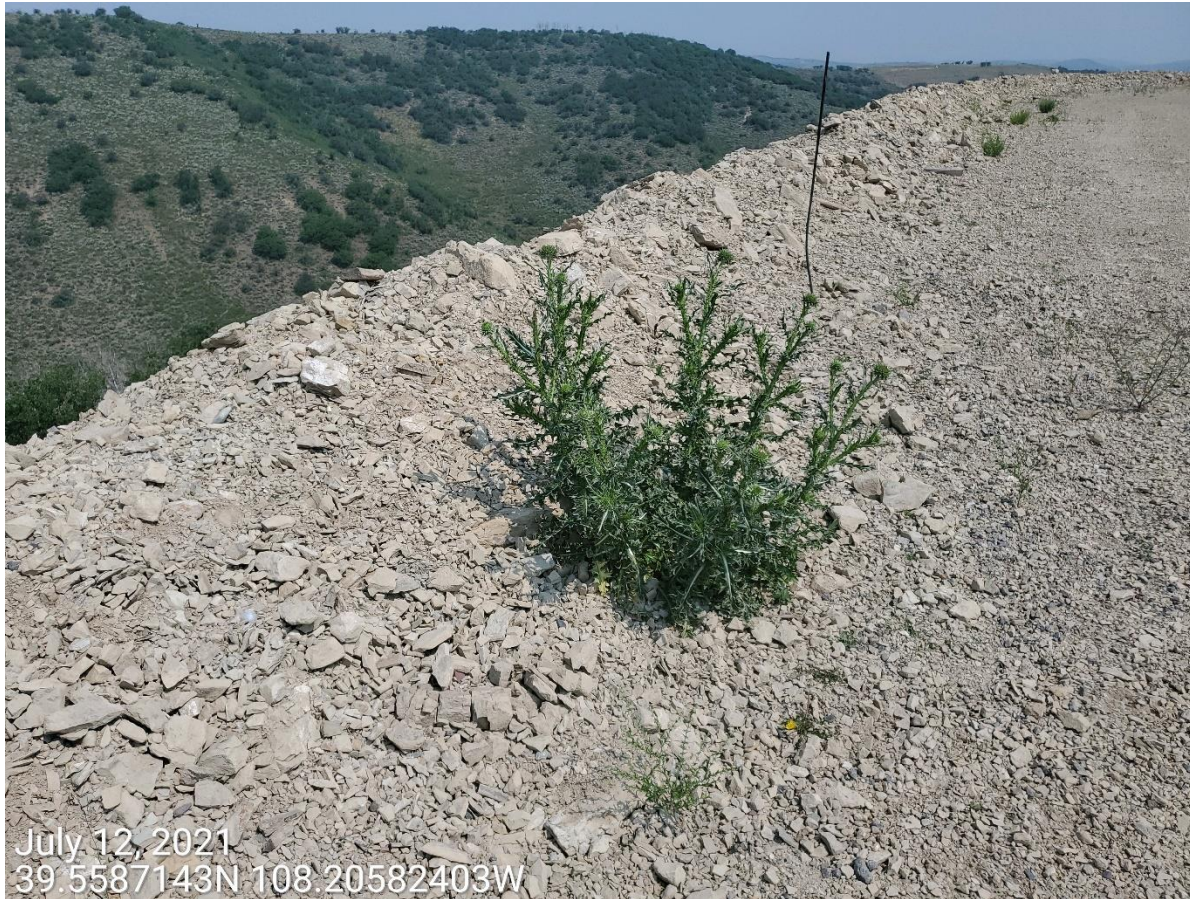
Photo 13: Photo taken from the west end of the pad, facing northwest. Photo shows example of noxious weeds (Musk thistle) observed on the location.

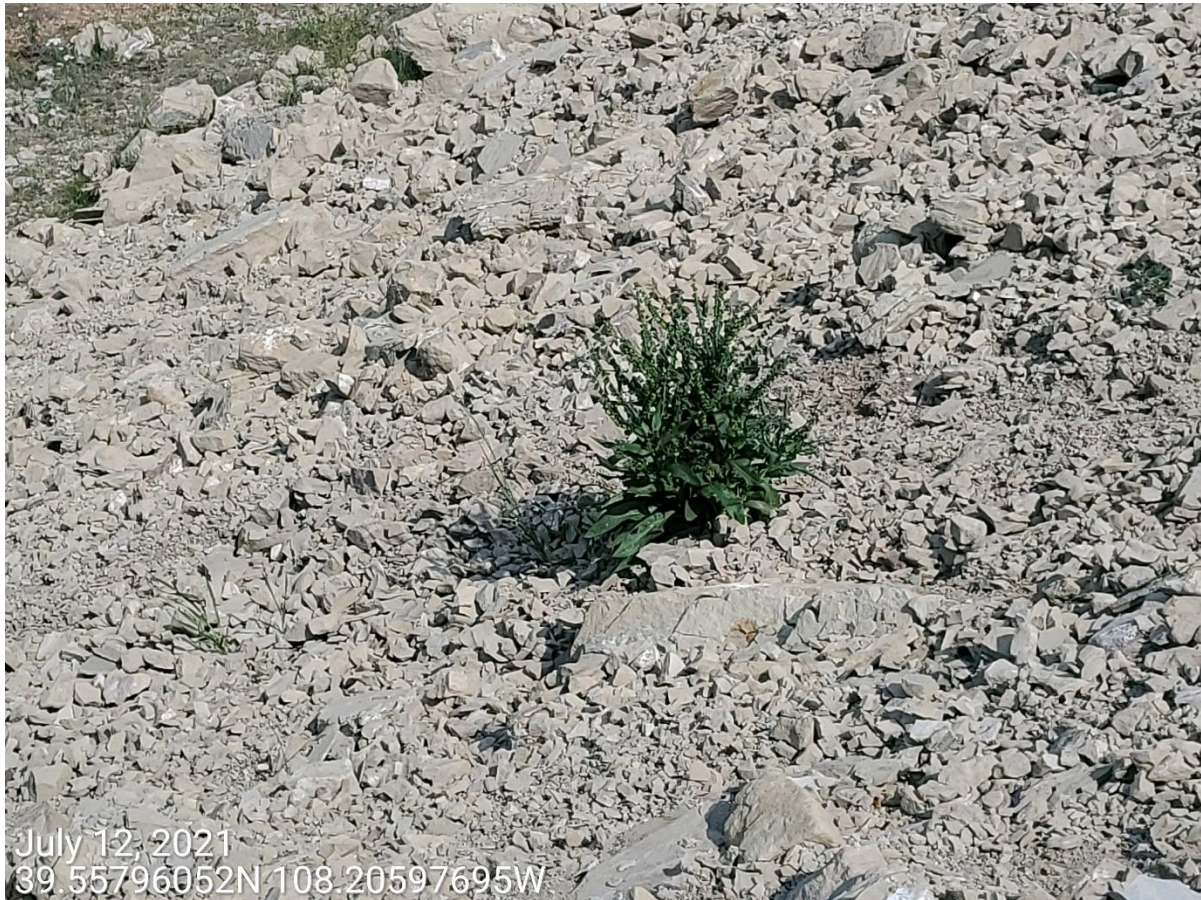
Photo 14: Photo taken from the west end of the Location, facing northwest. Photo shows example of noxious weeds (Houndstongue) observed on the location.

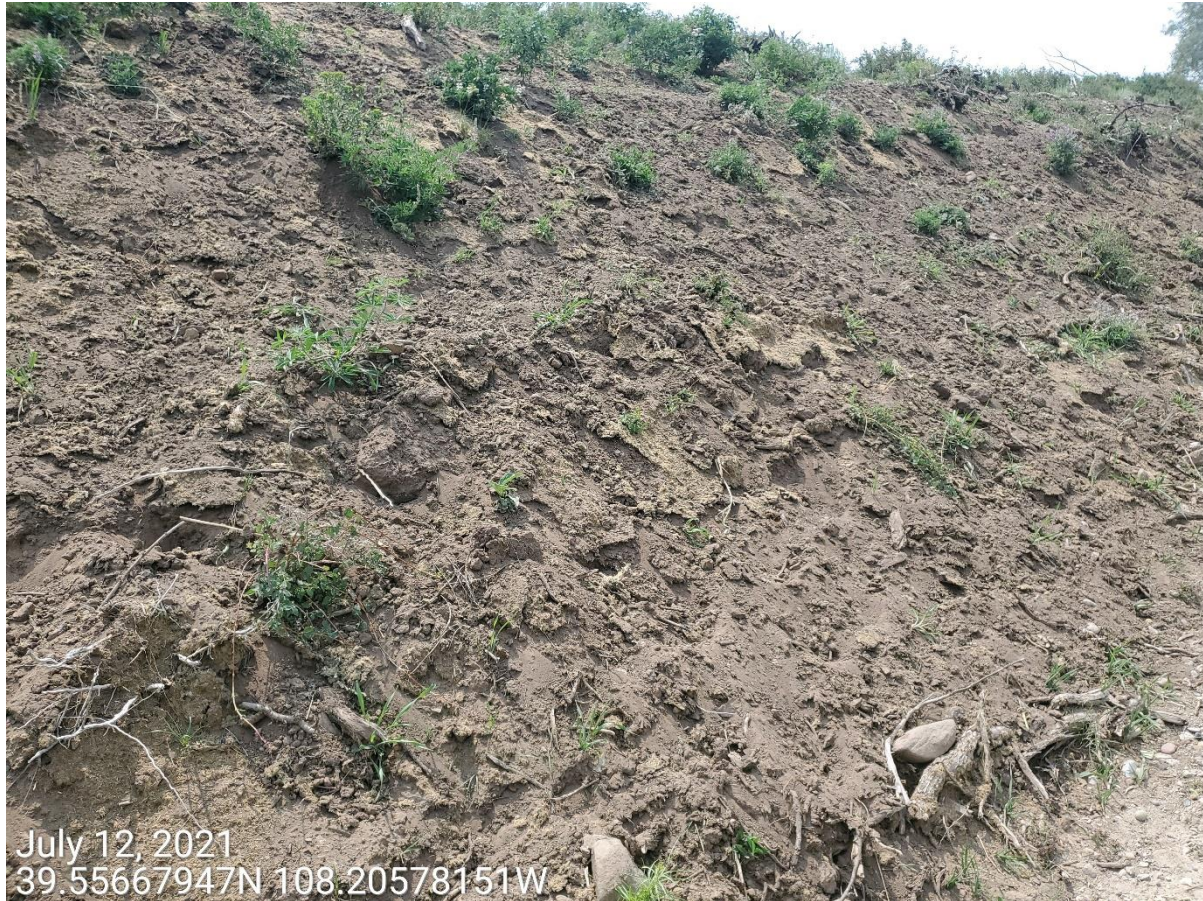
Photo 15: Photo taken from the access road. Previous inspections required Operator to conduct additional reclamation on the access road, and to implement control measures to stabilize the seeded soil and slopes. Operator submitted Resolution #402720079 showing additional seeding was performed along the slopes of the road and hydromulch applied. Photo shows hydromulch has not been maintained, and is no longer in proper functioning condition.

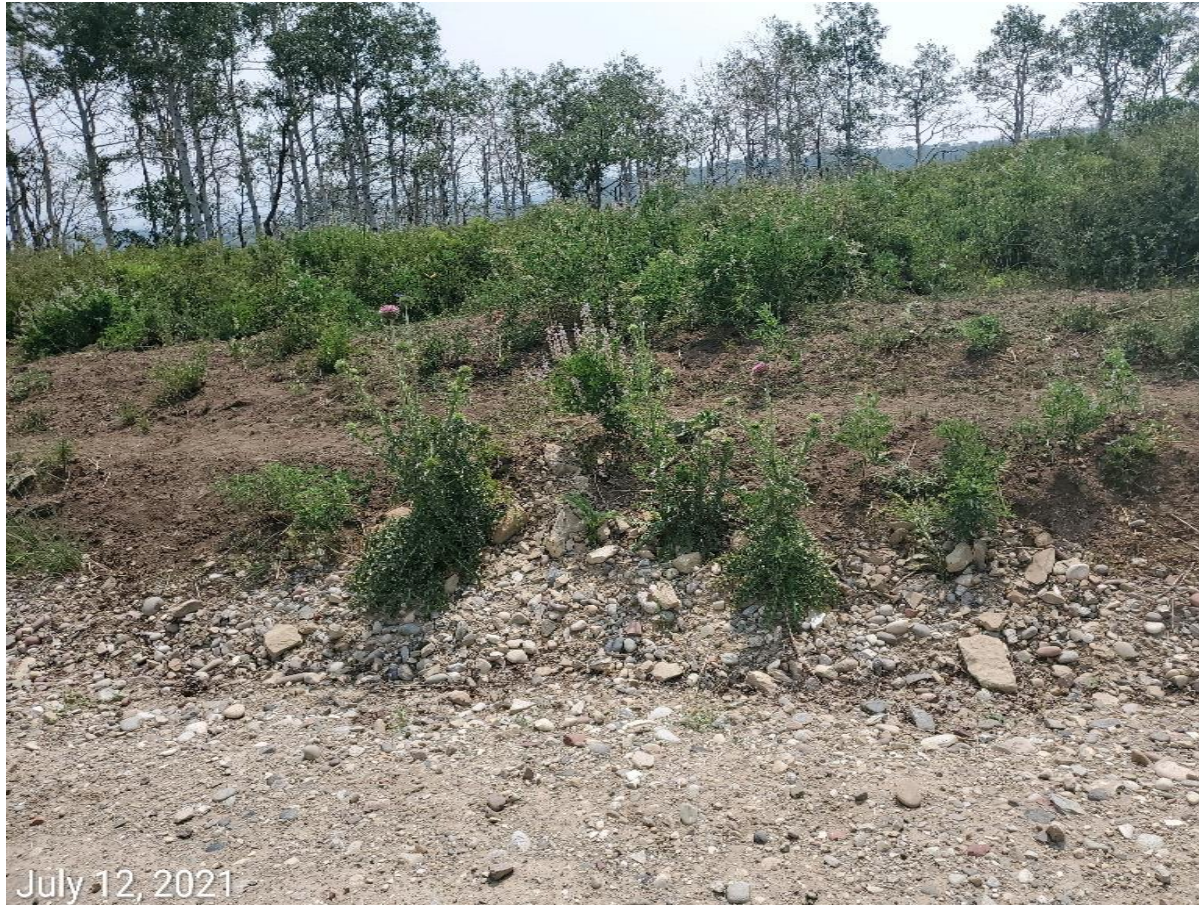
Photo 16: Photo shows noxious weeds (Musk thistle) established along the access road.
