Inspection Photos
Operator: Simcoe
API: 067-07487
Date: 7/13/2021

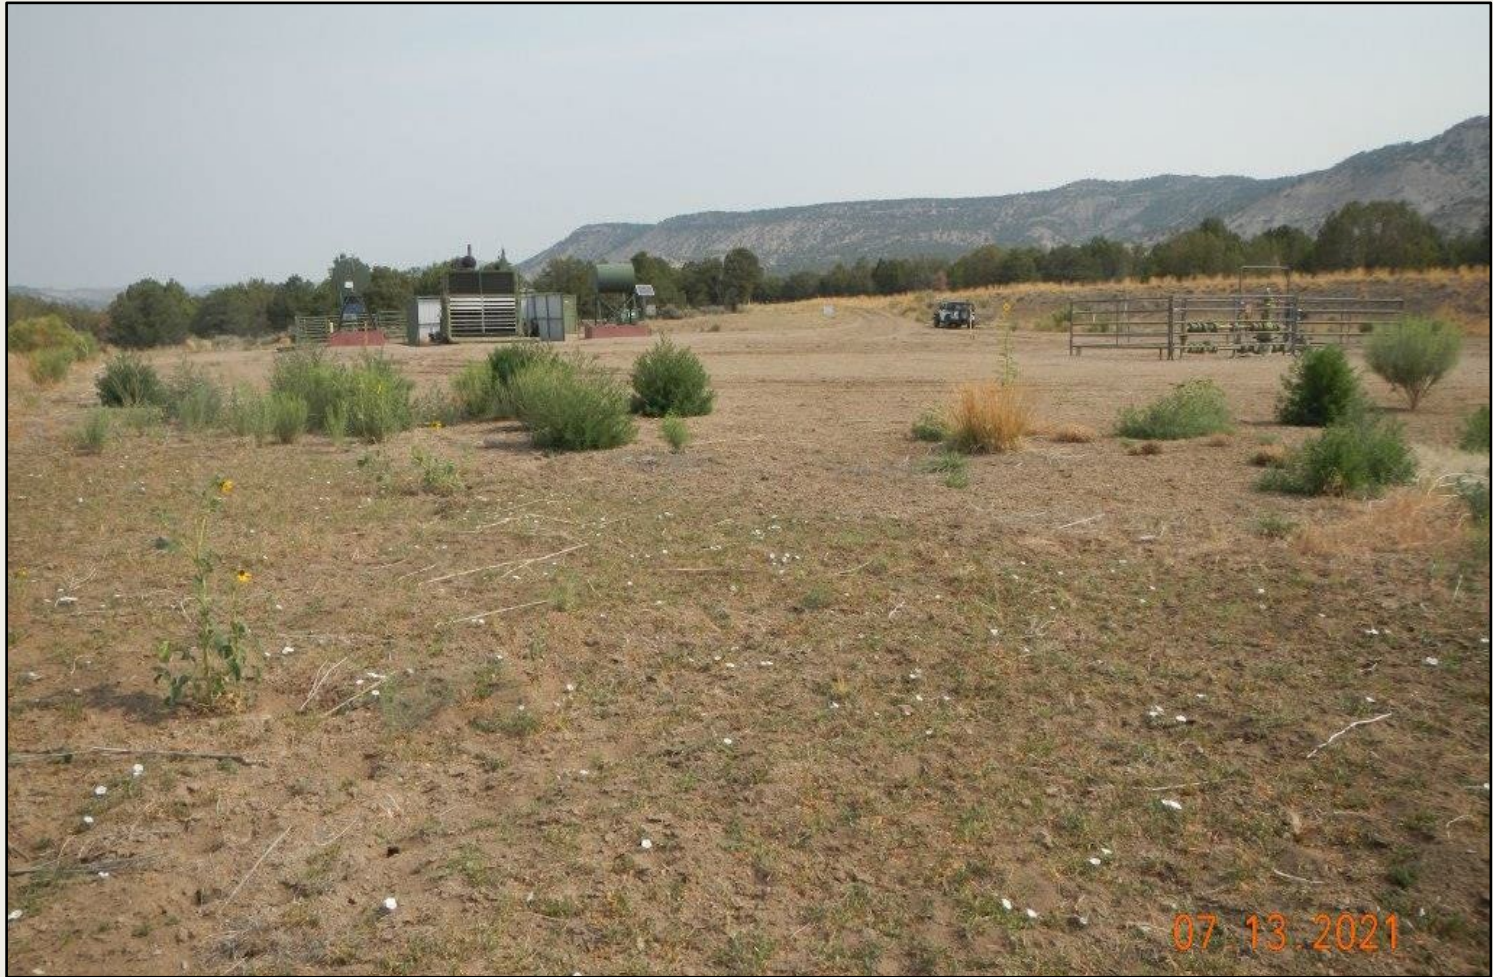
Photo 1. View the project area from the southwestern corner facing center.

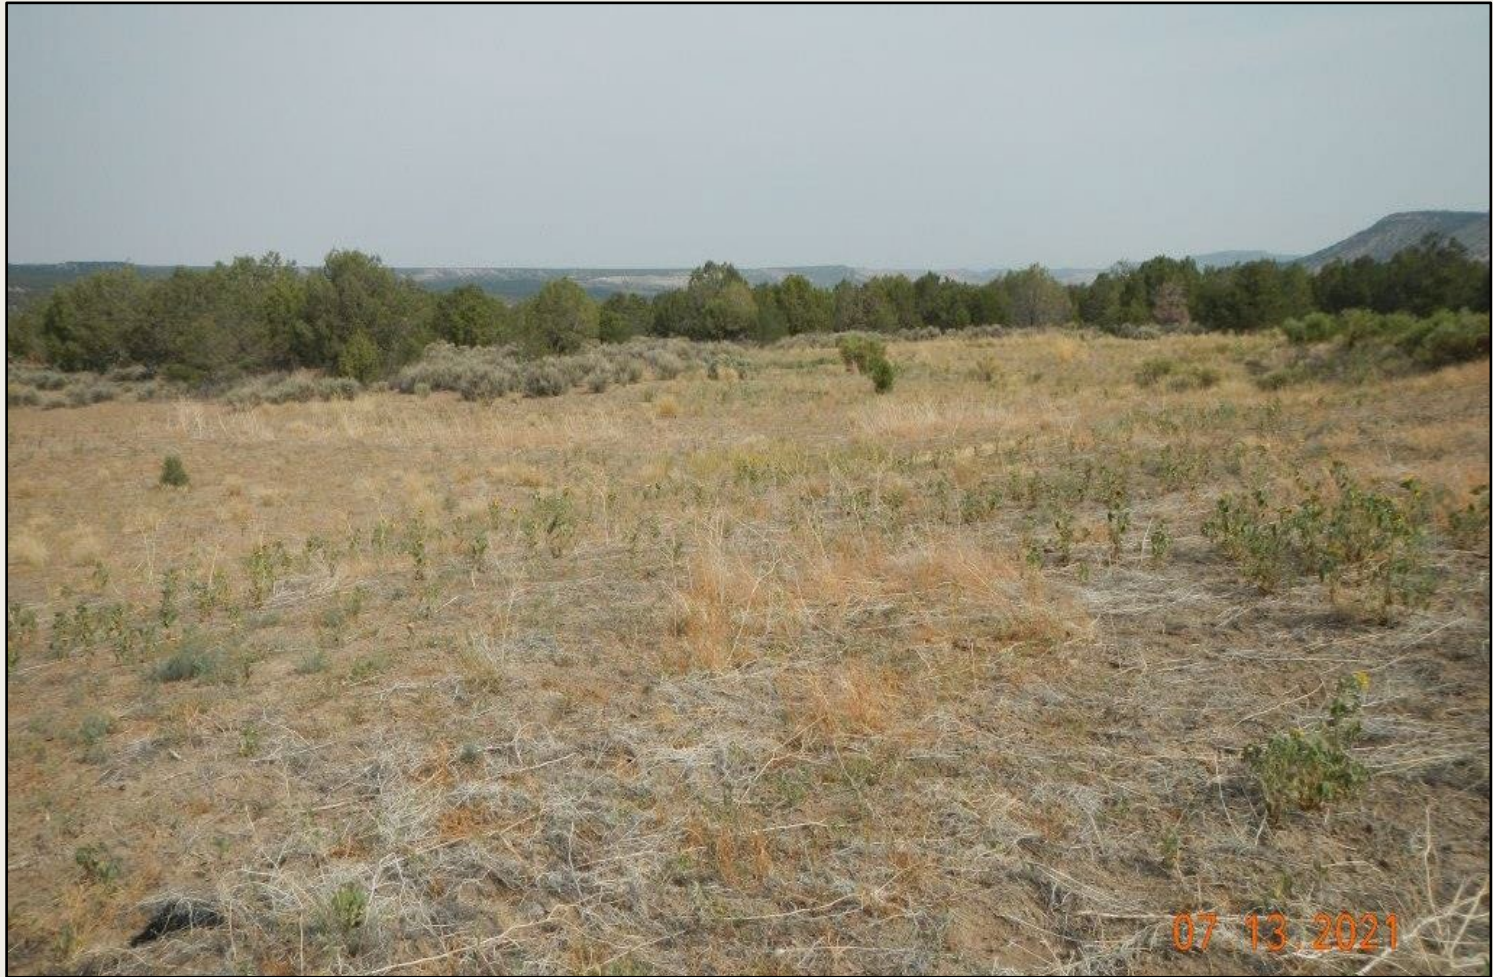
Photo 2. View of the western project area from the southwestern corner facing northward. Revegetation is progressing in portions with western wheatgrass, crested wheatgrass, and rubber rabbitbrush. Other portions remain sparse and weedy and need to be monitored.

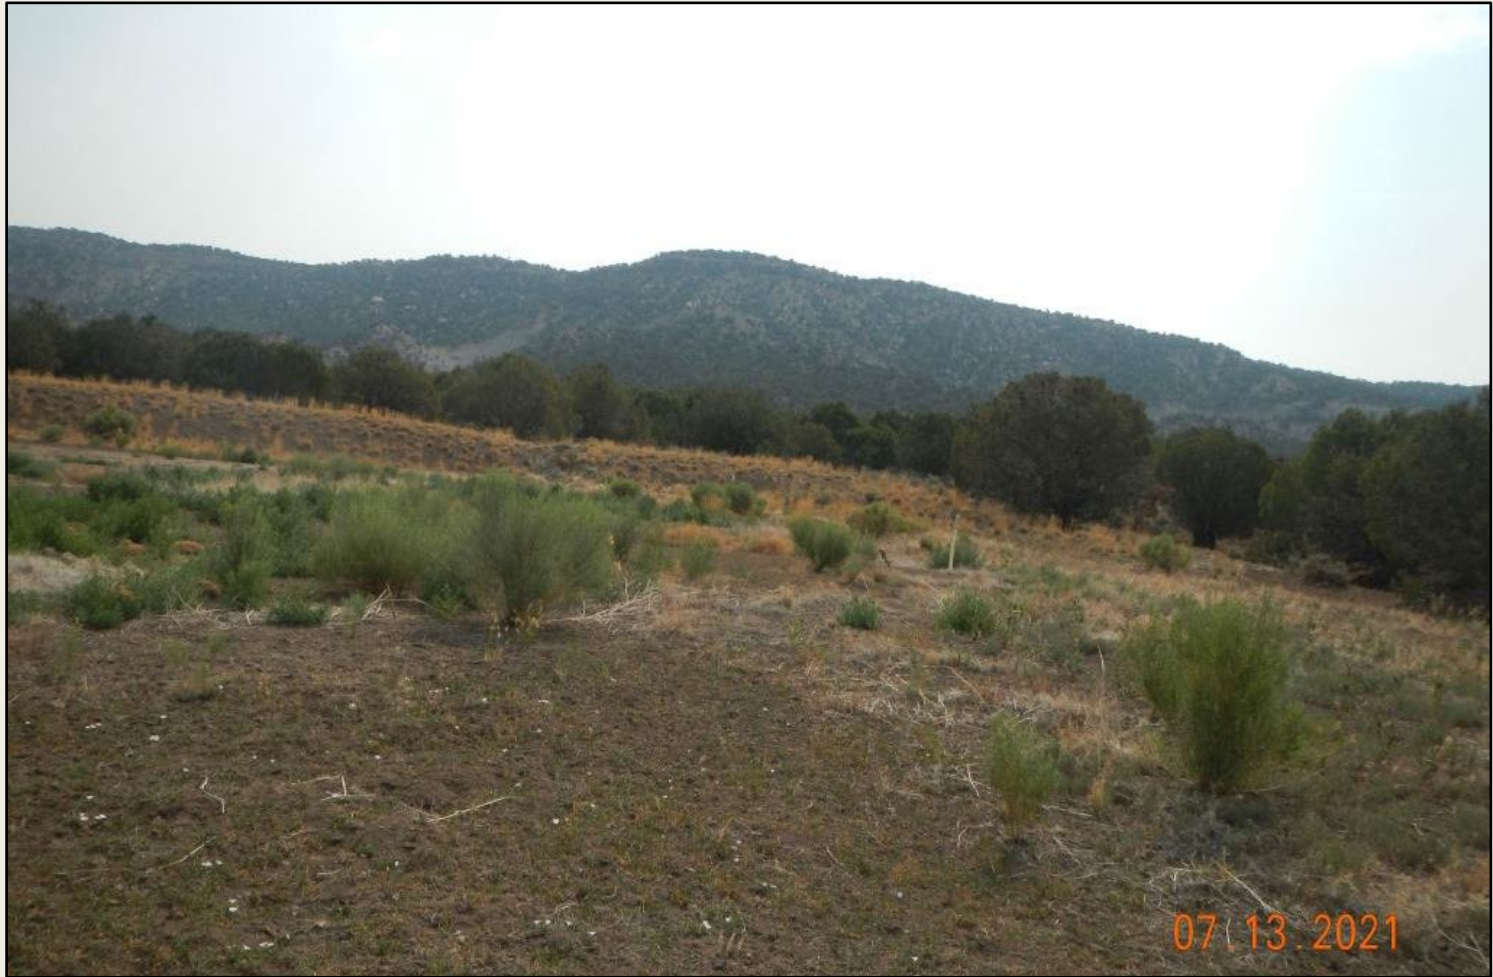
Photo 3. View the southern project area from the southwestern corner facing eastward.

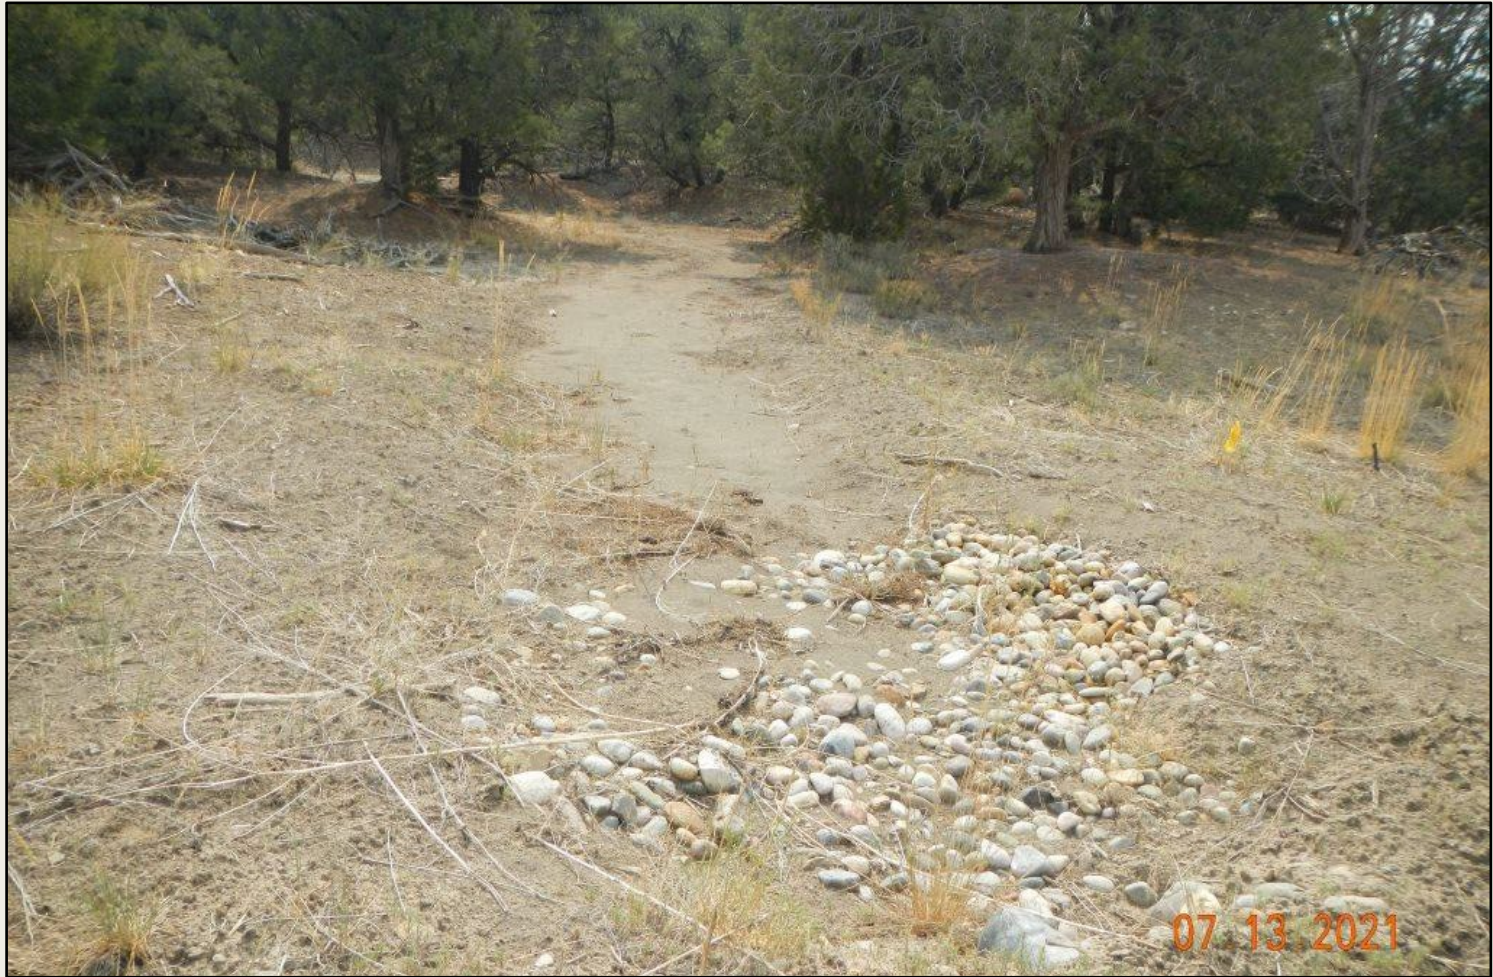
Photo 4. View of drainage along access road at culvert inlet. BMP needs maintenance and does not appear to be an adequate BMP here.

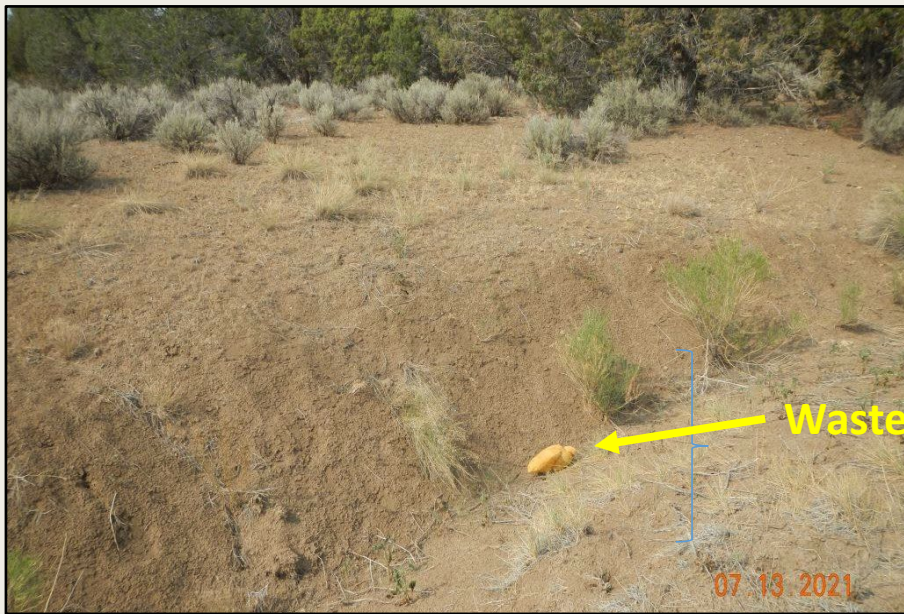
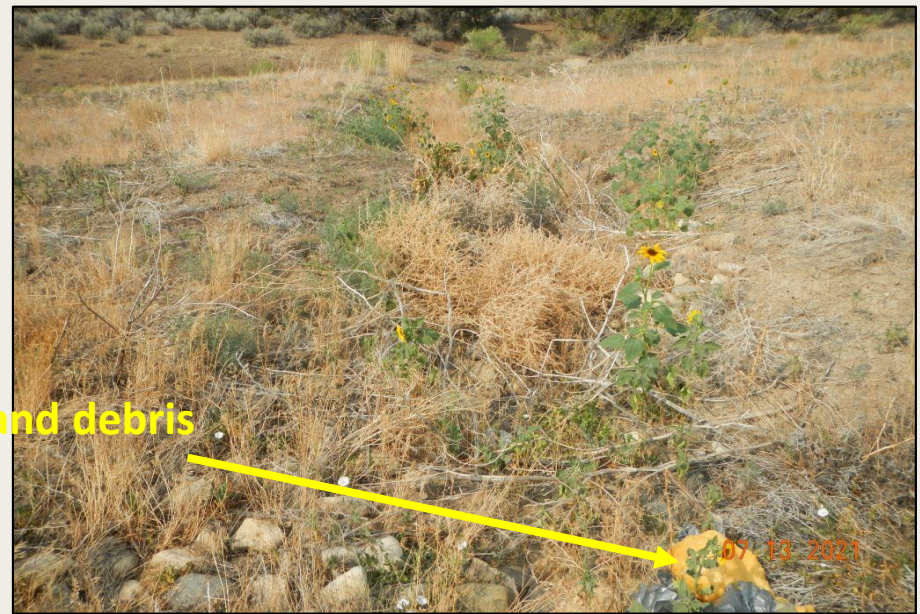
Photos 5/6. View of debris within the southern and southwestern project area.

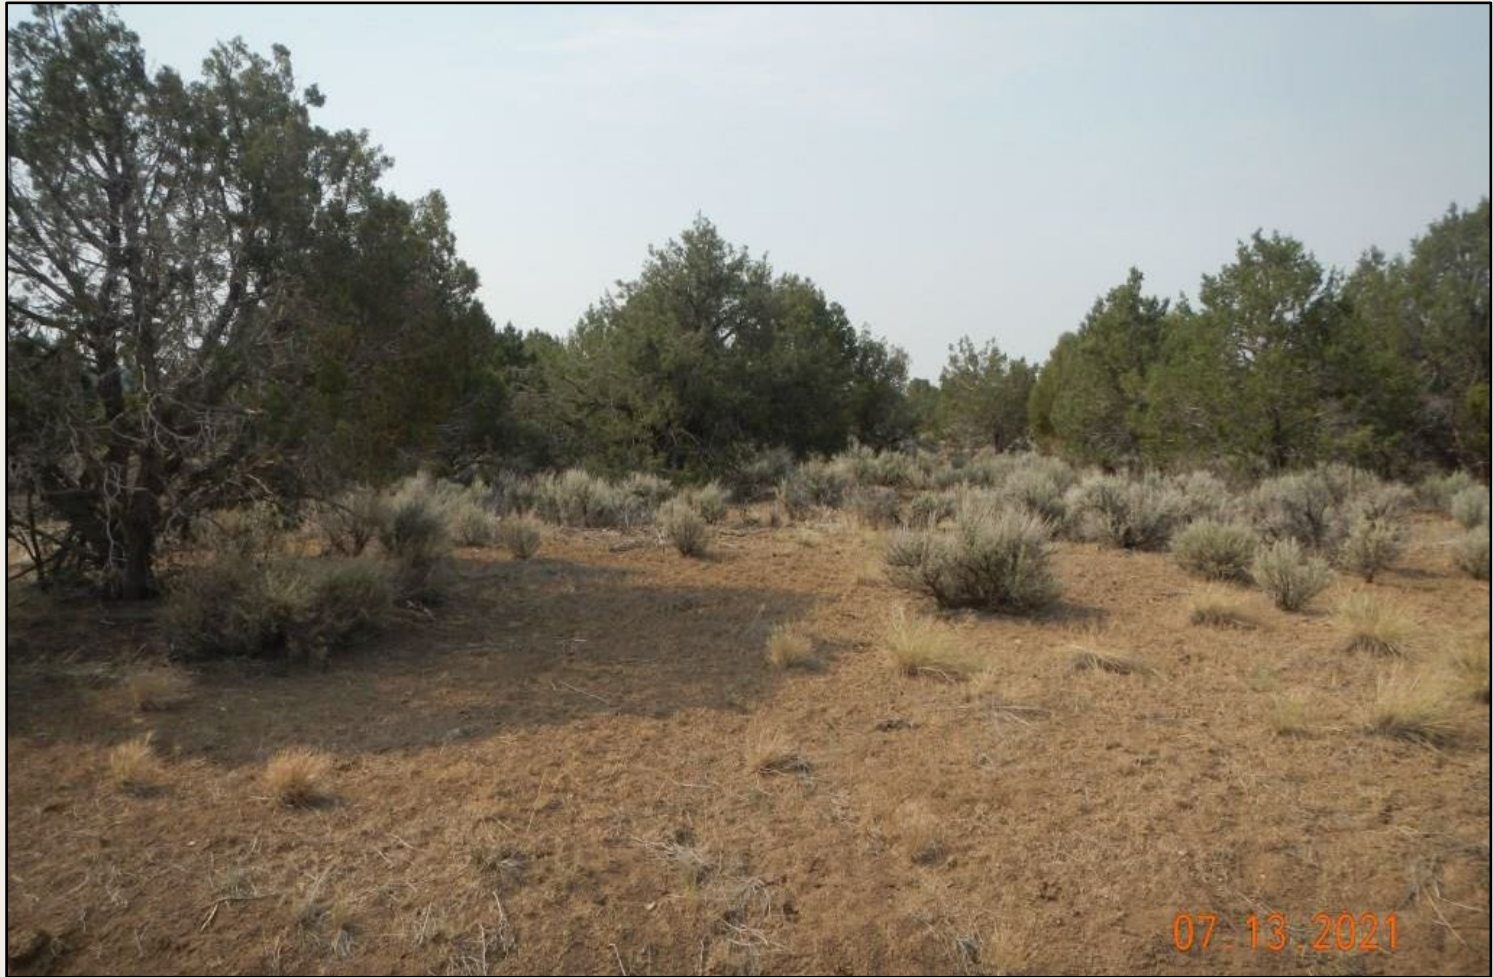
Photo 7. View the reference area comprised of pinyon and juniper woodland with sagebrush, Indian ricegrass, squirreltail, and threadleaf sunflower.
