Inspection Photos  
Operator: Simcoe  
API: 067-07486  
Date: 7/13/2021

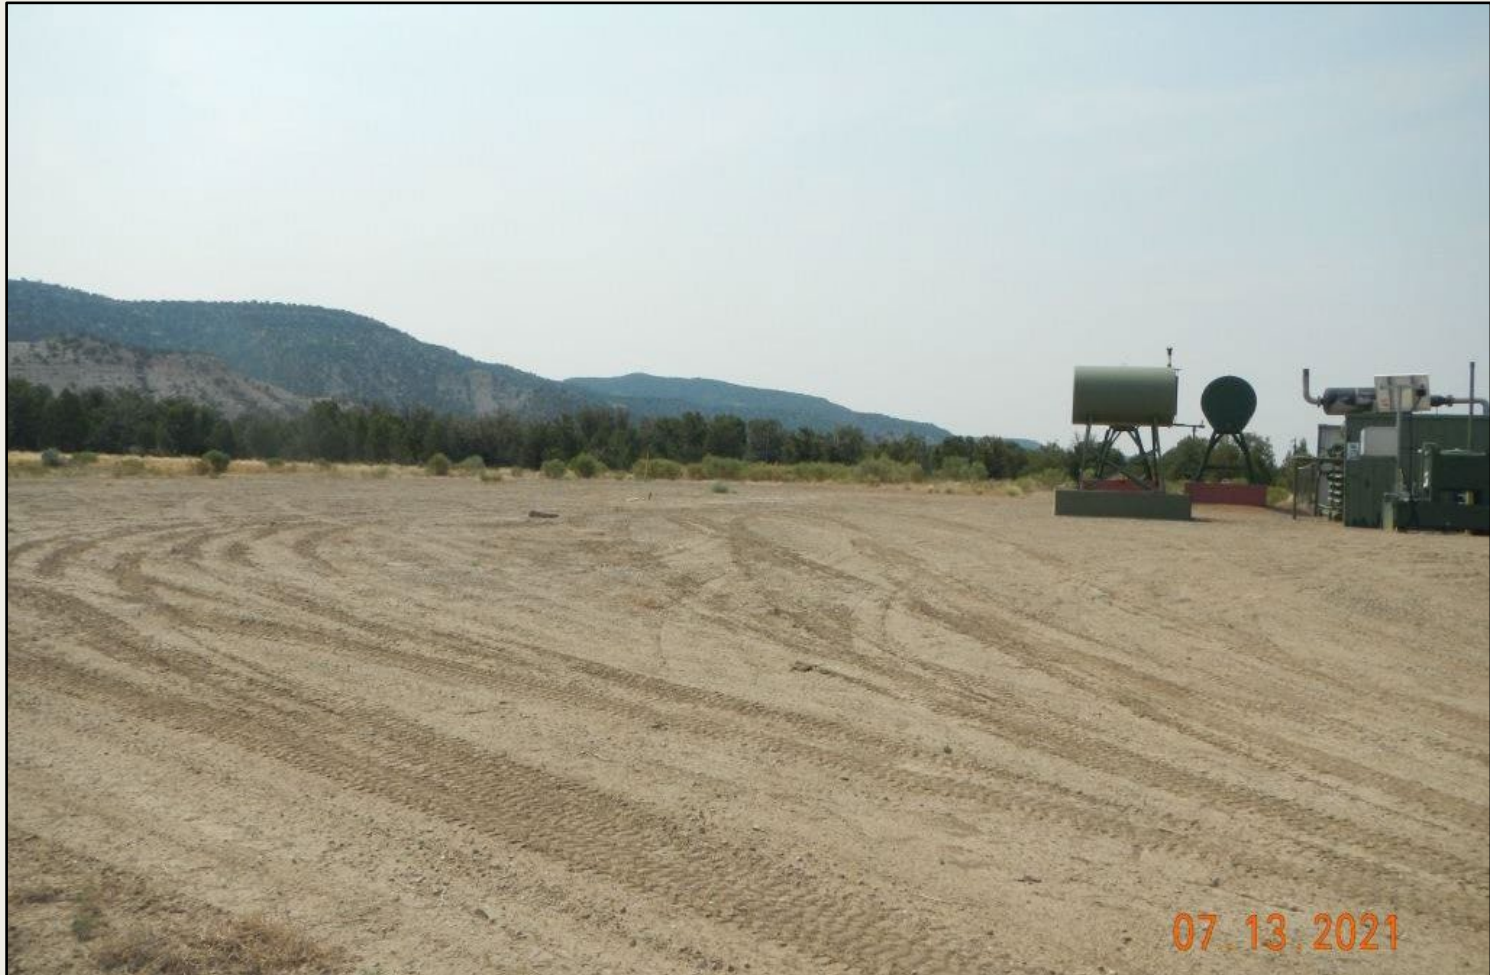
Photo 1. View the project area from the well pad entrance facing center.

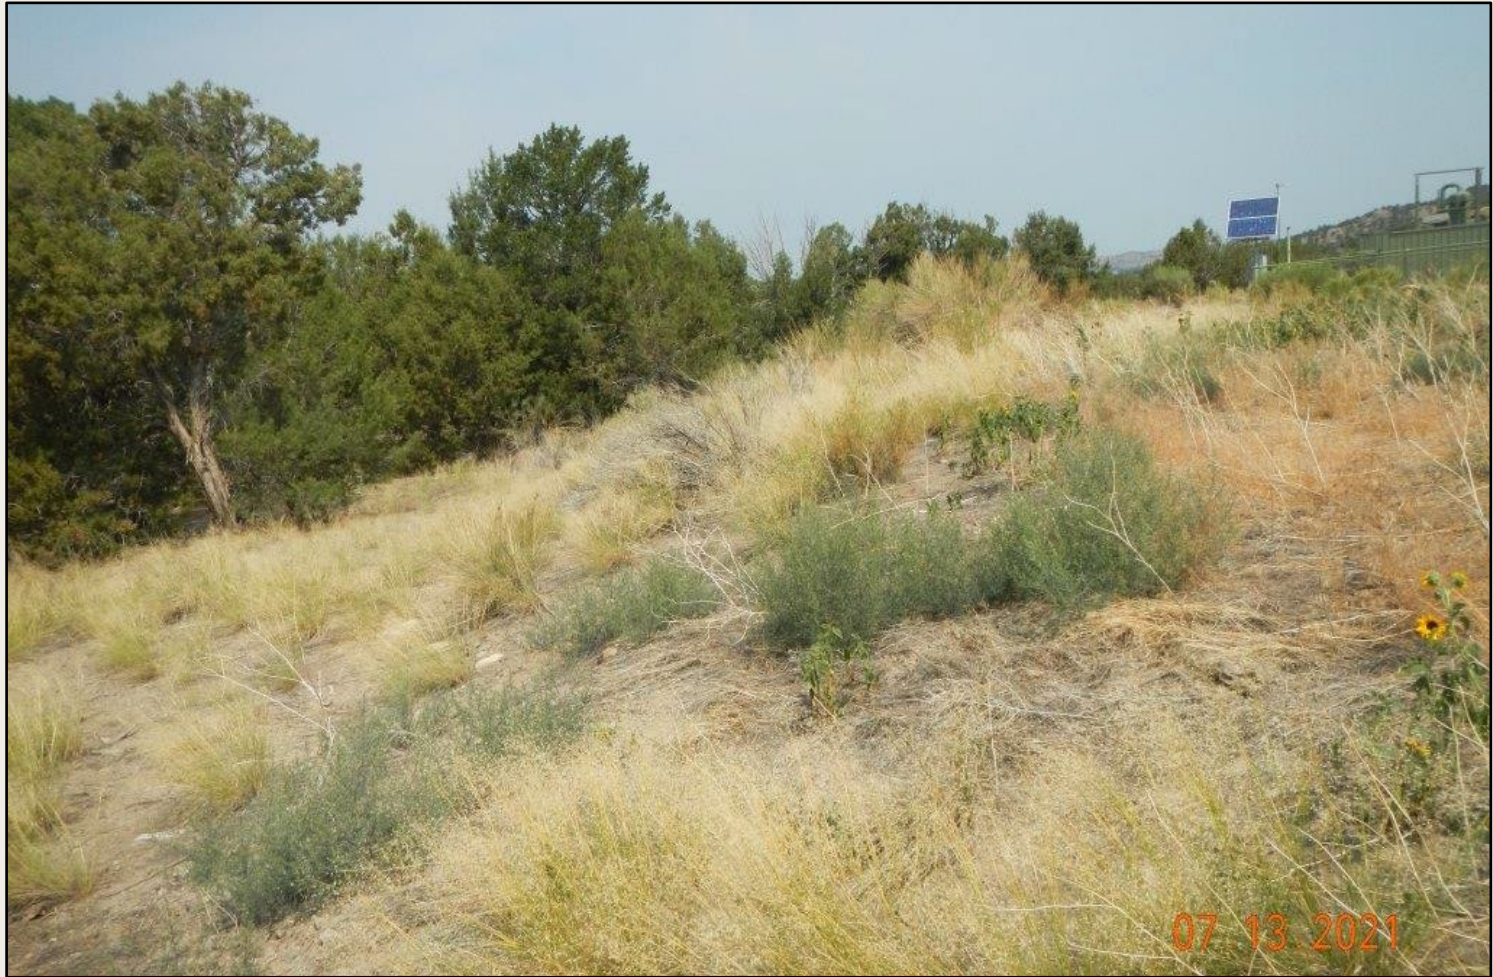
Photo 2. View of the western project area from the southwestern corner facing southward. Revegetation is progressing in portions with Indian ricegrass, rubber rabbitbrush, and crested wheatgrass. Other portions remain sparse and weedy and need to be monitored.

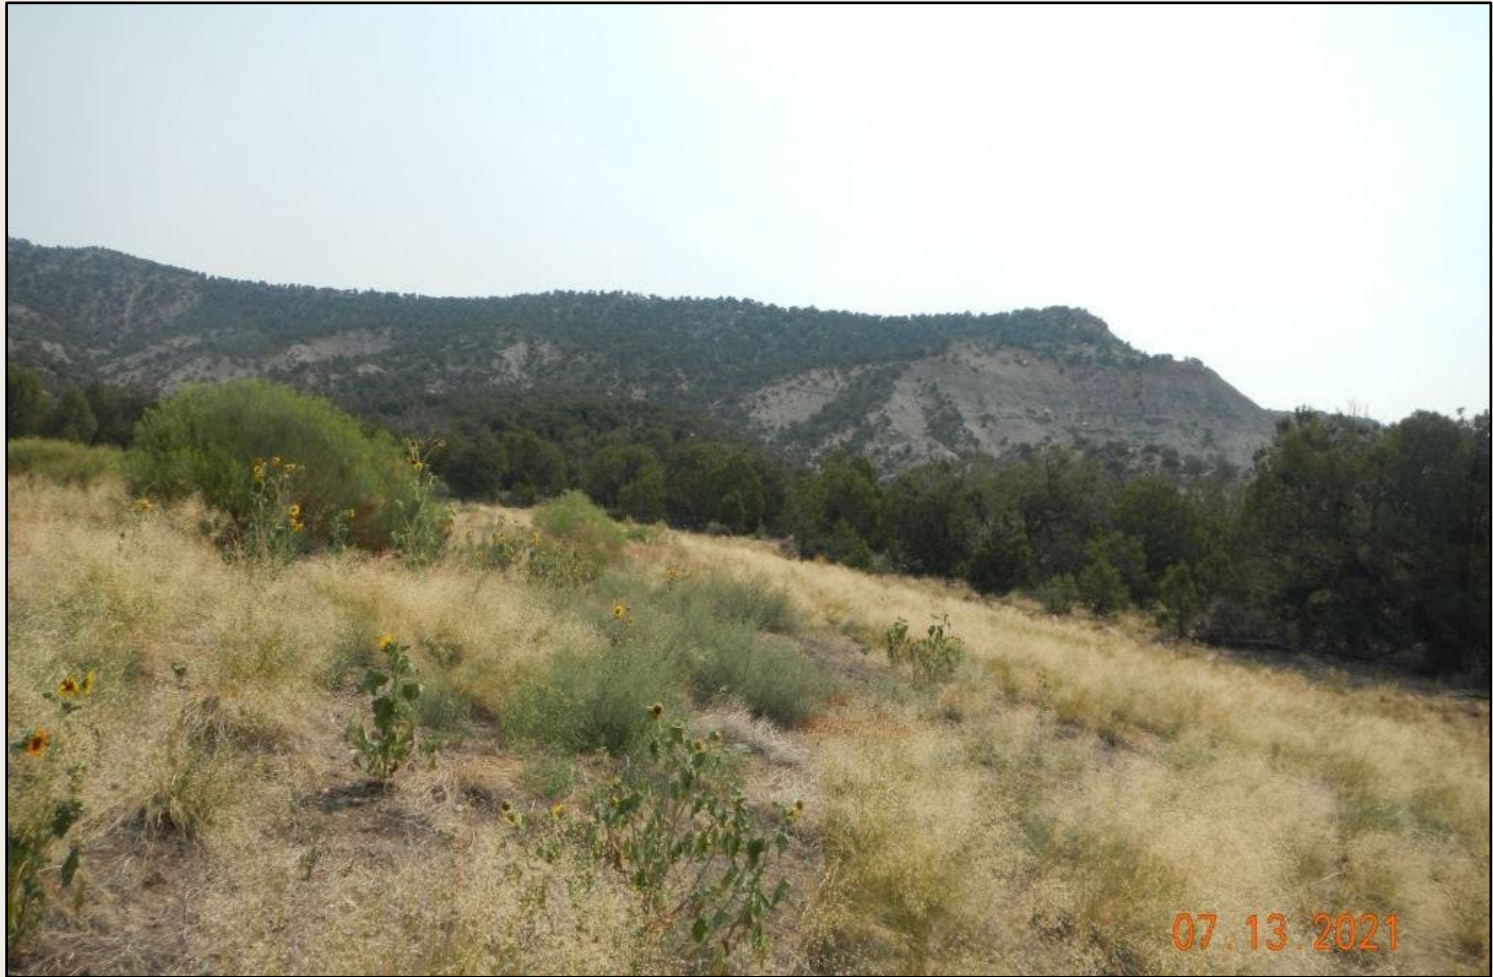
Photo 3. View the southern project area from the southwestern corner facing eastward.

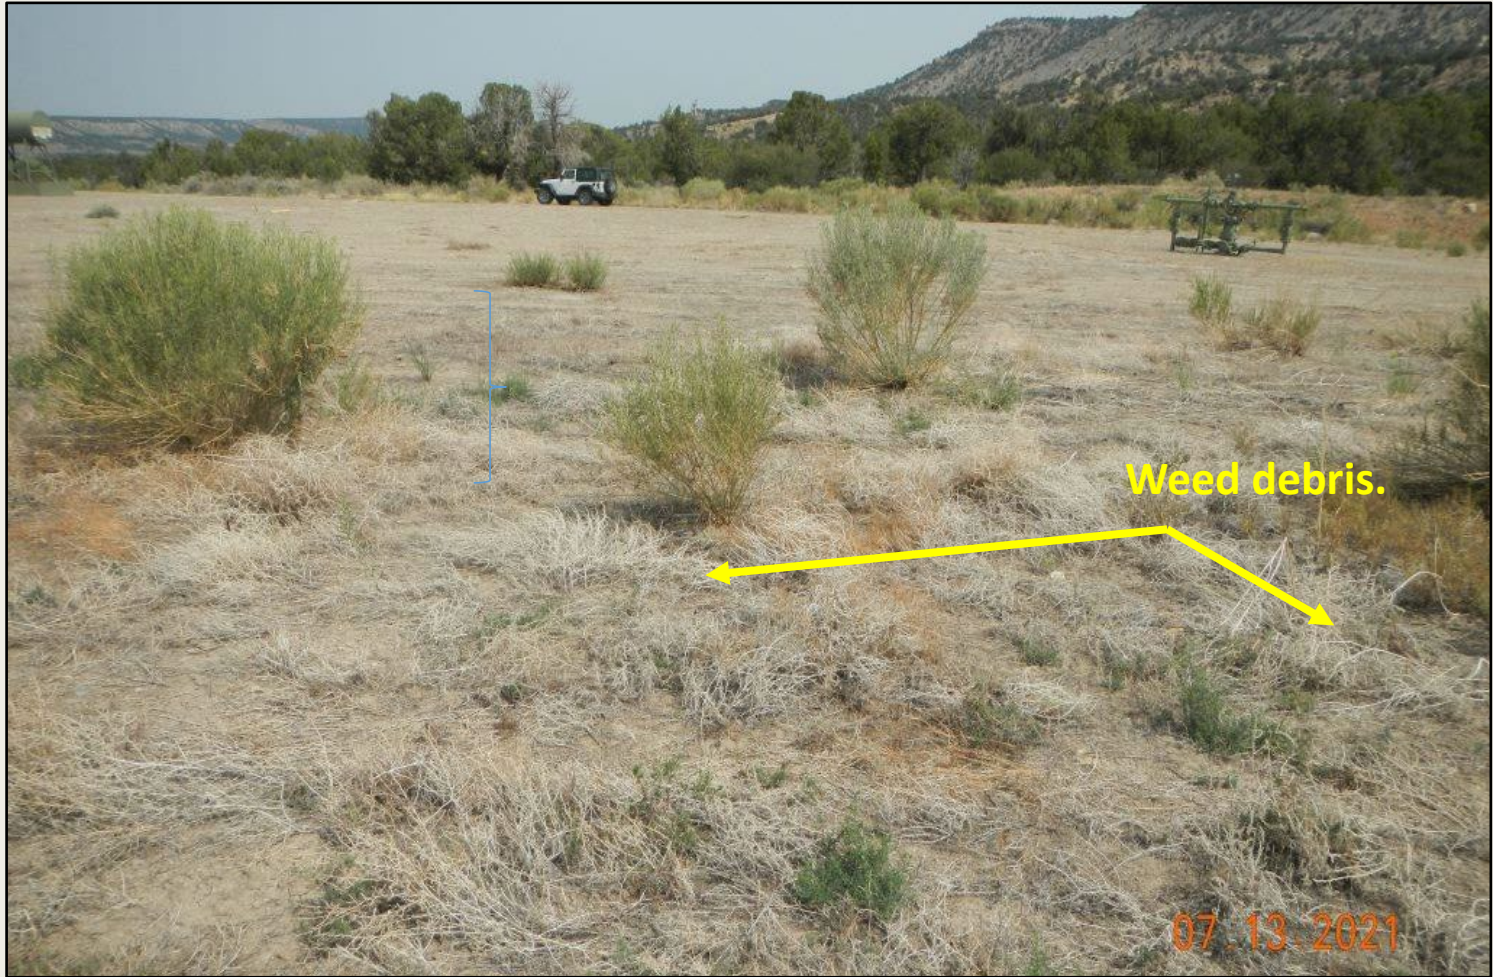
Photo 4. View of Russian thistle debris within the project area.

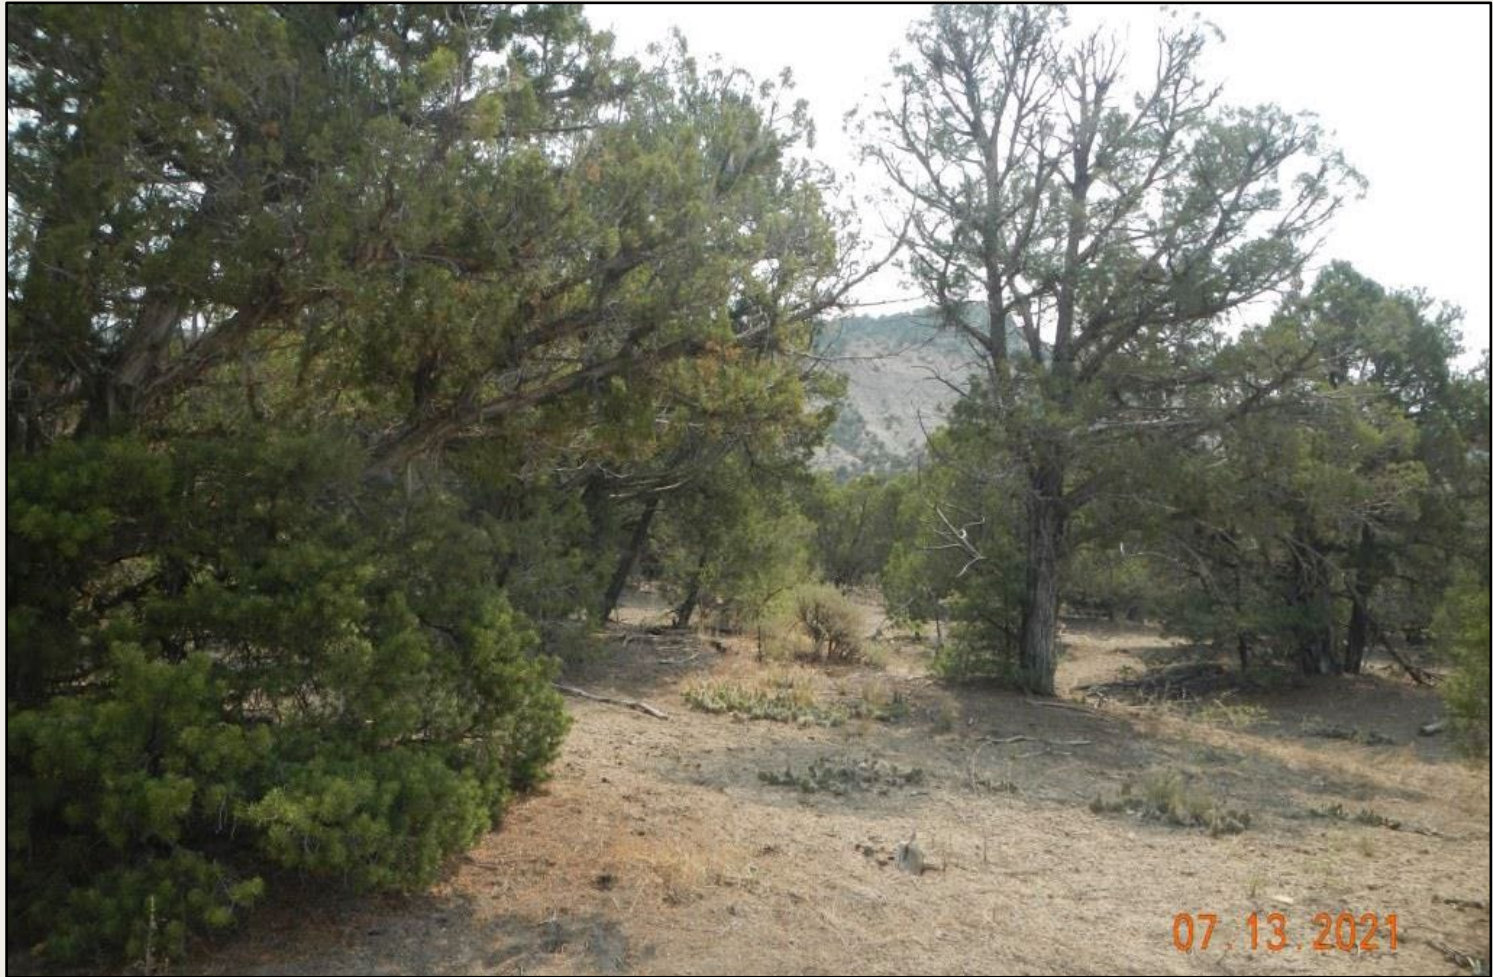
Photo 5. View the reference area comprised of pinyon and juniper woodland with understory of prickly pear, squirreltail, sagebrush, and gambel oak.
