Operator: SWN PRODUCTION COMPANY LLC

Location ID: 438248

SWN- Diamond T, #438248

Inspection and Issue Report

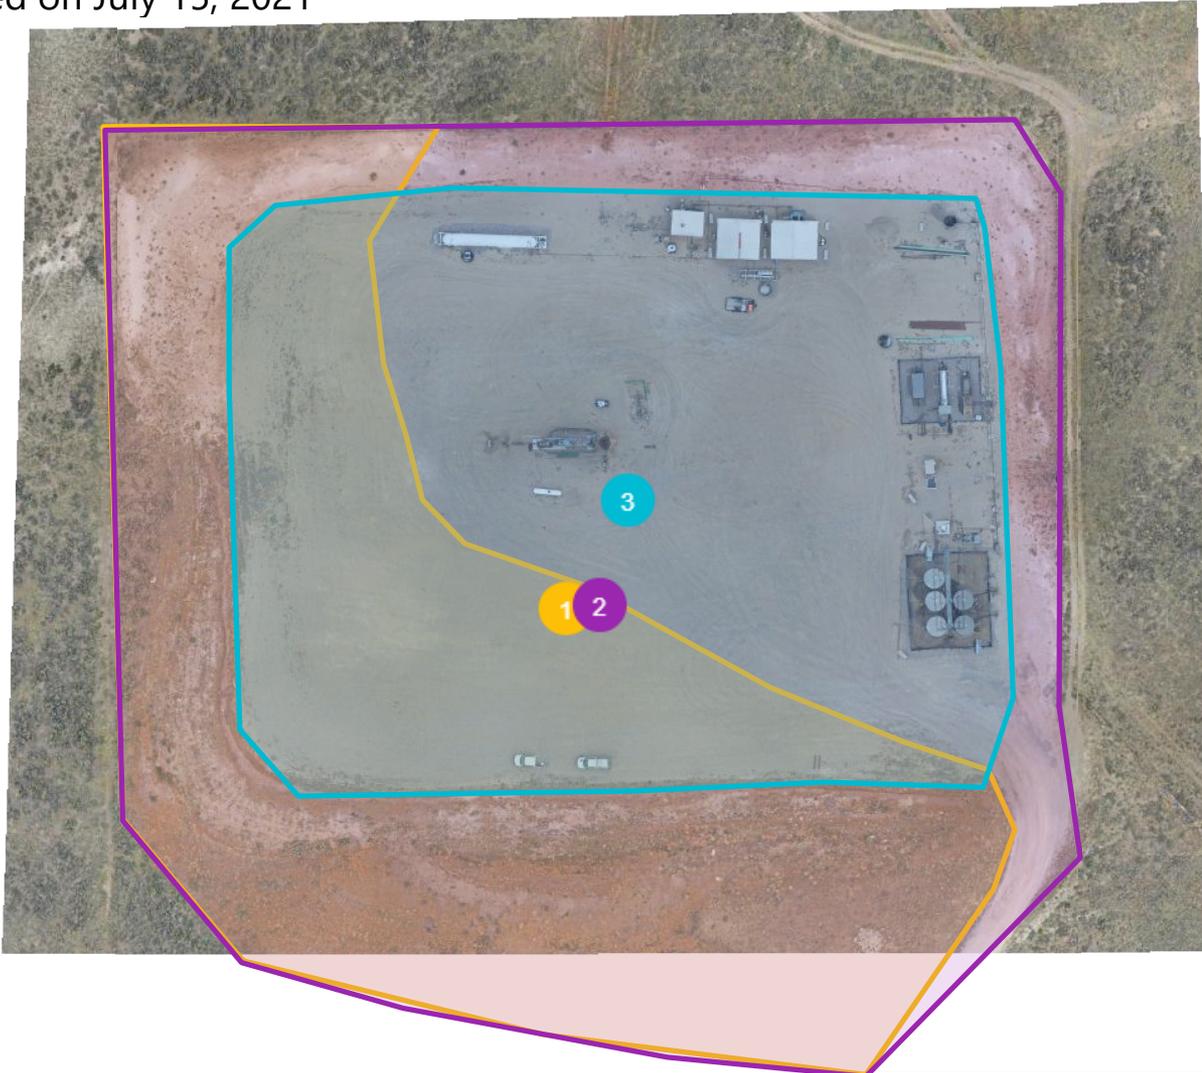
Aerial image of the Location. Photo shows disturbance area during construction, current pad, and areas not needed for production. Interim reclamation of the Location has not been conducted in accordance with COGCC 1003 Rules

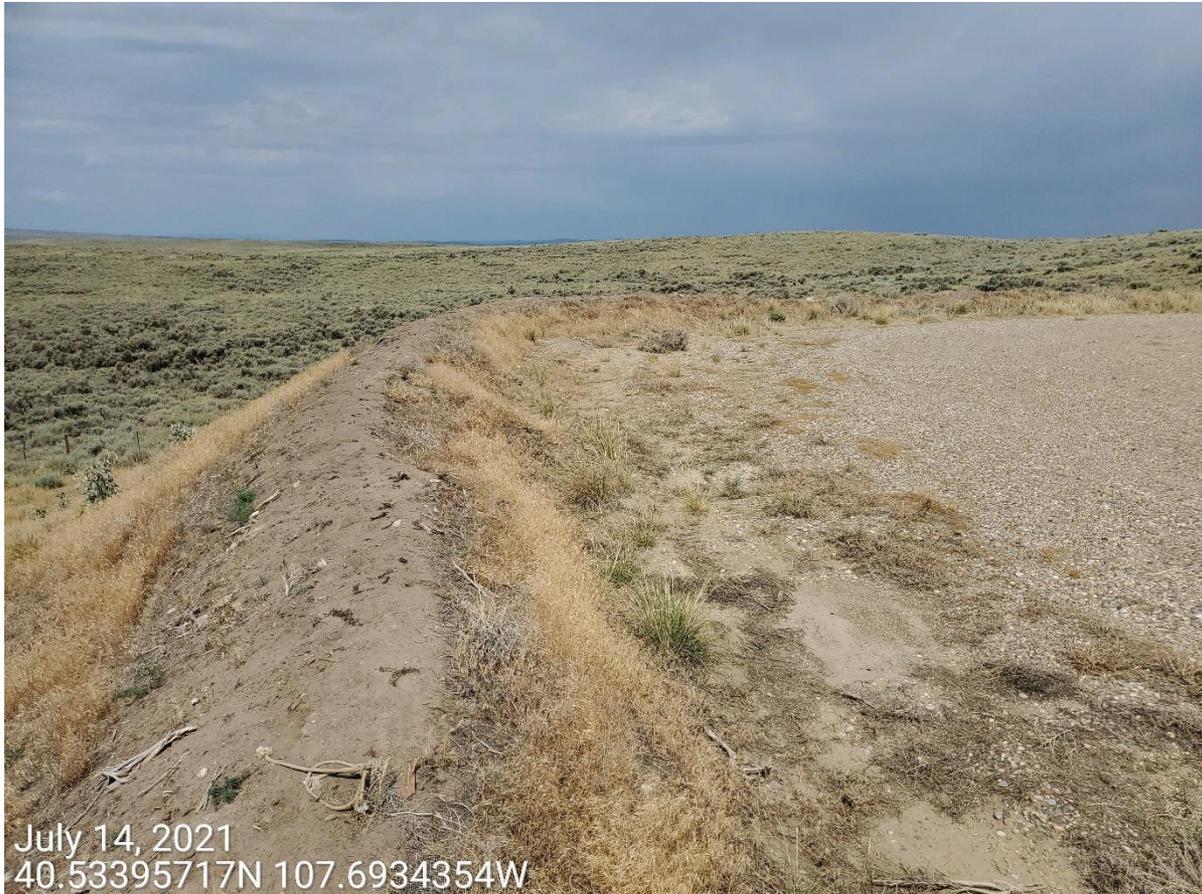
Photo 1: Photo taken from the south end of the Location, facing west. Photos 1-4 provide an overview of the Location from west, northwest, northeast to east. Photos show interim reclamation of areas not necessary for production, has not been performed in accordance with COGCC 1003 Rules.

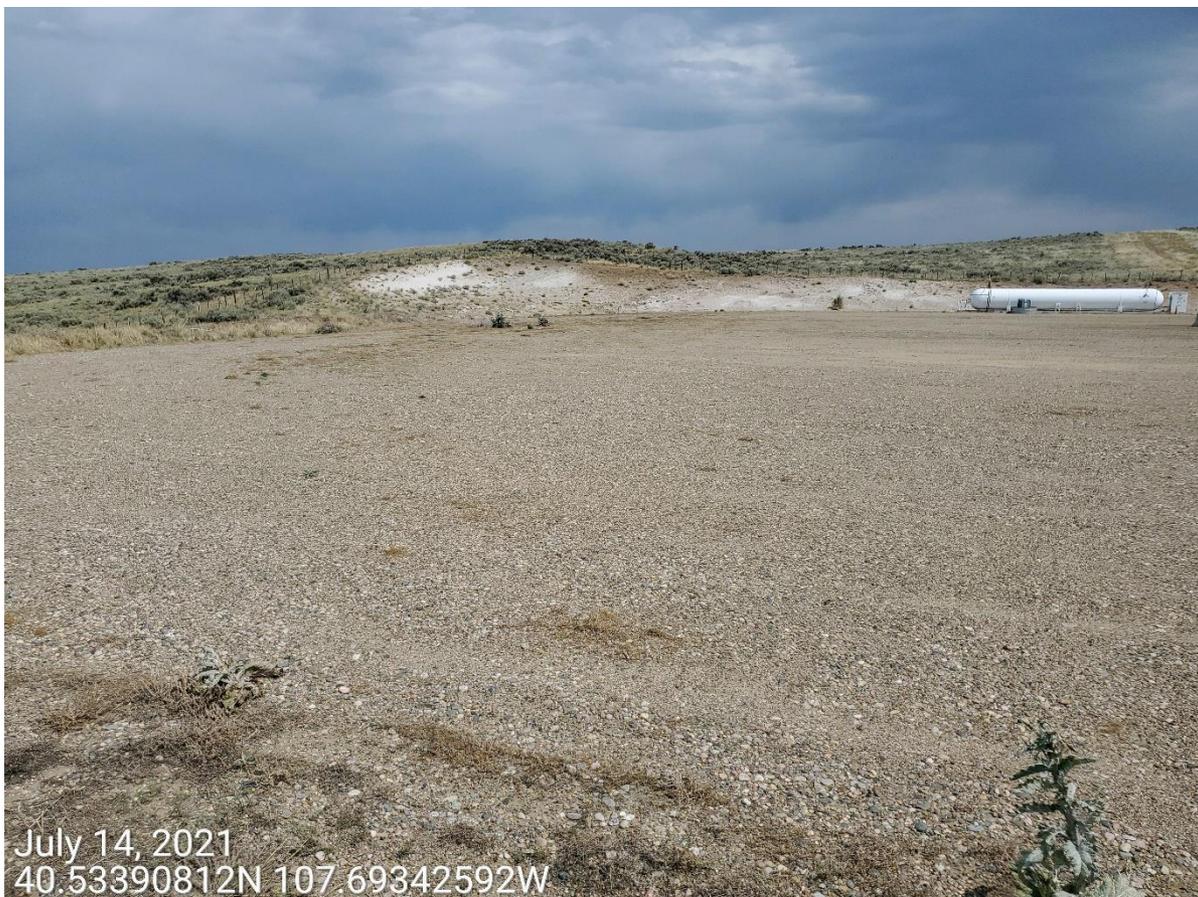
Photo 2: See comments under photo 1.

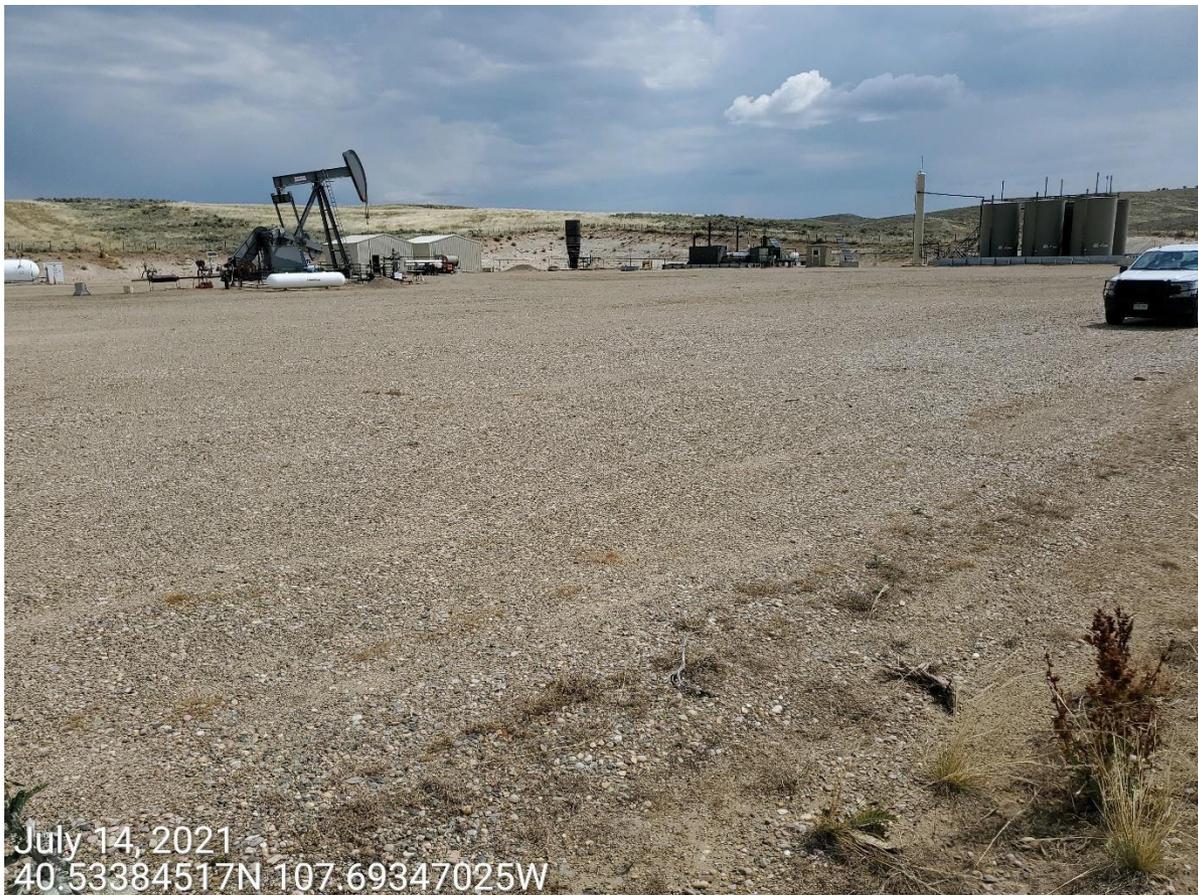
Photo 3: See comments under photo 1.

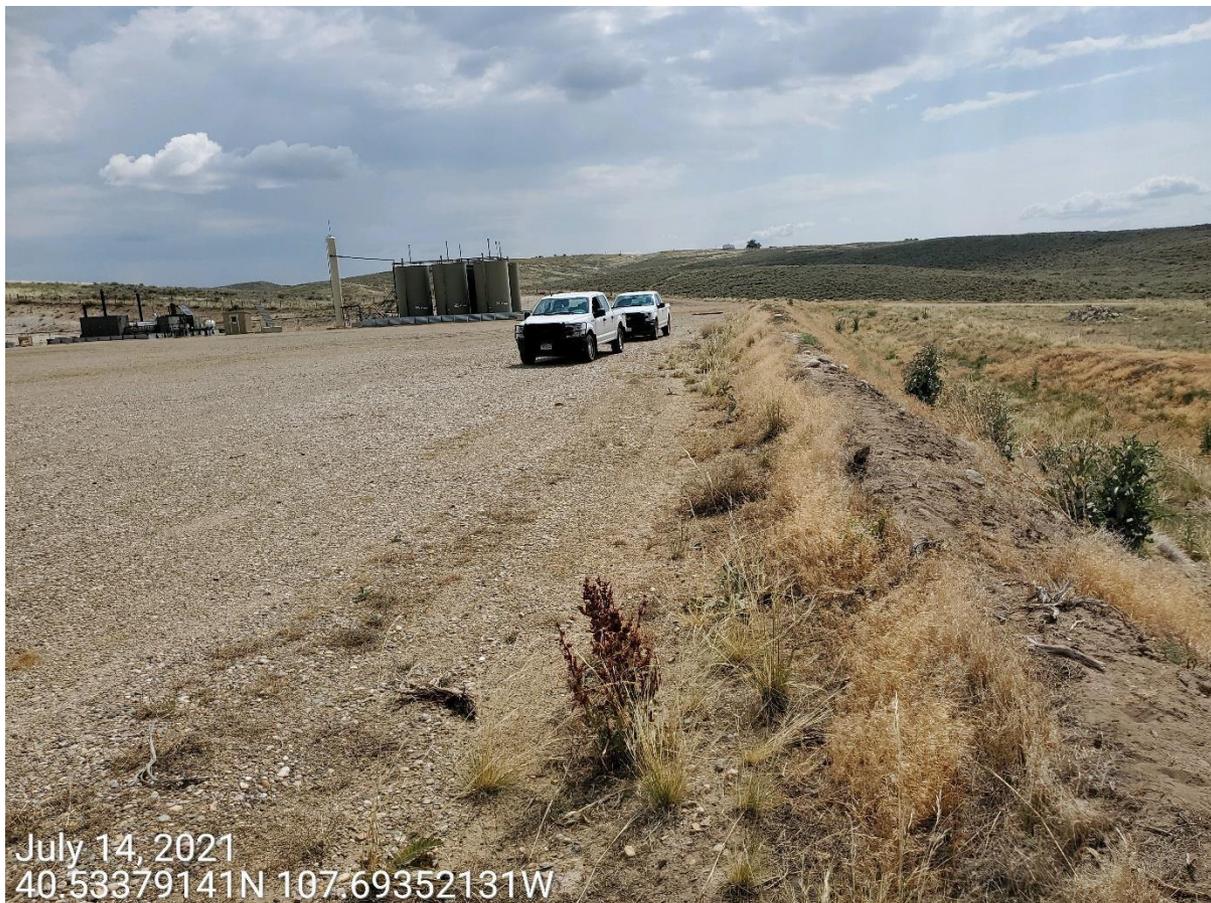
Photo 4: See comments under photo 1.

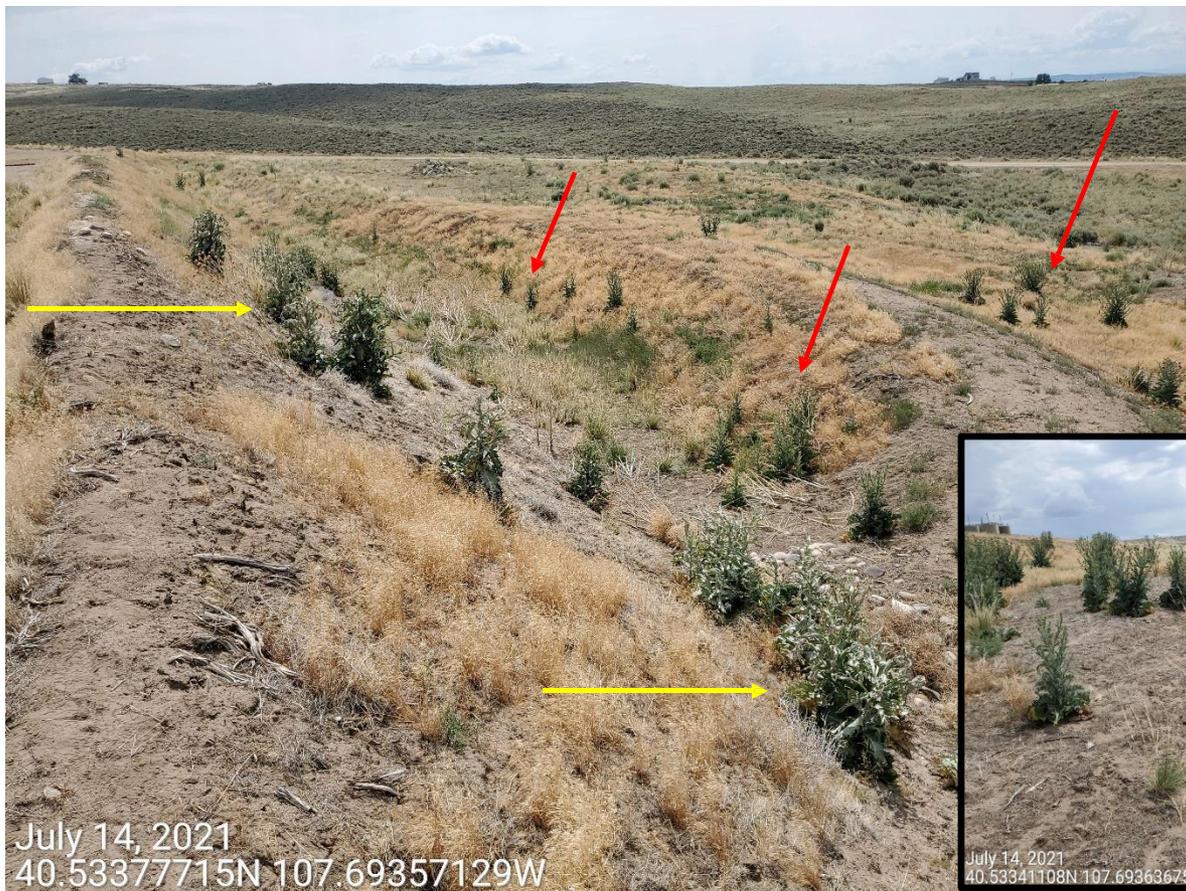
Photo 5: Photo taken from the south end of the Location, facing east. Photo shows example of undesirable and noxious weed (Scotch thistle) establishment observed on the Location; noxious and undesirable weeds observed on all areas of the Location Photo also shows weed establishment on the topsoil stockpile. Noxious weeds on the fill slope (yellow) do show signs of senescence/wilting and may have been sprayed, however, weeds beyond the fill slope (red) do not show signs that weed management was performed. Noxious weed management and protection of soils inadequate. Inset photo (bottom right) shows noxious weeds on topsoil stockpile. Photo also shows topsoil pile has been incorporated as part of a stormwater retention pond.

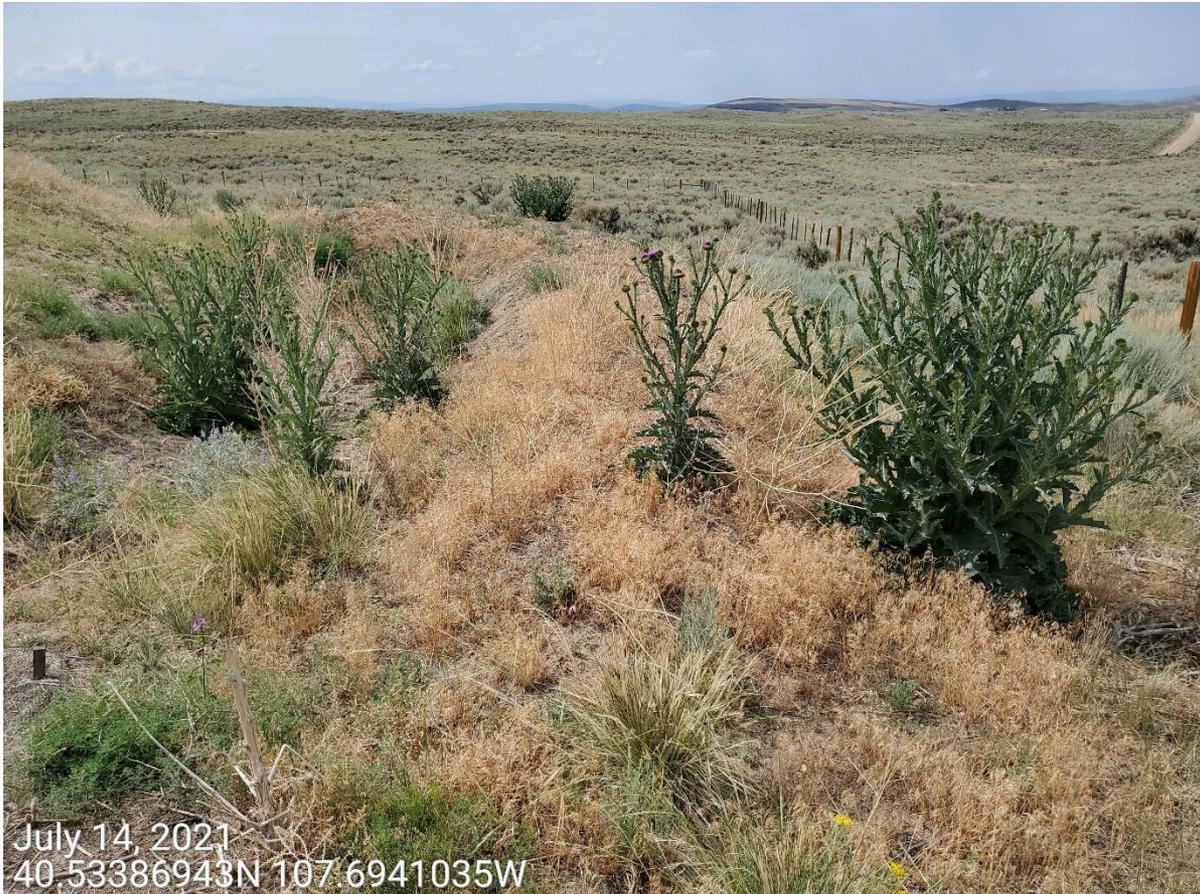
Photo 6: Photo taken from the west end of the Location, facing south. Photo shows noxious weed establishment on the Location.

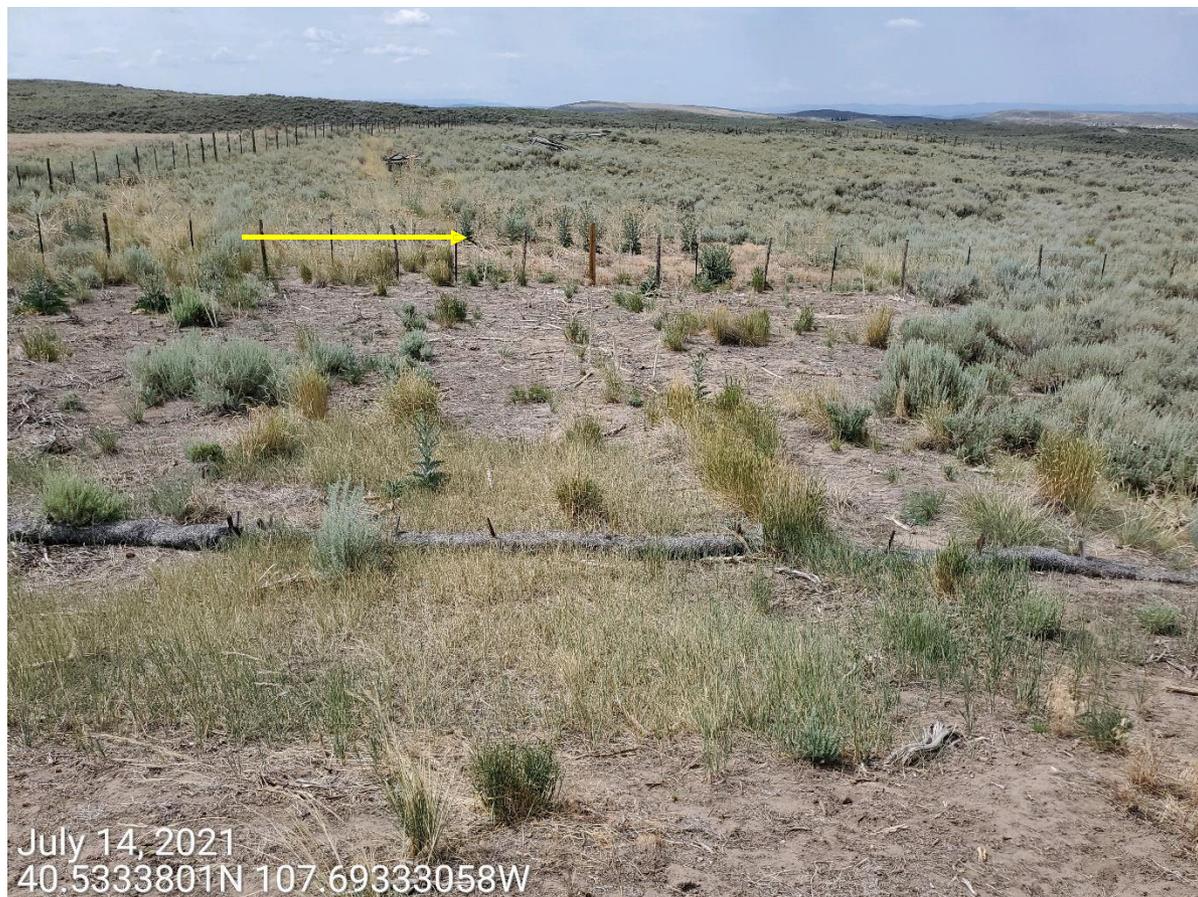
Photo 7: Photo taken from the south end of the Location, facing south. Photo shows noxious weeds from the Location appear to be encroaching onto the adjacent lands.

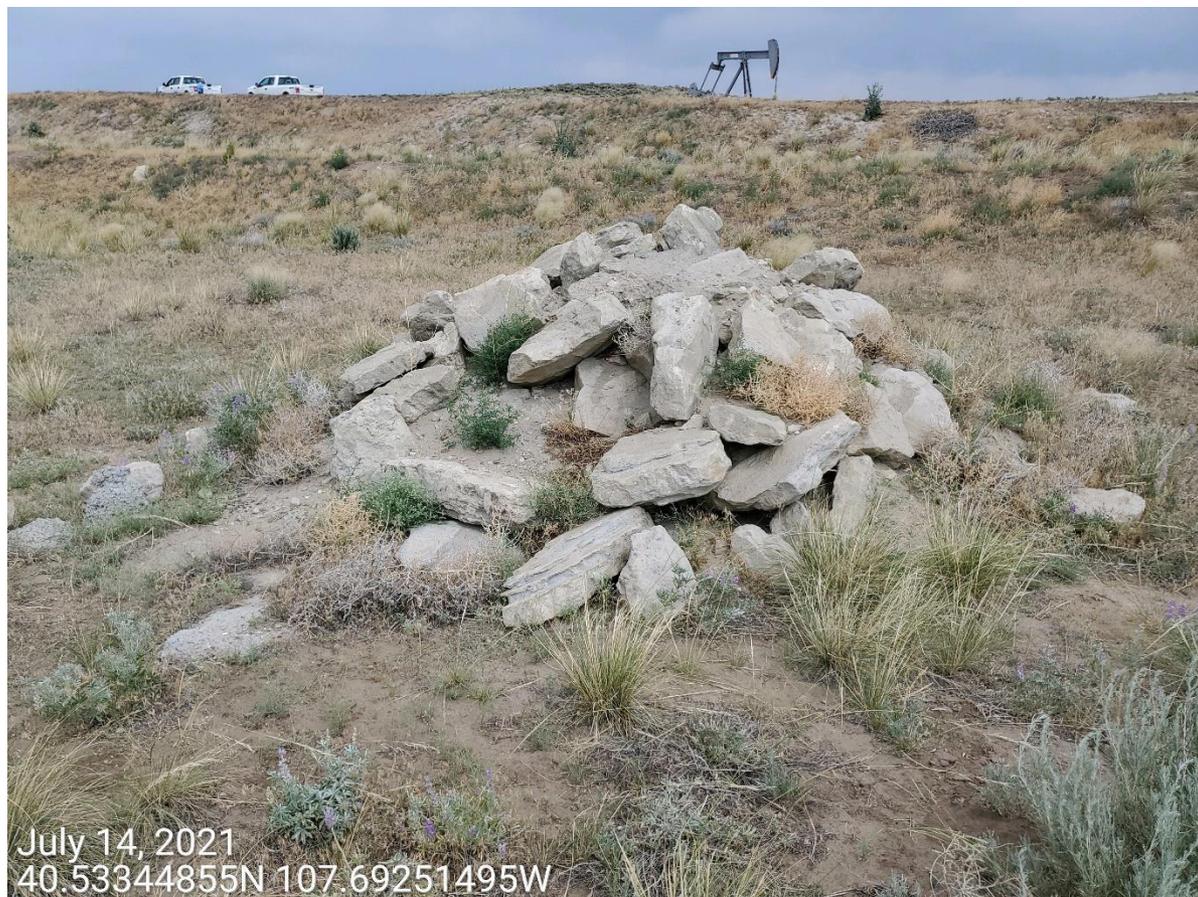
Photo 8: Photo shows concrete debris stored on the southeast end of the Location.

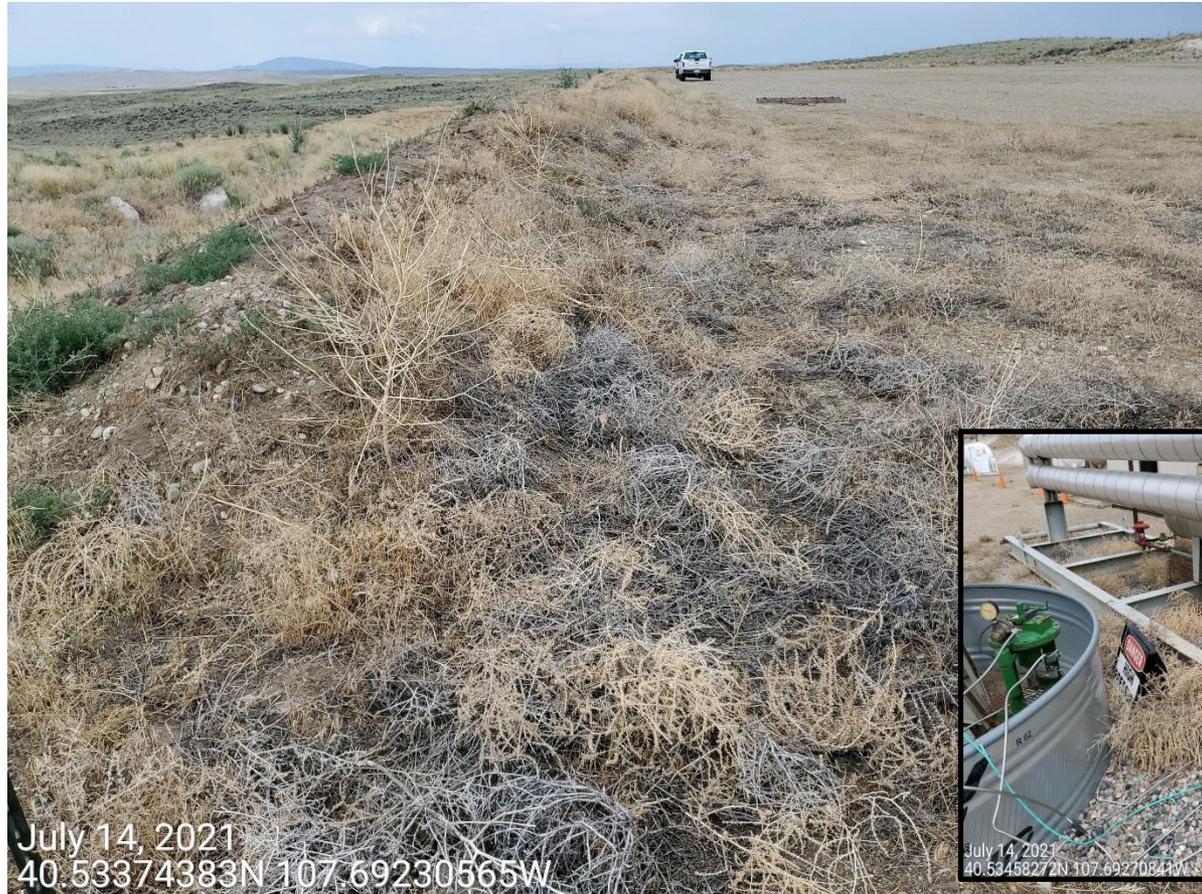
Photo 9: Photo taken from the southeast end of the Location, facing west. Photo shows example of undesirable plant (Russian thistle) establishment and weed debris accumulation observed throughout the Location. Inset photo (bottom right) provides example of weed debris around equipment.

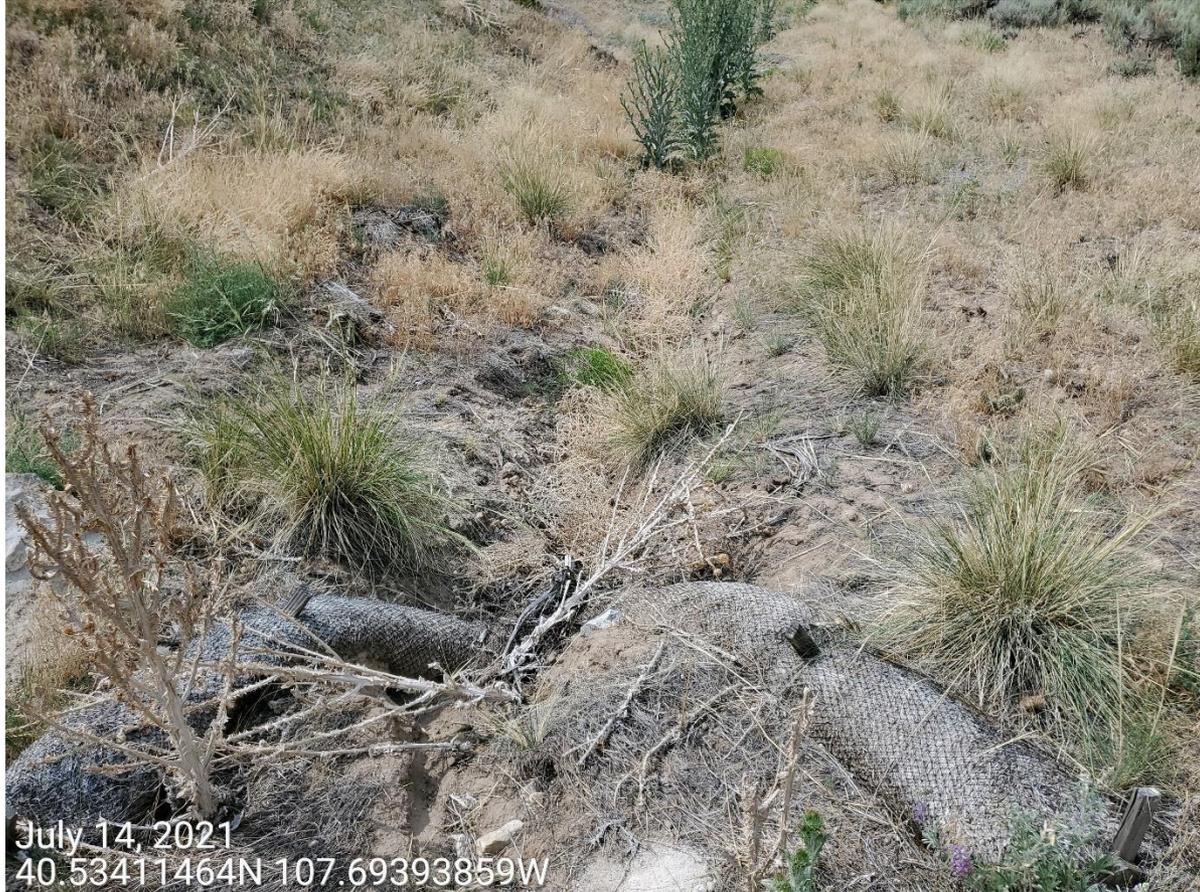
Photo 10: Photo taken from the west end of the Location, facing south. Photo shows stormwater ditch and velocity checks (straw wattles). BMPs has not been maintained and is no longer in proper functioning condition; erosion degradation with ditch evident.

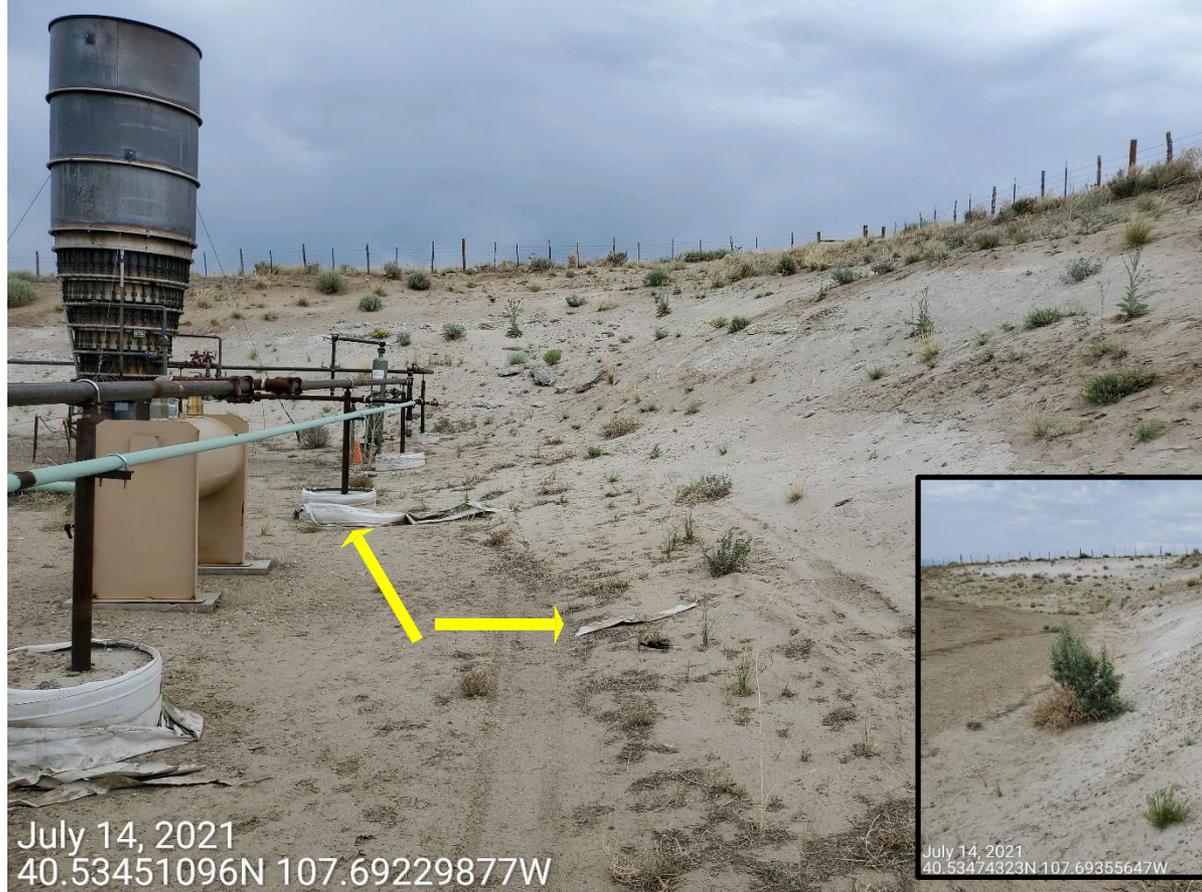
Photo 11: Photo taken from the cut slopes on the east end of the Location, facing north. Soils on slopes bare with a loose and powdery texture; soils at risk to wind erosion. Control measures to stabilize and protect slopes of the Location missing, or inadequate in accordance with Rule 1002.f.(2)C. Photo insert (bottom right) shows cut slopes on the north/northwest end of the Location. Photo also shows trash debris observed on Location.

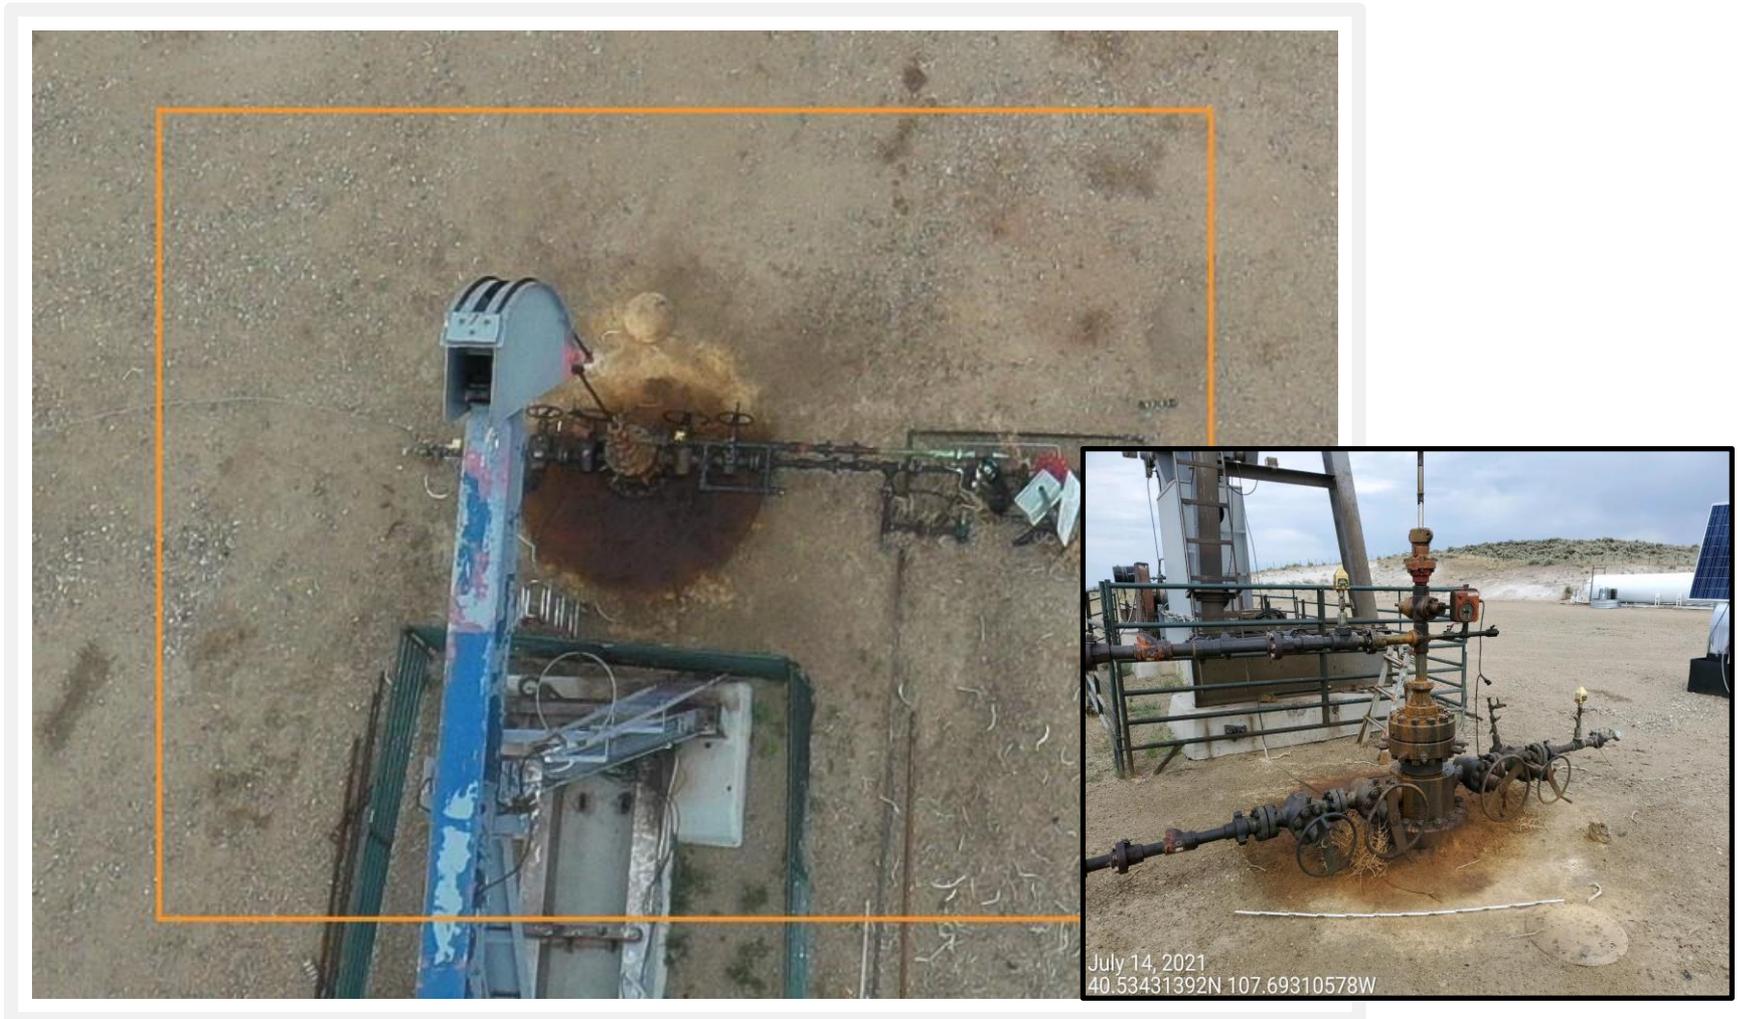
Photo 12: Photo taken from well 081-07817. Photo shows an ongoing release at the well of E&P waste resulting in impacted soils. 6 foot measuring stick for reference.

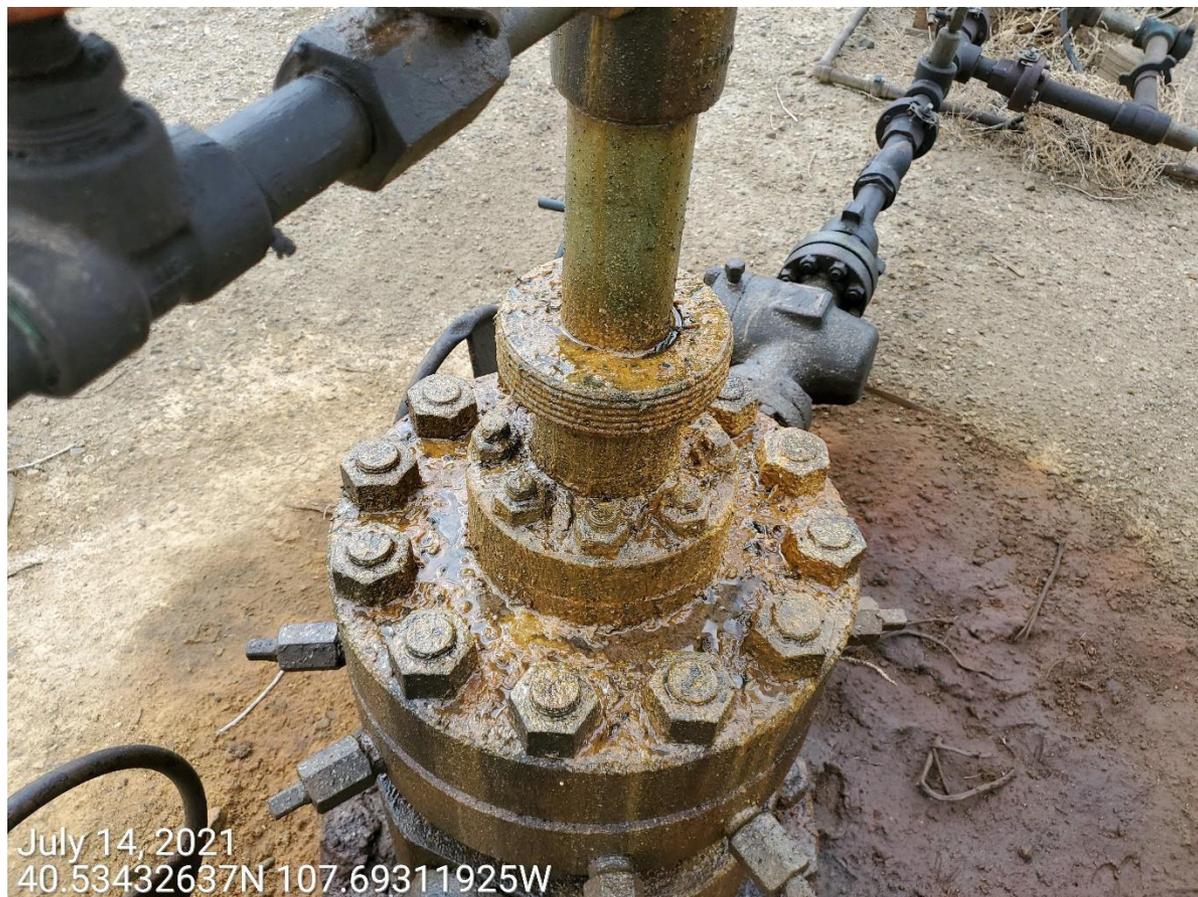
Photo 13: Photo shows ongoing release of E&P fluids.

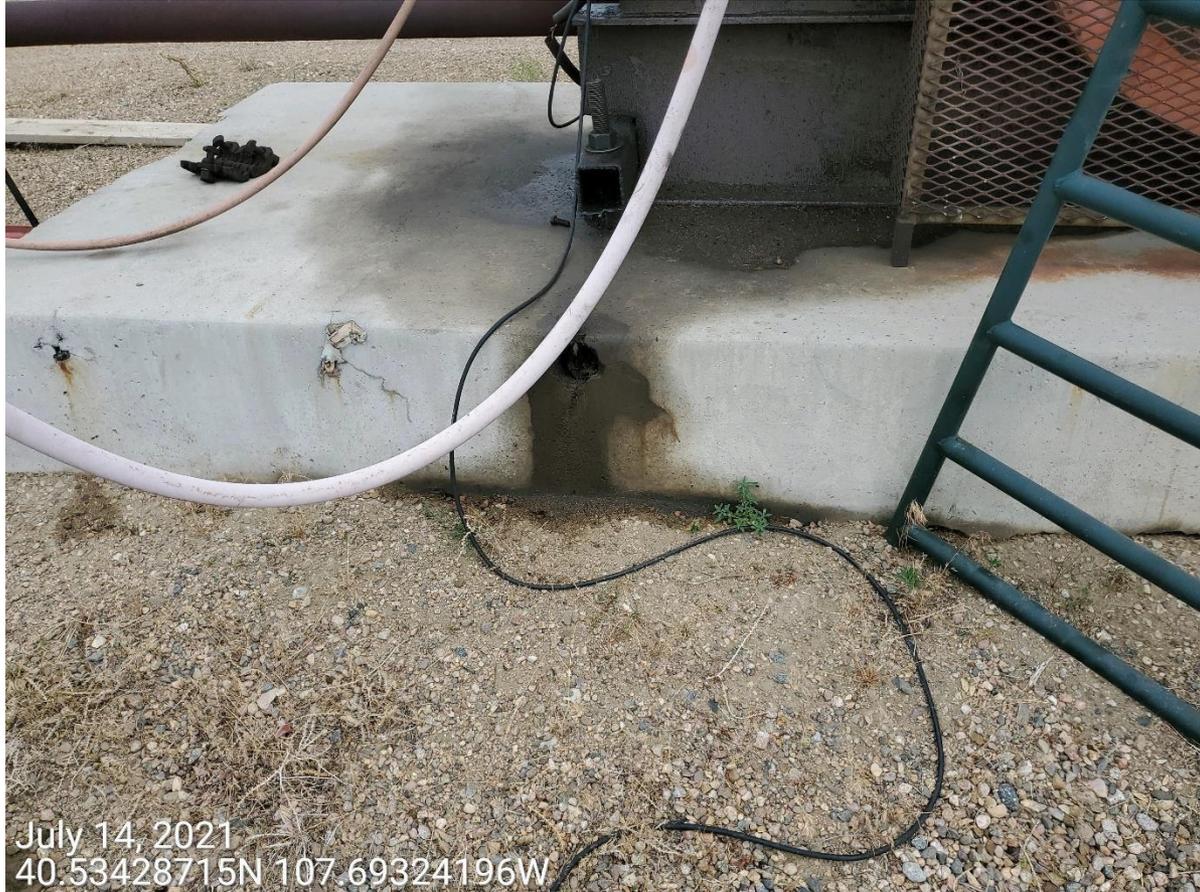
Photo 14: Photo taken from the southwest end of well 081-07817. Photo shows petroleum, oils and lubes ("POLs") leaking from pump jack motor. Repair and stop leaks, and comply with Ruled 906.a-d

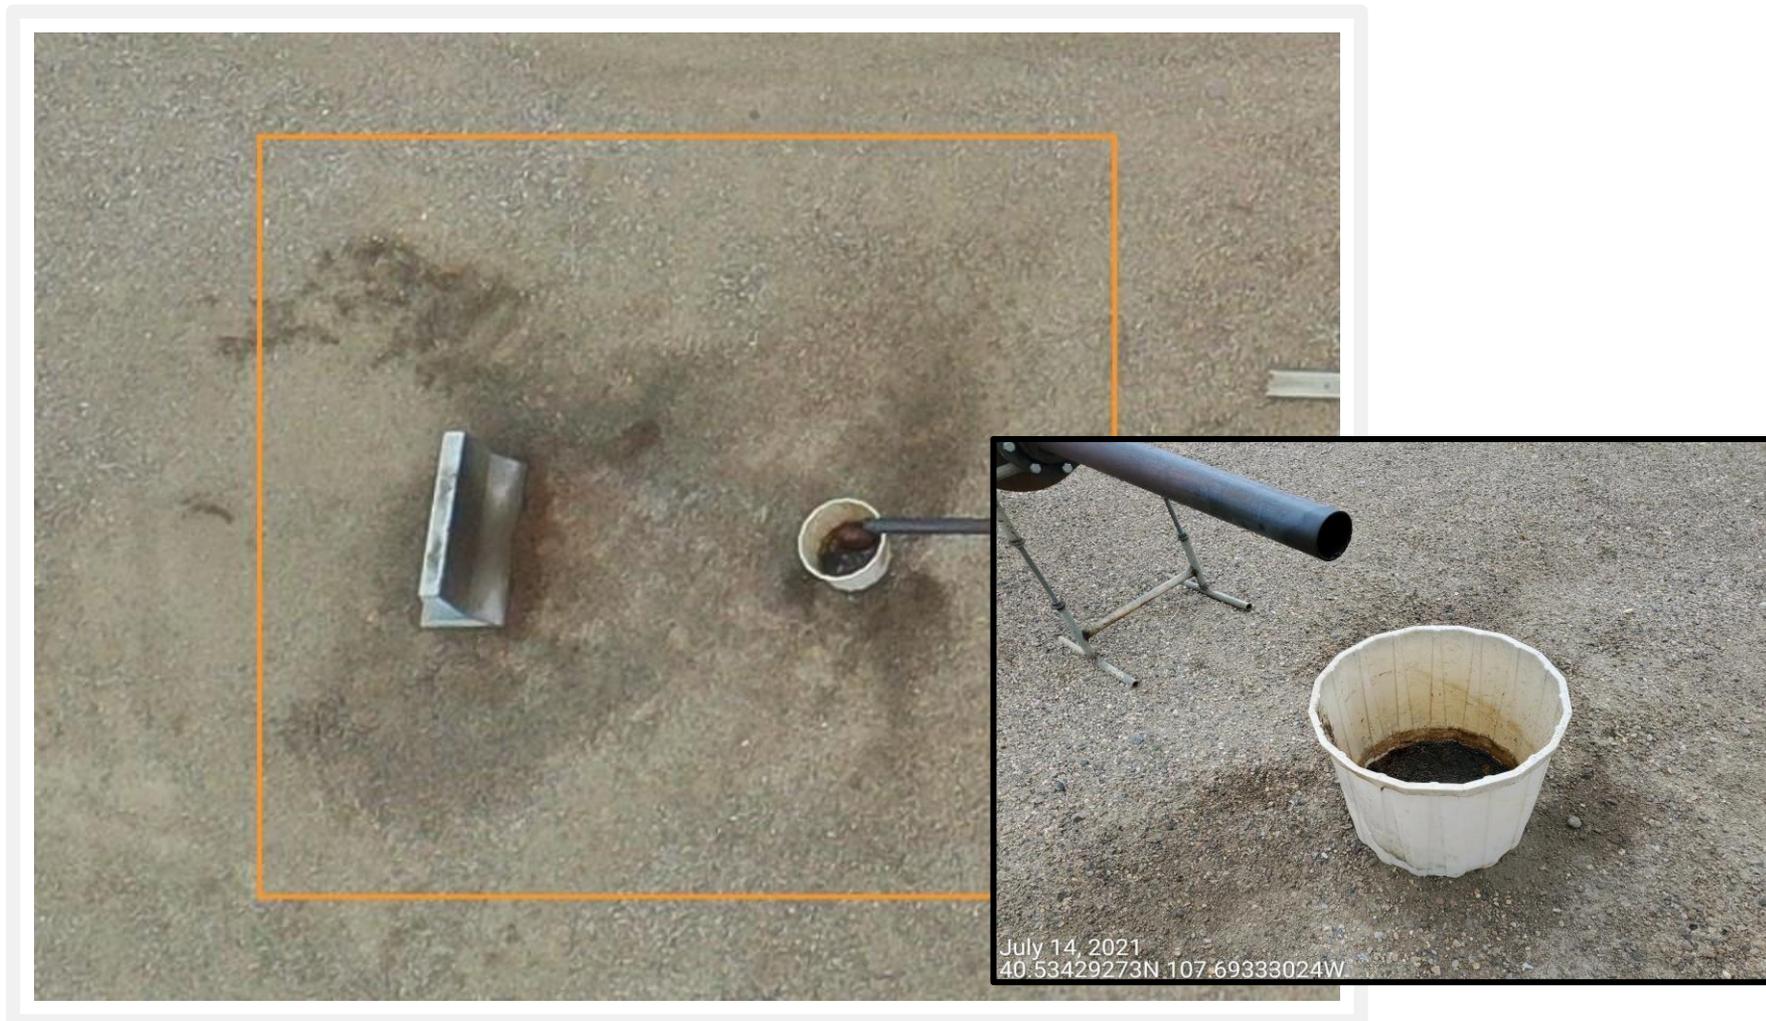
Photo 15: Photo taken from the pump jack muffler of well 081-07817. Inset photo (bottom right) shows Operator has placed a container in an attempt to capture fluids from the pipe. Photo also shows stained soils observed around area. No safety labeling applied identifying fluids within container. No Wildlife protection BMPs have been installed.

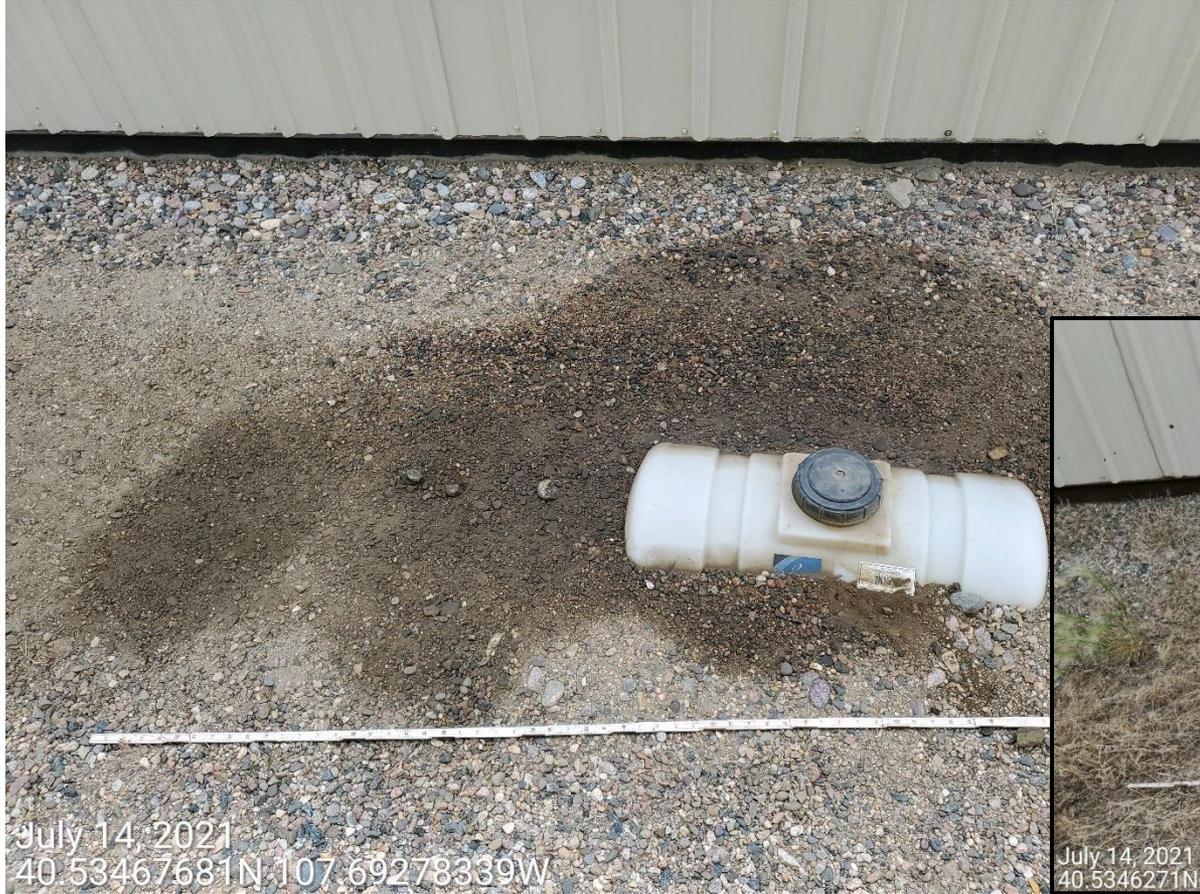
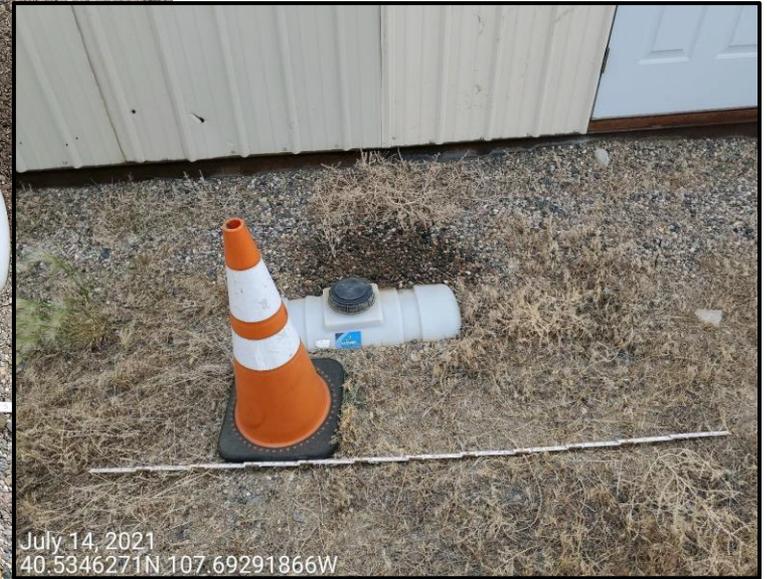
Photo 16: Photo taken from in between the two compressor sheds on the north end of the Location. Photo shows 2 partially buried vessels and impacted soils. Photos shows tank labeling is missing/insufficient. 6 foot measuring stick for reference.

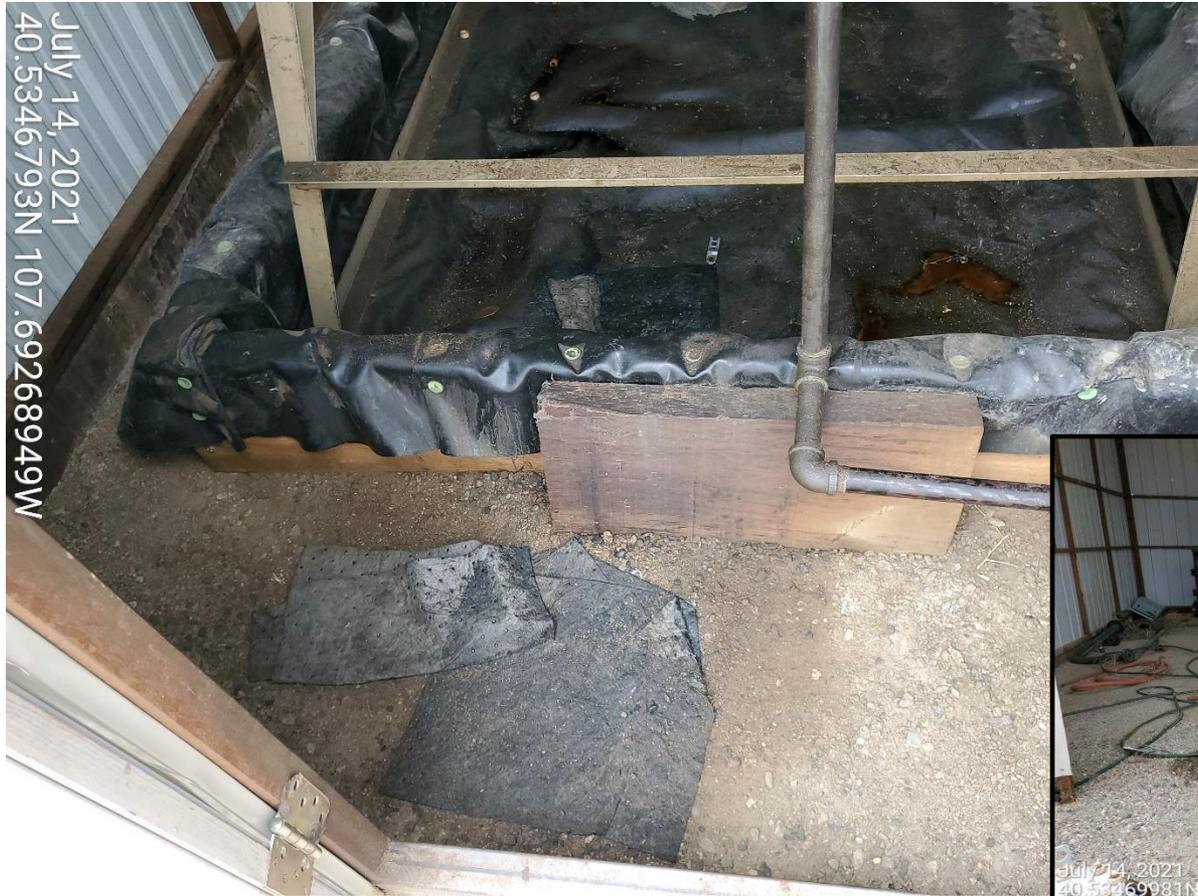
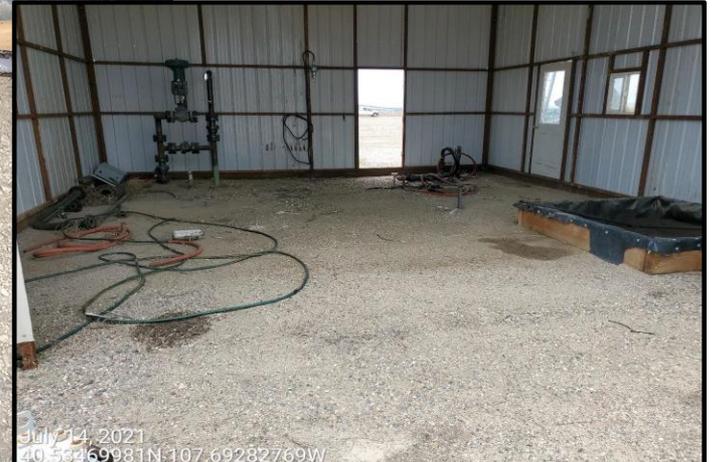
Photo 17: Photo taken from the eastern compressor shed on the north end of the Location. Photo shows stained soils within the shed. Inset photo (bottom right) shows additional stained soils observed within the western compressor shed.
