Operator: SWN PRODUCTION COMPANY LLC

Location ID: 438248

SWN- Diamond T, #438248

Inspection and Issue Report

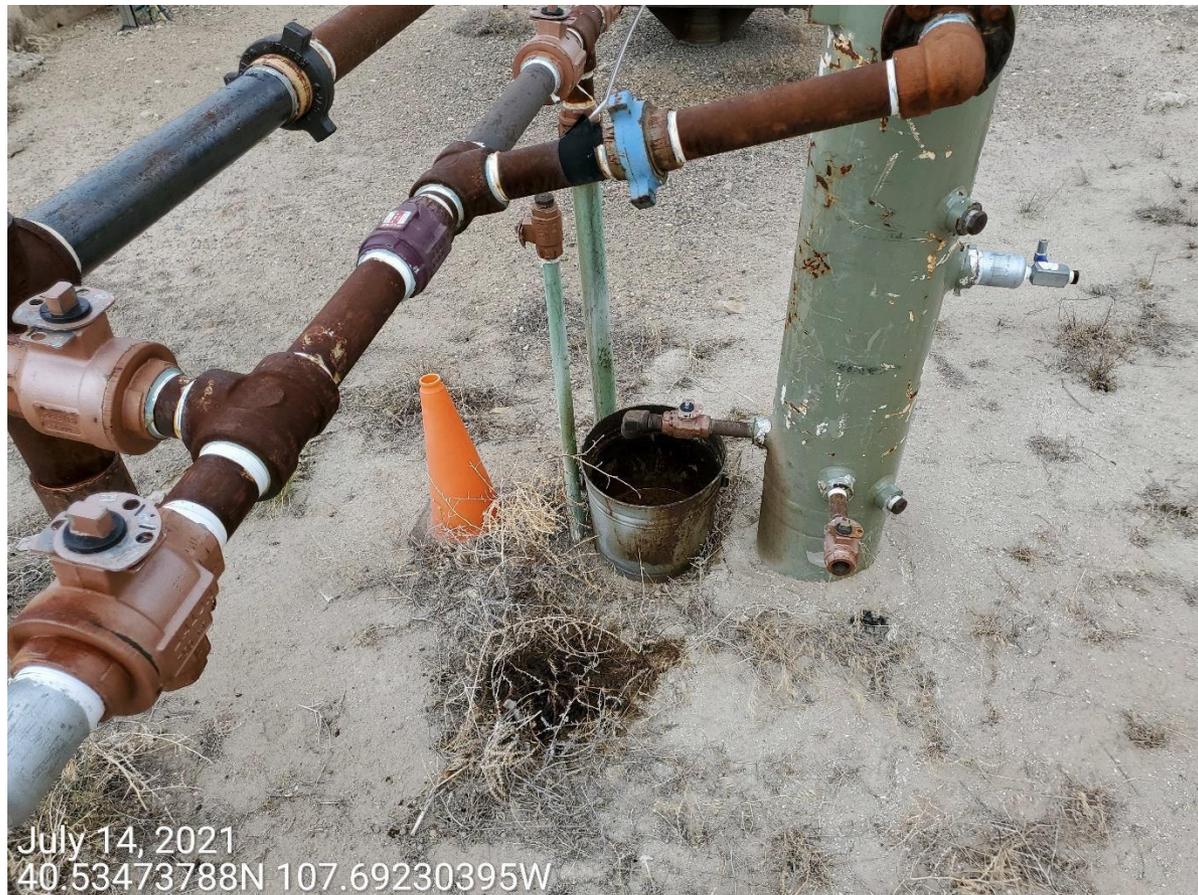
Photo 18: Photo taken from northeast corner of the Location. Photo shows Operator has placed a container to capture fluids drained from the scrubber unit. Safety labeling and wildlife protection BMP missing from container. Photo also shows stained soils observed at equipment.

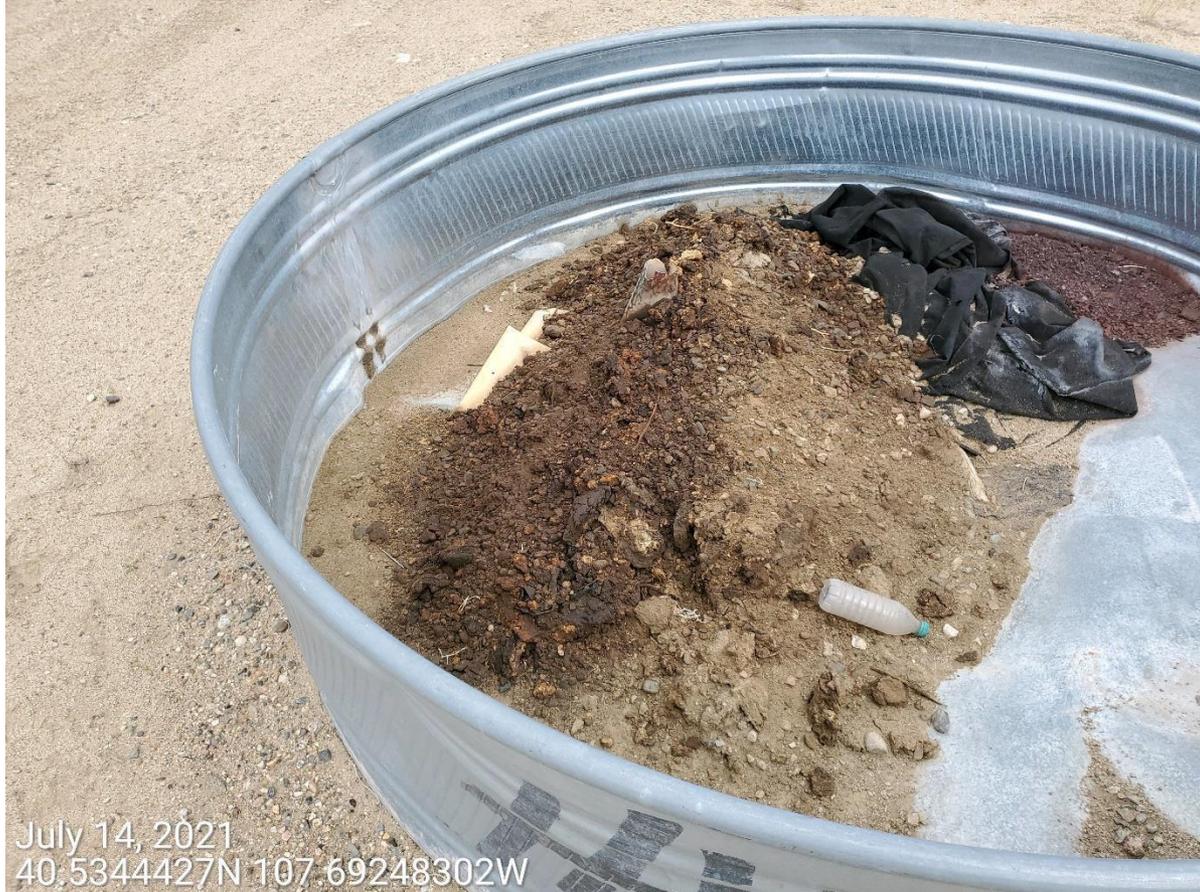
Photo 19: Photo taken from the east end of the Location. Photo shows stock tank containing impacted materials; Operator shall not collect and store E&P waste on the Location; impacted material requires removal. Stock tank is equipment not necessary for production and requires removal.

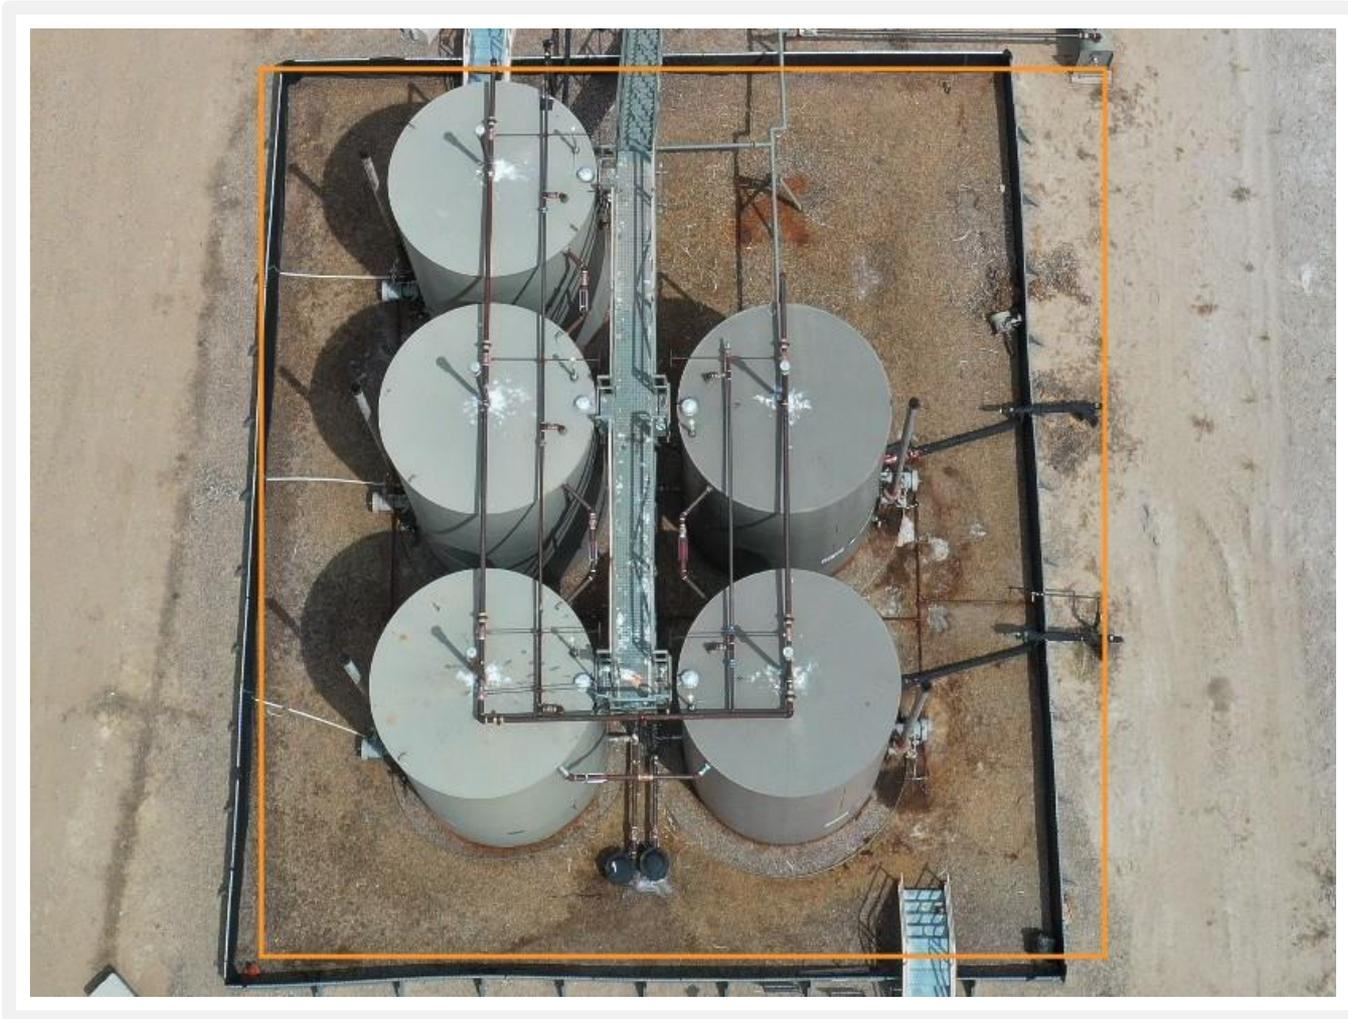
4 - Leak OPEN

SummaryImpacted soils within
containment**Created**

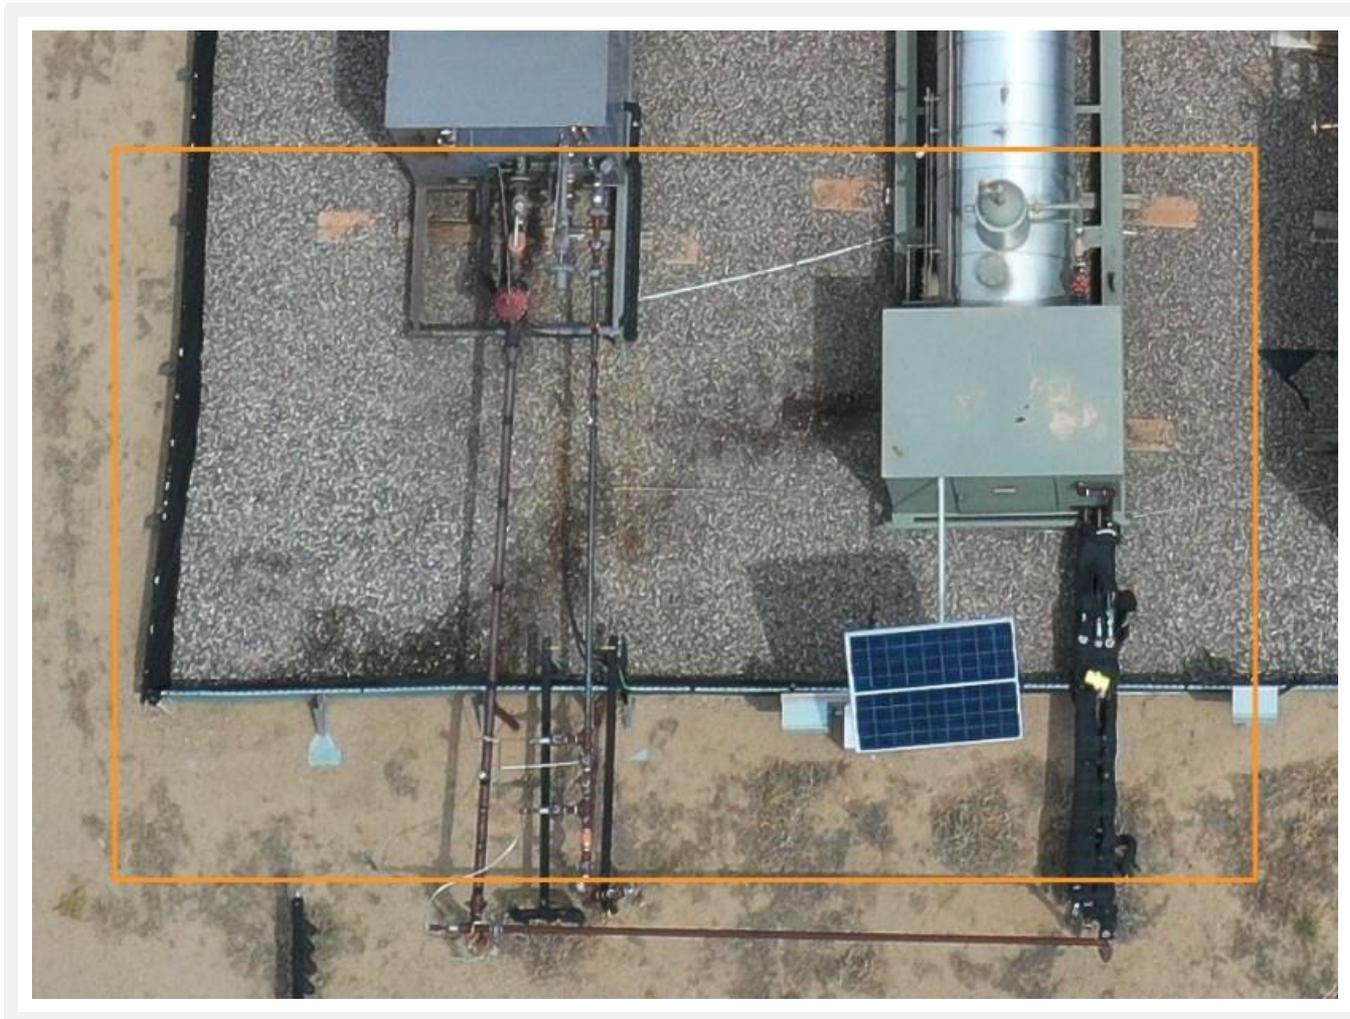
3 - Leak OPEN

SummaryImpacted soils within
containment**Created**

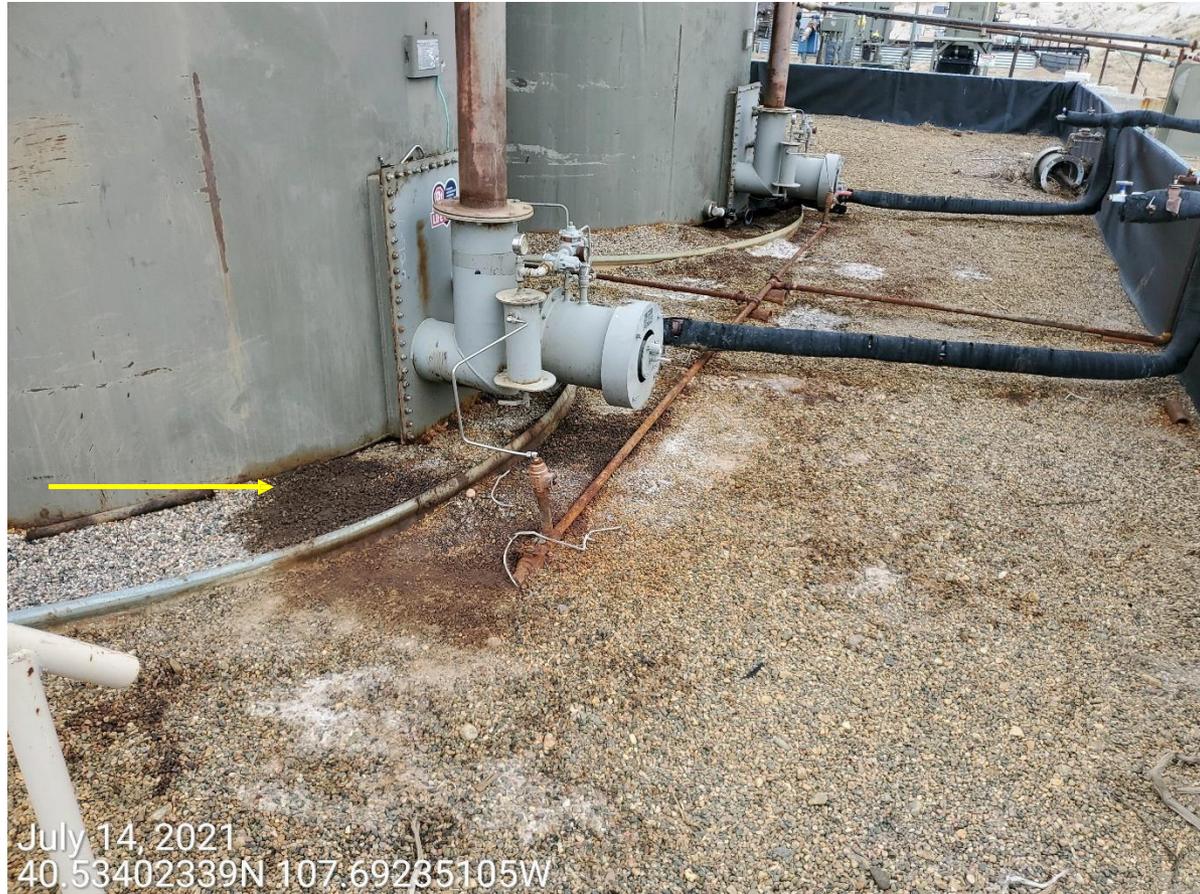
Photo 20: Photo taken from the tank battery on the east end of the Location. Photo shows impacted soils within and throughout the secondary containment. Photo also shows what appears to be weeping fluids at the base of the tanks.

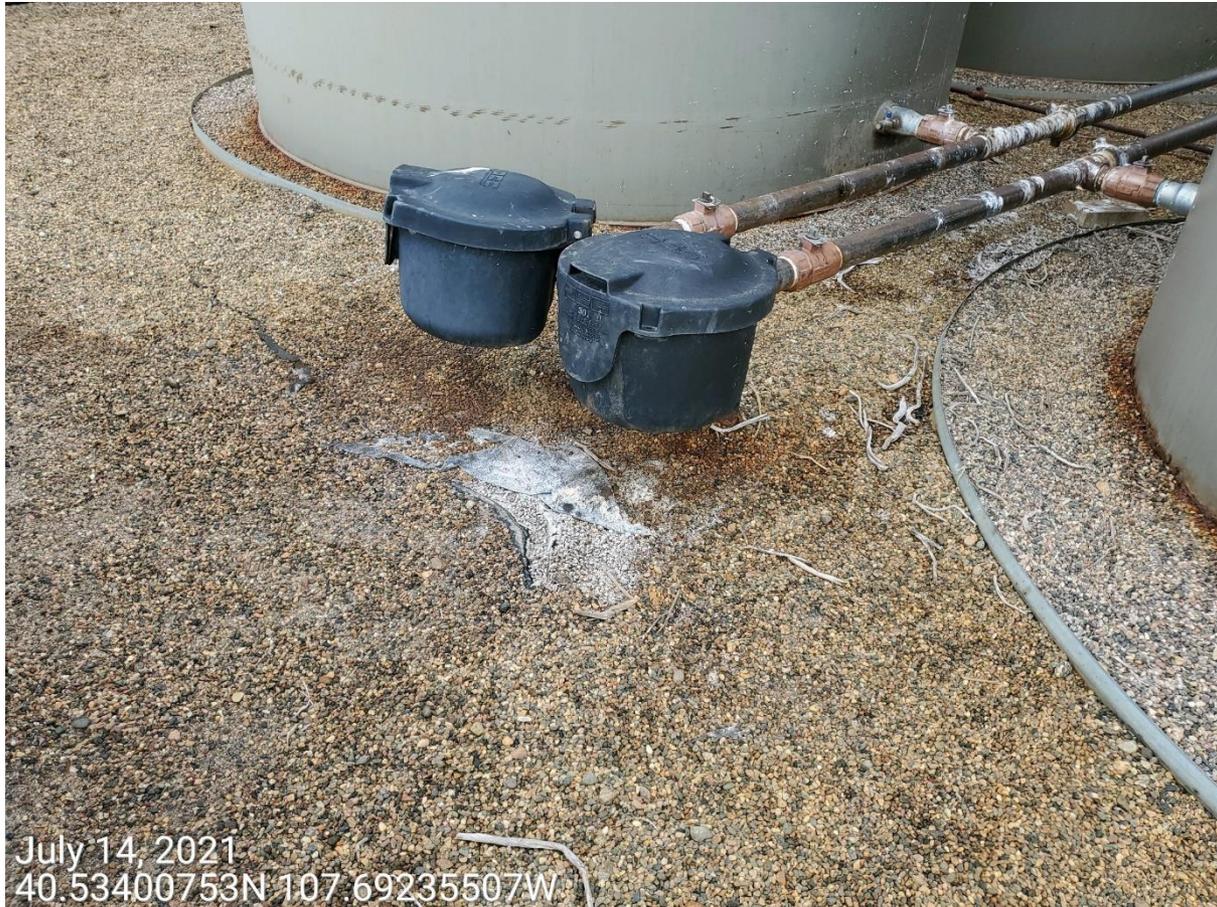
Photo 21: Photo show catchment basin at the end of the loadout lines. Photo shows impacted materials within the tank battery's secondary containment. White staining on plastic liner observed.

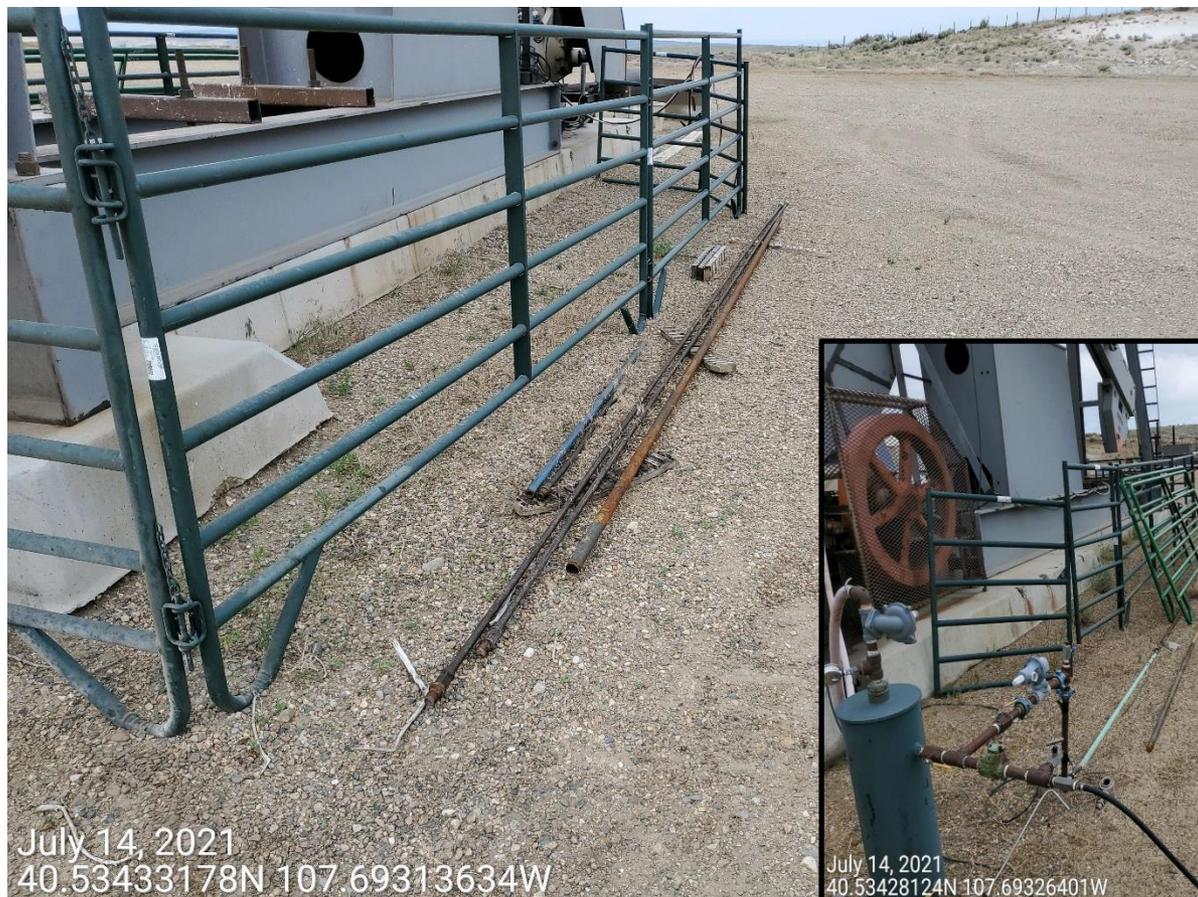
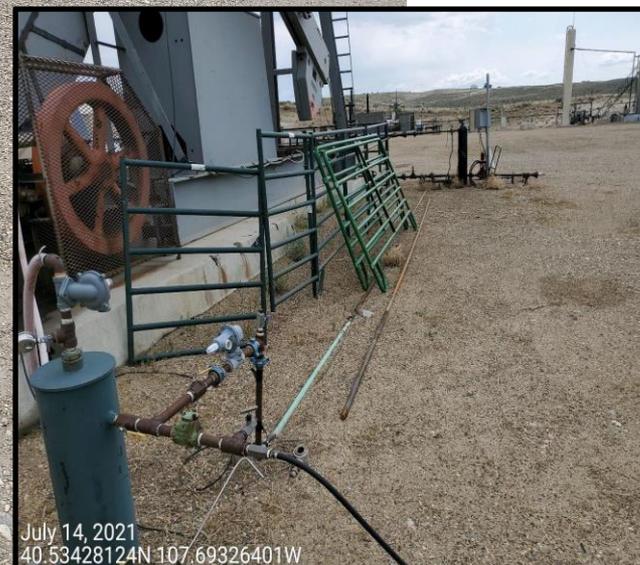
Photo 22: Photo shows unused panel and pipe equipment stored around the well.

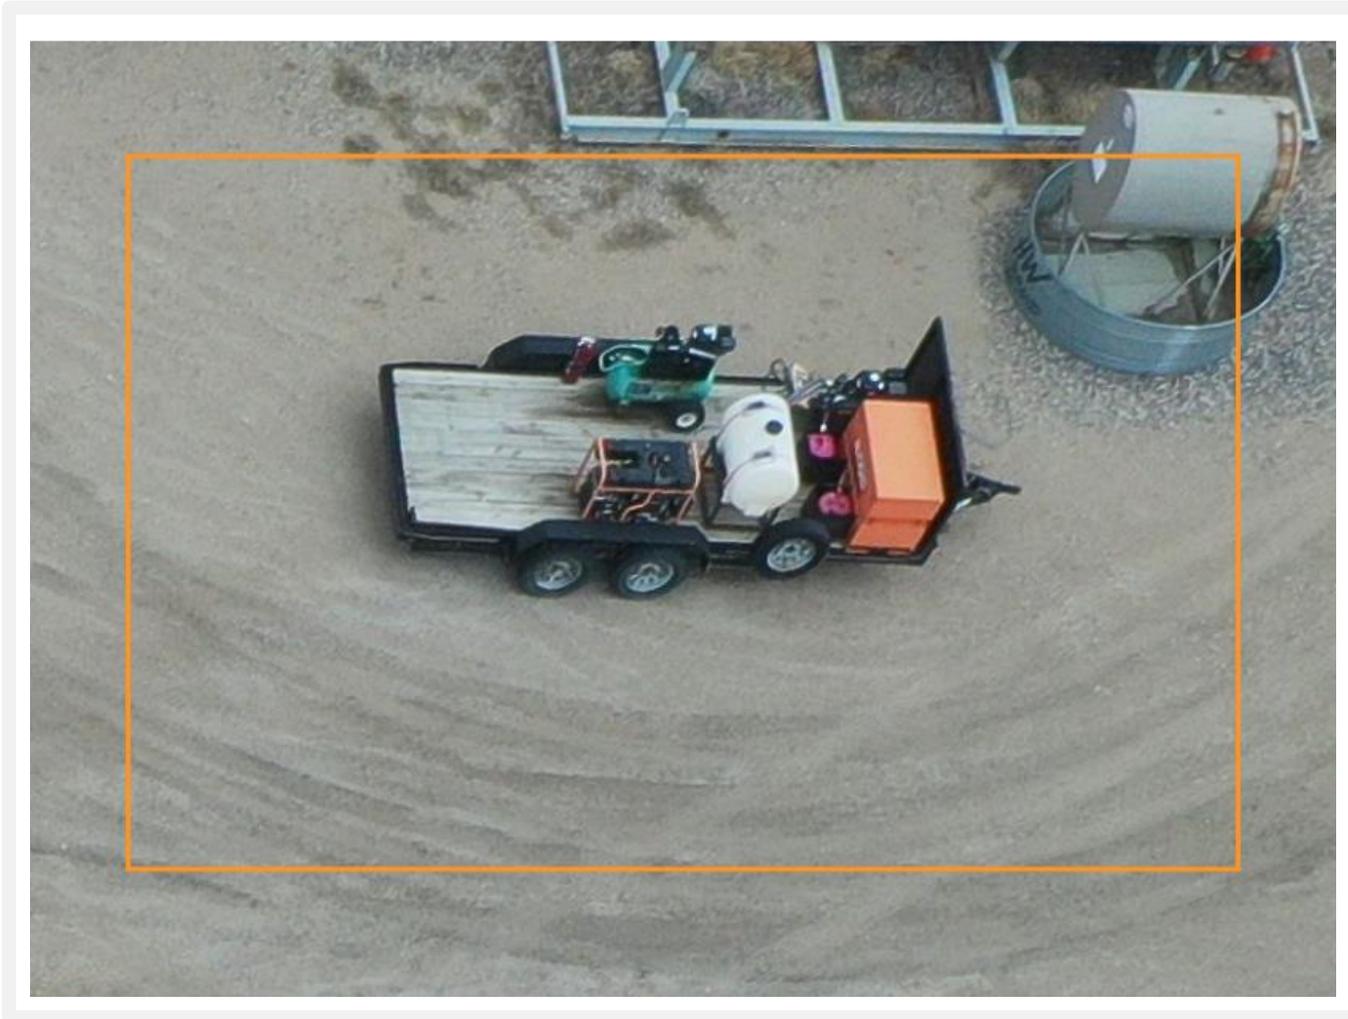
27 - Other **OPEN**

Trailer and equipment stored on the Location

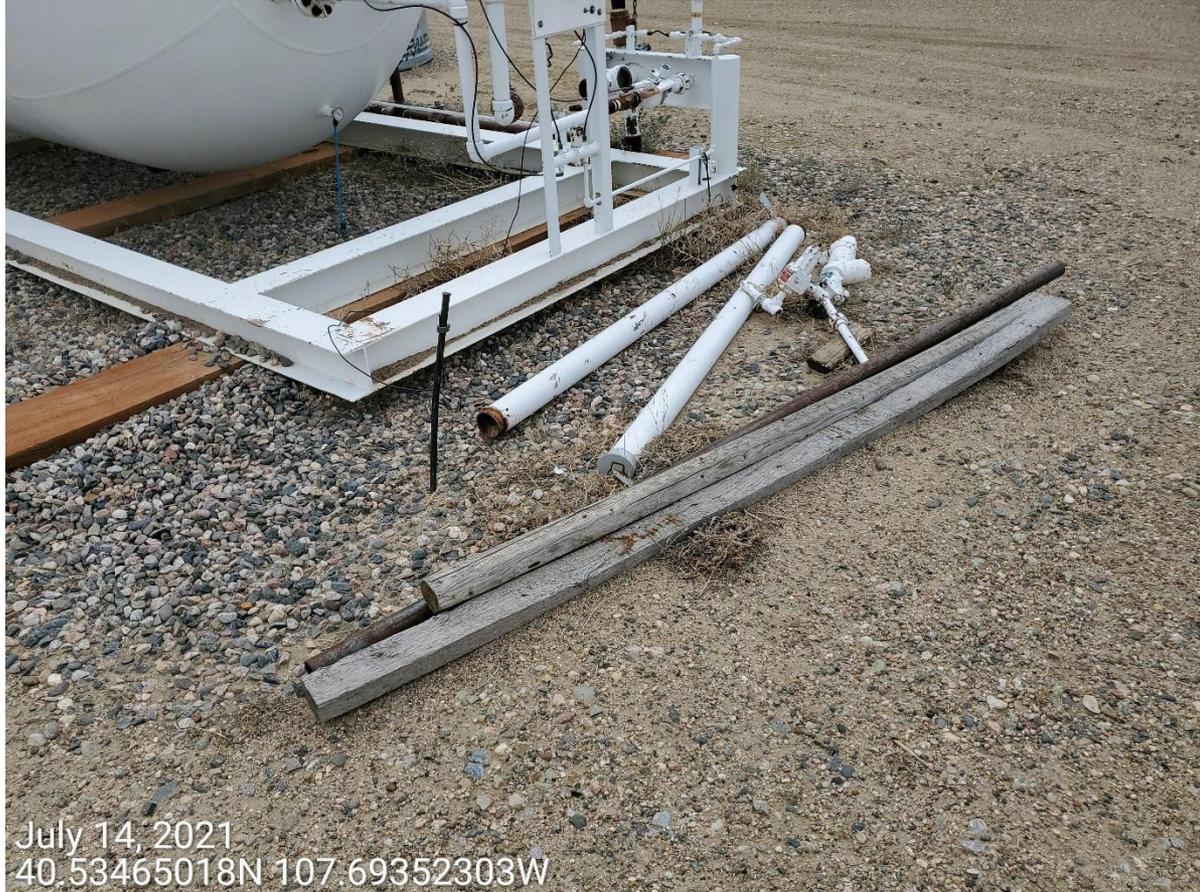
Photo 23: Photo taken from the west end of the of the white tank on the north end of the Location. Photo shows various wood debris and unused pipe equipment stored on the Location.

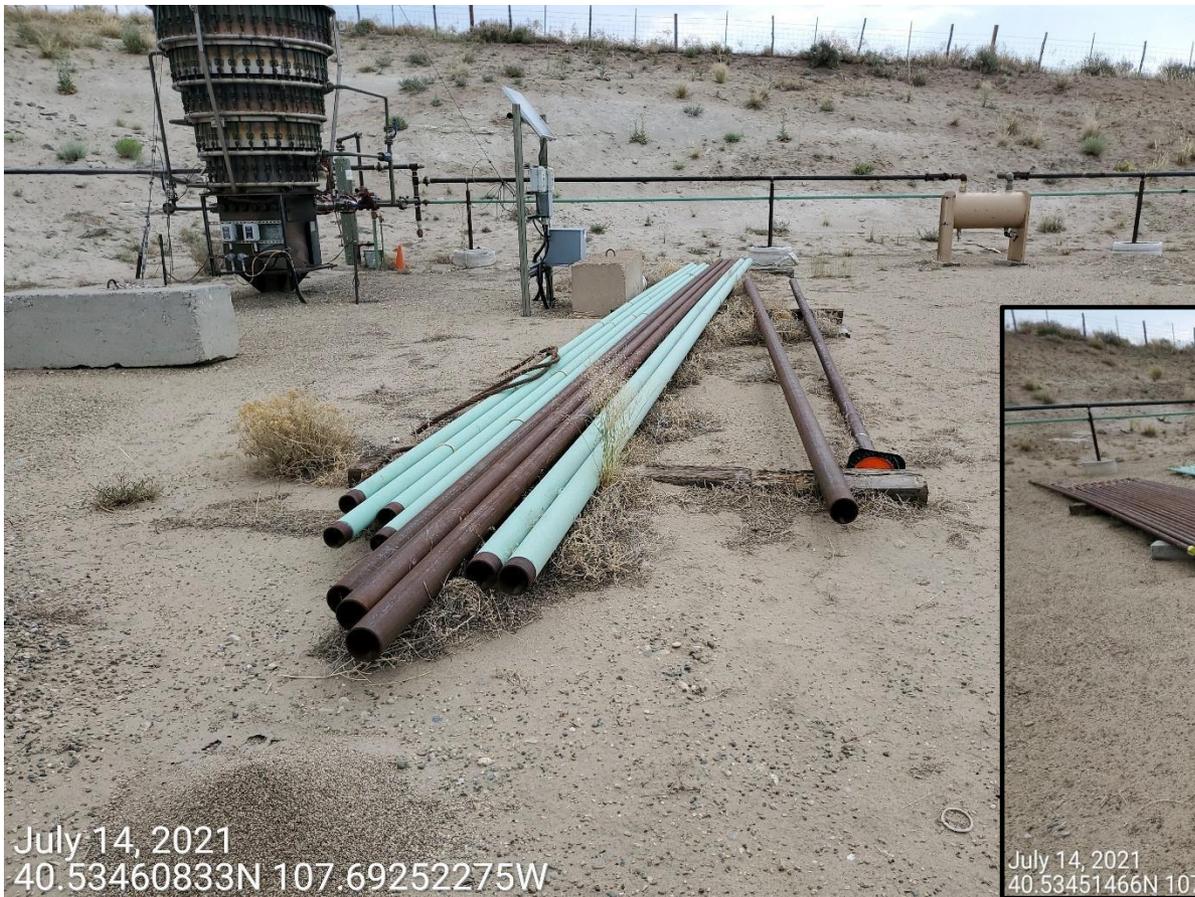
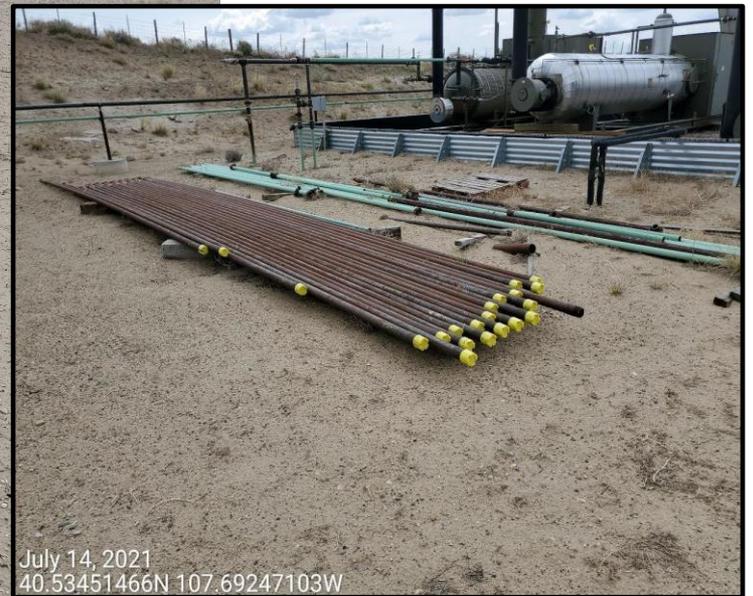
Photo 24: Photo shows unused equipment stored on the northwest end of the Location.

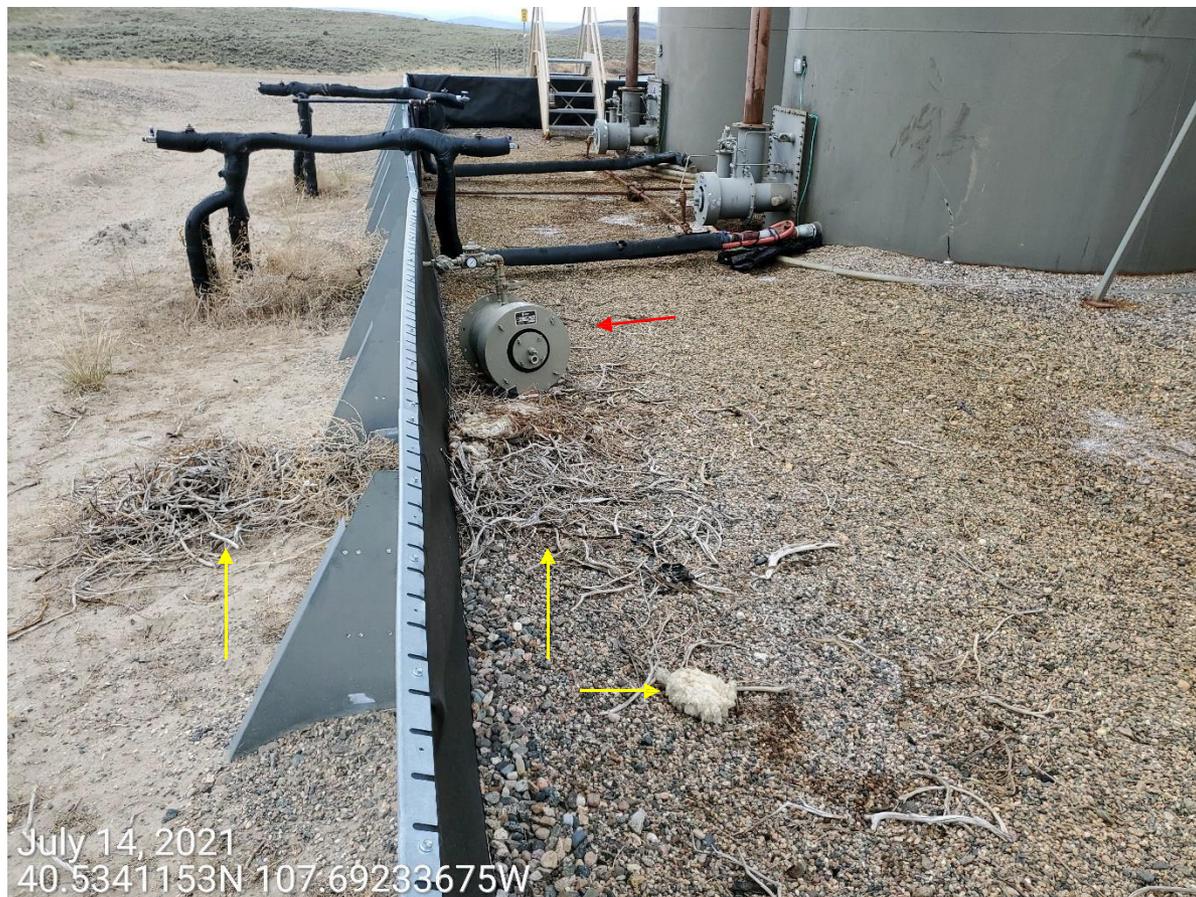
Photo 25: Photo taken from the northeast end of the tank battery, on the east end of the Location, facing south. Photo shows what appears to be a destroyed bird nest; various twigs/woody material, wildlife hair and sheep wool were observed amongst the debris (yellow arrow). Debris requires removal from secondary containment. Photo also shows an unused flame arrester stored within the secondary containment (red arrow) ; equipment requires removal.

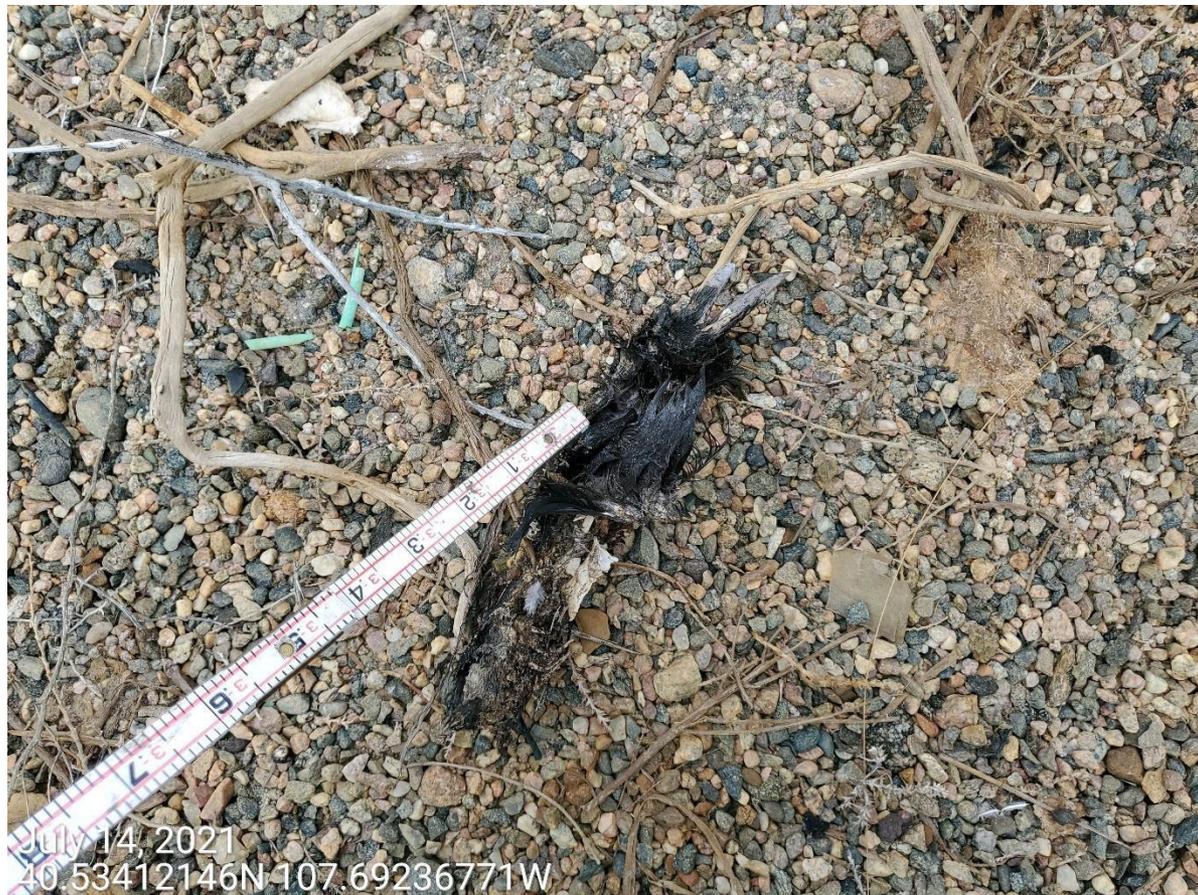
Photo 26: Photo shows a dead bird found amongst the debris observed in within the secondary containment. Bird appears to be a young crow.

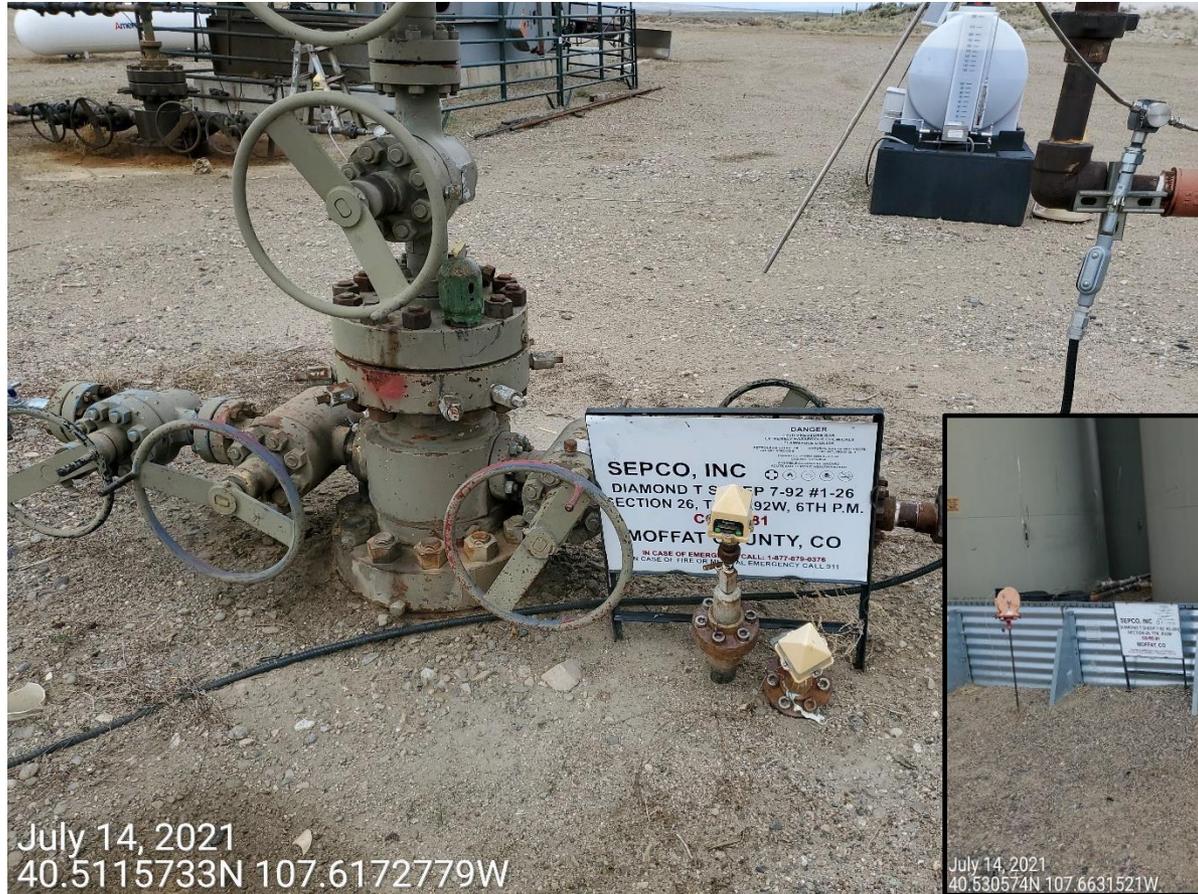
Photo 27: Photos show signage at wells and battery (including tanks) with incorrect Operator information; COGCC well file records show Operator as "SWN Production Company LLC #10396".

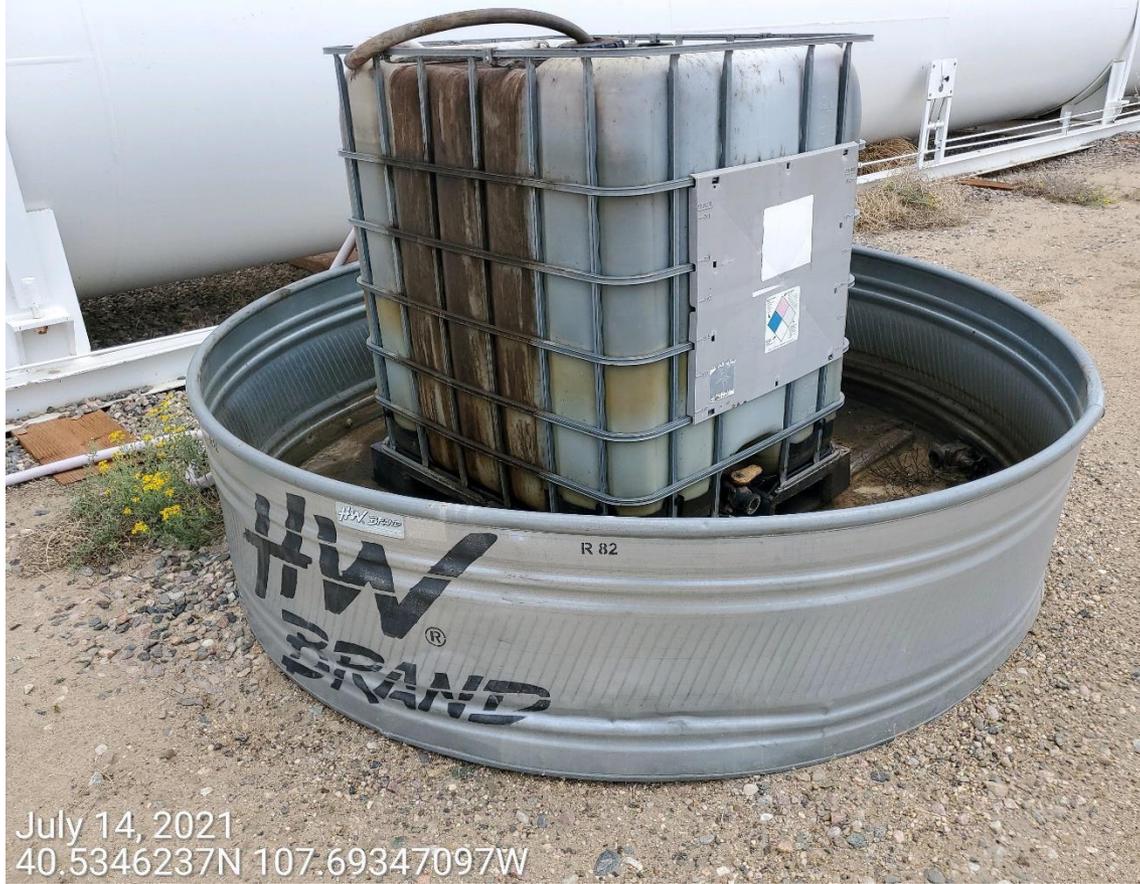
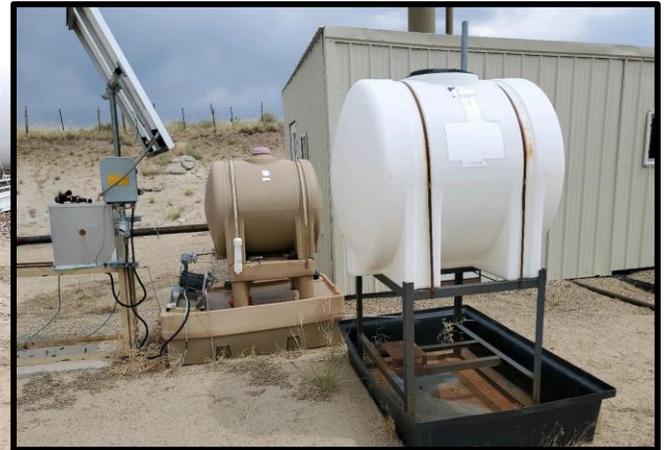
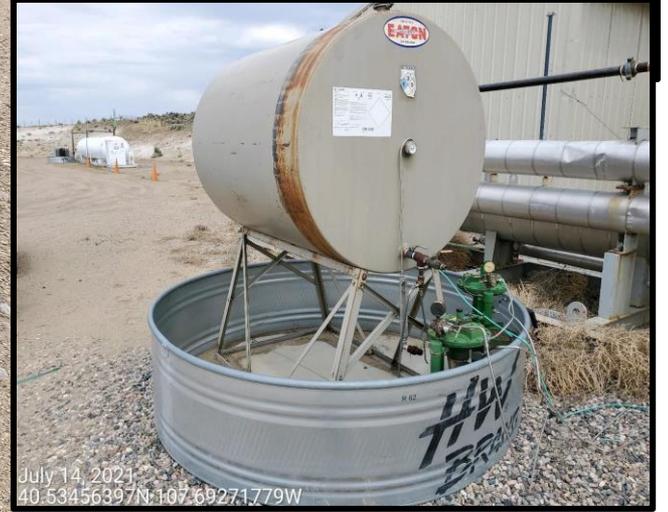
Photo 28: Photo shows example of tanks observed on Location with insufficient/inadequate labeling. Photo also shows wildlife protection equipment to prevent wildlife access to secondary containment is missing or insufficient.
