Inspection Photos

API: 071-06128

Operator: OGRIS OPERATING LLC

Inspection Date: 7/7/2021

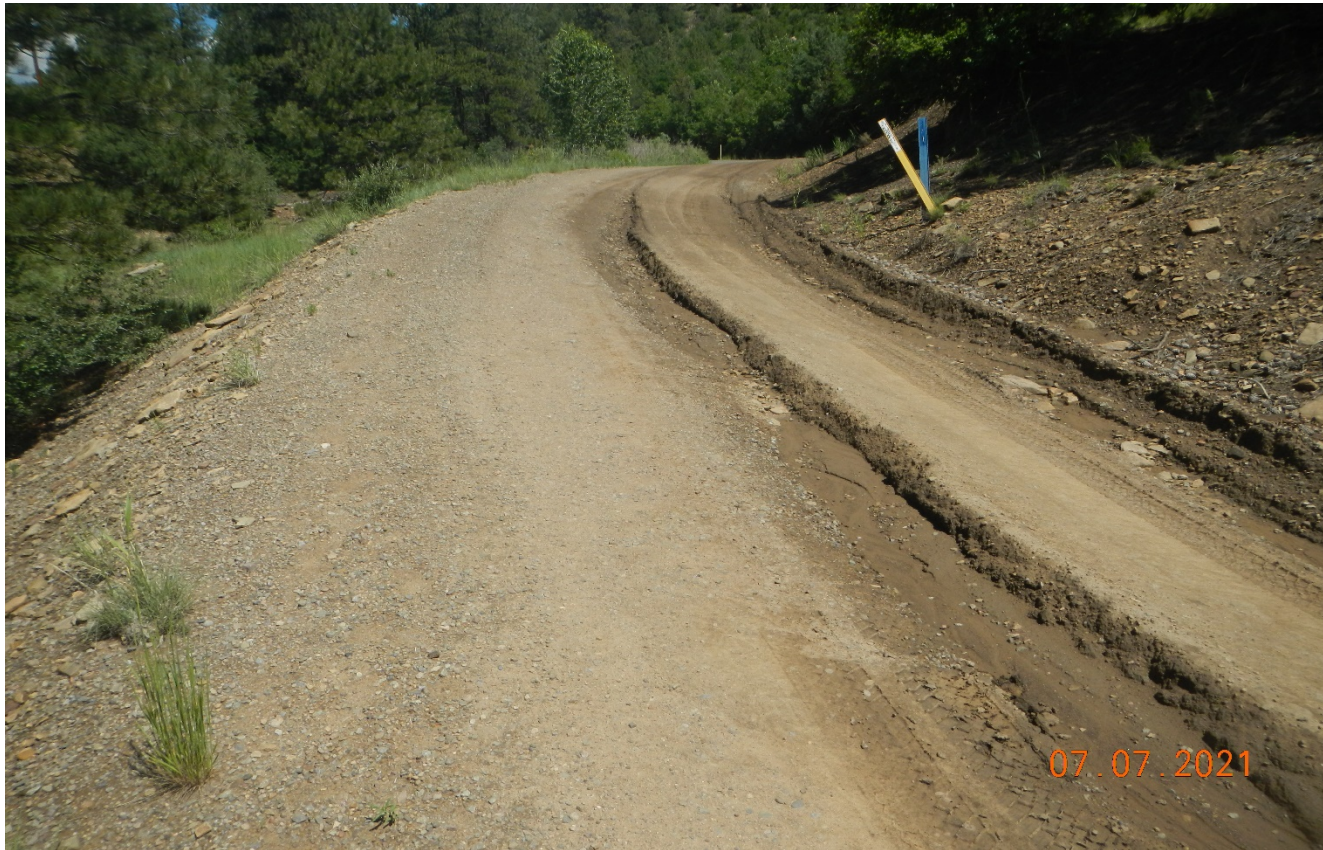
Photo 1. There is vehicle rutting along the main road. Areas of rutting need to be stabilized. Previous corrective action was not performed.

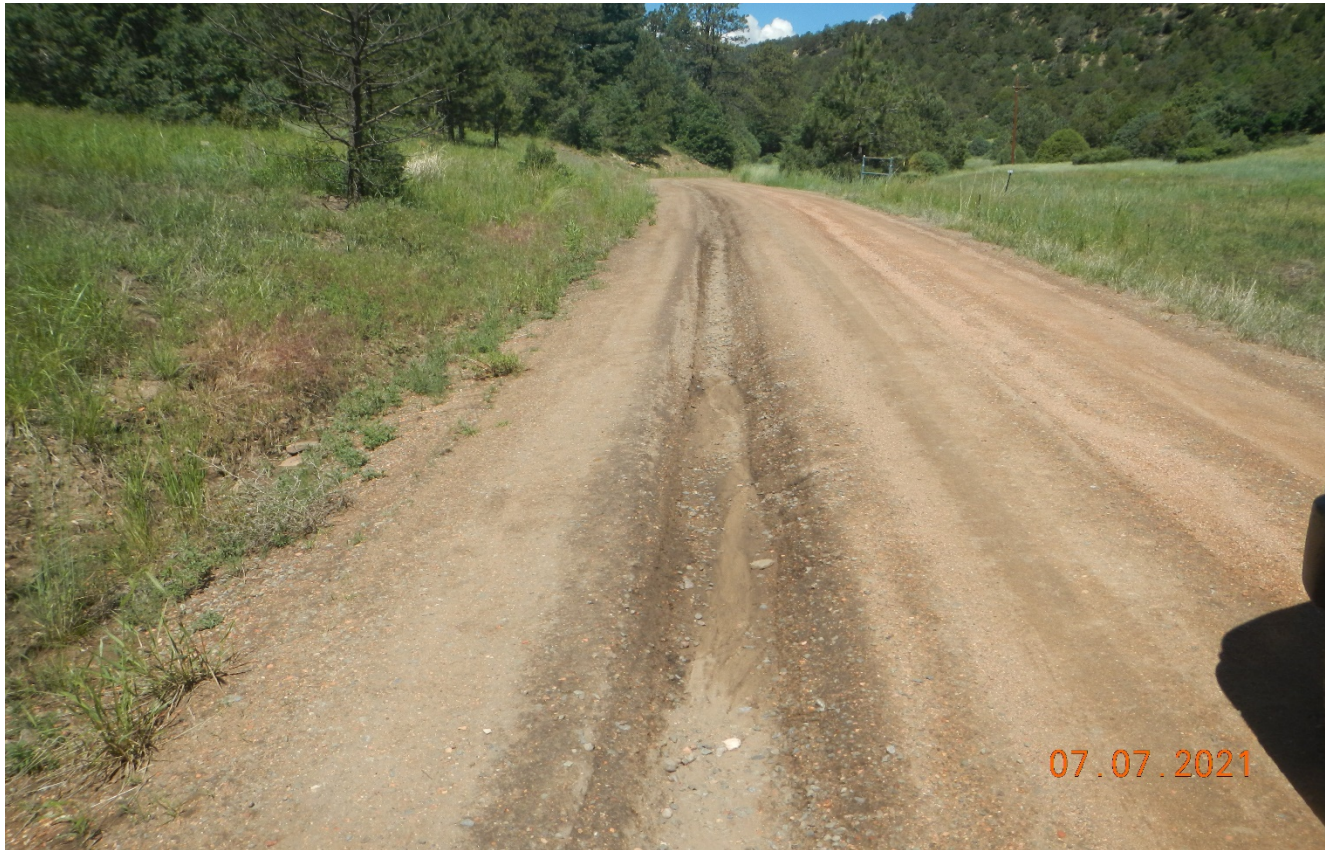
Photo 2. There is vehicle rutting along the main road. Areas of rutting need to be stabilized. Previous corrective action was not performed.

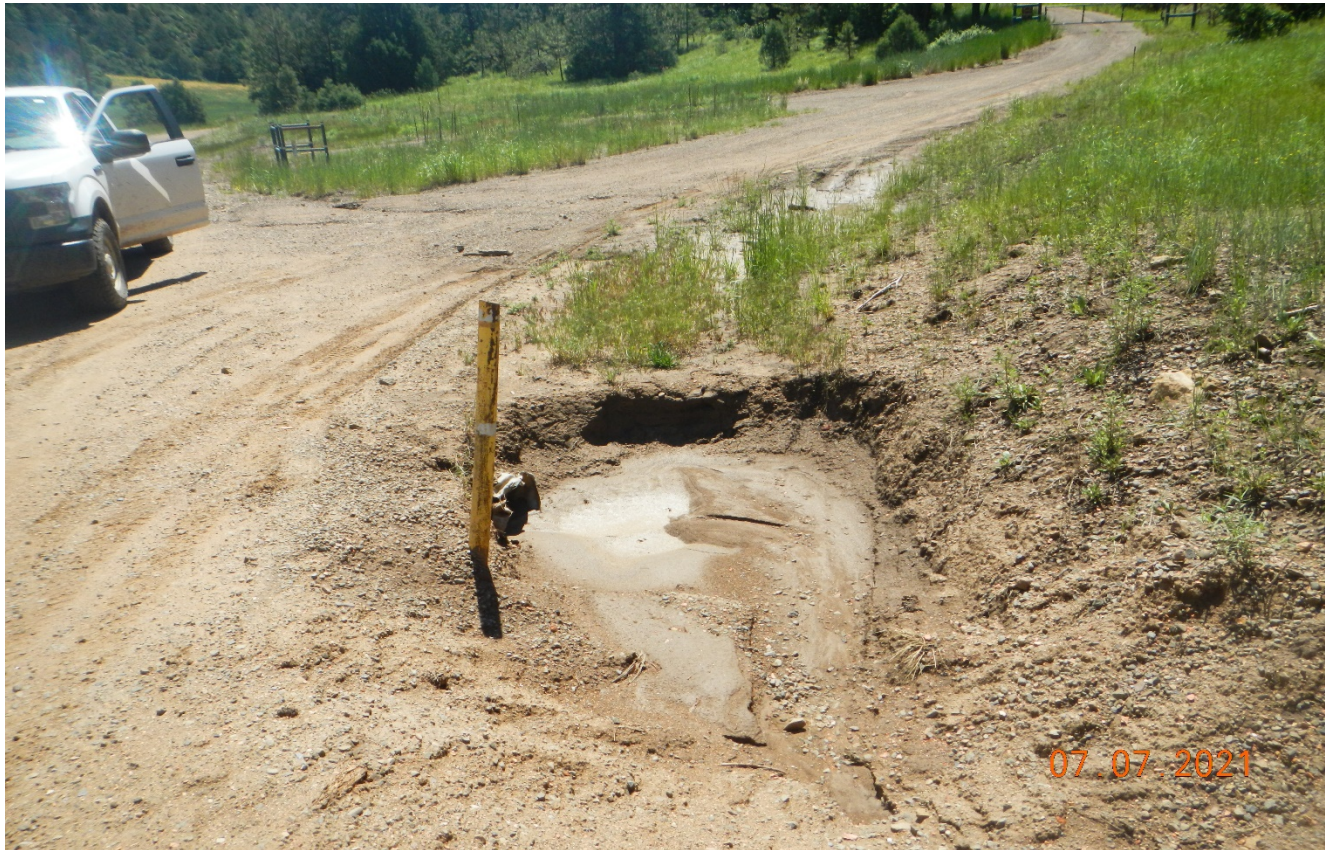
Photo 3. It appears sediment was removed from culvert inlet but has partially filled back in with recent storm events. Ongoing maintenance needs to be performed.

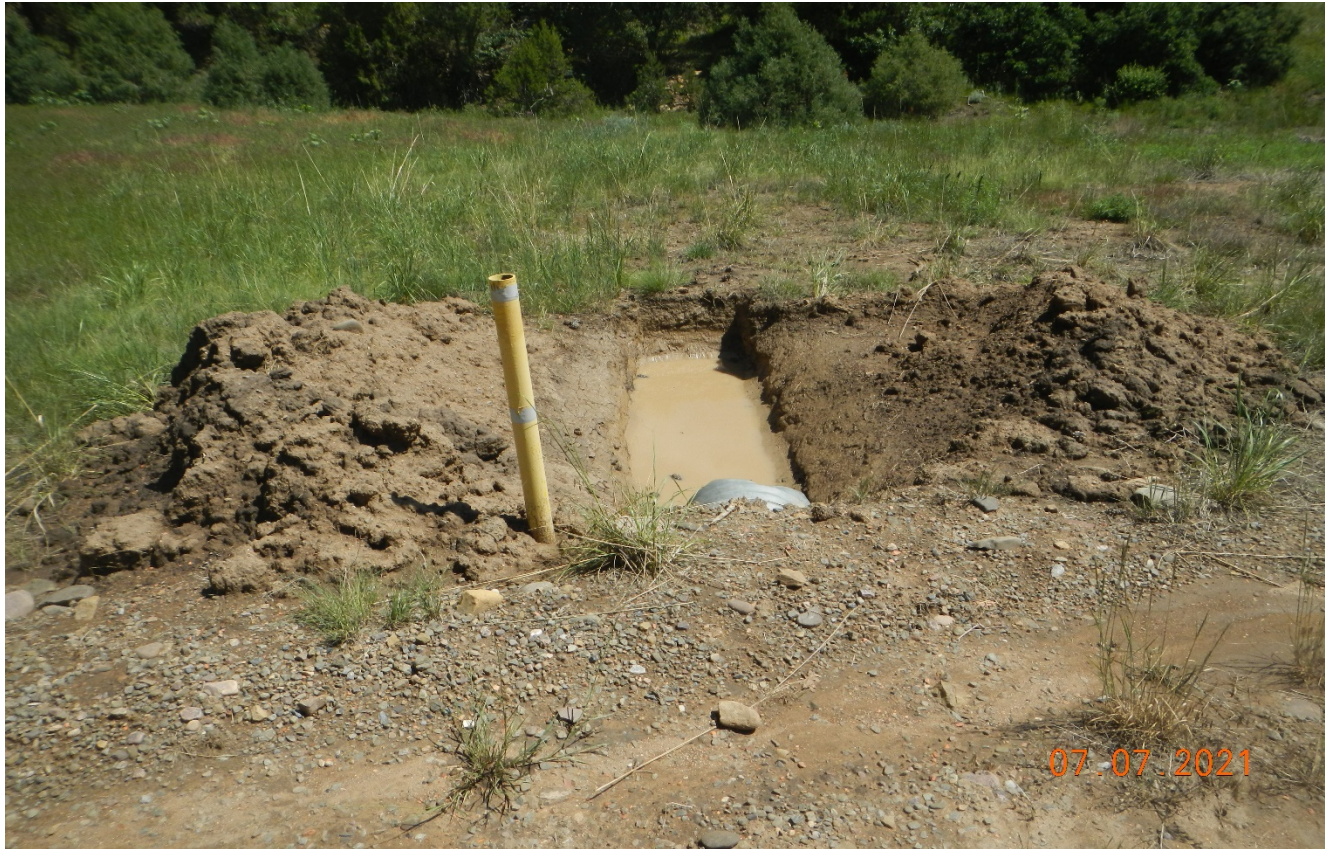
Photo 4. The same culvert outlet was excavated with sediment piles. The sediment piles need to be removed or stabilized and proper drainage is needed at the outlet along with installation of outlet protection or sediment trap.

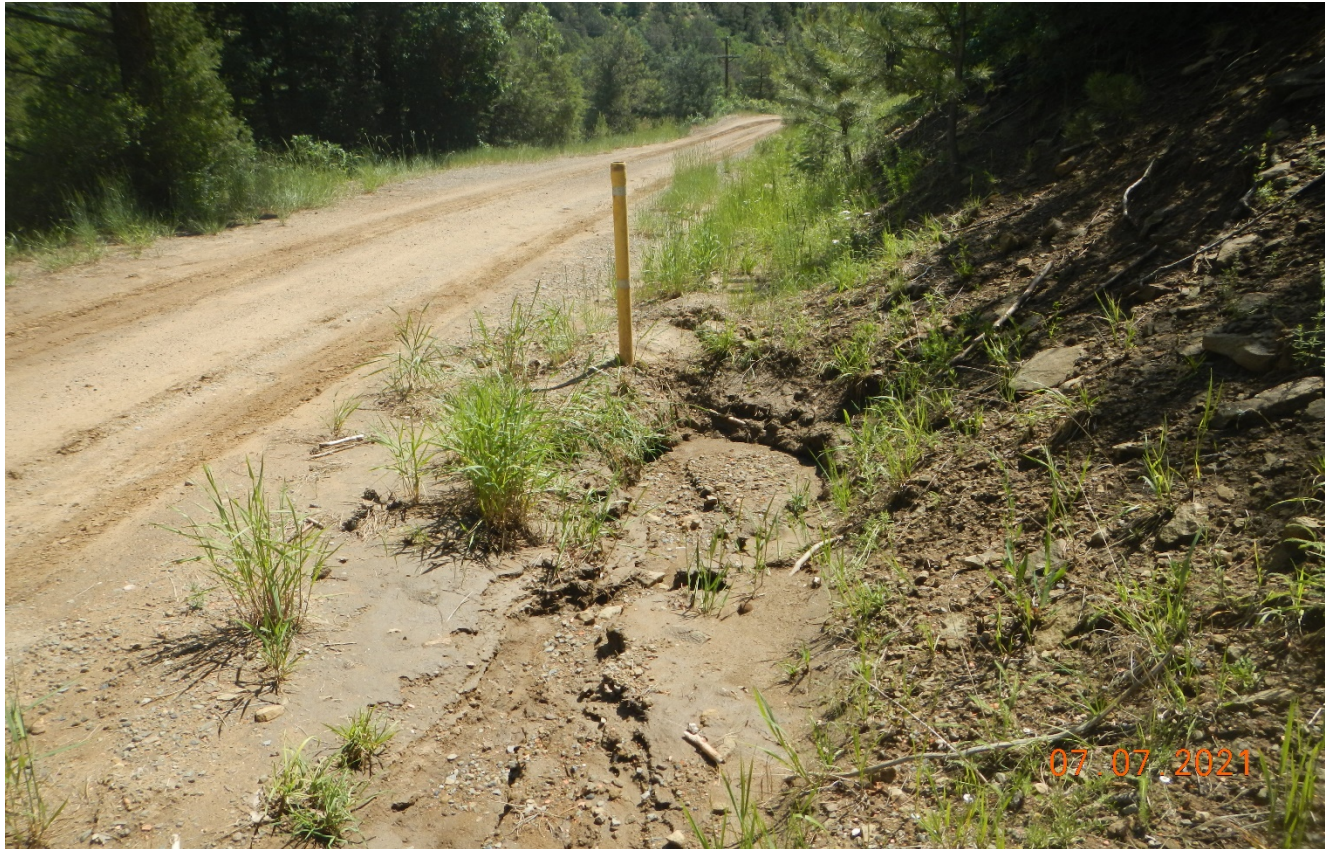
Photo 5. Further along the access road toward the location, another culvert is filled in with sediment.

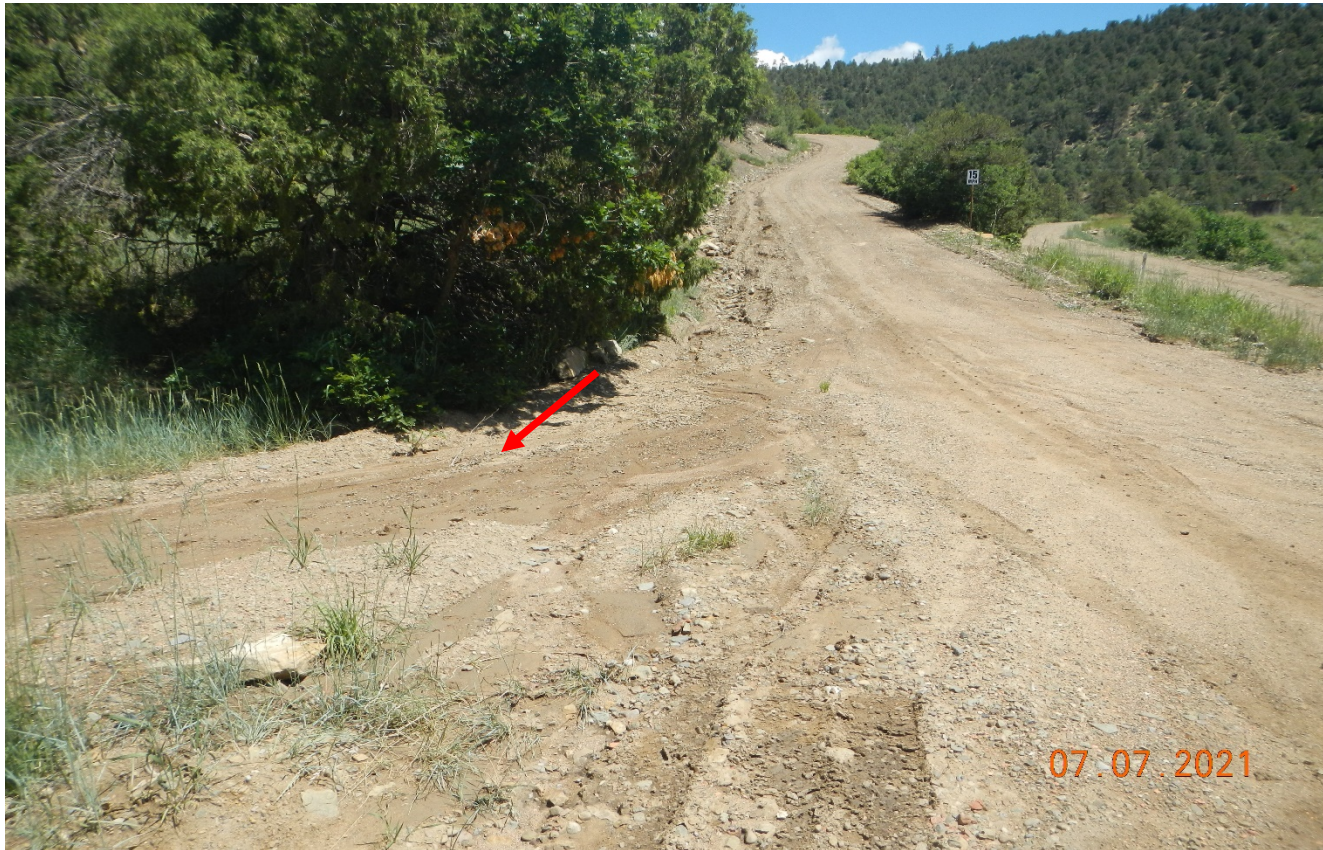
Photo 6. Facing north as the road ascends the hill side. Sediment is being deposited in the area shown at red arrow. BMP's are needed along the steep grade of the road to prevent erosion.

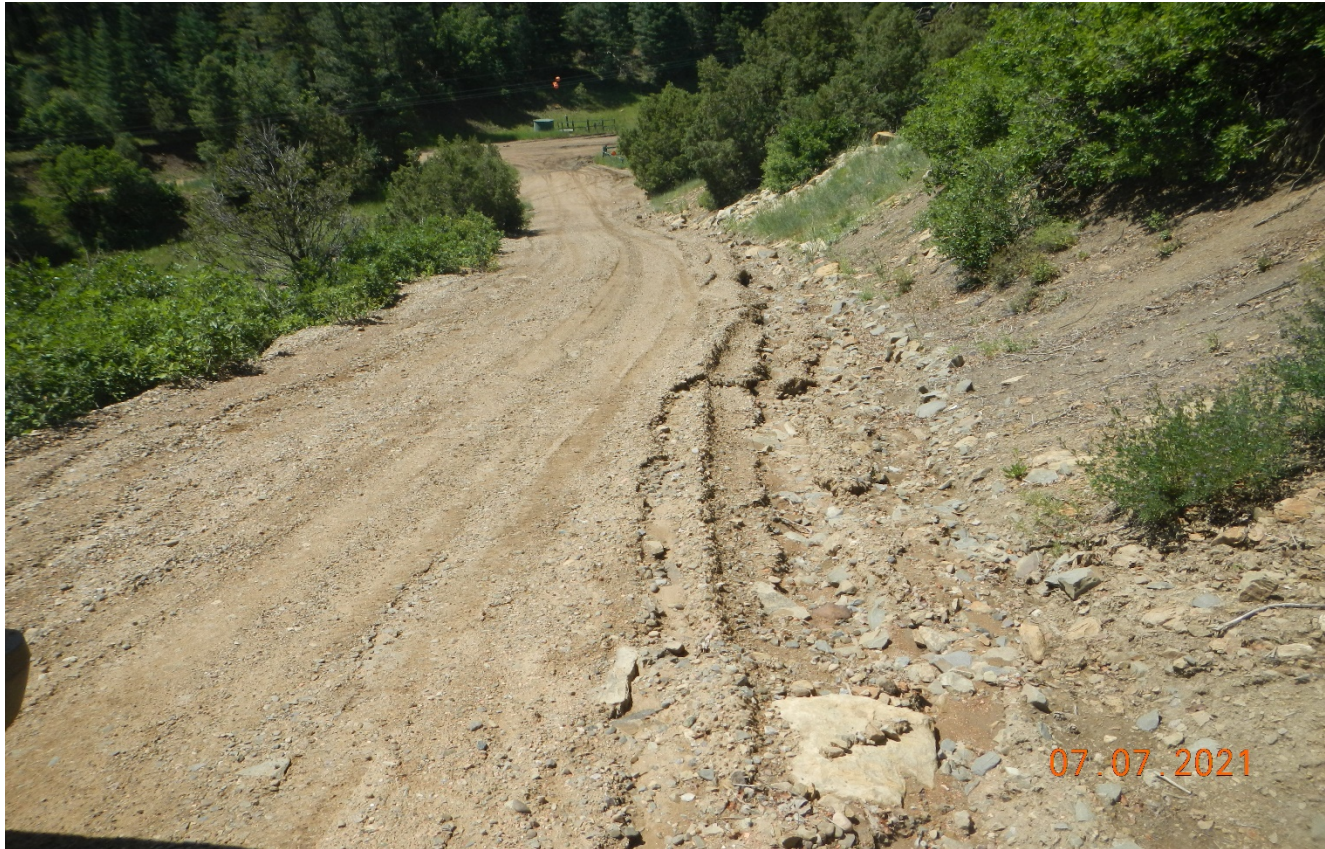
Photo 7. Facing back down the steep grade of the road. BMP's are needed along the steep grade of the road to prevent erosion.

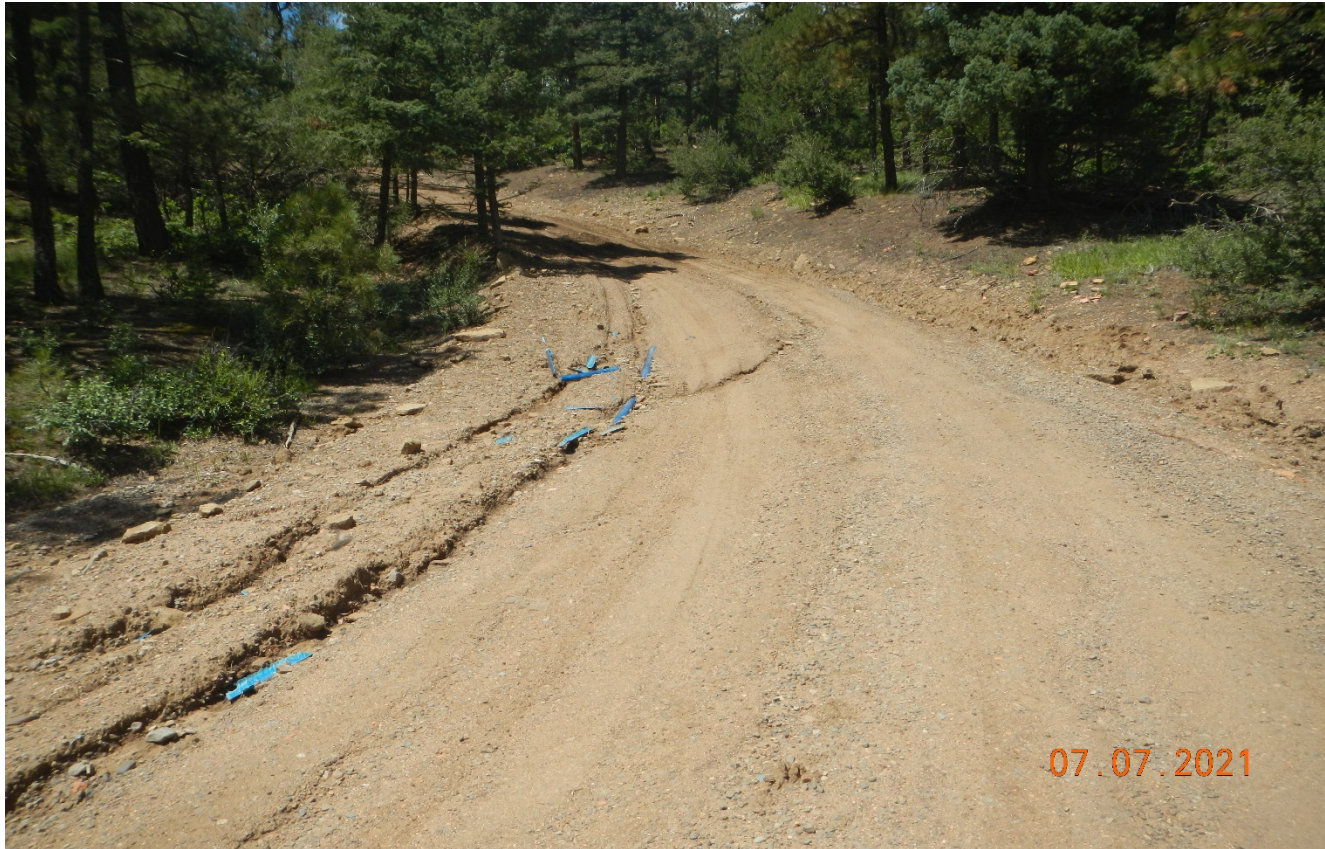
Photo 8. There is pieces of blue pipe laying on the road. This debris needs to be disposed. Previous corrective action was not performed.

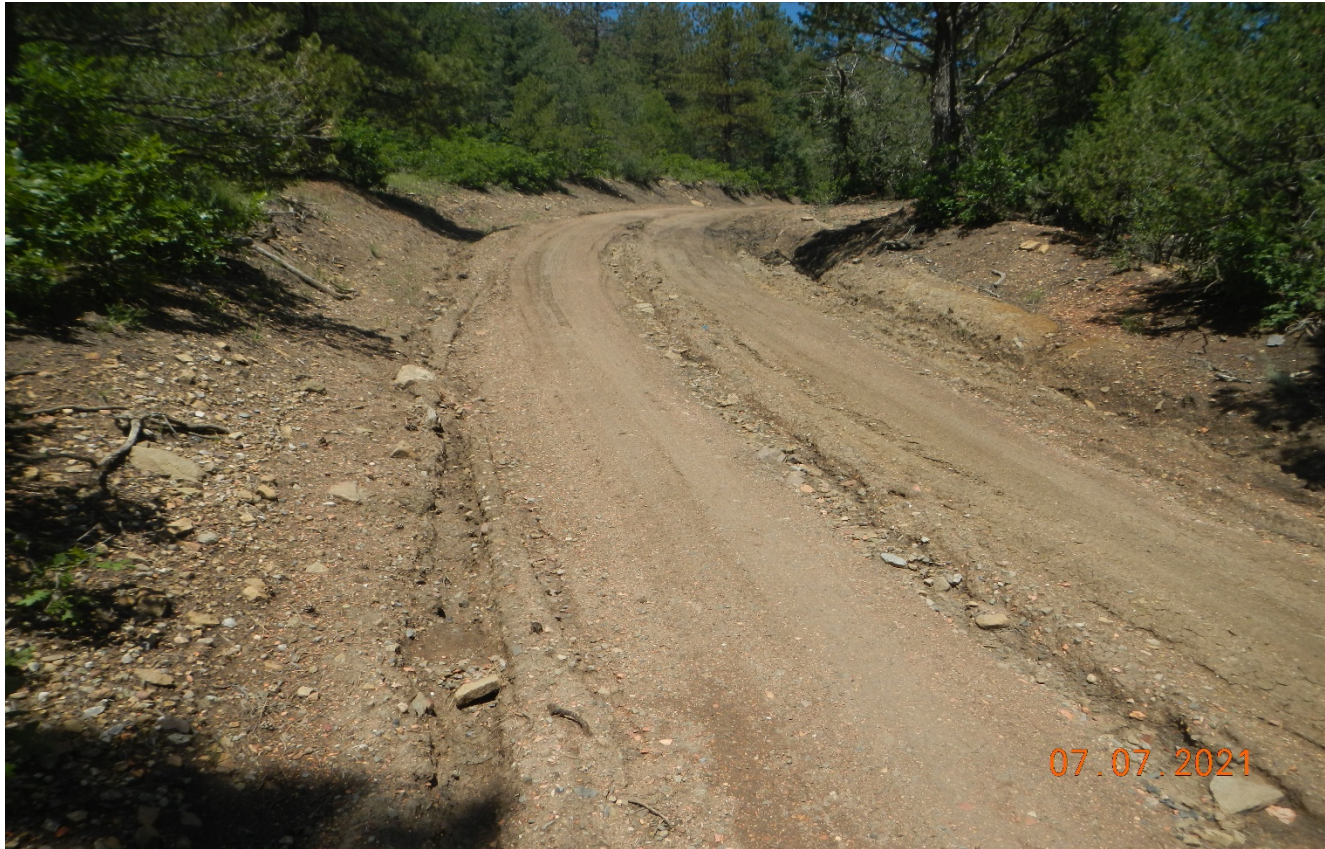
Photo 9. The vehicle rutting has not been repaired since previous inspection. Areas of the road are not stabilized and susceptible to further erosion.

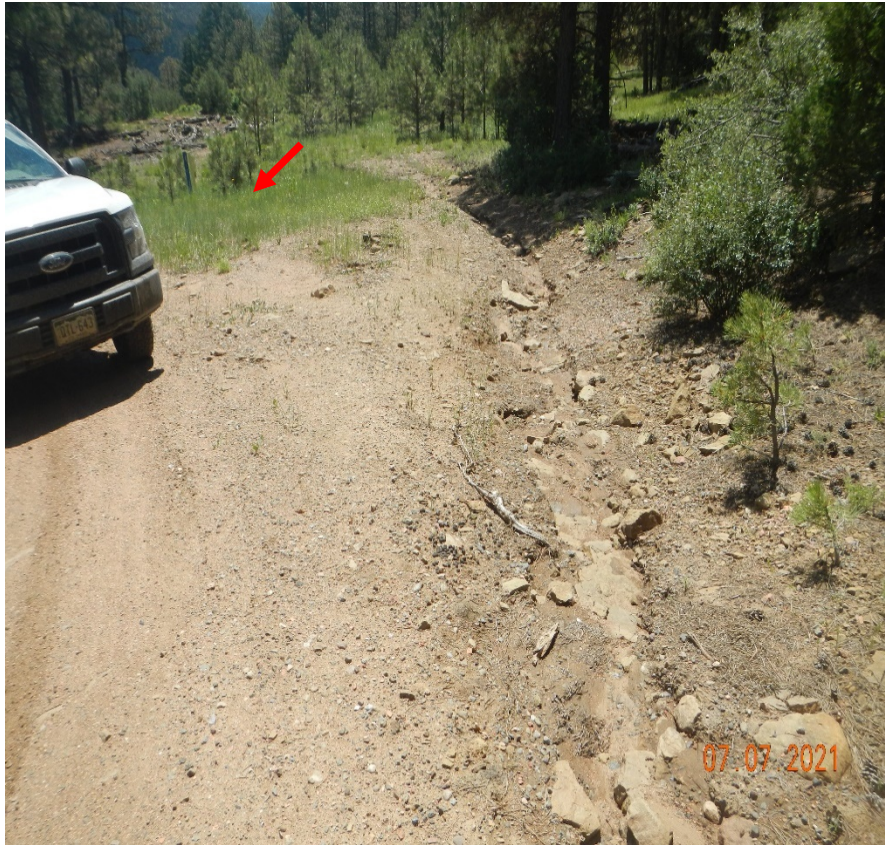
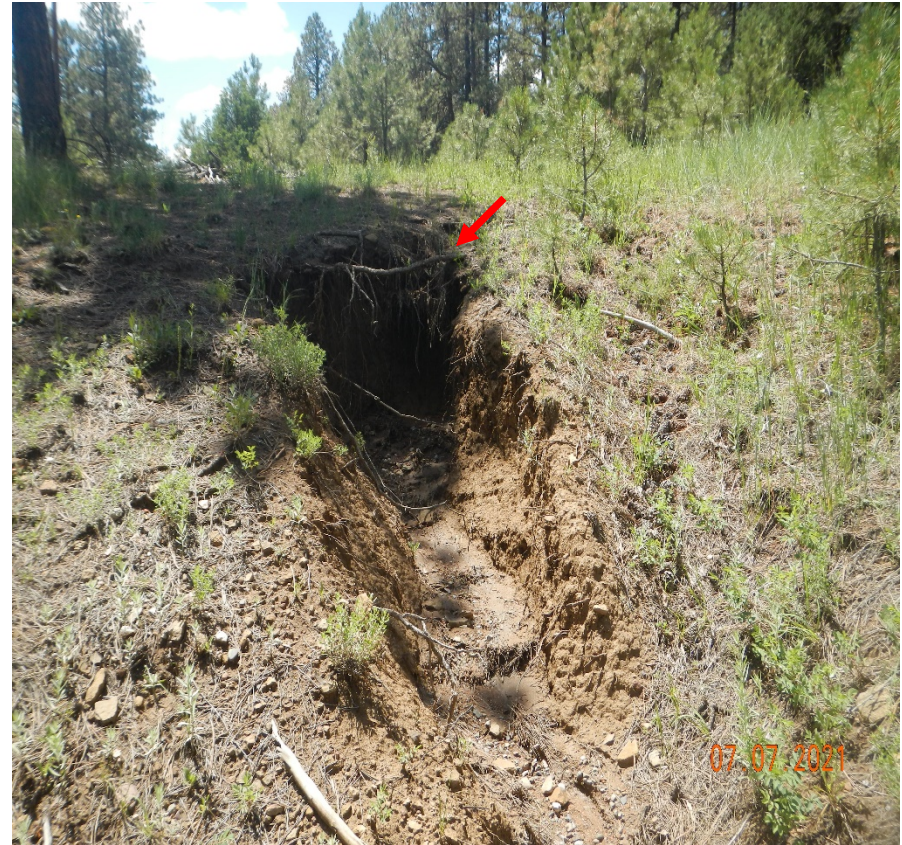
Photo 10. Stormwater directed from the road has caused a washout at area shown at red arrows. Lat/Long:37.09432,-104.94607. Previous corrective action was not performed.
