# Inspection Photos

API: 071-06340

Operator: OGRIS OPERATING LLC

Inspection Date: 7/7/2021

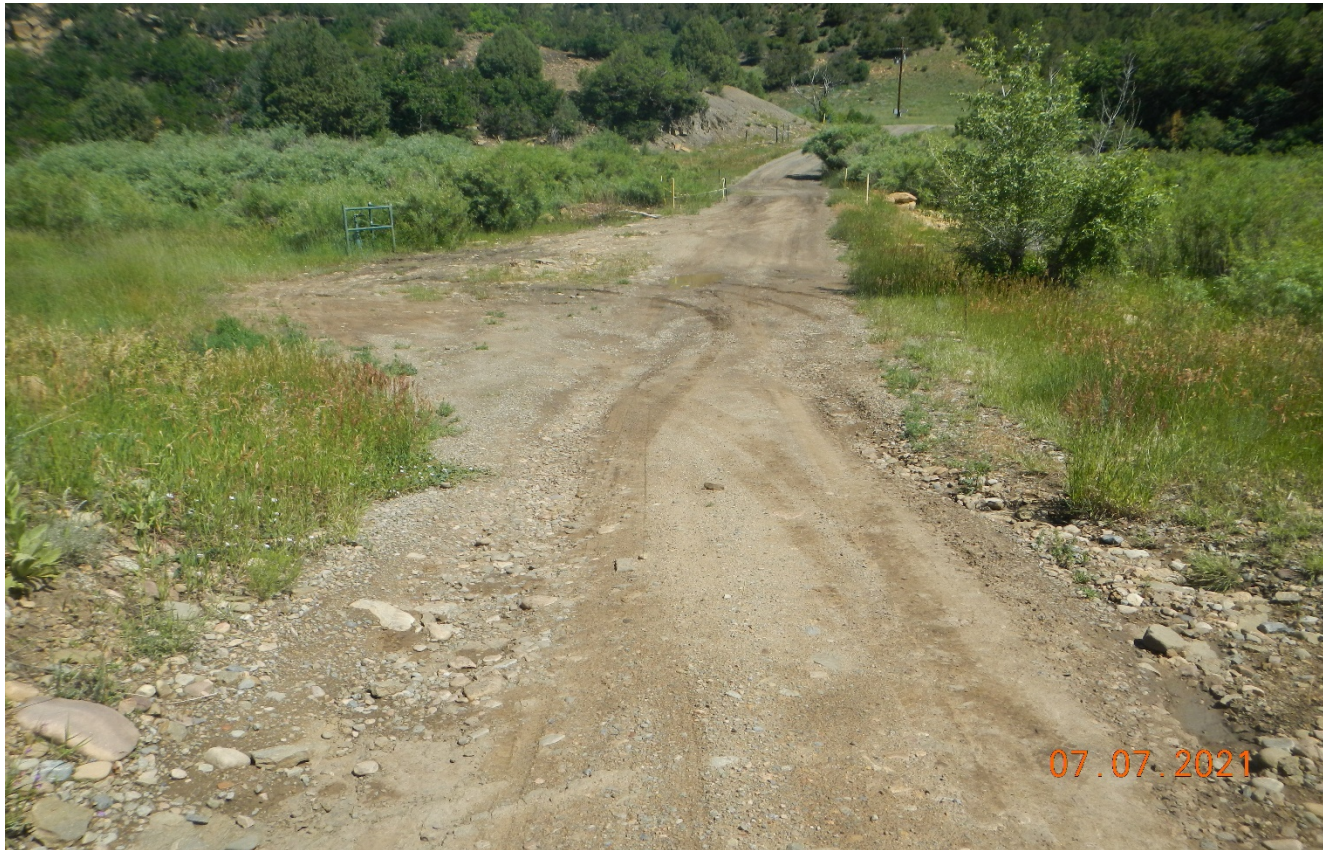
**Photo 1.** Facing north near the stream crossing. This area was observed previously with water flowing across the road. BMP's need to be installed to prevent erosion of this area.

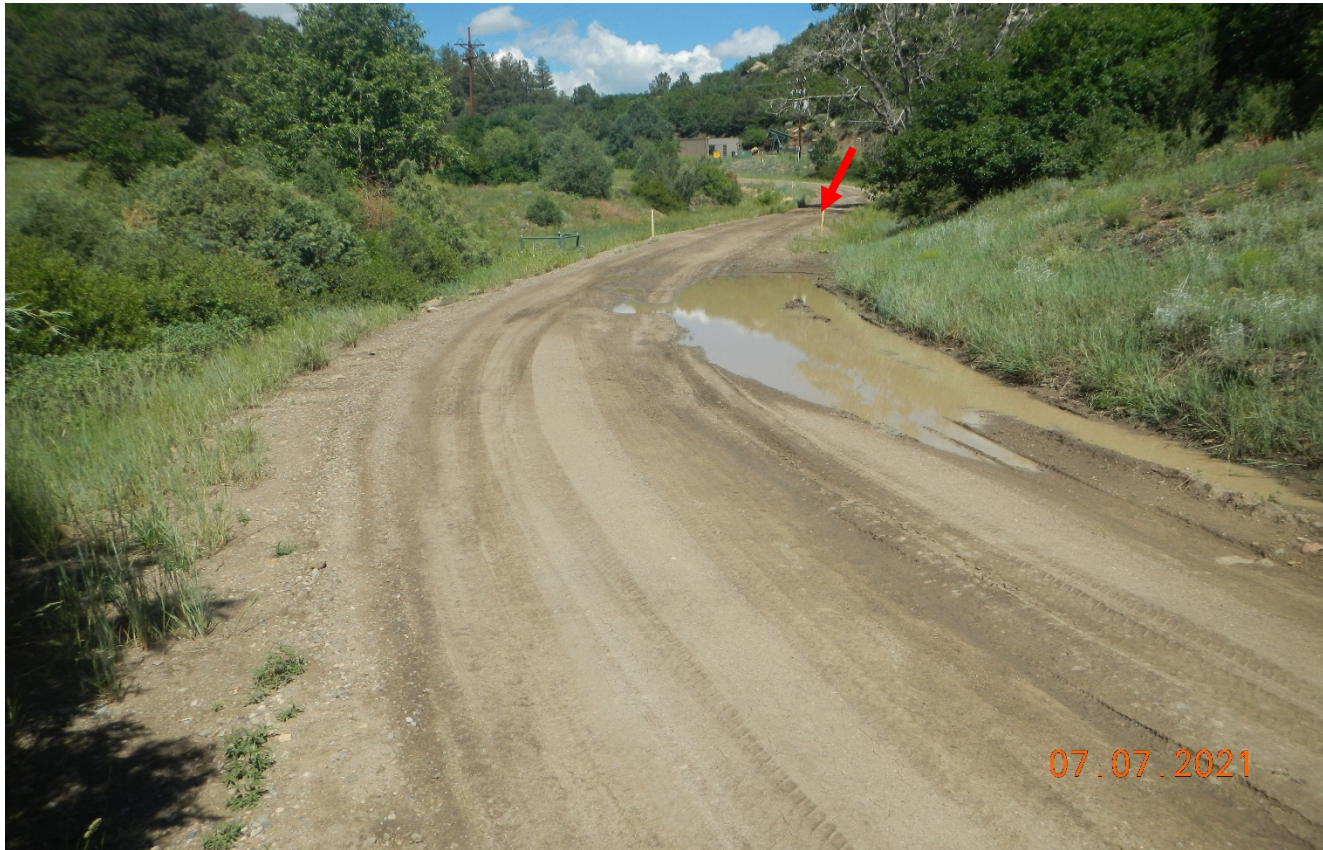
**Photo 2.** Stormwater is not directed toward the culvert (at red arrow) causing stormwater to accumulate on the road. Areas of rutting need to be stabilized. Previous corrective action was not performed.

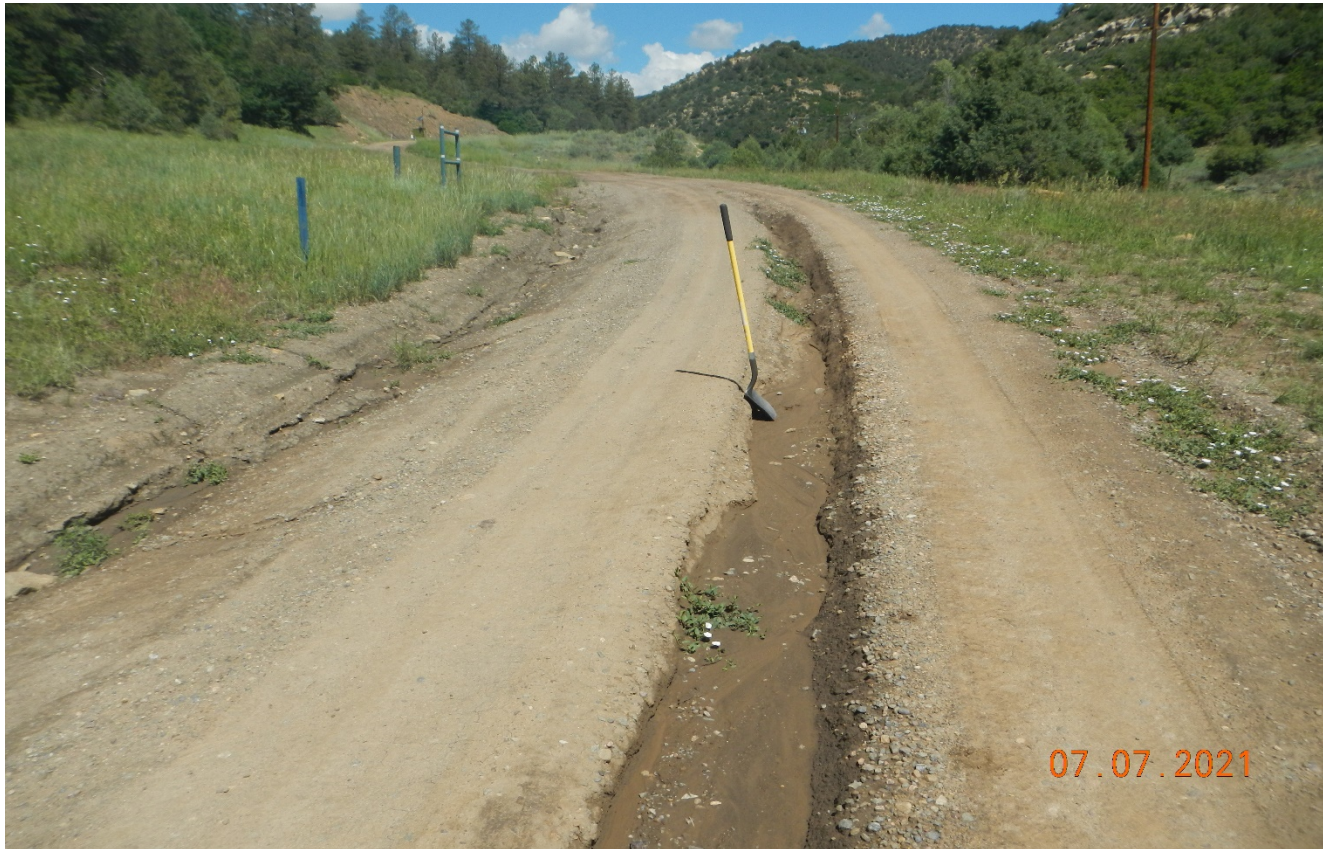
**Photo 3.** There is vehicle rutting along the main road. Areas of rutting need to be stabilized. Previous corrective action was not performed.

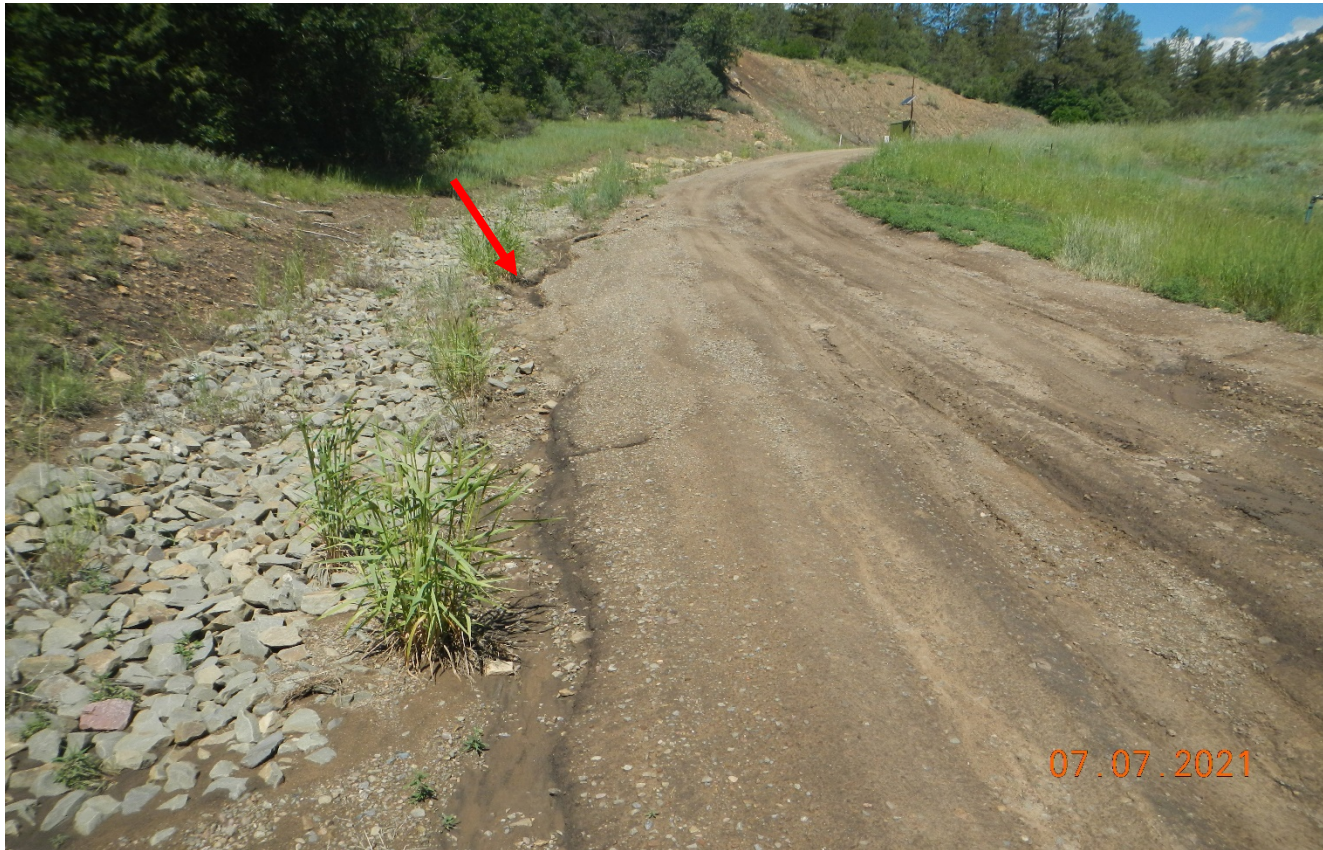
**Photo 4.** Stormwater is causing erosion along the side of the rip/rap.

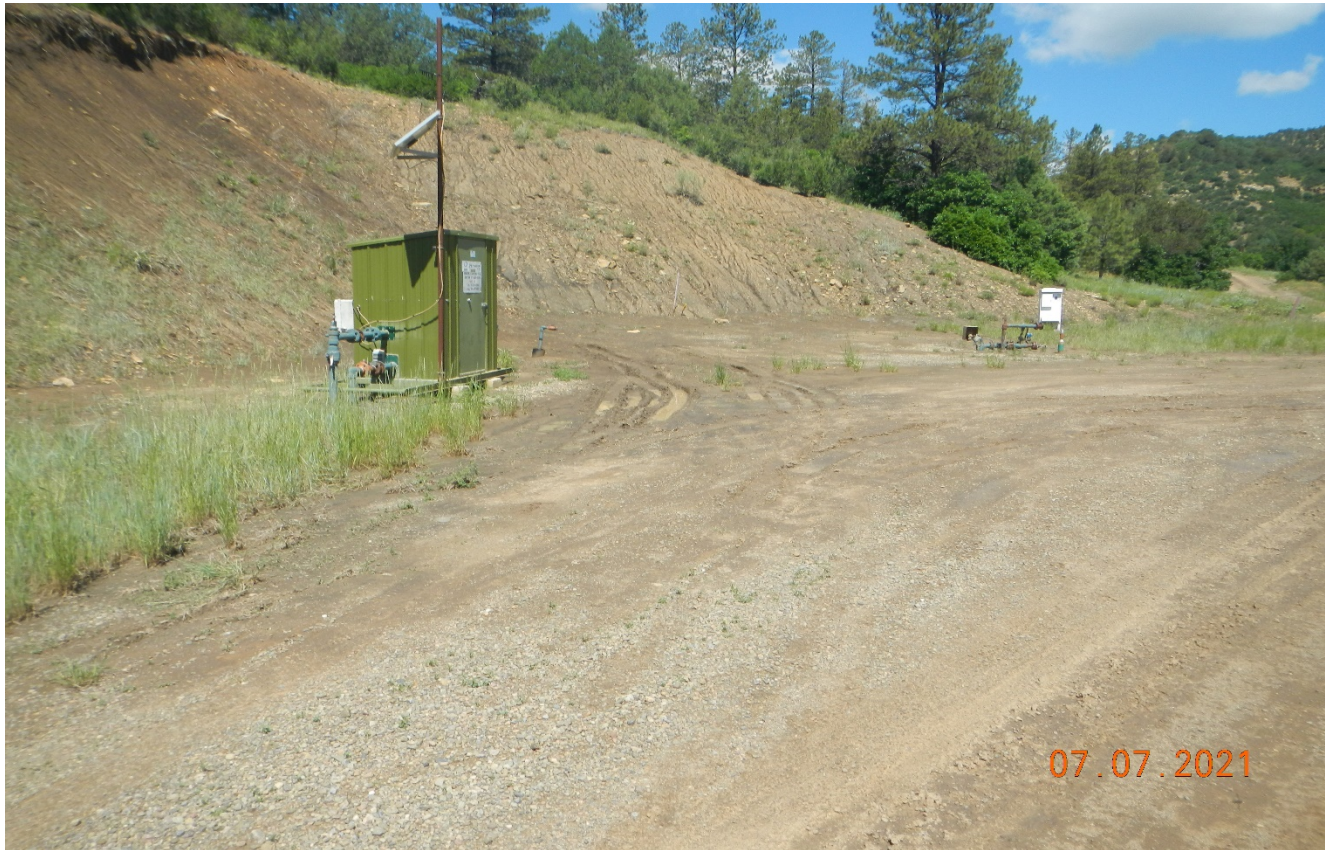
**Photo 5.** Facing toward the location.
