Inspection Photos

API: 125-06293

Operator: PUCKETT-WARREN OIL CO

Inspection Date: 7/13/2021

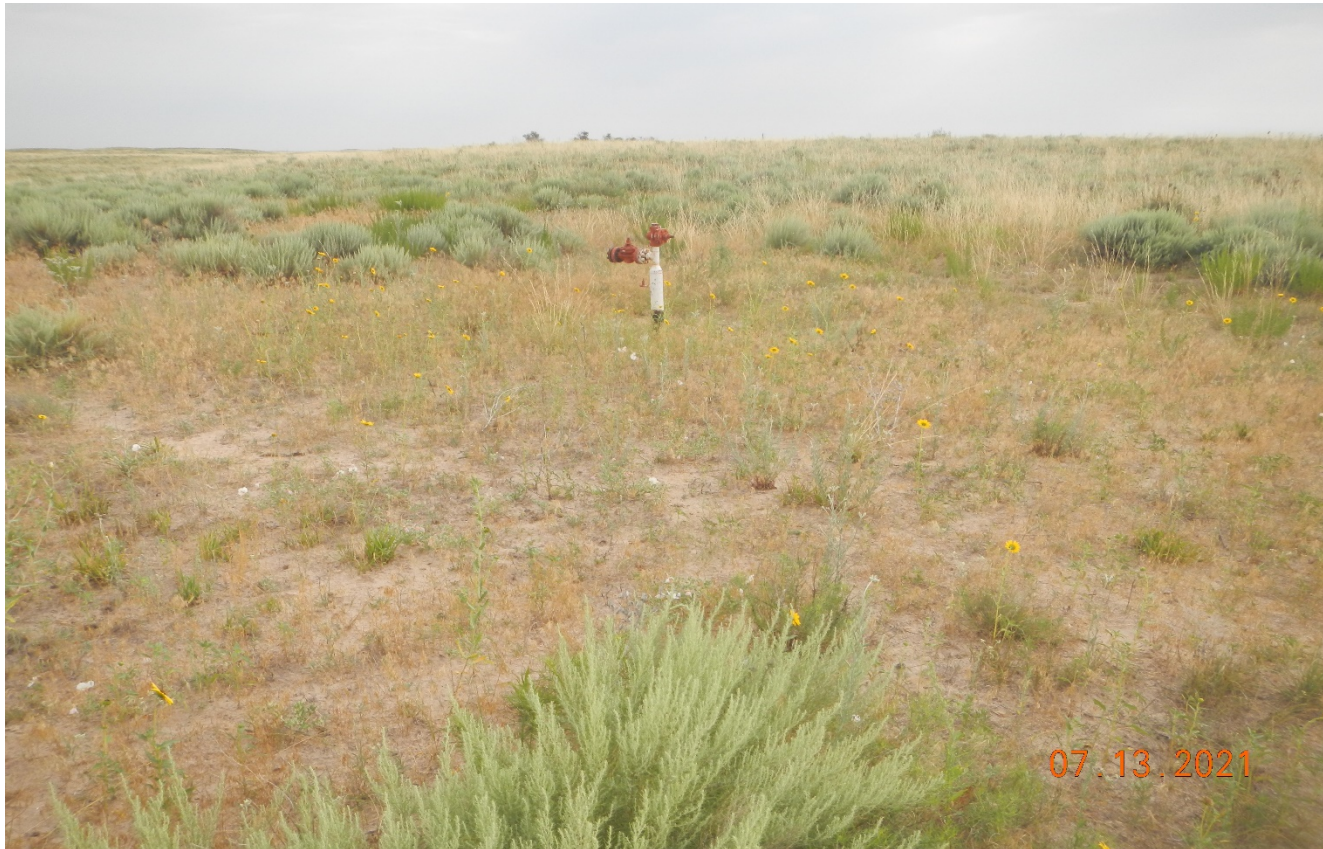
Photo 1. Facing north at the location. An abandoned pipe riser remains and the area around the riser has not established a desirable perennial vegetation cover.

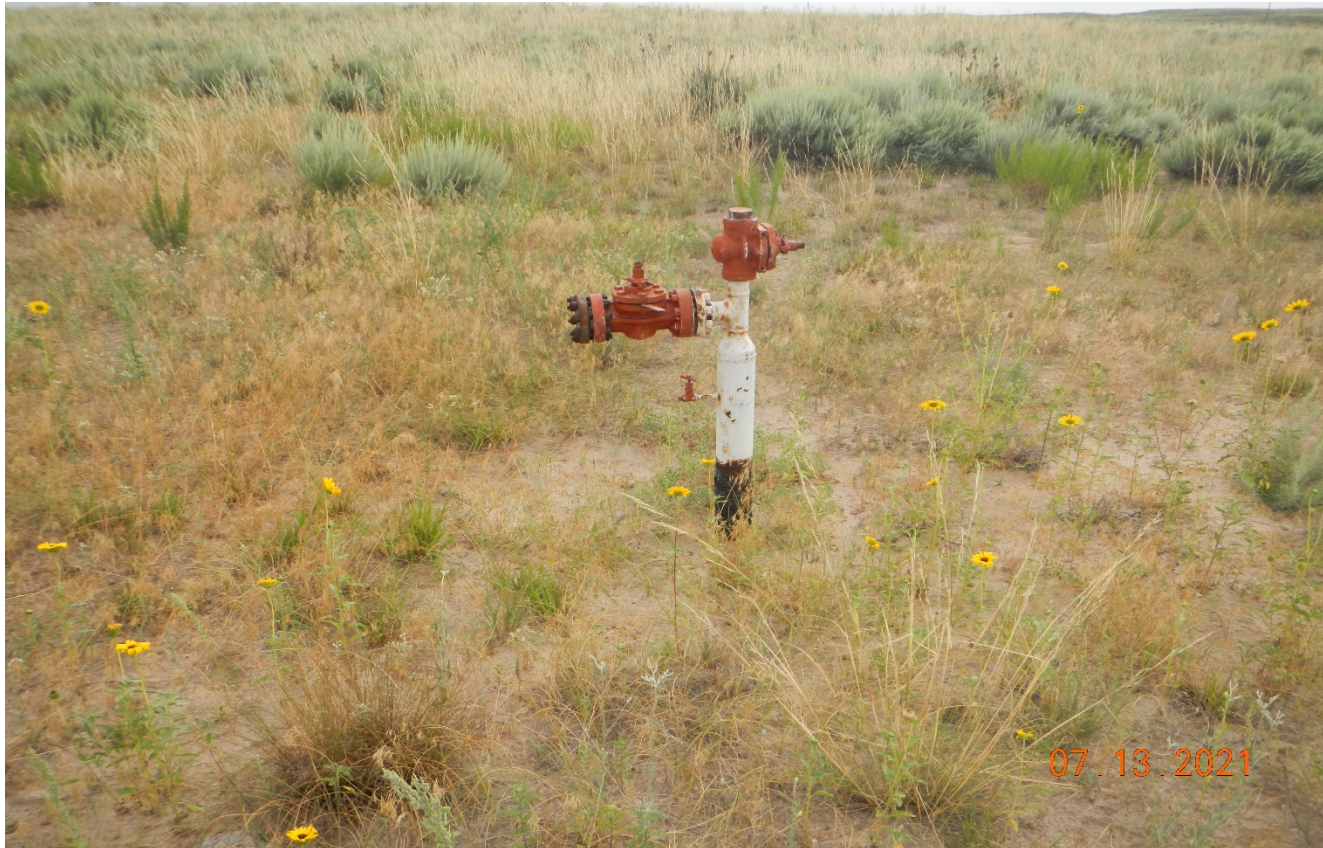
Photo 2. There is a pipe riser that remains at the location. All abandoned risers should have been removed within 3 months of plugging the well.

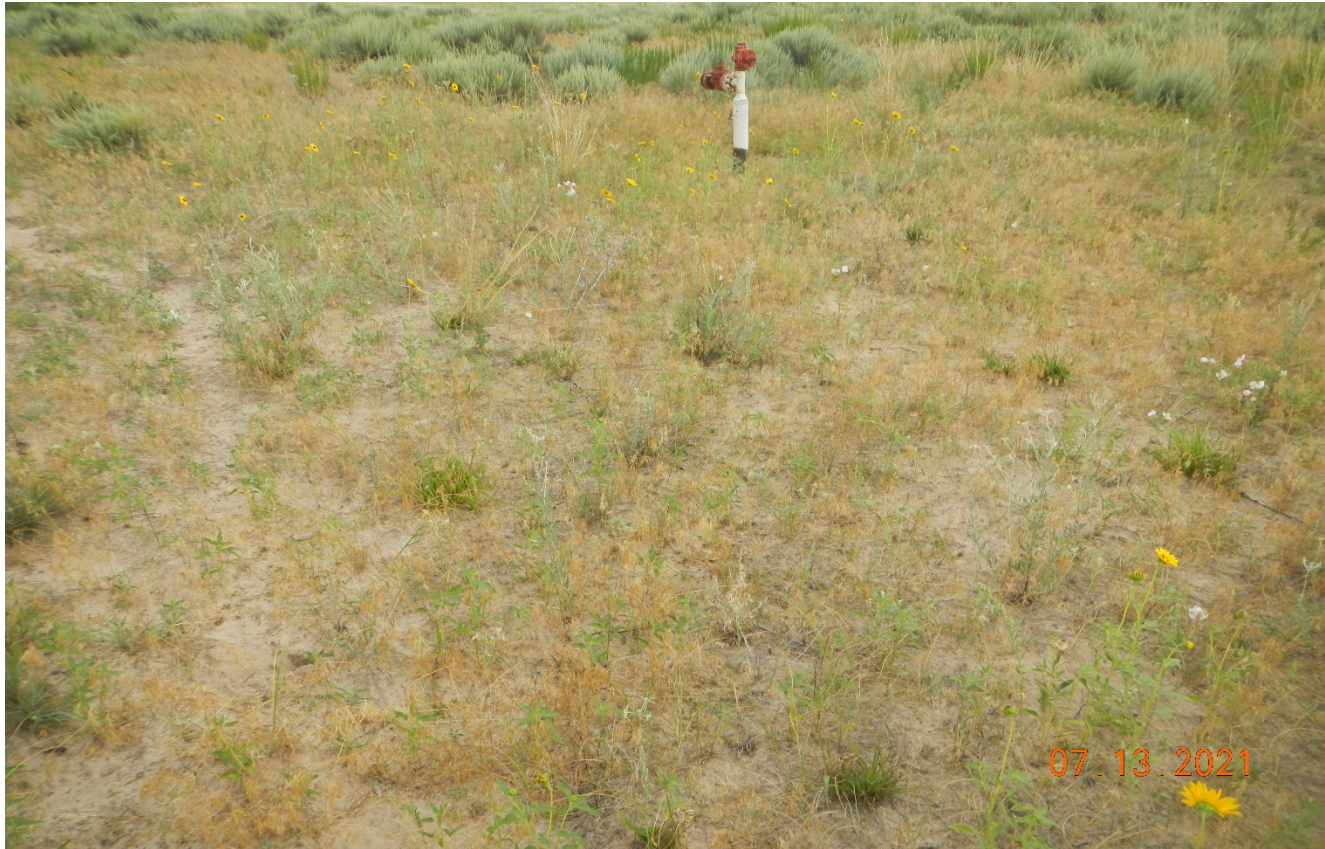
Photo 3. The area around the abandoned pipe riser consists of undesirable noxious vegetation of Cheat grass.

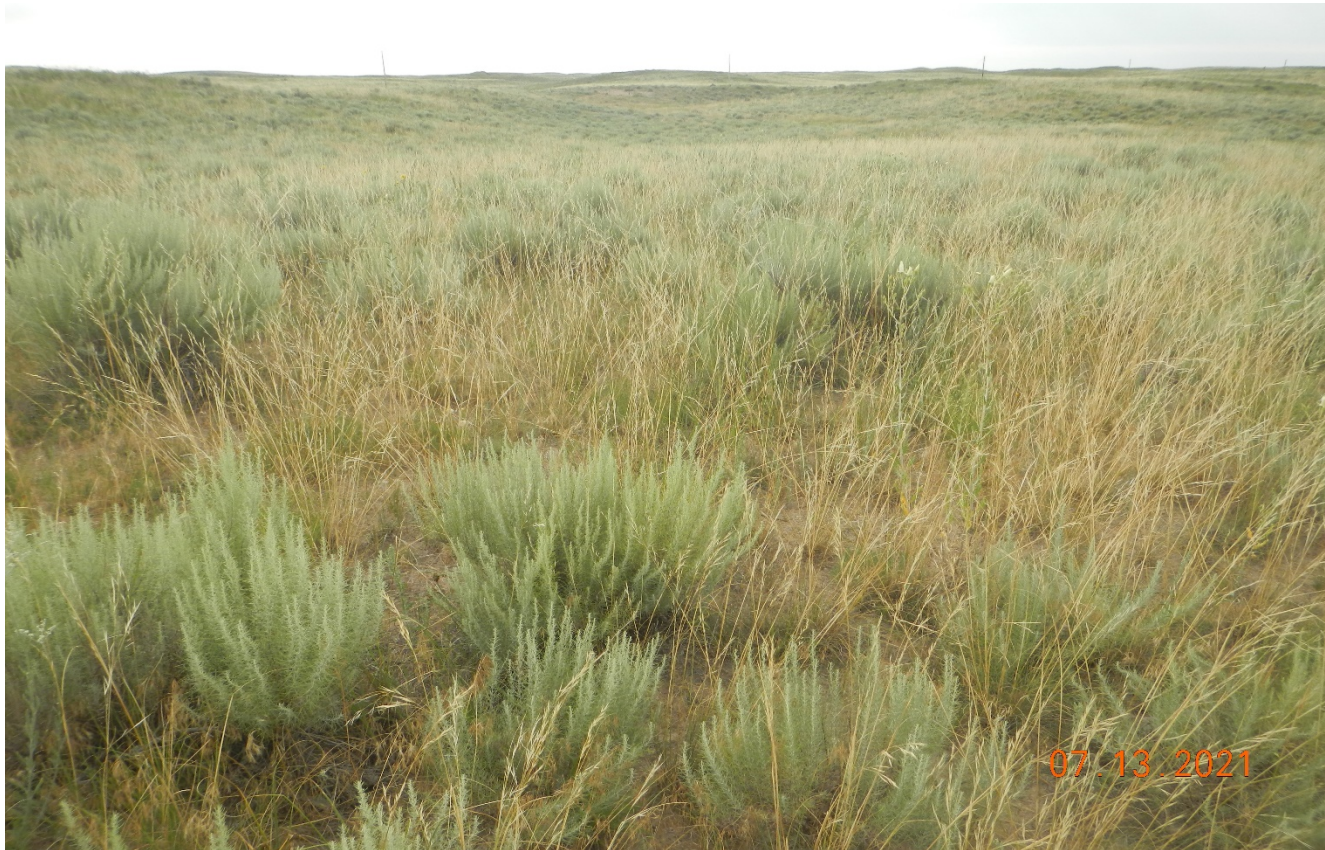
Photo 4. Facing east toward the surrounding undisturbed vegetation which consists of Sand sage, Prairie sand reed, among other perennial native species.
