# Inspection Photos

API: 121-10095

Operator: PETRON DEVELOPMENT COMPANY

Inspection Date: 7/14/2021

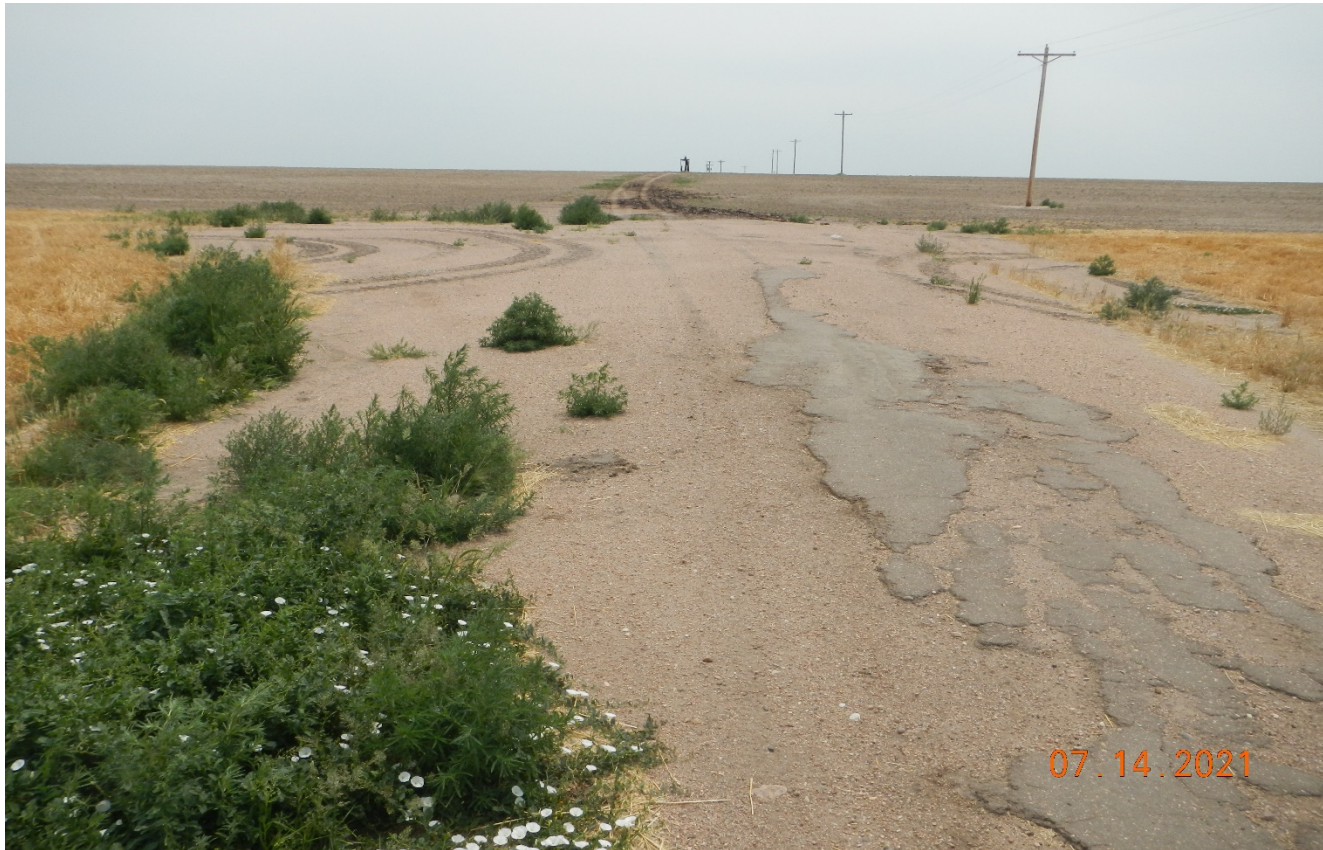
**Photo 1.** Facing south toward the location. The access road travels thru the location to an active sites. Areas out side of the road at the location were not reclaimed.

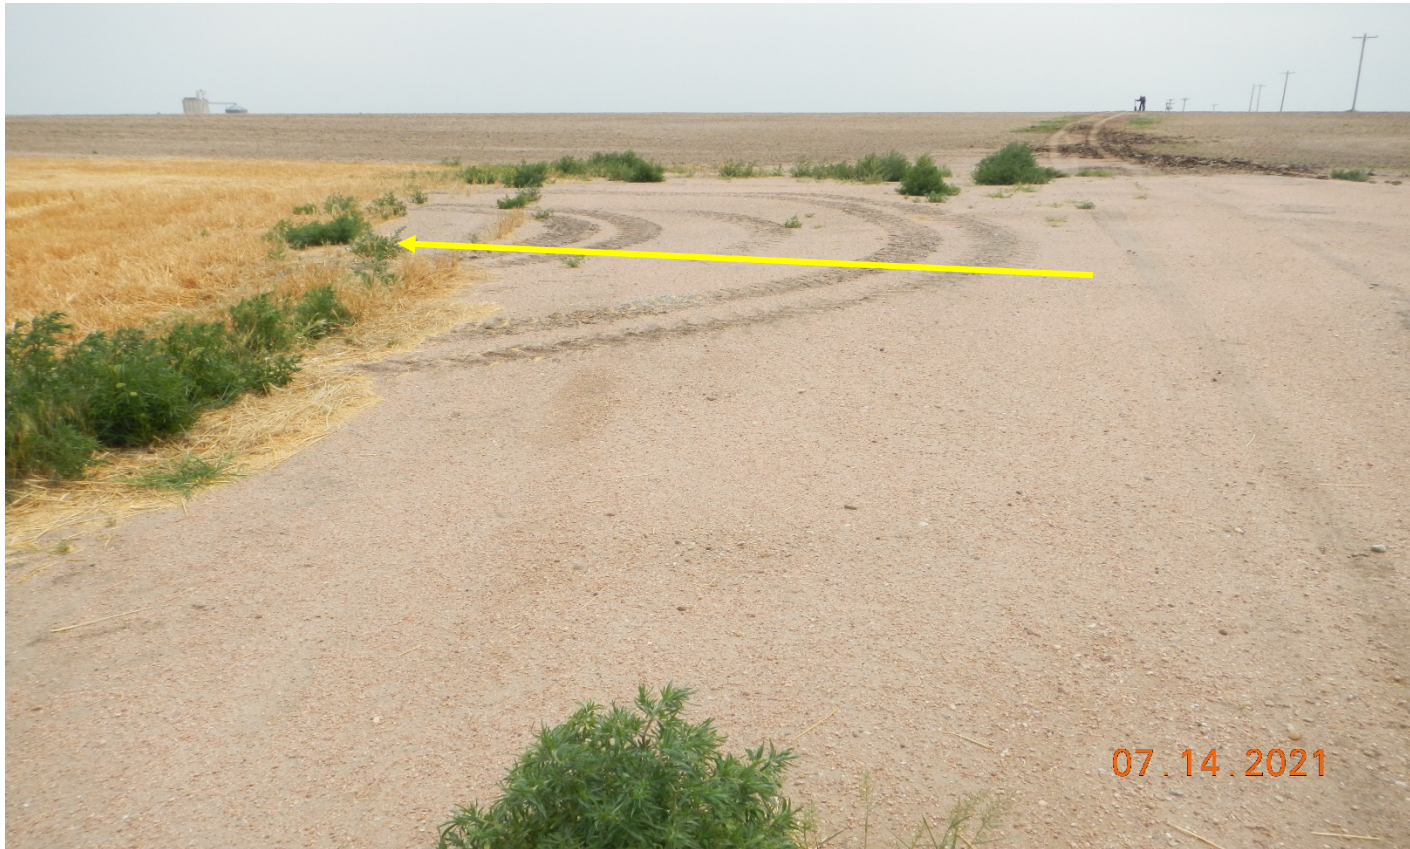
**Photo 2.** Facing south at the location which has not been reclaimed and remains bare of vegetation growth. The area shown by the yellow line next to the road is 50 ft. for reference.

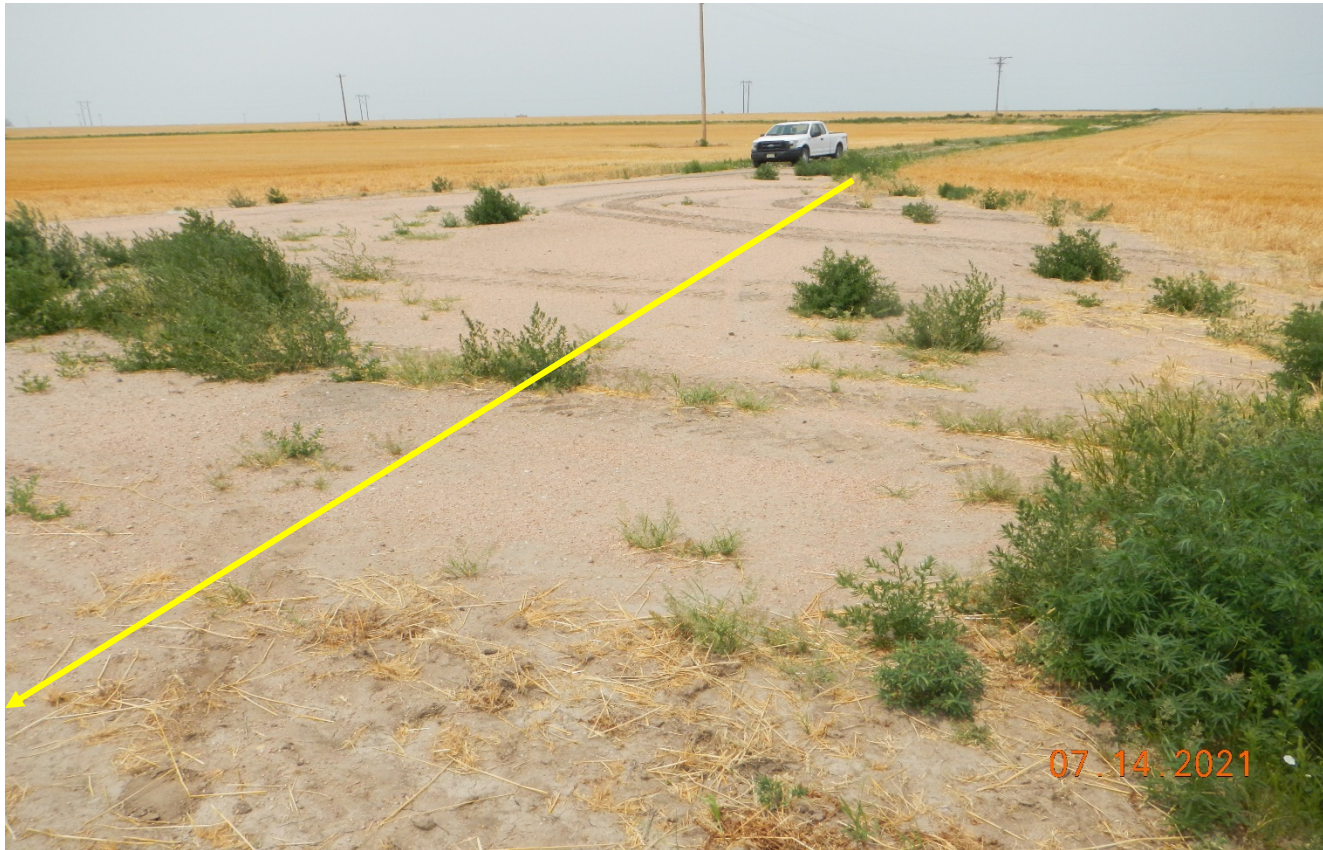
**Photo 3.** Facing back northwest toward the area of the location which has not been reclaimed. The area shown by the yellow line is approximately 200 ft.

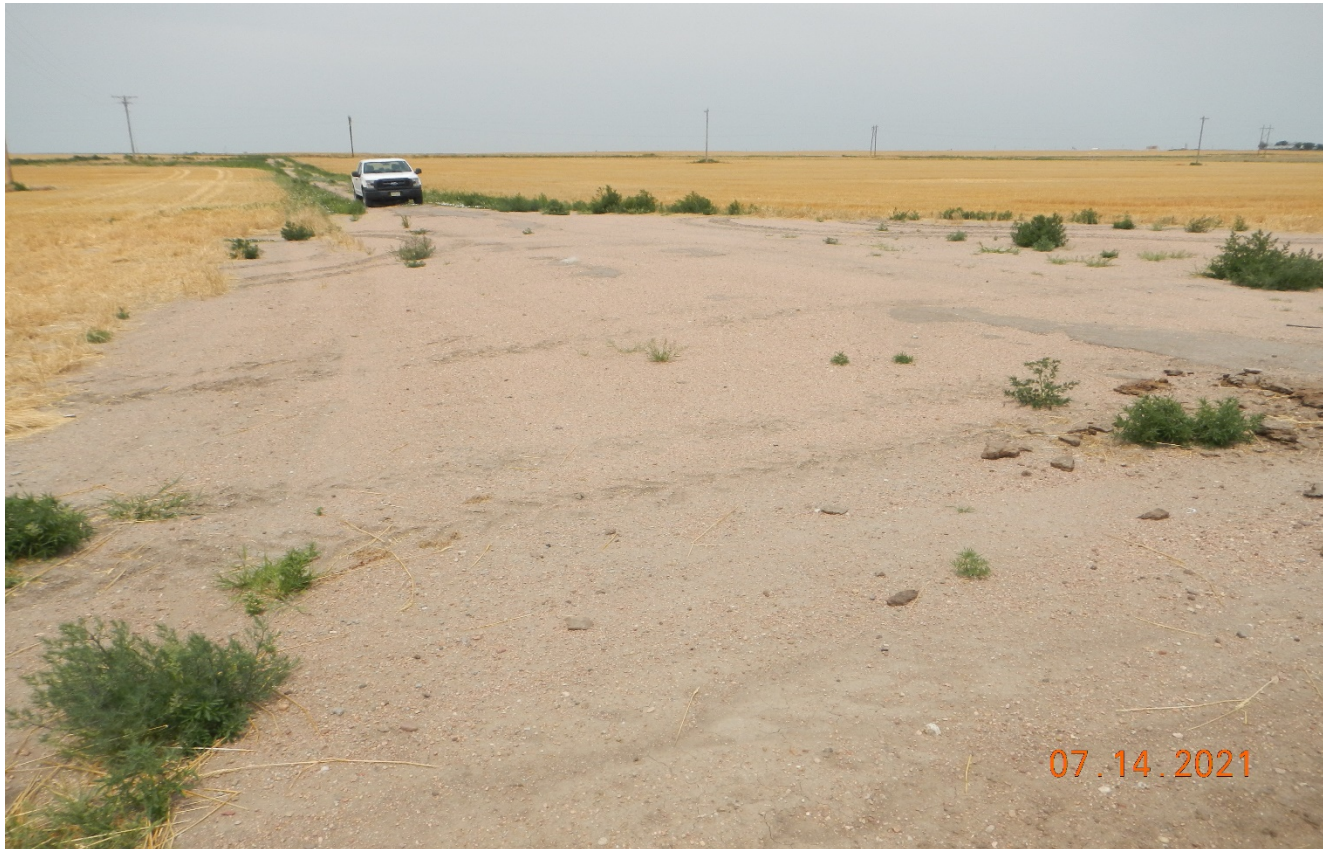
**Photo 4.** Facing northeast at the west side of the location.

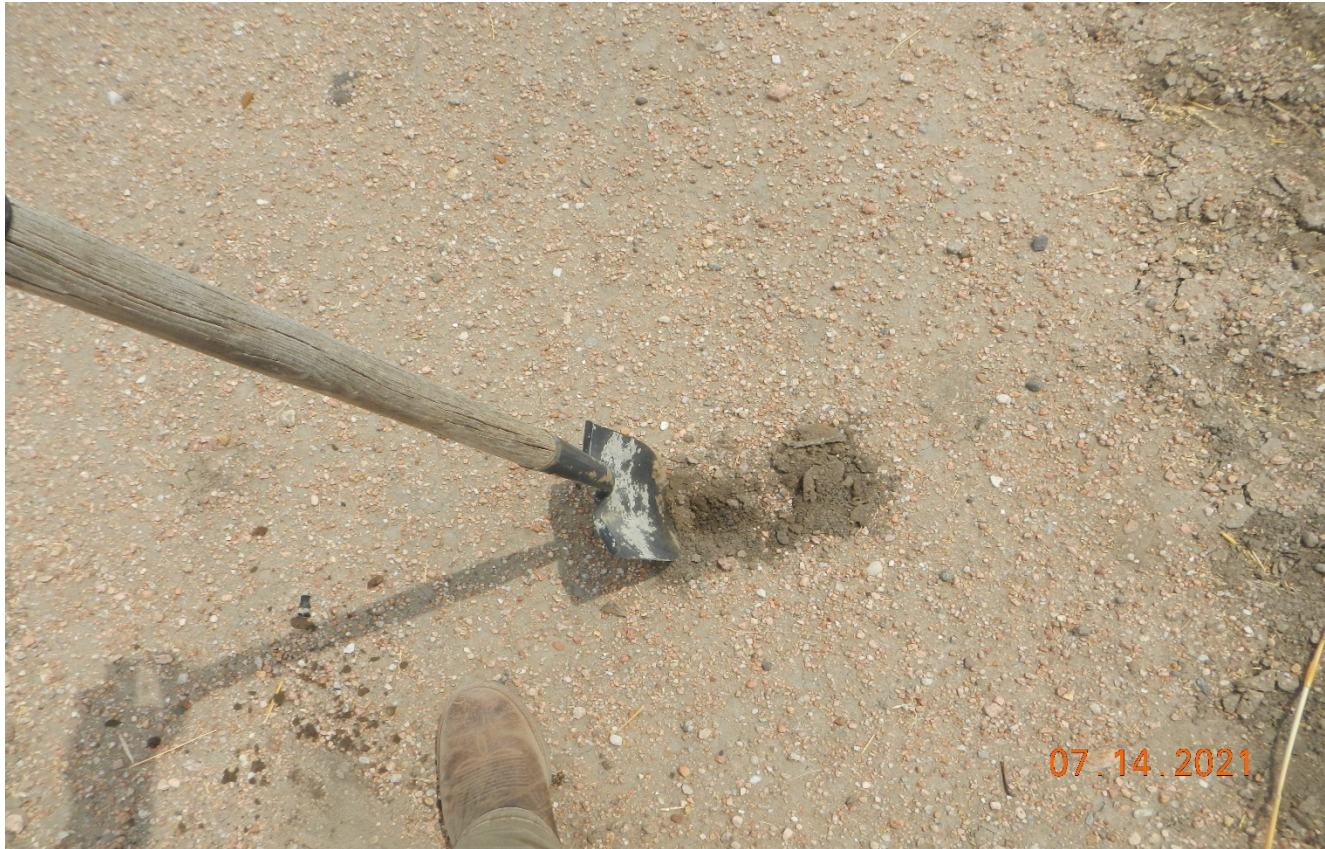
**Photo 5.** The soils throughout the location are compacted. The shovel could not penetrate through the soil.

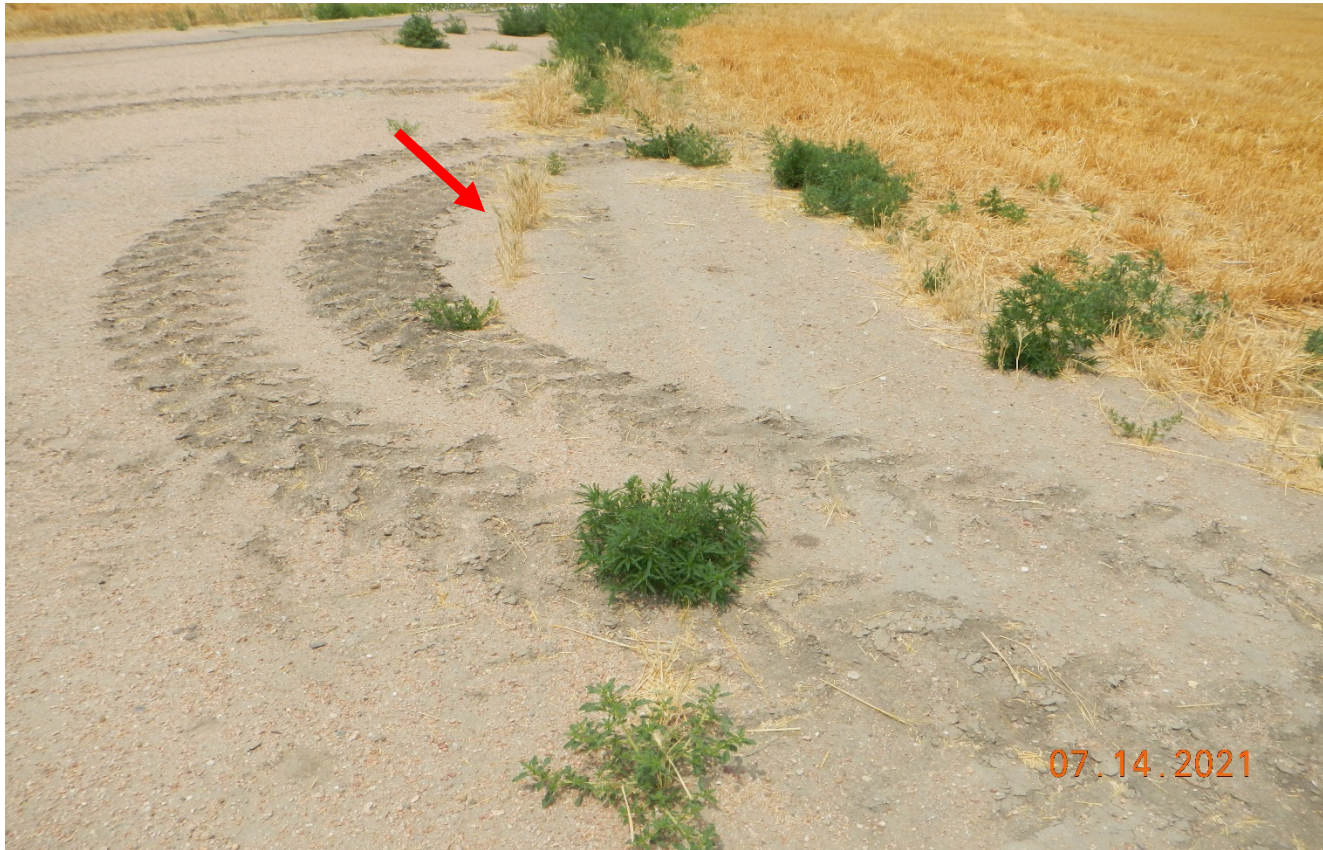
**Photo 6.** This photo indicates the crop was planted in this area shown by wheat stubble at red arrow. The crop did not establish any further at red arrow indicating soil issues impacted crop growth.
