Inspection Photos
Operator: Benson Montin Greer
API: 067-06290
Date: 7/20/2021

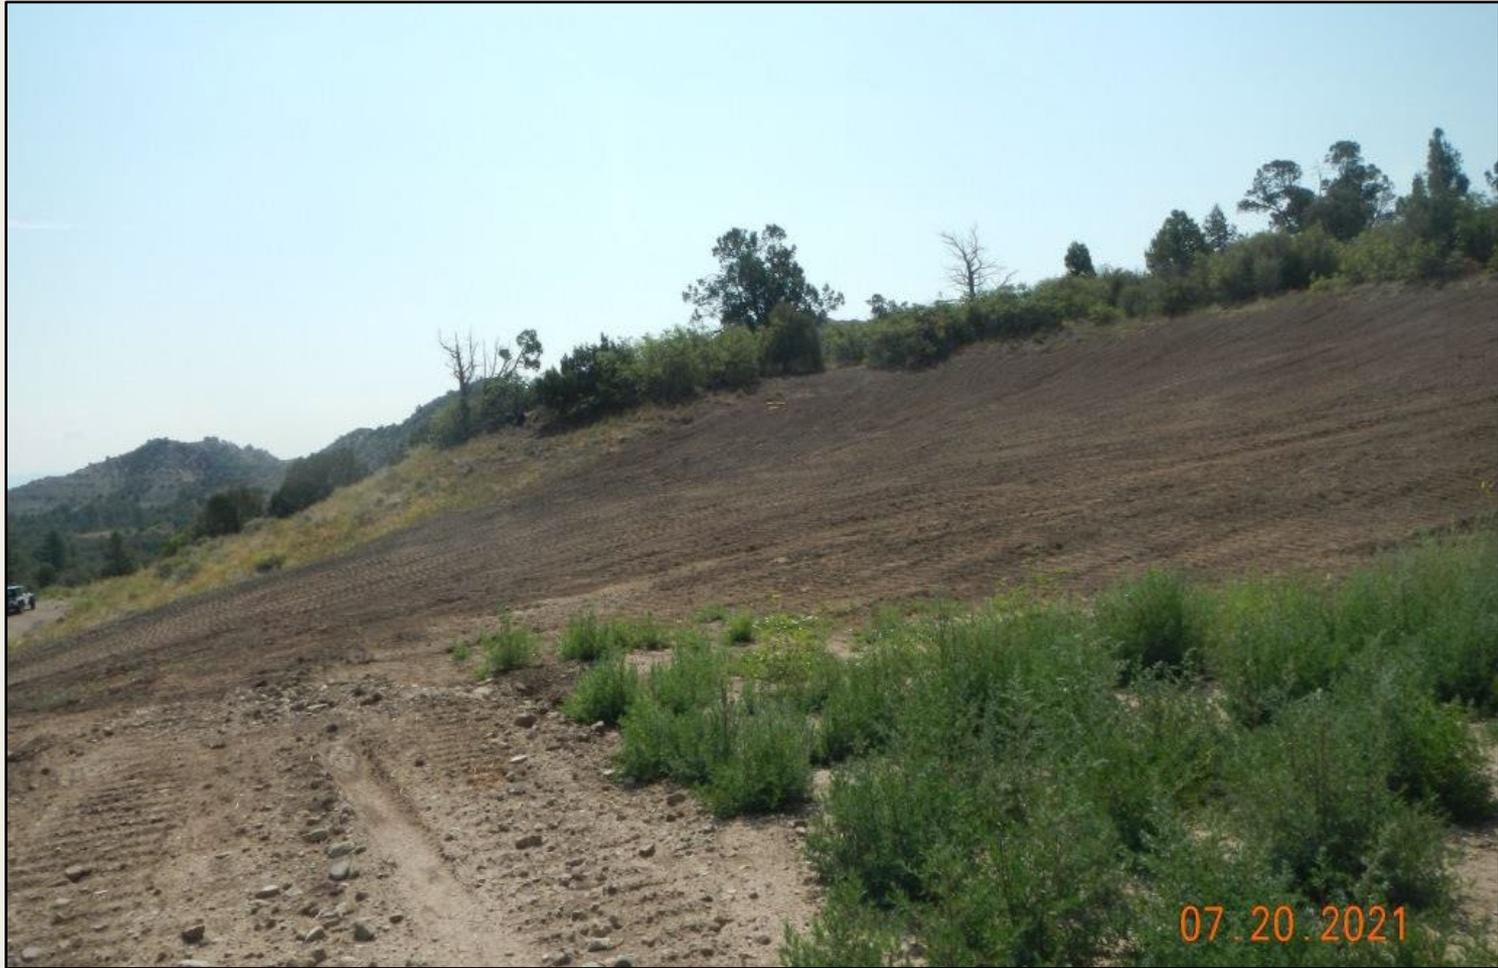
Photo 1. View the project area from the northwestern corner facing southeastward. Area is graded and recontoured. Germination not observed.

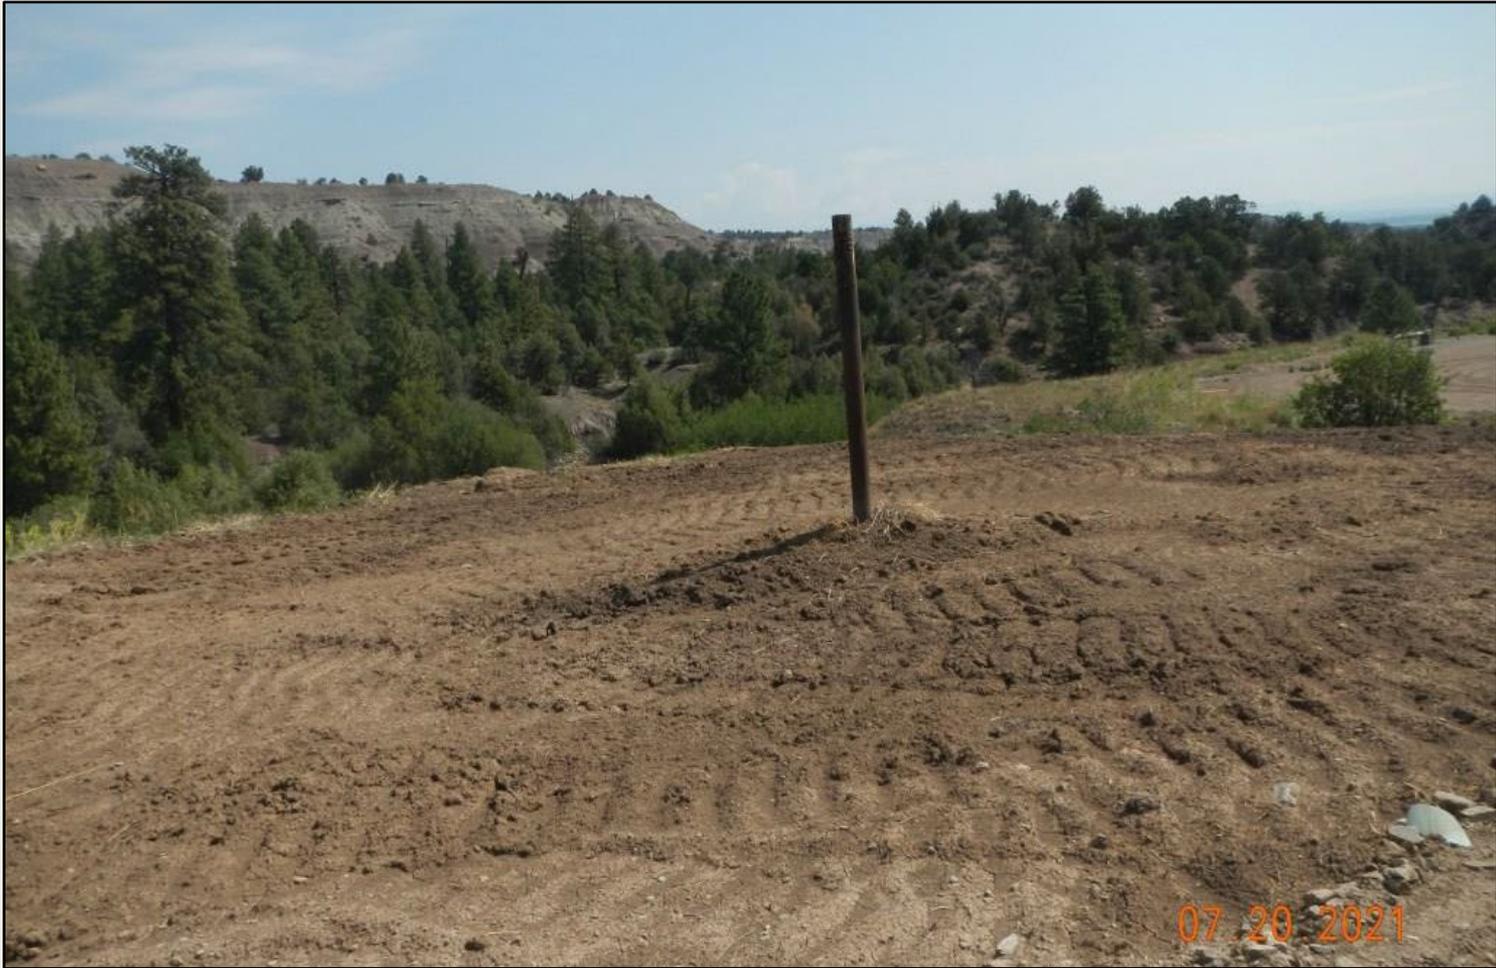
Photo 2. View of plugged well marker facing northward. Area is graded.

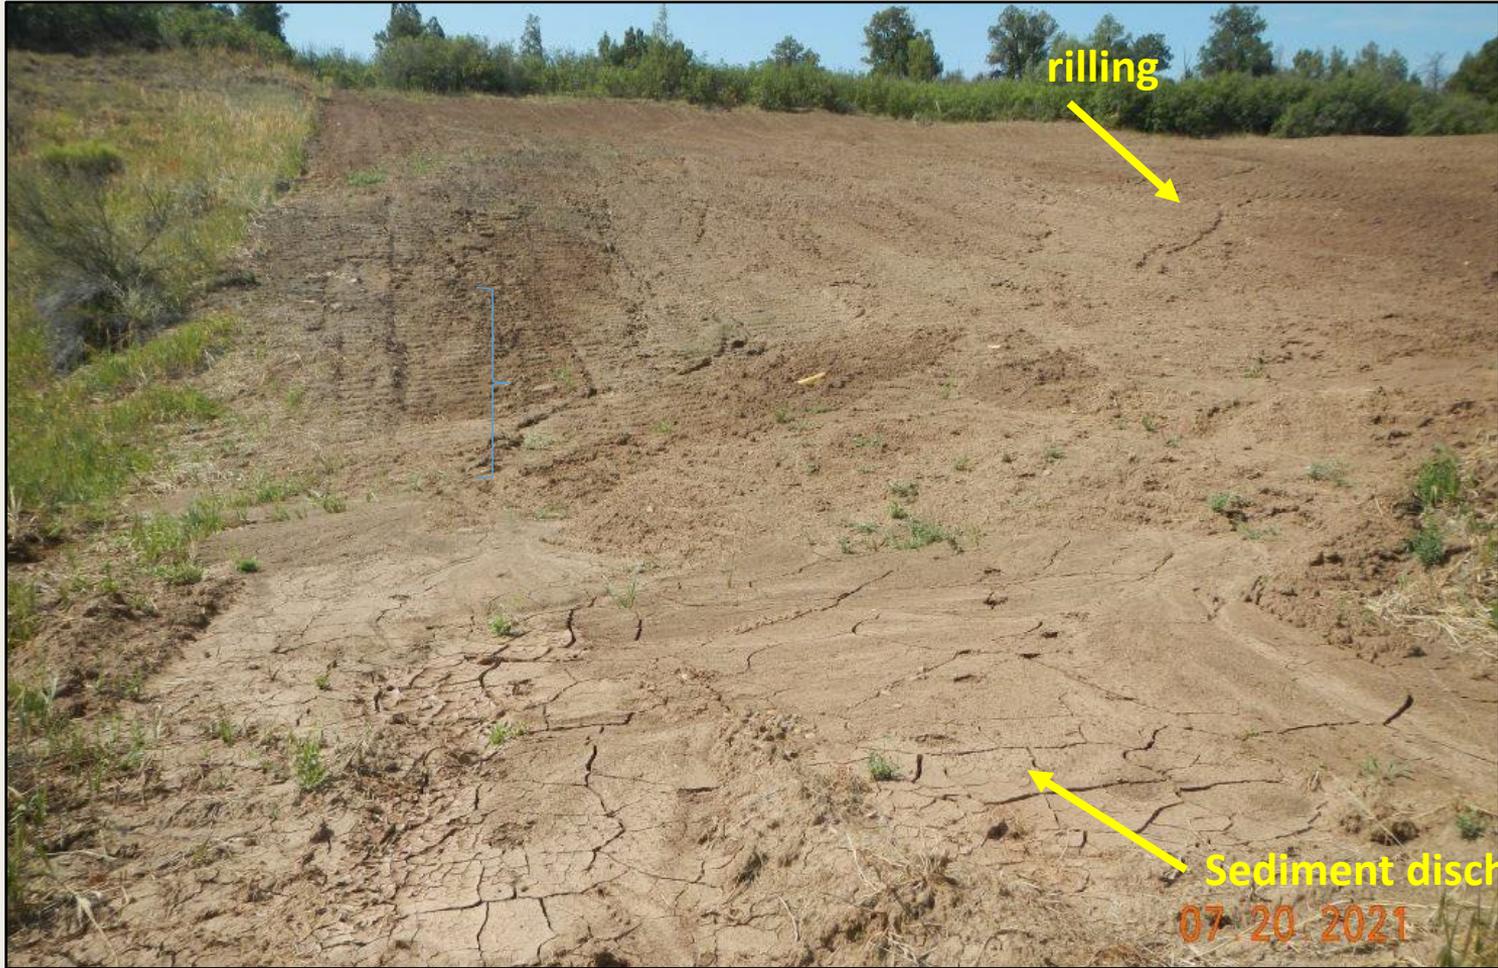
Photo 4. View of erosional rilling and sediment discharge from bare soils in the northeastern corner of the project area (facing upslope)

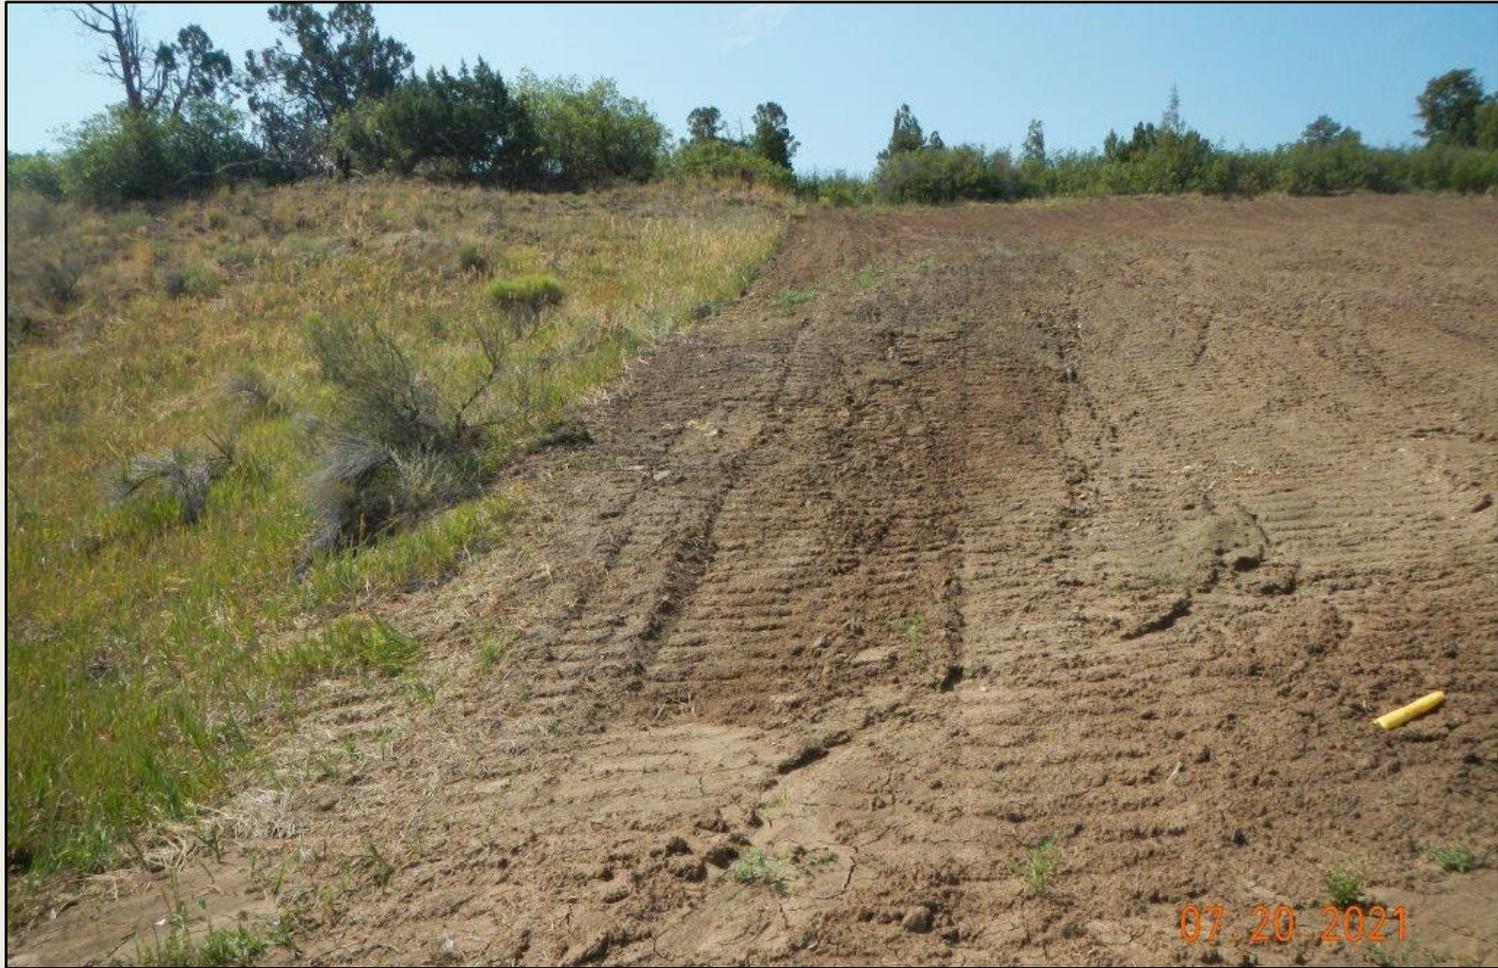
Photo 4. View of the northern edge of the project area facing eastward.

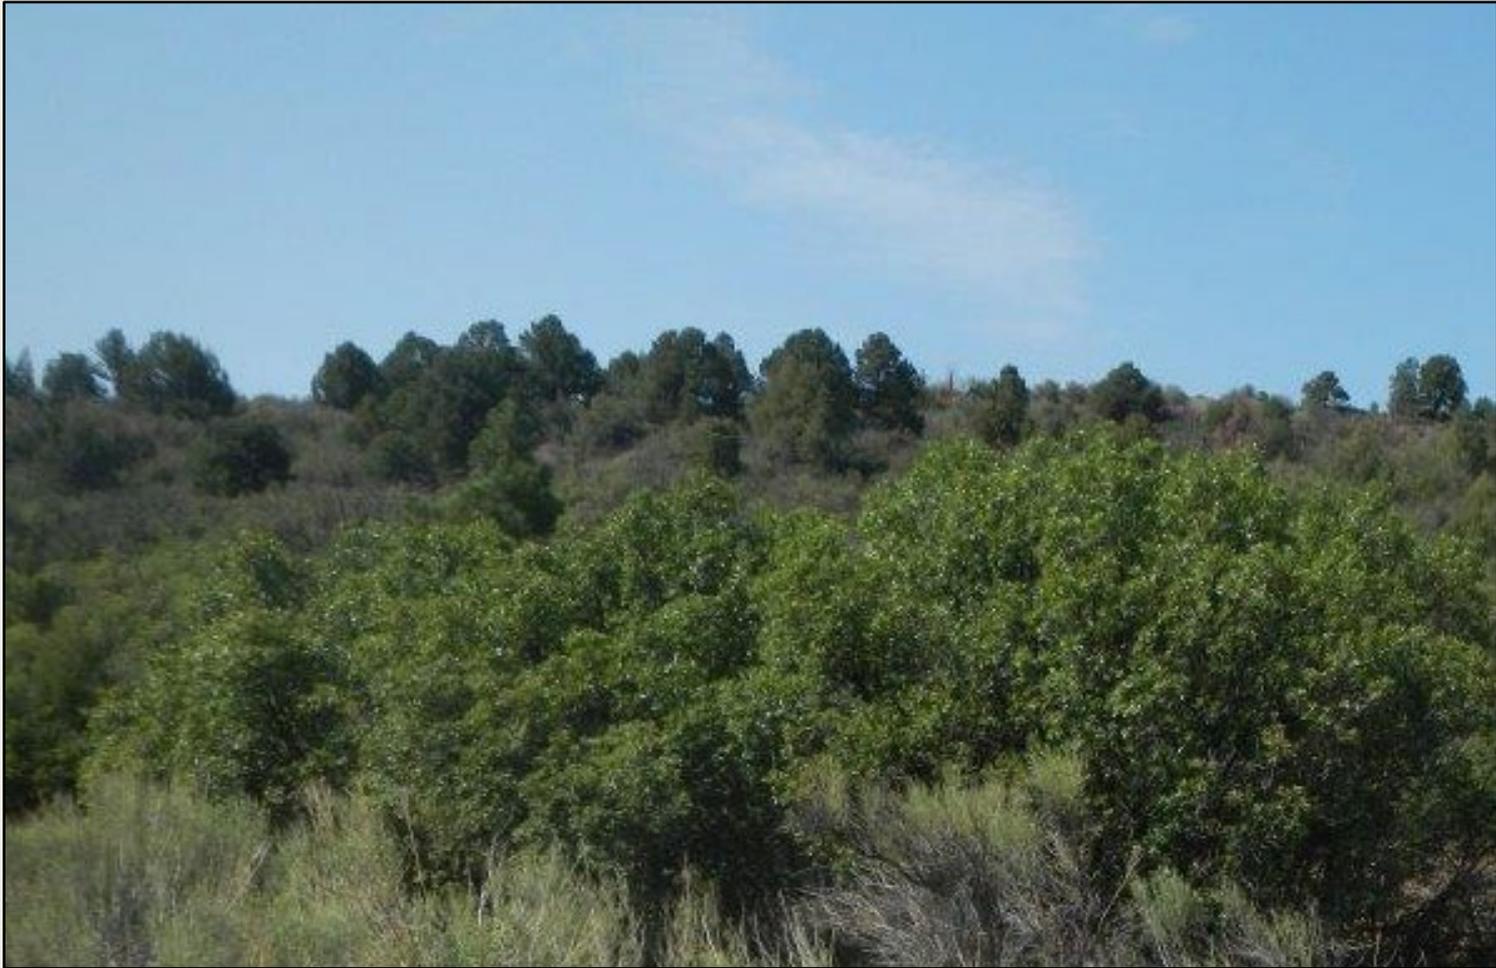
Photo 5. View the reference area comprised of gambel oak shrubland with pinyon and juniper trees and scattered ponderosa pine trees. Vegetation in the understory includes western wheatgrass, Indian ricegrass, Indian paintbrush, and goldenweed.
